Refurbishment / Demolition Asbestos Survey

**Lowdham Leisure World,
Blackmoorfoot Road,
Huddersfield, HD4 5NU**

Issue number:	1
Survey number:	7168
Survey date:	10/06/2021
Client:	Redrow Homes Ltd
Survey carried out by:	Phil Cox
Survey compiled by:	Graham Brown
Survey checked by:	Phil Cox
Survey Issued	21/06/2021

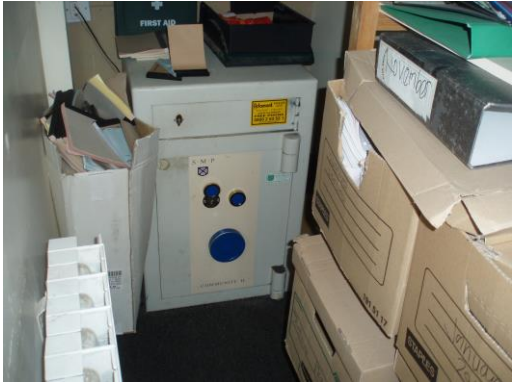
Level of ID:	Visually inspected	Ref:	P1
	Building / Floor: 1 / Ground Area: R13 File store Location: Floor Description: Asbestos Type: Crocidalite Amount: Item			
Recommendations:				
Any works that would disturb or require the removal of this material must be carried out in accordance with the Control of Asbestos Regulations 2012

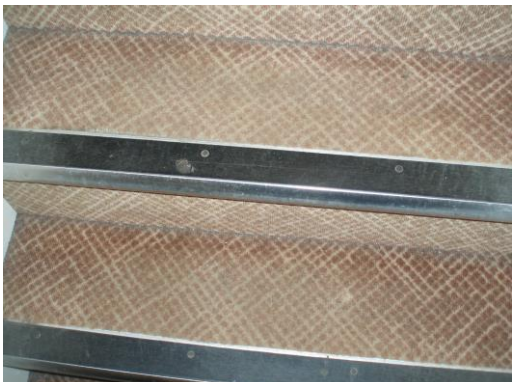
Level of ID:	Sampled	Ref:	S01
	Building / Floor: 1 / First Area: R18 Fire escape staircase Location: Stairs Description: Stair nosing Asbestos Type: No asbestos detected Amount:			
Recommendations:				
No action required

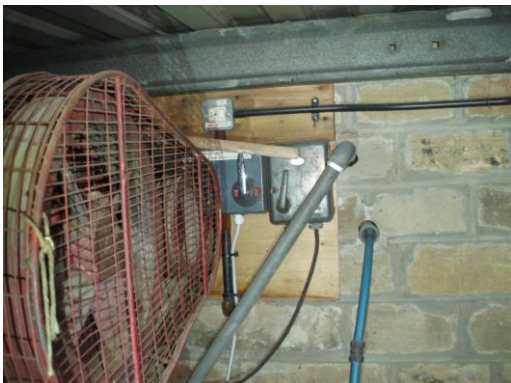
Level of ID:	Visually inspected	Ref:	P2
	Building / Floor: 2 / Ground Area: R20 Compressor room Location: Wall Description: Electrics Asbestos Type: Chrysotile Amount: Item			
Recommendations:				
Any works that would disturb or require the removal of this material must be carried out in accordance with the Control of Asbestos Regulations 2012

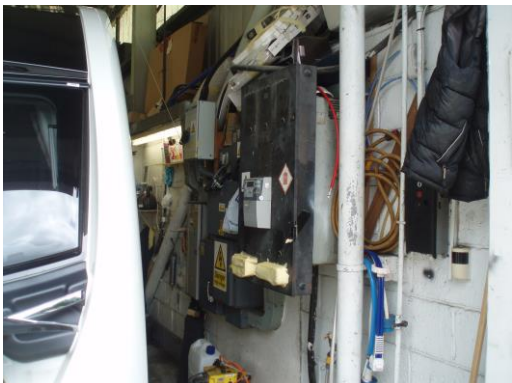
Level of ID:	Visually inspected	Ref:	P3
	<p>Building / Floor: 2 / First</p> <p>Area: R21 Garage</p> <p>Location: Throughout</p> <p>Description: Presume flash guards to the electrical installations throughout the garage</p> <p>Asbestos Type: Chrysotile</p> <p>Amount: Items</p>			
Recommendations:				
Any works that would disturb or require the removal of this material must be carried out in accordance with the Control of Asbestos Regulations 2012

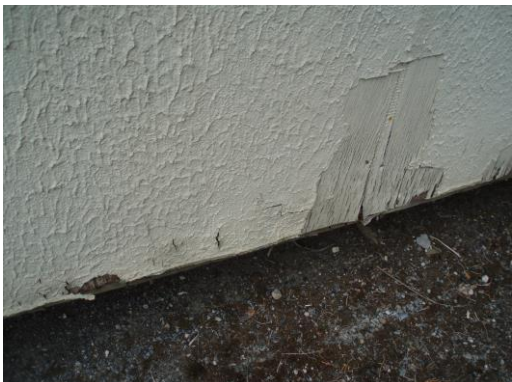
Level of ID:	Visually inspected	Ref:	S03
	<p>Building / Floor: 6 / Ground</p> <p>Area: R28 Prefabricated cabin(Canteen)</p> <p>Location: Wall</p> <p>Description: Insulated timber, external textured coating (S03)</p> <p>Asbestos Type: No asbestos detected</p> <p>Amount:</p>			
Recommendations:				
No action required

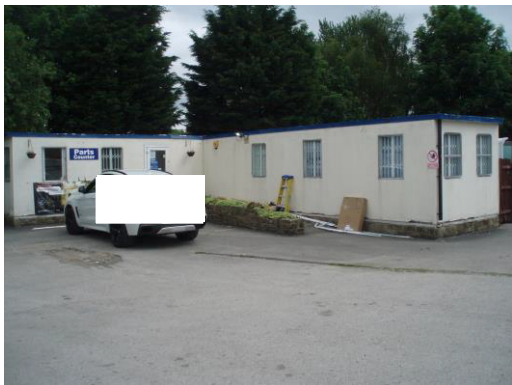
Level of ID:	Visually inspected	Ref:	S04
	<p>Building / Floor: 7 / Ground</p> <p>Area: R29 Prefabricated cabin(Parts)</p> <p>Location: Wall</p> <p>Description: Insulated timber, external textured coating (S04) internal de-mountable partitions</p> <p>Asbestos Type: No asbestos detected</p> <p>Amount:</p>			
Recommendations:				
No action required

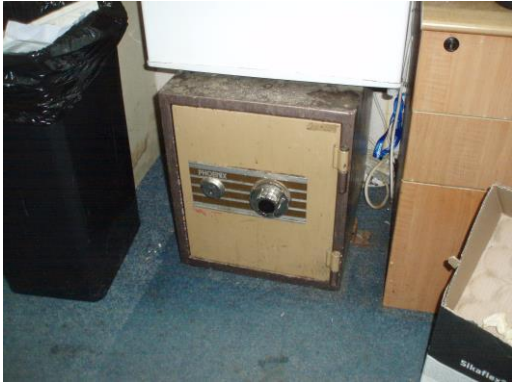
Level of ID:	Visually inspected	Ref:	P4
	<p>Building / Floor: 7 / Ground</p> <p>Area: R29 Prefabricated cabin(Parts)</p> <p>Location: Floor</p> <p>Description: Safe lining</p> <p>Asbestos Type: Crocidalite</p> <p>Amount: Item</p>			
Recommendations:				
<p>Any works that would disturb or require the removal of this material must be carried out in accordance with the Control of Asbestos Regulations 2012</p>

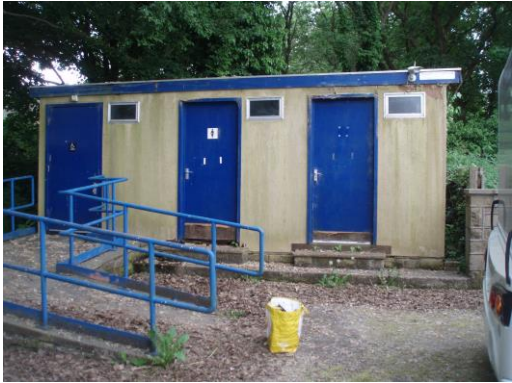
Level of ID:	Visually inspected	Ref:	As S03
	<p>Building / Floor: 15 / Ground</p> <p>Area: R34 Prefabricated cabin</p> <p>Location: Wall</p> <p>Description: Insulated timber, external textured coating (As S03)</p> <p>Asbestos Type: No asbestos detected</p> <p>Amount:</p>			
Recommendations:				
No access due to a Bee's nest, visually the same as building 6
