Project Name: SHAPE ENG MIRFIELD

Project Description: WinCan Import in Miraculix WRc4 Standard

Project Date: 20/04/2021

Company: Shape Engineering
Description: Structural CCTV Investigation Survey
Street: Knowl Grove
Town or City: Mirfield
Post Code: WF14 9RU

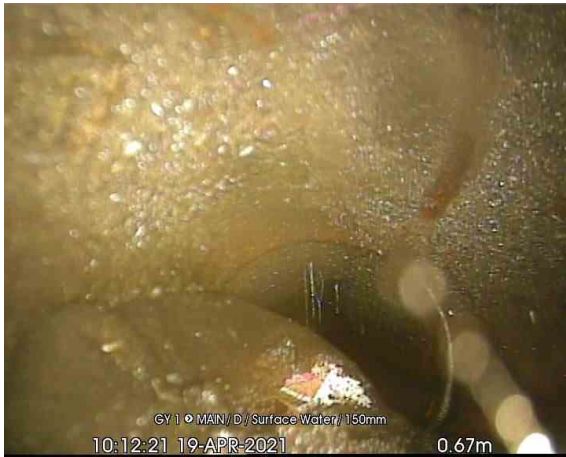
| No. | m+ | Code | Observation |
|---|---|---|--|
| 3 | 0.67 | DES | Settled deposits, fine, 70% cross-sectional area loss |

KNOWLE GROVE_0-67m_101221.jpg, 00:00:12, 0.67 m
Settled deposits, fine, 70% cross-sectional area loss

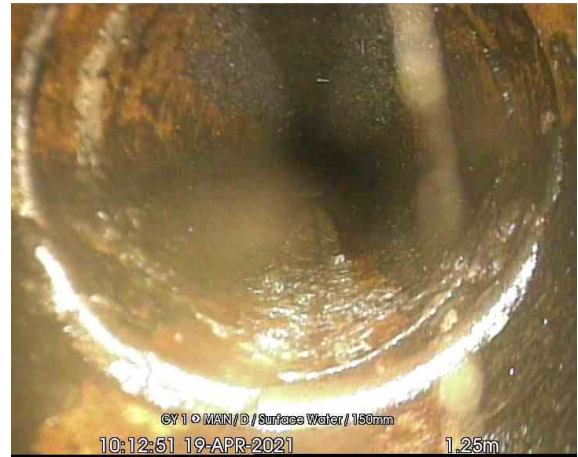
| Section | PLR | Grade | Description |
|---|---|---|--|
| 1 | GY 1X | 3 | Fracture, circumferential at joint from 4 o'clock to 6 o'clock |

<table><tr> <td style="width: 10%; text-align: right;">0.20</td> <td style="width: 10%;">GY</td> <td style="width: 40%;">Start node type, gully, reference number: GY 1</td> <td style="width: 10%;">00:00:01</td> <td></td> <td></td> <td></td> </tr><tr> <td style="text-align: right;">1.25</td> <td>FCJ</td> <td>Fracture, circumferential at joint from 4 o'clock to 6 o'clock</td> <td>00:00:29</td> <td>KNOWLE GROVE_1 -25m_101</td> <td>3</td> <td></td> </tr></table>

KNOWLE GROVE_1-25m_101251.jpg, 00:00:29, 1.25 m
Fracture, circumferential at joint from 4 o'clock to 6 o'clock

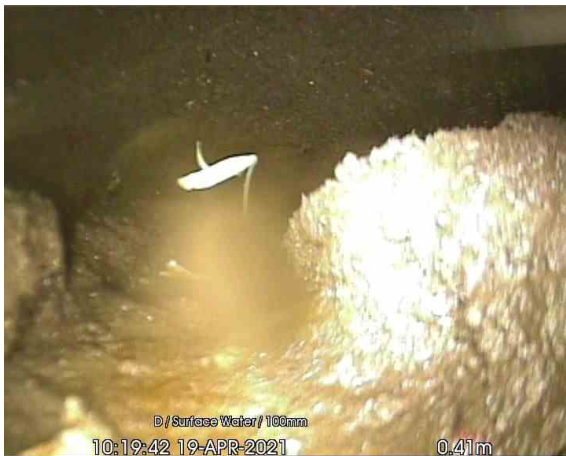
GY2_0-41m_101942.jpg, 00:00:09, 0.41 m
Settled deposits, fine, 50% cross-sectional area loss

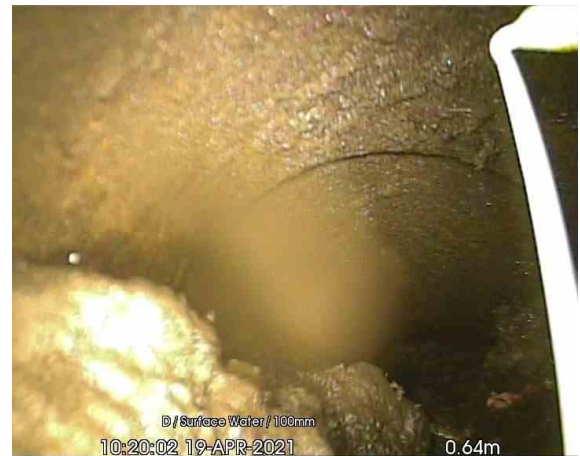
| Section | PLR | Grade | Description |
|---|---|---|---|
| 2 | GY2X | 5 | Settled deposits, fine, 80% cross-sectional area loss |

GY2_0-64m_102002.jpg, 00:00:18, 0.64 m
Settled deposits, fine, 80% cross-sectional area loss

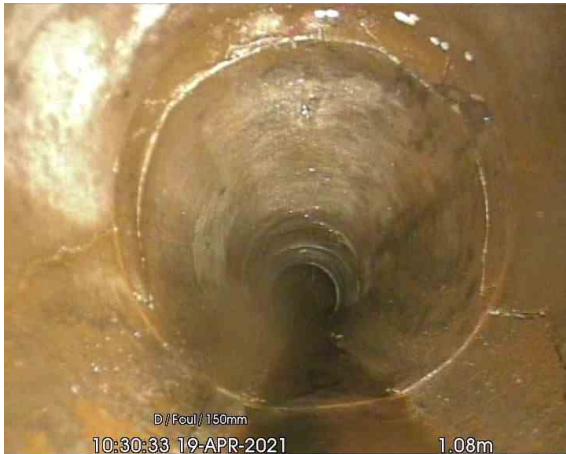
<table><tr> <td style="width: 10%; text-align: right;">0.20</td> <td style="width: 10%;">MH</td> <td colspan="2">Start node type, manhole, reference number: FW 1</td> <td style="width: 10%;">00:00:01</td> <td></td> <td></td> </tr><tr> <td style="text-align: right; color: red;">1.08</td> <td>BJ</td> <td colspan="2">Broken pipe at joint from 7 o'clock to 5 o'clock ,</td> <td>00:00:20</td> <td>FW 1-FW 2_1-08m_103033.jpg</td> <td style="text-align: center;">4</td> </tr></table>

FW 1-FW 2_1-08m_103033.jpg, 00:00:20, 1.08 m
Broken pipe at joint from 7 o'clock to 5 o'clock ,

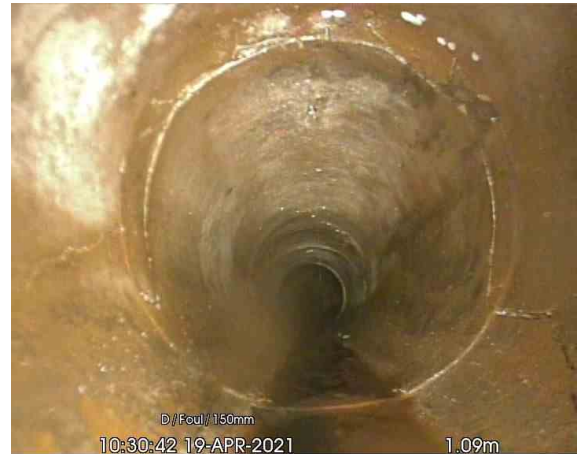
<table><tr> <td style="width: 10%; text-align: right;">0.20</td> <td style="width: 10%;">MH</td> <td colspan="2">Start node type, manhole, reference number: FW 1</td> <td style="width: 10%;">00:00:01</td> <td></td> <td></td> </tr><tr> <td style="text-align: right; color: red;">1.09</td> <td>FL</td> <td colspan="2">Fracture, longitudinal at 4 o'clock</td> <td>00:00:23</td> <td>FW 1-FW 2_1-09m_103042.jpg</td> <td style="text-align: center;">3</td> </tr></table>

FW 1-FW 2_1-09m_103042.jpg, 00:00:23, 1.09 m
Fracture, longitudinal at 4 o'clock

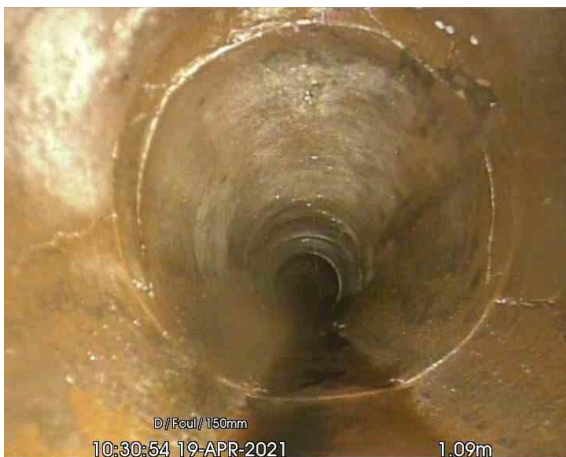
<table><tr> <td style="width: 10%; text-align: right;">0.20</td> <td style="width: 10%;">MH</td> <td colspan="2">Start node type, manhole, reference number: FW 1</td> <td style="width: 10%;">00:00:01</td> <td></td> <td></td> </tr><tr> <td style="text-align: right; color: red;">1.09</td> <td>CL</td> <td colspan="2">Crack, longitudinal at 8 o'clock</td> <td>00:00:26</td> <td>FW 1-FW 2_1-09m_103054.jpg</td> <td style="text-align: center;">2</td> </tr></table>

FW 1-FW 2_1-09m_103054.jpg, 00:00:26, 1.09 m
Crack, longitudinal at 8 o'clock

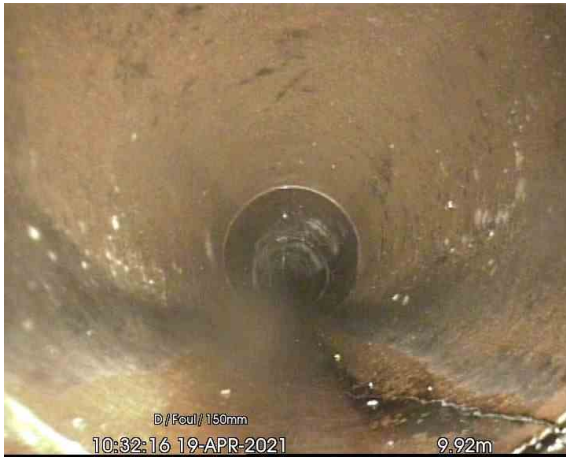
<table><tr> <td style="width: 10%; text-align: right;">0.20</td> <td style="width: 10%;">MH</td> <td colspan="2">Start node type, manhole, reference number: FW 1</td> <td style="width: 10%;">00:00:01</td> <td></td> <td></td> </tr><tr> <td style="text-align: right; color: red;">9.92</td> <td>FLJ</td> <td colspan="2">Fracture, longitudinal at joint at 5 o'clock</td> <td>00:01:24</td> <td>FW 1-FW 2_9-92m_103216.jpg</td> <td style="text-align: center;">3</td> </tr></table>

FW 1-FW 2_9-92m_103216.jpg, 00:01:24, 9.92 m
Fracture, longitudinal at joint at 5 o'clock

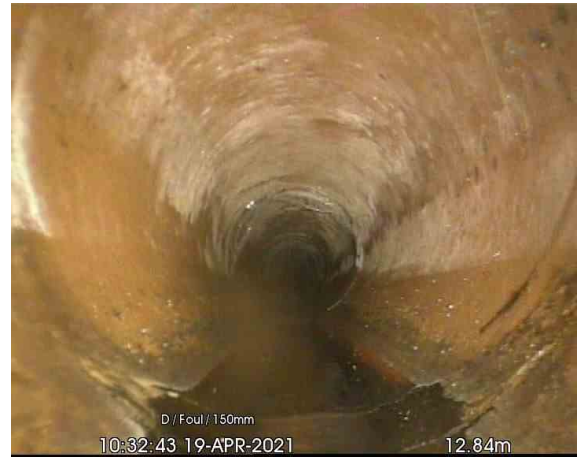
<table><tr> <td style="width: 10%; text-align: right;">0.20</td> <td style="width: 10%;">MH</td> <td colspan="2">Start node type, manhole, reference number: FW 1</td> <td style="width: 10%;">00:00:01</td> <td></td> <td></td> </tr><tr> <td style="text-align: right; color: red;">12.84</td> <td>CCJ</td> <td colspan="2">Crack, circumferential at joint from 4 o'clock to 8 o'clock</td> <td>00:01:41</td> <td>FW 1-FW 2_12-84m_103243.j</td> <td style="text-align: center;">2</td> </tr></table>

FW 1-FW 2_12-84m_103243.jpg, 00:01:41, 12.84 m
Crack, circumferential at joint from 4 o'clock to 8 o'clock

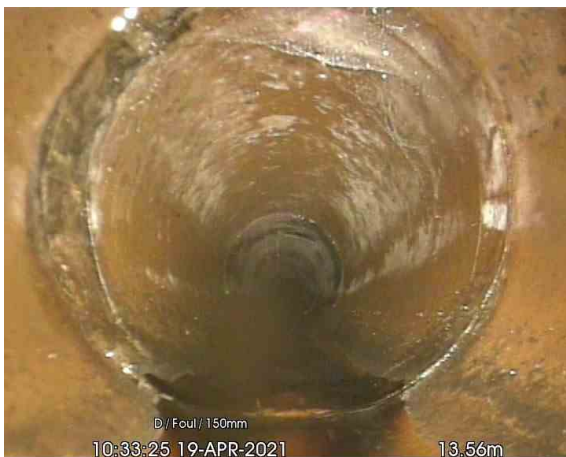
<table><tr> <td style="width: 10%; text-align: right;">0.20</td> <td style="width: 10%;">MH</td> <td colspan="2">Start node type, manhole, reference number: FW 1</td> <td style="width: 10%;">00:00:01</td> <td></td> <td></td> </tr><tr> <td style="text-align: right; color: red;">13.56</td> <td>CCJ</td> <td colspan="2">Crack, circumferential at joint from 6 o'clock to 11 o'clock</td> <td>00:02:11</td> <td>FW 1-FW 2_13-56m_103325.j</td> <td style="text-align: center;">2</td> </tr></table>

FW 1-FW 2_13-56m_103325.jpg, 00:02:11, 13.56 m
Crack, circumferential at joint from 6 o'clock to 11 o'clock

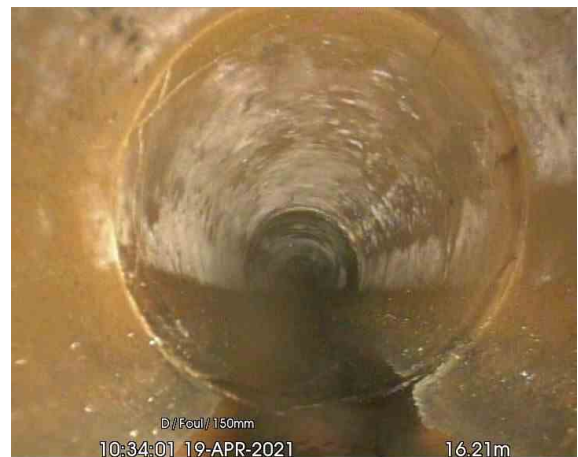
<table><tr> <td style="width: 10%; text-align: right;">0.20</td> <td style="width: 10%;">MH</td> <td colspan="2">Start node type, manhole, reference number: FW 1</td> <td style="width: 10%;">00:00:01</td> <td></td> <td></td> </tr><tr> <td style="text-align: right; color: red;">16.21</td> <td>CCJ</td> <td colspan="2">Crack, circumferential at joint from 8 o'clock to 11 o'clock</td> <td>00:02:38</td> <td>FW 1-FW 2_16-21m_103401.j</td> <td style="text-align: center;">2</td> </tr></table>

FW 1-FW 2_16-21m_103401.jpg, 00:02:38, 16.21 m
Crack, circumferential at joint from 8 o'clock to 11 o'clock

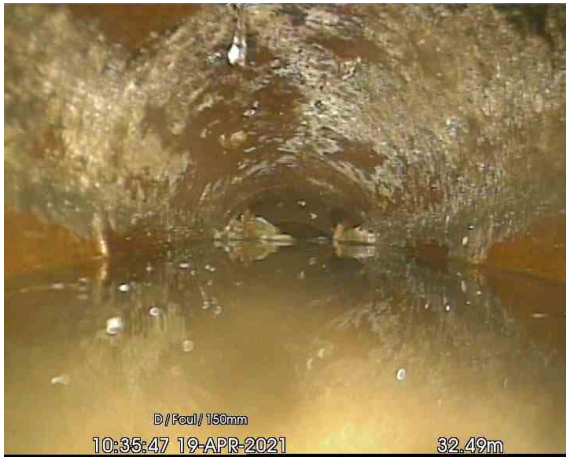
FW 1-FW 2_32-49m_103547.jpg, 00:04:11, 32.49 m
Water level, 80% of the vertical dimension, BLOCKED

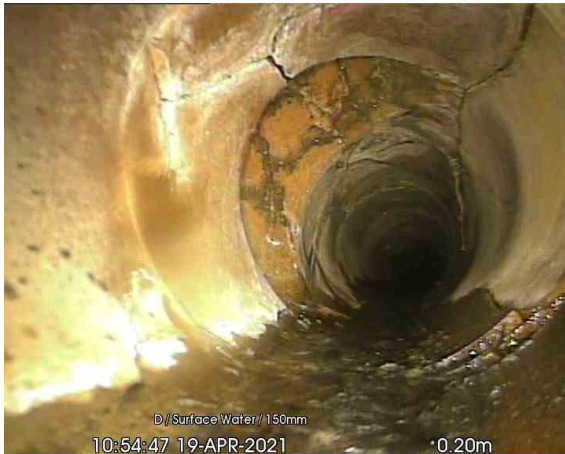
| Scale: | 1:231 | Position [m] | Code | Observation | MPEG | Photo | Grade |
|---|---|---|---|--|---|---|---|
| | | 0.20 | B | Broken pipe from 10 o'clock to 6 o'clock | 00:00:04 | SW1-SW2_0-20m_105447.jpg | 4 |

SW1-SW2_0-20m_105447.jpg, 00:00:04, 0.20 m
Broken pipe from 10 o'clock to 6 o'clock

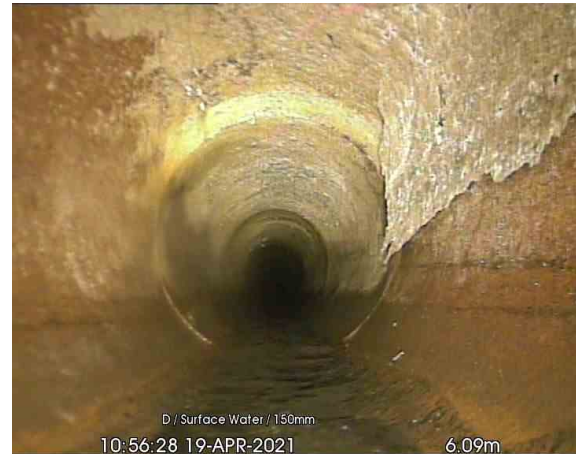
SW1-SW2_6-09m_105628.jpg, 00:01:16, 6.09 m
Settled deposits, hard or compacted, 5% cross-sectional area loss

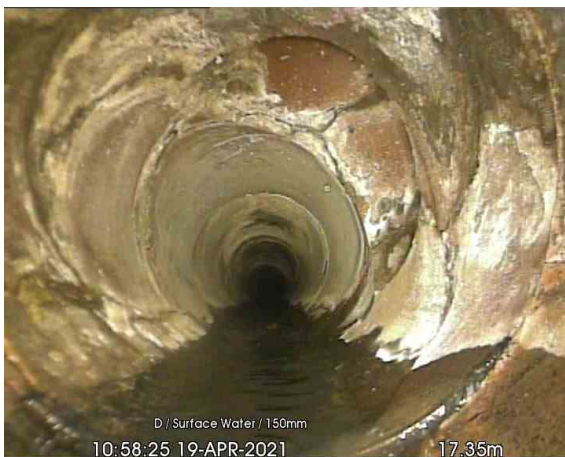
| Scale: | 1:231 | Position [m] | Code | Observation | MPEG | Photo | Grade |
|---|---|---|---|--|---|---|---|
| | | 17.35 | FMJ | Fracture, multiple at joint from 8 o'clock to 4 o'clock | 00:02:57 | SW1-SW2_17-35m_105825.jpg | 4 |

SW1-SW2_17-35m_105825.jpg, 00:02:57, 17.35 m
Fracture, multiple at joint from 8 o'clock to 4 o'clock

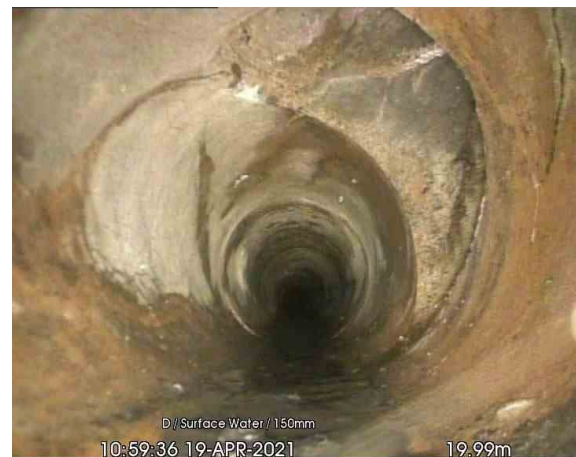
| Scale: | 1:231 | Position [m] | Code | Observation | MPEG | Photo | Grade |
|---|---|---|---|--|---|---|---|
| | | 19.99 | CC | Crack, circumferential from 8 o'clock to 11 o'clock | 00:03:38 | SW1-SW2_19-99m_105936.jpg | 2 |

SW1-SW2_19-99m_105936.jpg, 00:03:38, 19.99 m
Crack, circumferential from 8 o'clock to 11 o'clock

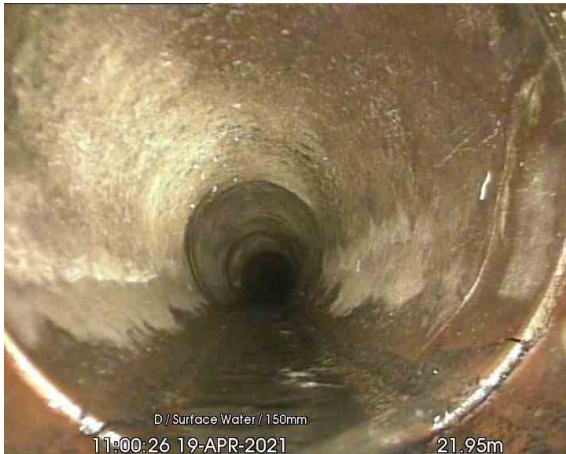
| Scale: | 1:231 | Position [m] | Code | Observation | MPEG | Photo | Grade |
|---|---|---|---|--|---|---|---|
| | | 21.95 | FCJ | Fracture, circumferential at joint from 2 o'clock to 4 o'clock | 00:04:04 | SW1-SW2_21-95m_110026.jpg | 3 |

SW1-SW2_21-95m_110026.jpg, 00:04:04, 21.95 m
Fracture, circumferential at joint from 2 o'clock to 4 o'clock

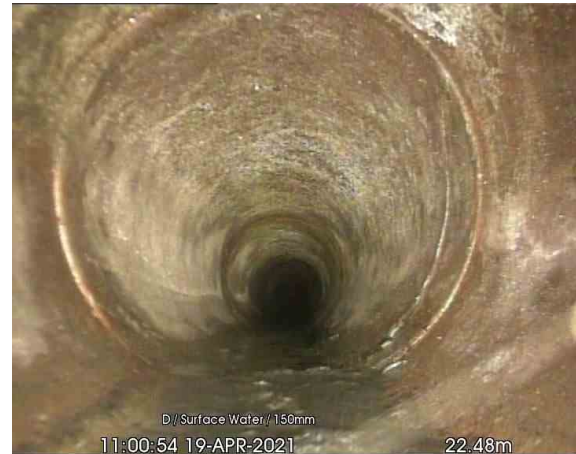
| Scale: | 1:231 | Position [m] | Code | Observation | MPEG | Photo | Grade |
|---|---|---|---|--|---|---|---|
| | | 22.48 | CCJ | Crack, circumferential at joint from 1 o'clock to 5 o'clock | 00:04:21 | SW1-SW2_22-48m_110054.jpg | 2 |

SW1-SW2_22-48m_110054.jpg, 00:04:21, 22.48 m
Crack, circumferential at joint from 1 o'clock to 5 o'clock

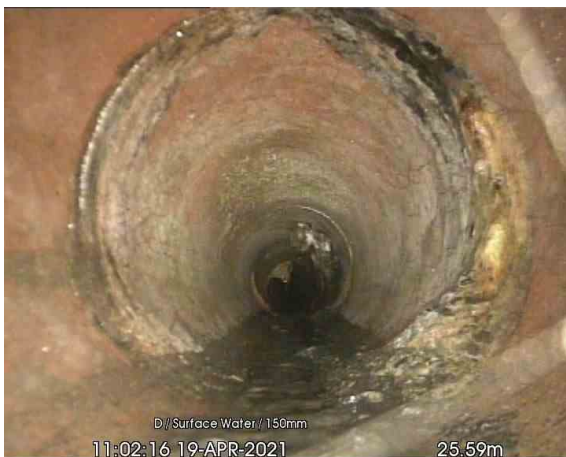
SW1-SW2_25-59m_110216.jpg, 00:05:29, 25.59 m
Settled deposits, hard or compacted at joint, 5%
cross-sectional area loss

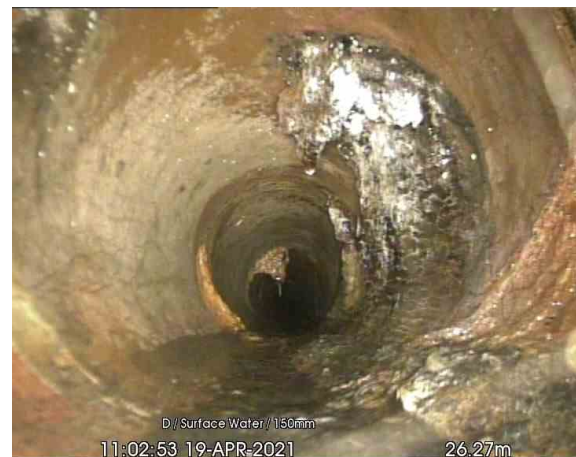
SW1-SW2_26-27m_110253.jpg, 00:05:53, 26.27 m
Settled deposits, hard or compacted at joint, 5%
cross-sectional area loss

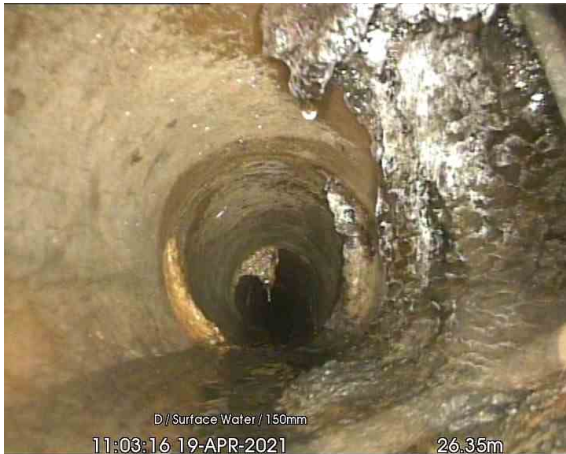
SW1-SW2_26-35m_110316.jpg, 00:06:08, 26.35 m
Settled deposits, hard or compacted, 20% cross-sectional area loss

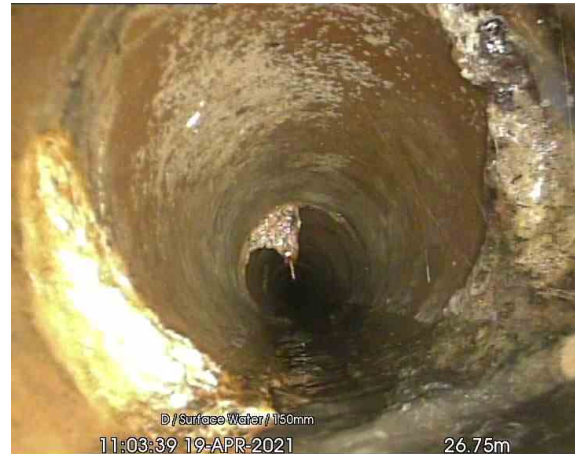
SW1-SW2_26-75m_110339.jpg, 00:06:18, 26.75 m
Settled deposits, hard or compacted at joint, 10% cross-sectional area loss

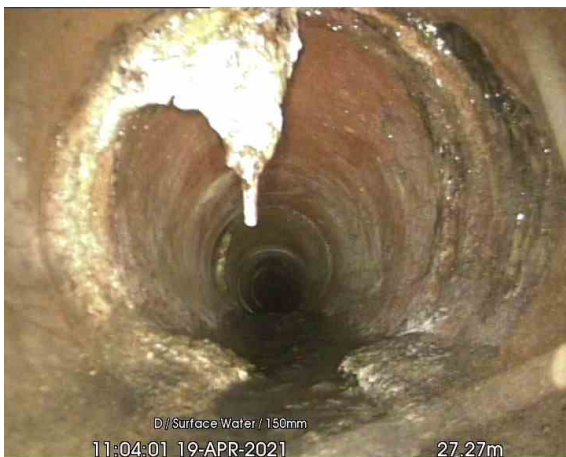
SW1-SW2_27-27m_110401.jpg, 00:06:30, 27.27 m
Settled deposits, hard or compacted at joint, 10% cross-sectional area loss

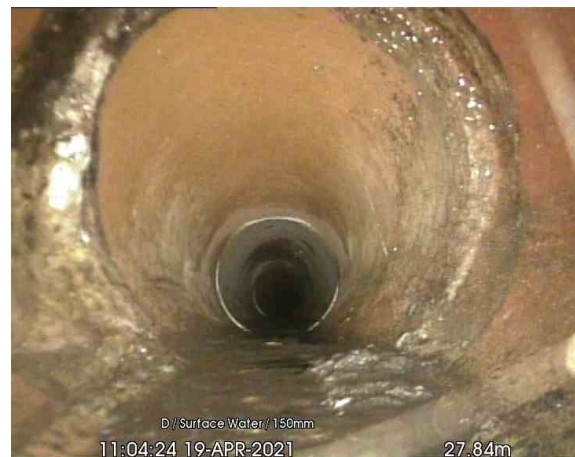
SW1-SW2_27-84m_110424.jpg, 00:06:41, 27.84 m
Settled deposits, hard or compacted at joint, 5% cross-sectional area loss

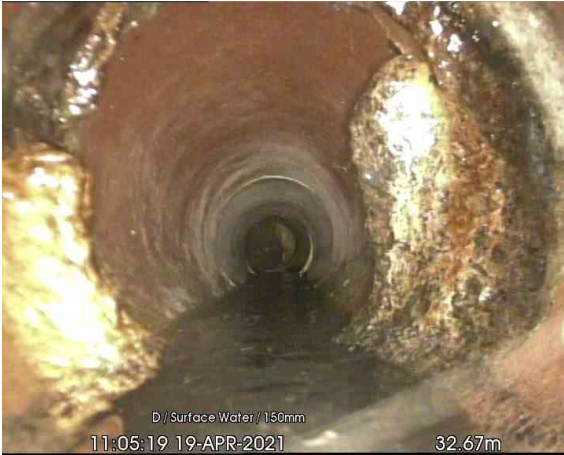
SW1-SW2_32-67m_110519.jpg, 00:07:20, 32.67 m
Settled deposits, hard or compacted at joint, 15%
cross-sectional area loss

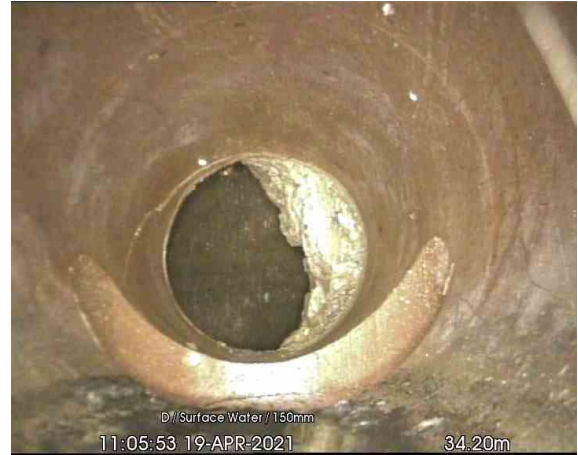
SW1-SW2_34-20m_110553.jpg, 00:07:40, 34.20 m
General remark, DROP SHAFT

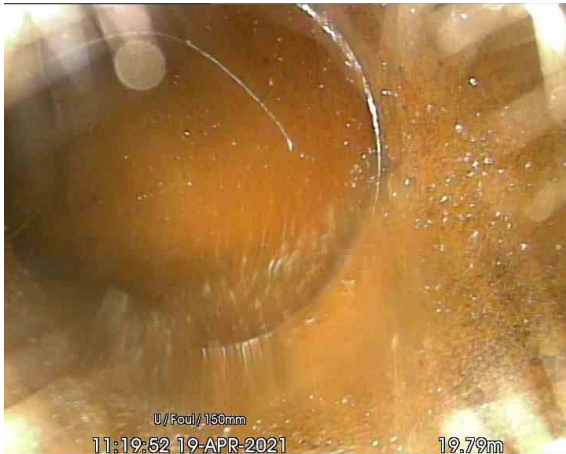
<table><tr> <td style="width: 10%; text-align: right;">0.20</td> <td style="width: 10%;">MH</td> <td style="width: 40%;">Start node type, manhole, reference number: FW 1</td> <td style="width: 10%;">00:00:00</td> <td></td> <td></td> <td></td> </tr><tr> <td style="text-align: right; color: red;">19.79</td> <td>CCJ</td> <td style="color: red;">Crack, circumferential at joint from 9 o'clock to 2 o'clock</td> <td>00:01:06</td> <td style="color: red;">FW 1- A_19-79m _111952.j</td> <td></td> <td style="color: red;">2</td> </tr></table>

FW 1- A_19-79m_111952.jpg, 00:01:06, 19.79 m
Crack, circumferential at joint from 9 o'clock to 2 o'clock

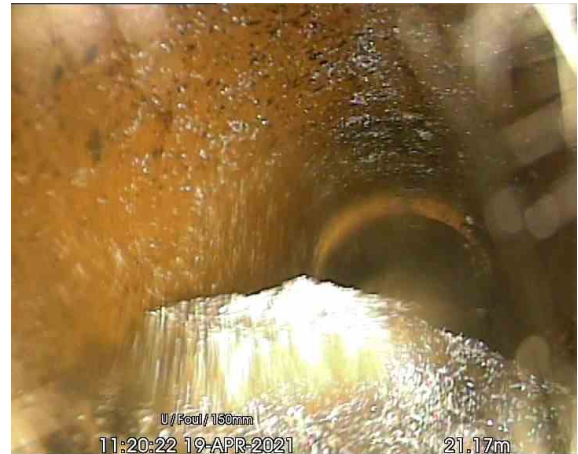
| Section | PLR | Grade | Description |
|---|---|---|---|
| 6 | AX | 4 | Settled deposits, fine, 50% cross-sectional area loss |

FW 1- A_21-17m_112022.jpg, 00:01:27, 21.17 m
Settled deposits, fine, 50% cross-sectional area loss
