## **EDGEWORTH, HEPWORTH, HUDDERSFIELD**

### **Arboricultural Inspection and Method Statement**

April 2021

Revision A October 2021

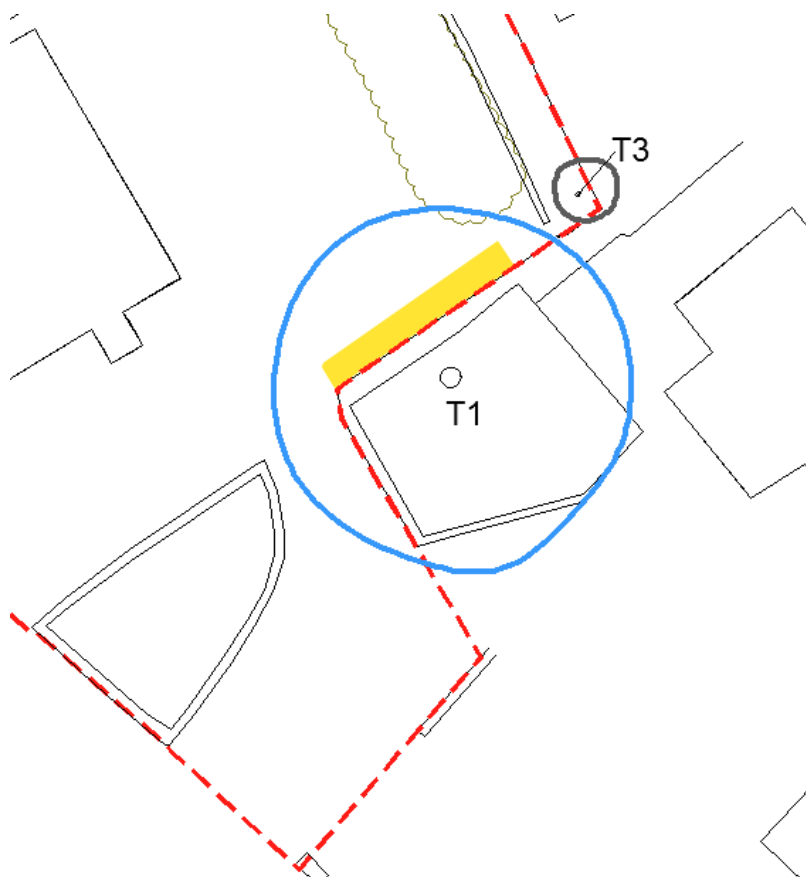
Therefore, further investigation was undertaken by hand digging an inspection trench adjacent to the boundary wall.

*Location of inspection trench (yellow)*

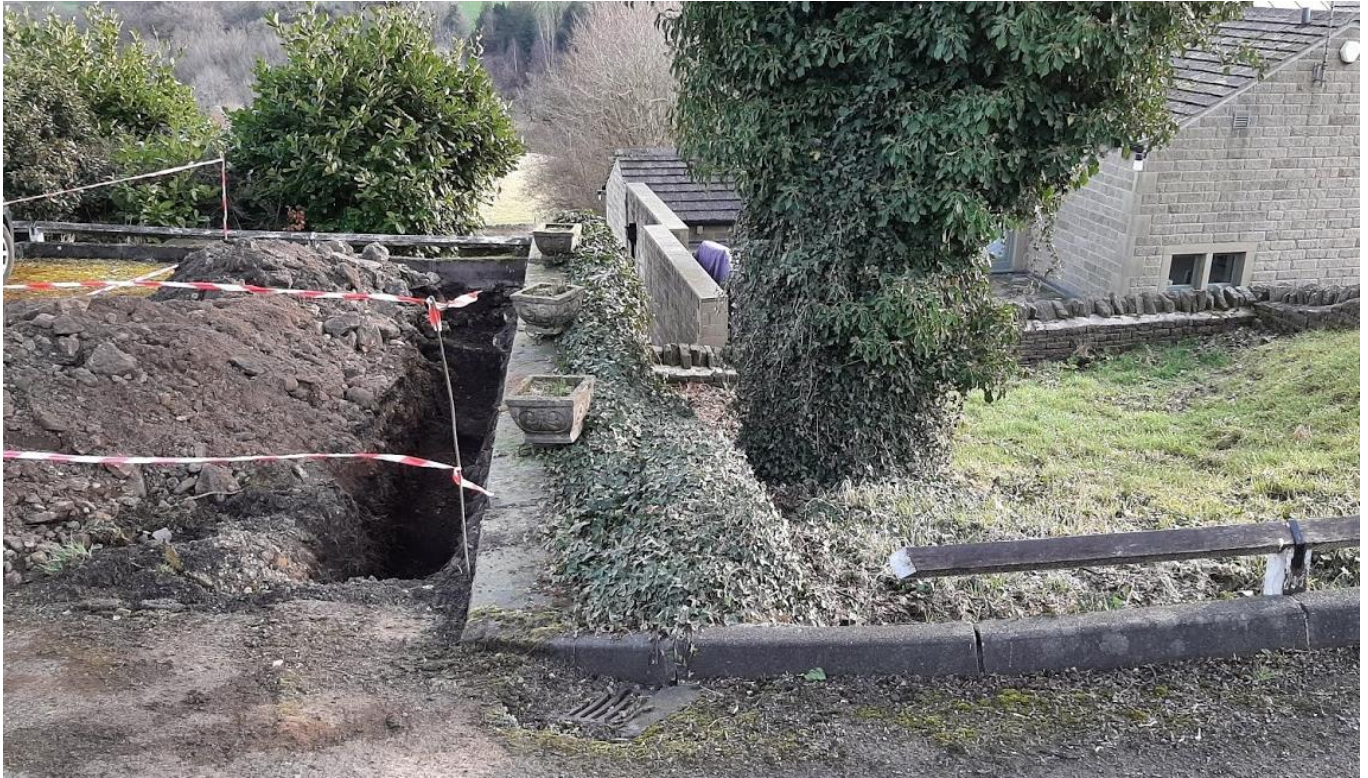
*Inspection trench from south west*

The trench was dug under arboricultural supervision to approximately 300-400mm wide down to a maximum depth of 1.1m in line with the tree. This is approximately 400mm below the ground level on the tree side of the retaining wall.

No tree roots were found. Some small fibrous roots 3-6mm were found in the top 350mm from the Ivy which covers the retaining wall.

The inspection trench has been backfilled to ensure the stability of the wall.

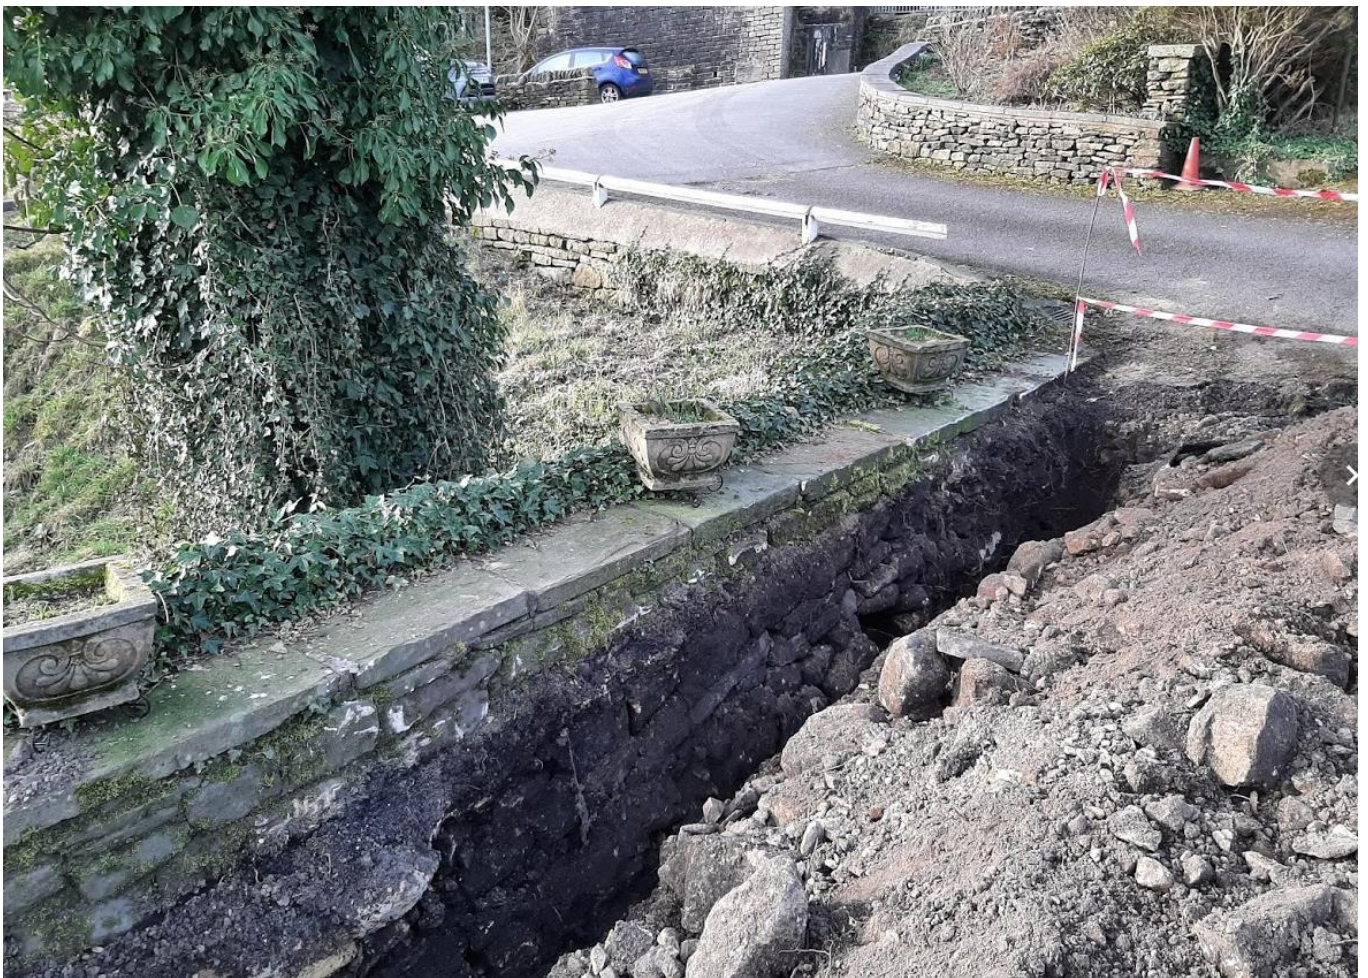
*Inspection trench from north*

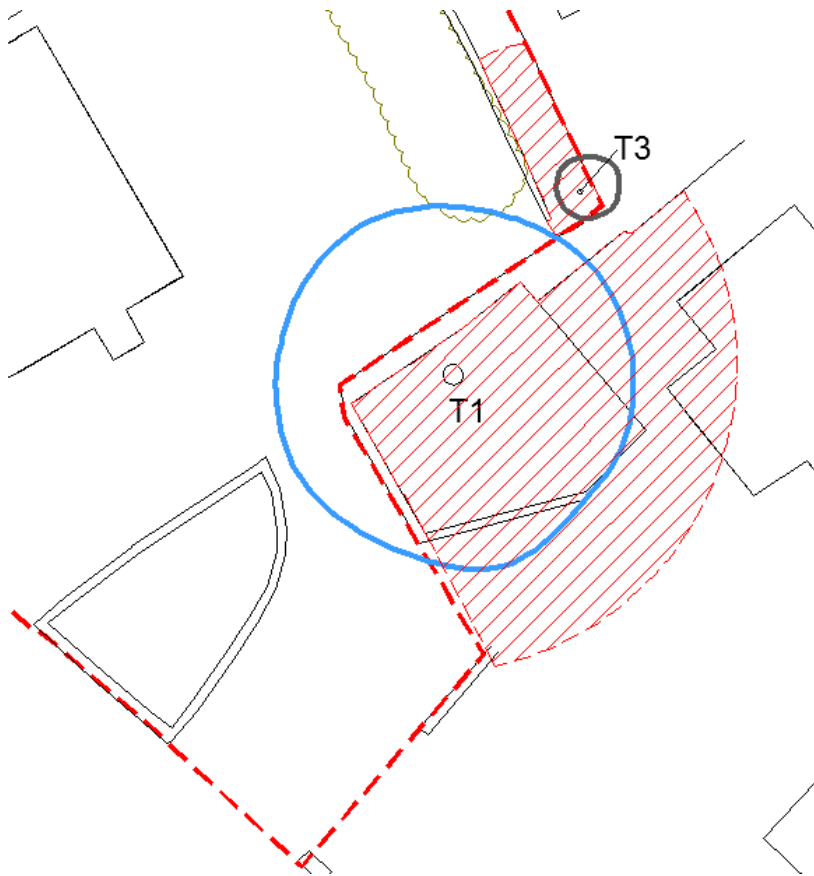
We can therefore conclude that the RPA of T1 is constrained by the retaining wall. The *vast majority* of its RPA is likely to be within the adjacent grassed area below the retaining walls. T1's RPA has therefore been reshaped (in accordance with section 4.6.3 clause a of BS5837:2012) to take account of this constraint as shown below.

*T1 RPA reshaped to account of retaining wall constraints.*
