GEOSHIELD Verification Report

PROJECT REFERENCE: GEO101204

PROJECT: Signature Homes - Holmfirth

PROJECT ADDRESS: New Mill Road

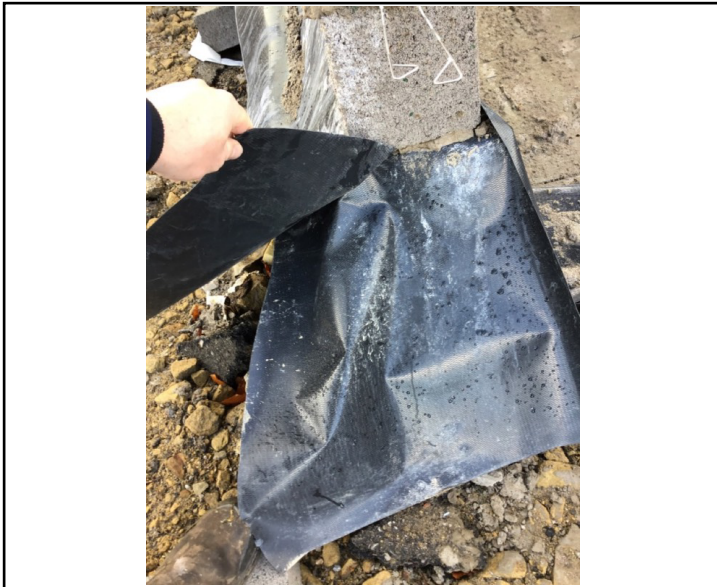
1. Image from Report 001 shows the DPC being used as the cavity tray. It states there is no double sided butyl tape in the cavity tray. It is not GR DPC because it's black on both sides. The GR DPC is lower in the wall.

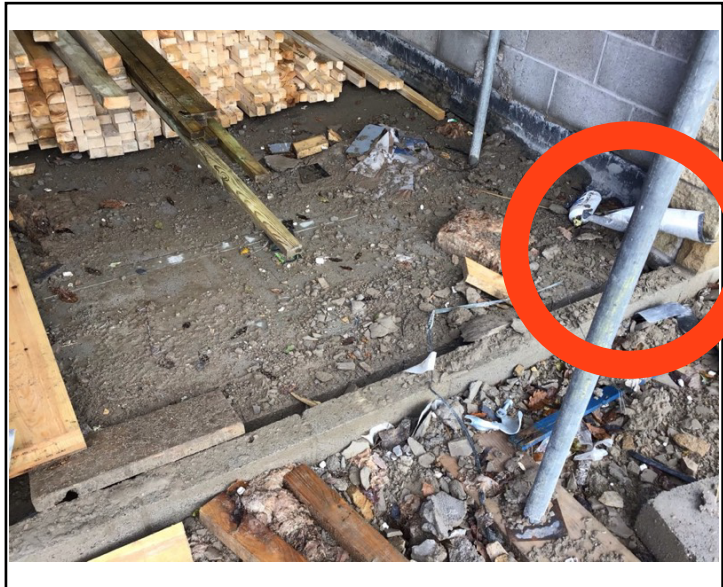
2. Report 004. Door threshold not sealed but there is sufficient GR DPC to seal (circled)

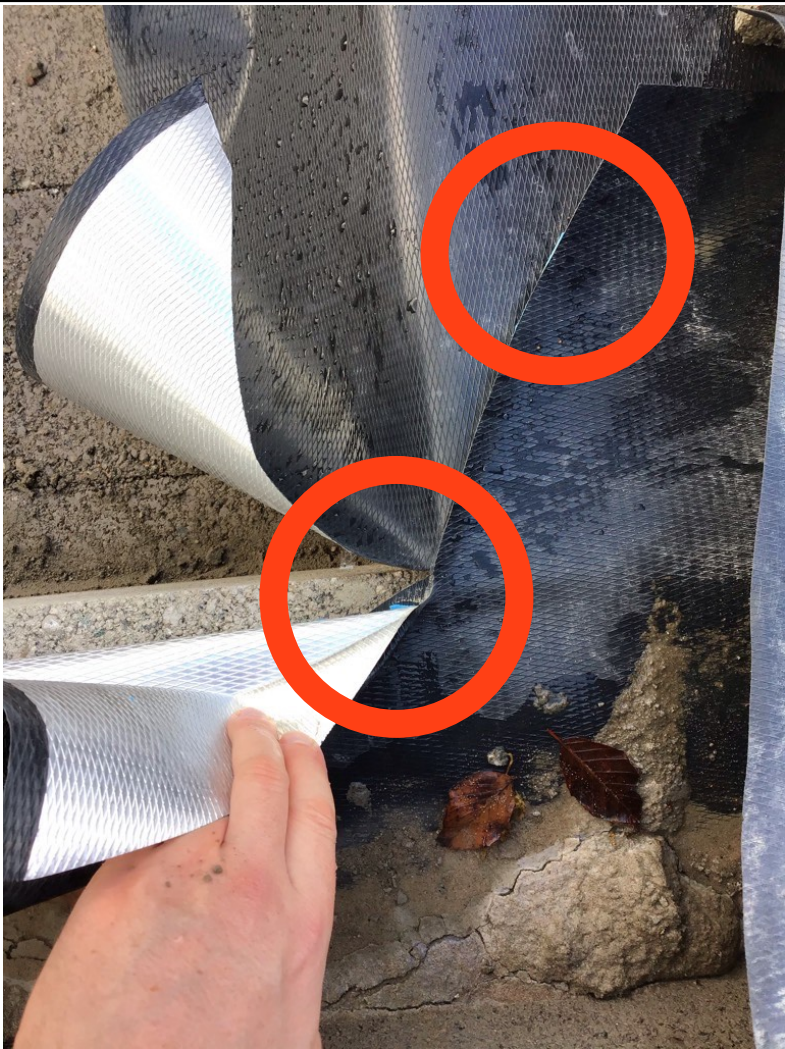
RESTRICTIONS AND LIMITATIONS: Corner details were not sealed and reinforced with GR SAM. But double sided butyl tape was installed with in the joints of GR DPC. On closer inspection they are sealed running through the walls but not down the vertical face. Therefore it was deemed a retro fit solution acceptable.

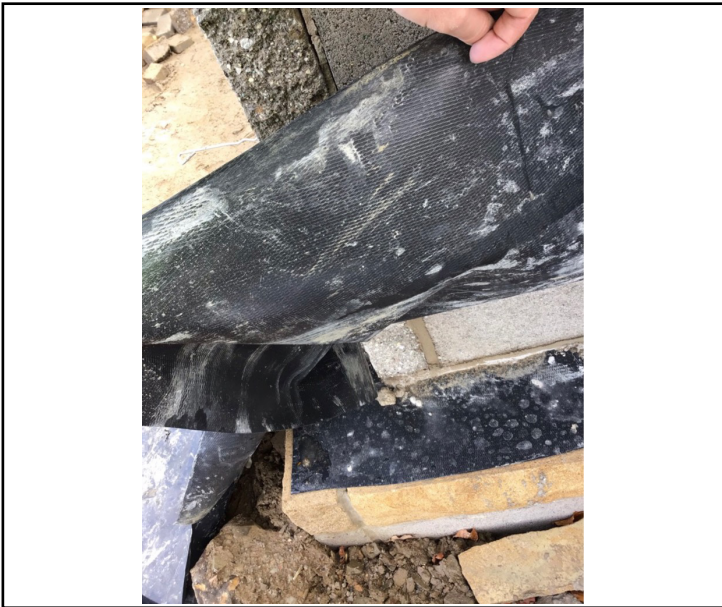
1. GR DPC installed as one piece through the wall.

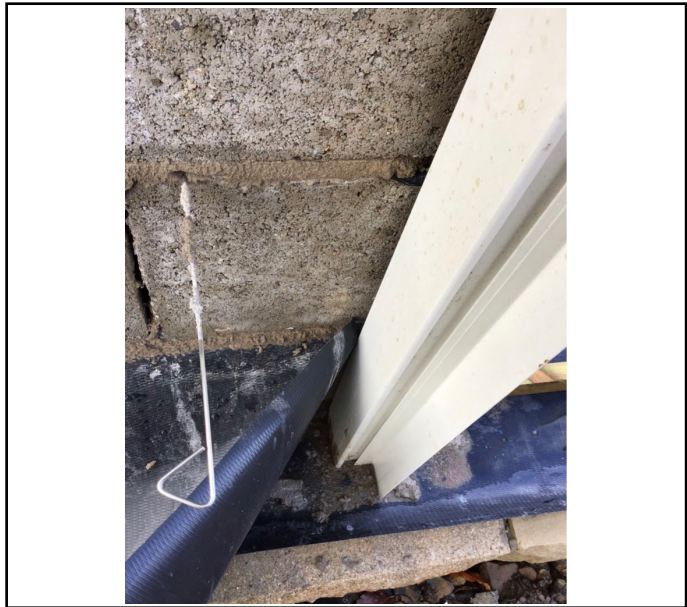
2. GR DPC running straight through the wall - no double sided butyl tape

required to seal the joint as there is no joint to seal. Temporary door frame for

setting out the wall does not penetrate through the GR DPC.

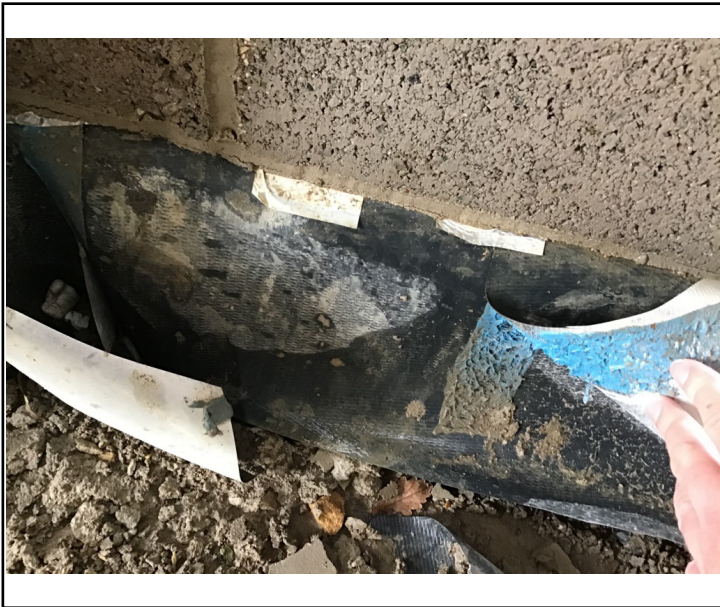
1. Butyl tape installed in between the GR DPC in a joint running straight through the wall.

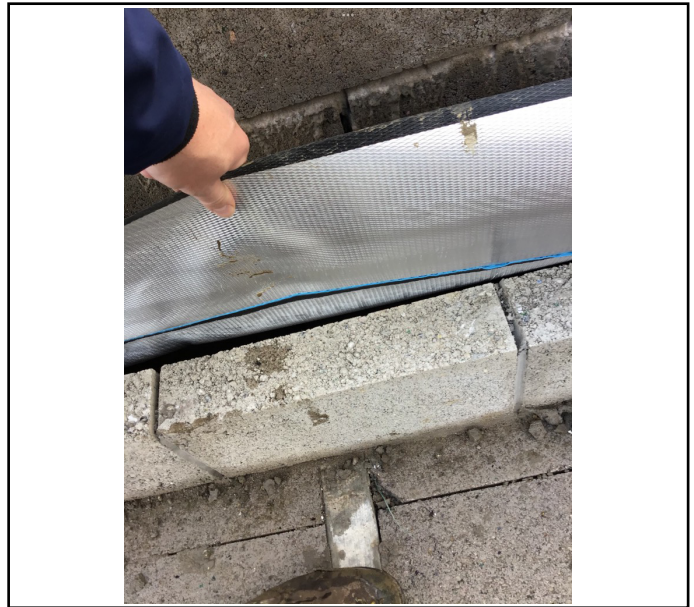
2. Butyl tape installed inside joints in the GR DPC.

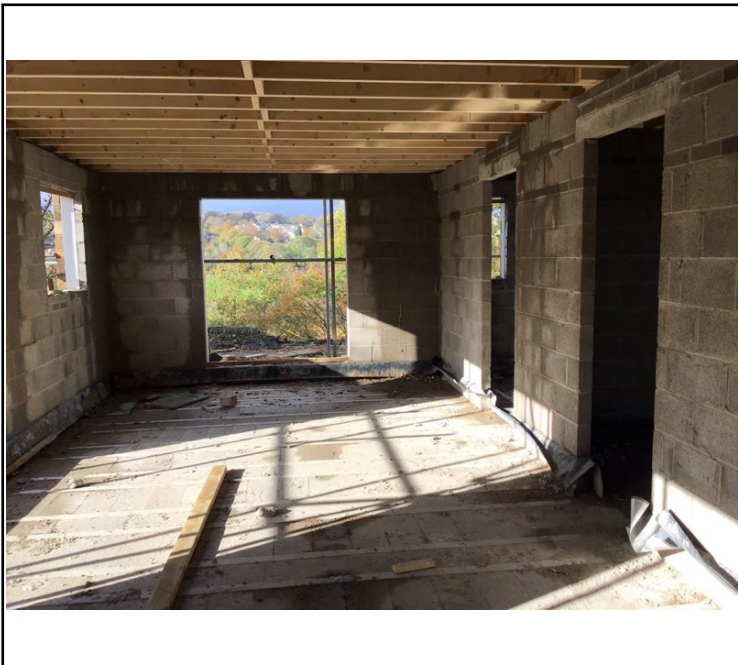
1. GR DPC tailed hanging out to form sufficient seal inside the building (Report 03).

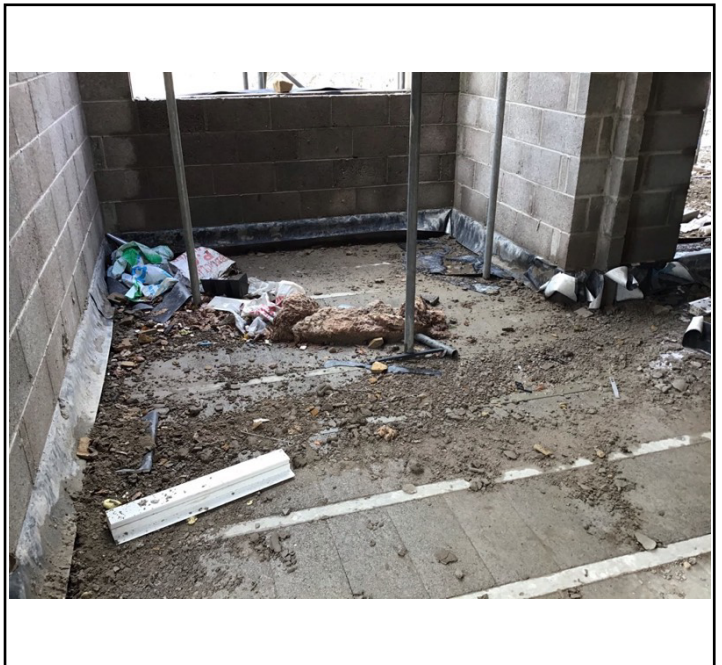
2. Enough GR DPC extruding to form sealed corner detail (Report 04).

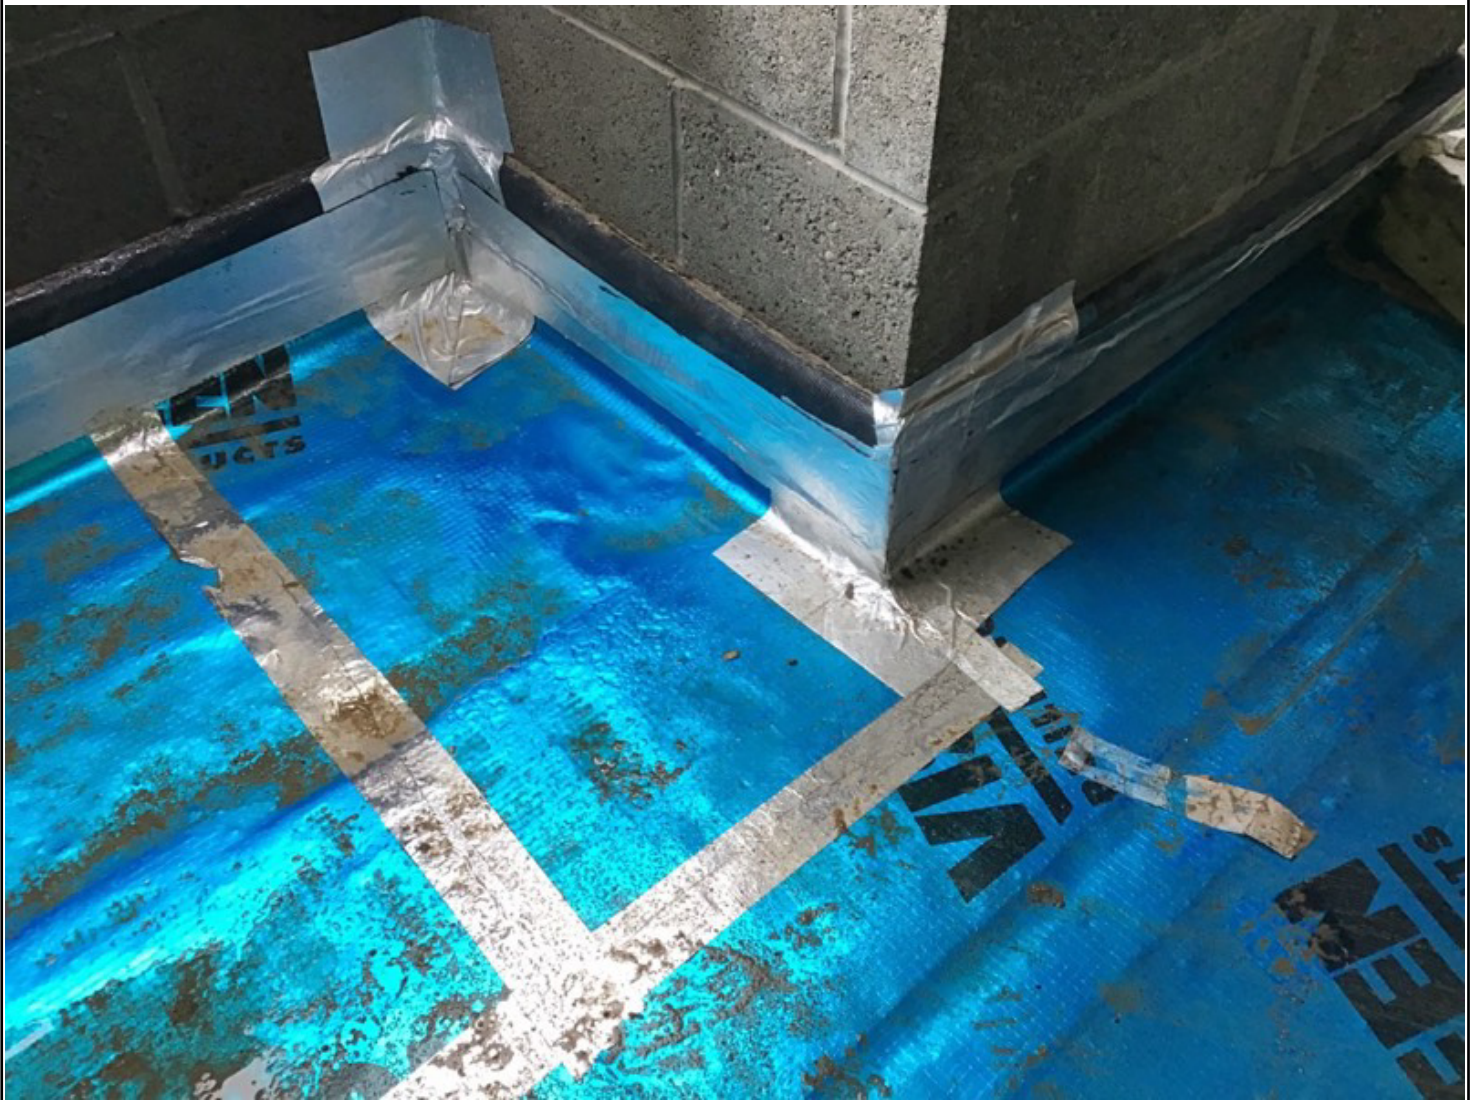
3. The corner details were not sealed with GR SAM as per NVQ Level 2. However,

butyl tape was installed in side the joints in the GR DPC running through the wall.

Geoshield confirmed the installation could be finished in accordance with CIRIA 795

and seal the corner details internally.

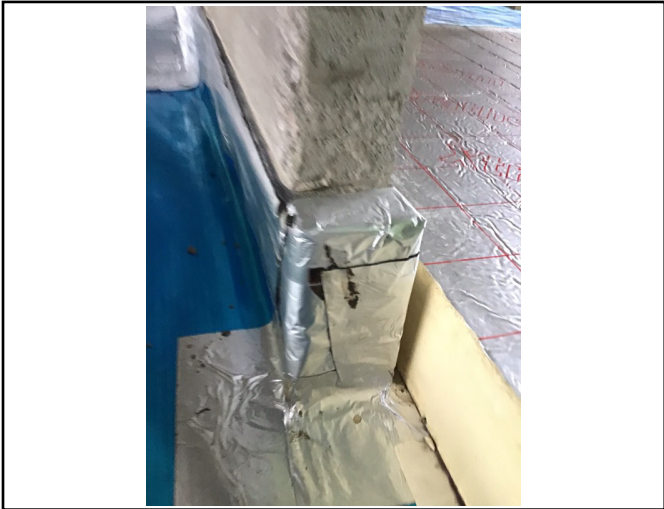
1. Example of corner detail sealed from inside the property.

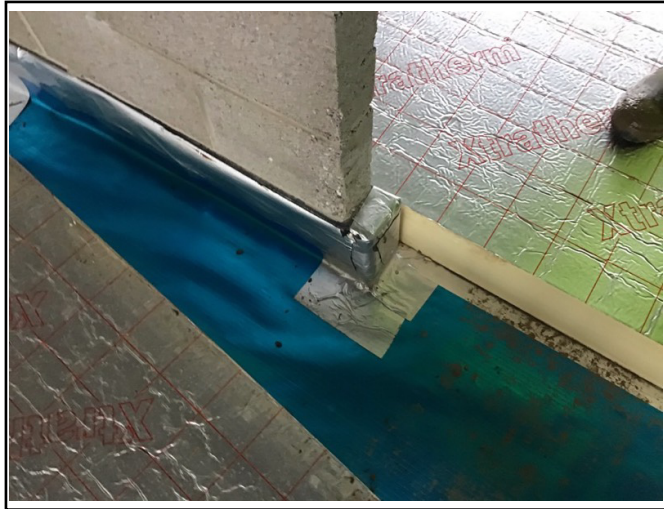
2. Example of corner detail sealed from inside the property.

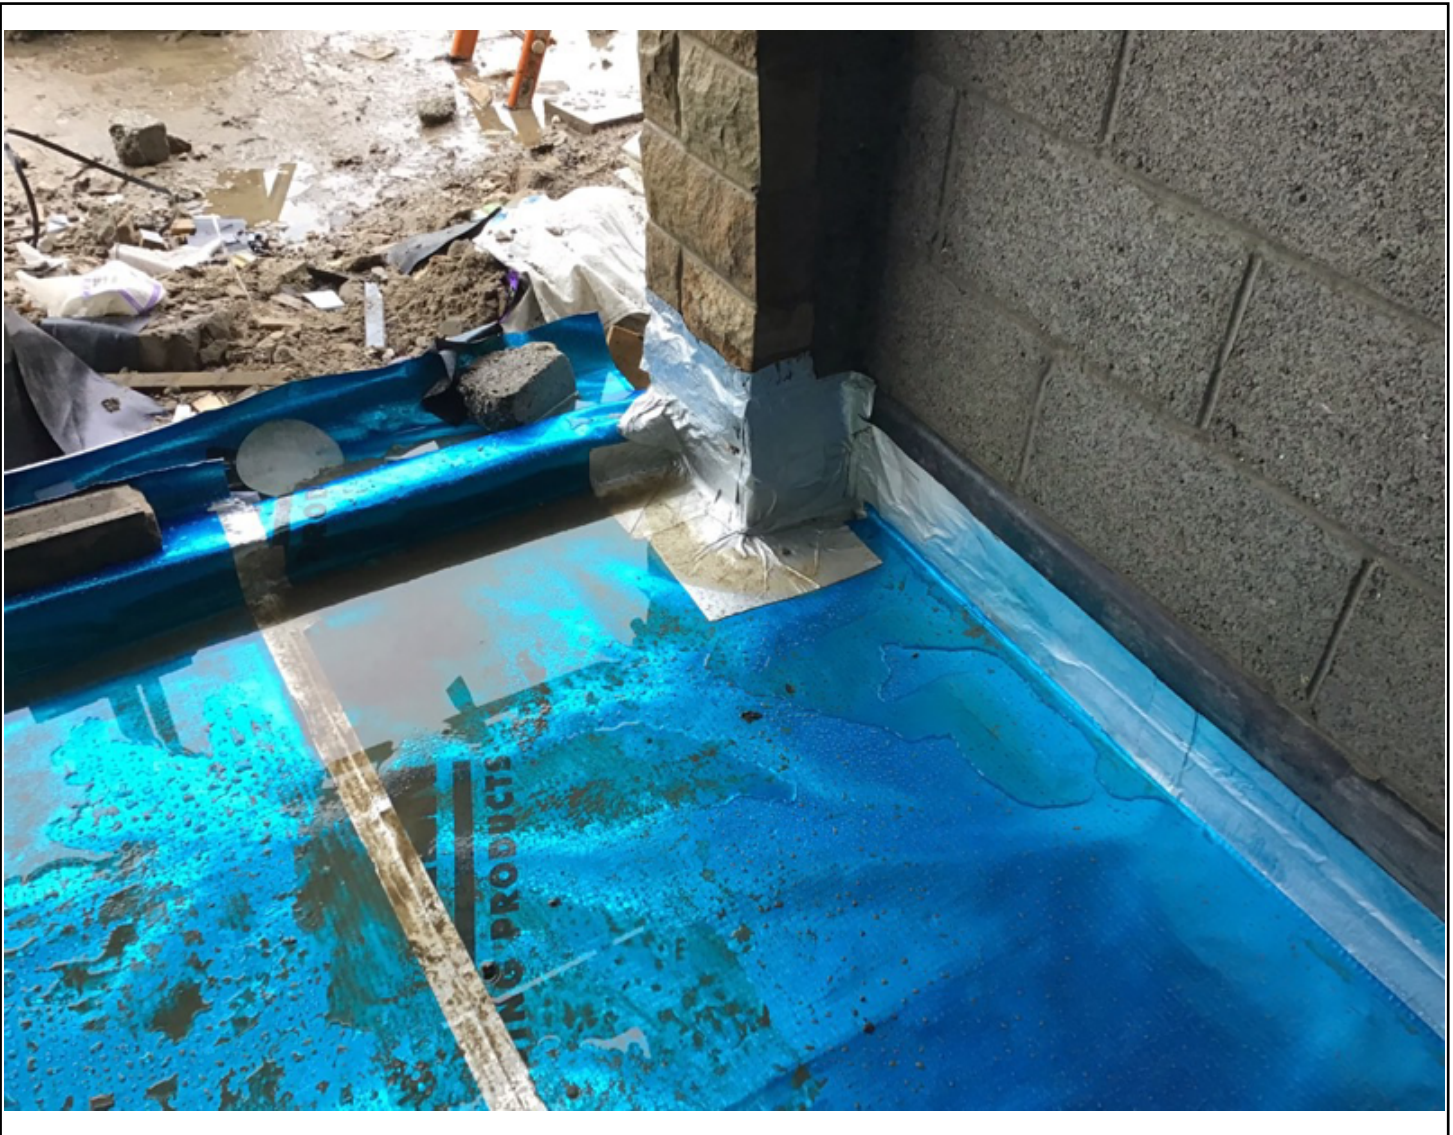
3. Geoshield have signed off the installation as all door thresholds have

been sealed with the floor infill. All corners details addressed and sealed to

the GR DPC as per CIRIA 795. Passed and verified.
