ARBORICULTURAL REPORT & Impact Assessment to **BS5837:2012 at:**

***Lady Ann Road,
Batley,
West Yorkshire
WF17***

Prepared for:
D. Noble Ltd
*Noble House
Perseverance Street,
Castleford
WF10 1LD*

Reference: *AWA3652*

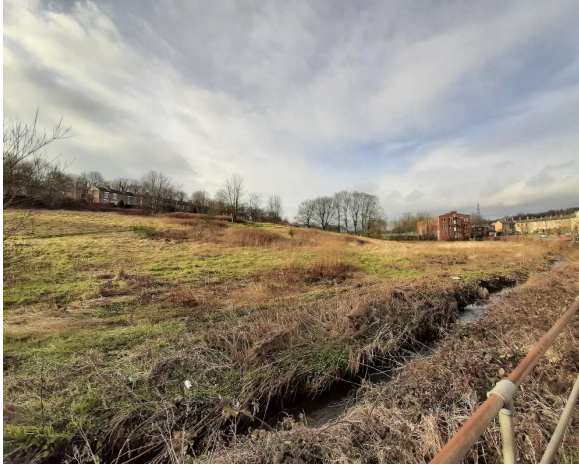
Photo 1: The site, as viewed from Lady Ann Road at the east boundary

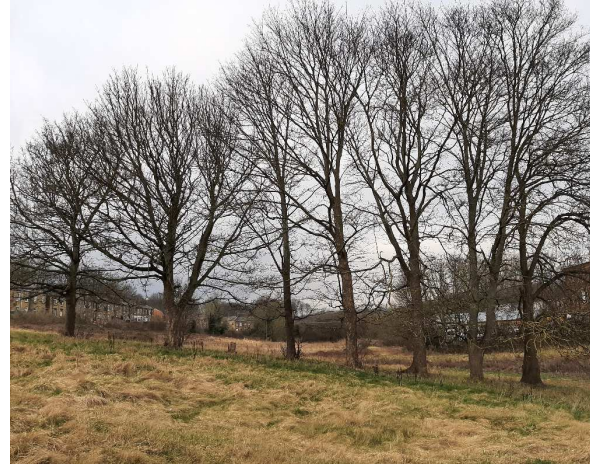
- 3.2.6 Most of the trees are semi-mature with only occasional early mature to mature trees.
- 3.2.7 The most significant trees on site are trees T29 to T35, a linear group of mature Sycamore and Ash situated in the centre of the site. Collectively, these trees are a prominent landscape feature, that typically have good long-term value and collective amenity value. Of these trees, T32 and T35 have defects that may limit long-term value.

Photo 2: T29 to T35, prominent trees on site

4.2.3 Of the trees to be removed to facilitate development, 5 trees are retention category 'B'; T29, T30, T31, T33 and T34. These are prominent trees with moderate amenity value and good long-term prospects, and so their removal will result in a moderate loss of arboricultural and landscape value.

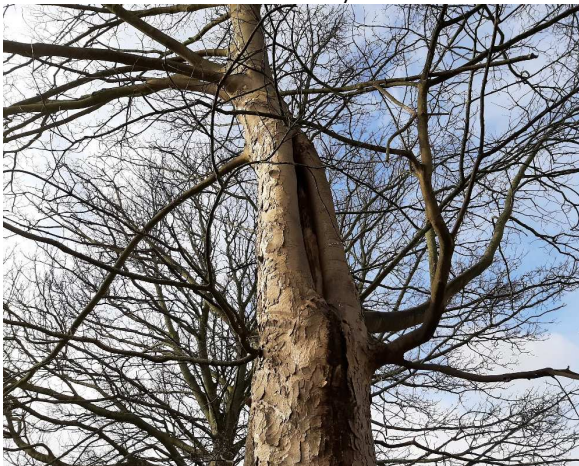
- 3.2.8 T32 has a large, open cavity (2m long, and 200mm wide) at the eastern aspect of its stem, approximately 3m from ground level. There is evidence of strengthening reaction growth at the edges of the cavity, indicating the tree has at least partially adapted to it; however, the defect may limit the long-term prospects of the tree. Further detailed decay detection could assess the extent of decay.

Photo 3: Cavity on T32

4.2.4 The remaining trees and to be removed are retention category 'C'. Of these trees, a number have more moderate amenity value; T2, T5, T7, T32 and T35. T2, T5, T7 and T35 are Ash trees, and their long-term prospects are likely to be limited by Ash dieback, which is prevalent on site. Additionally, T7, T32 and T35 have notable defects that limit their prospects. As such, while the removal of these trees will have a negative short-term impact, in the long-term the impact will be more limited.

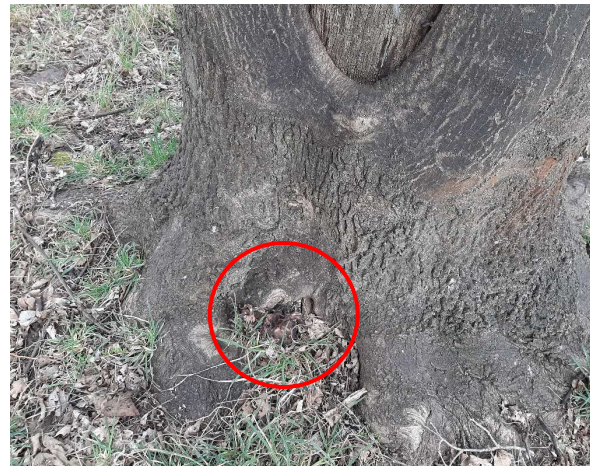
- 3.2.9 Ash T35 has bark wounds at the base of the stem, and 1m from ground level, at the west aspect. Desiccated fungal brackets were present on both bark wounds at time of survey, with surface wood being slightly decayed and with evidence of wood-boring insect activity. The damage appeared localised, with some evidence of reactive growth. However, as the stem leans slightly east, with a slightly unbalanced crown, decay on the western aspect of the stem has the potential to limit long-term value, particularly if the tree is affected by Ash dieback and its capacity to reinforce structural weaknesses is diminished.

Photo 4: Bark damage and fungal bracket (circled red) on T35

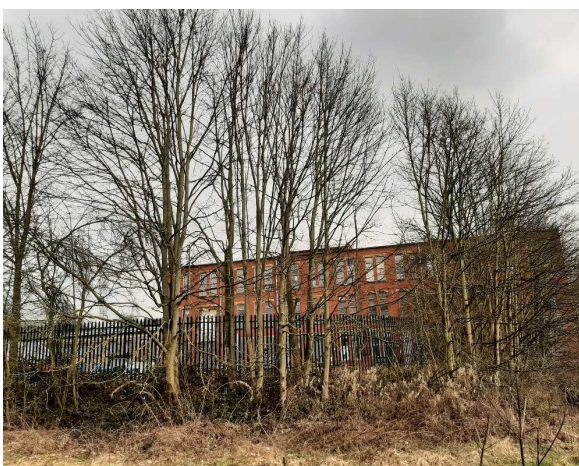
- 3.2.16 At the eastern boundary, on the banking of the beck that extends through the site, are a number of trees and groups that provide reasonable screening for the site. Of these, Sycamore group G16 is considered of more moderate value, providing good screening for the adjacent business park. The remaining trees and groups are typically small and sparse, so have more limited screening value.

Photo 5: G16, at the eastern boundary

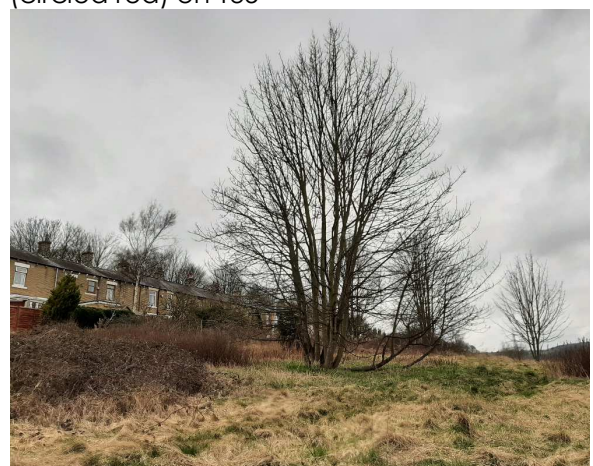
- 3.2.12 The majority of trees on site are self-set Sycamore, Ash and Willow trees. These trees are low value, with long-term prospects limited by common defects, in particular tight unions with partially included bark, and squirrel damage, while the Ash specifically will be affected by Ash dieback disease, which is established on site.

Photo 6: T47, a multi-stemmed Sycamore, is typical of the self-set trees found on site

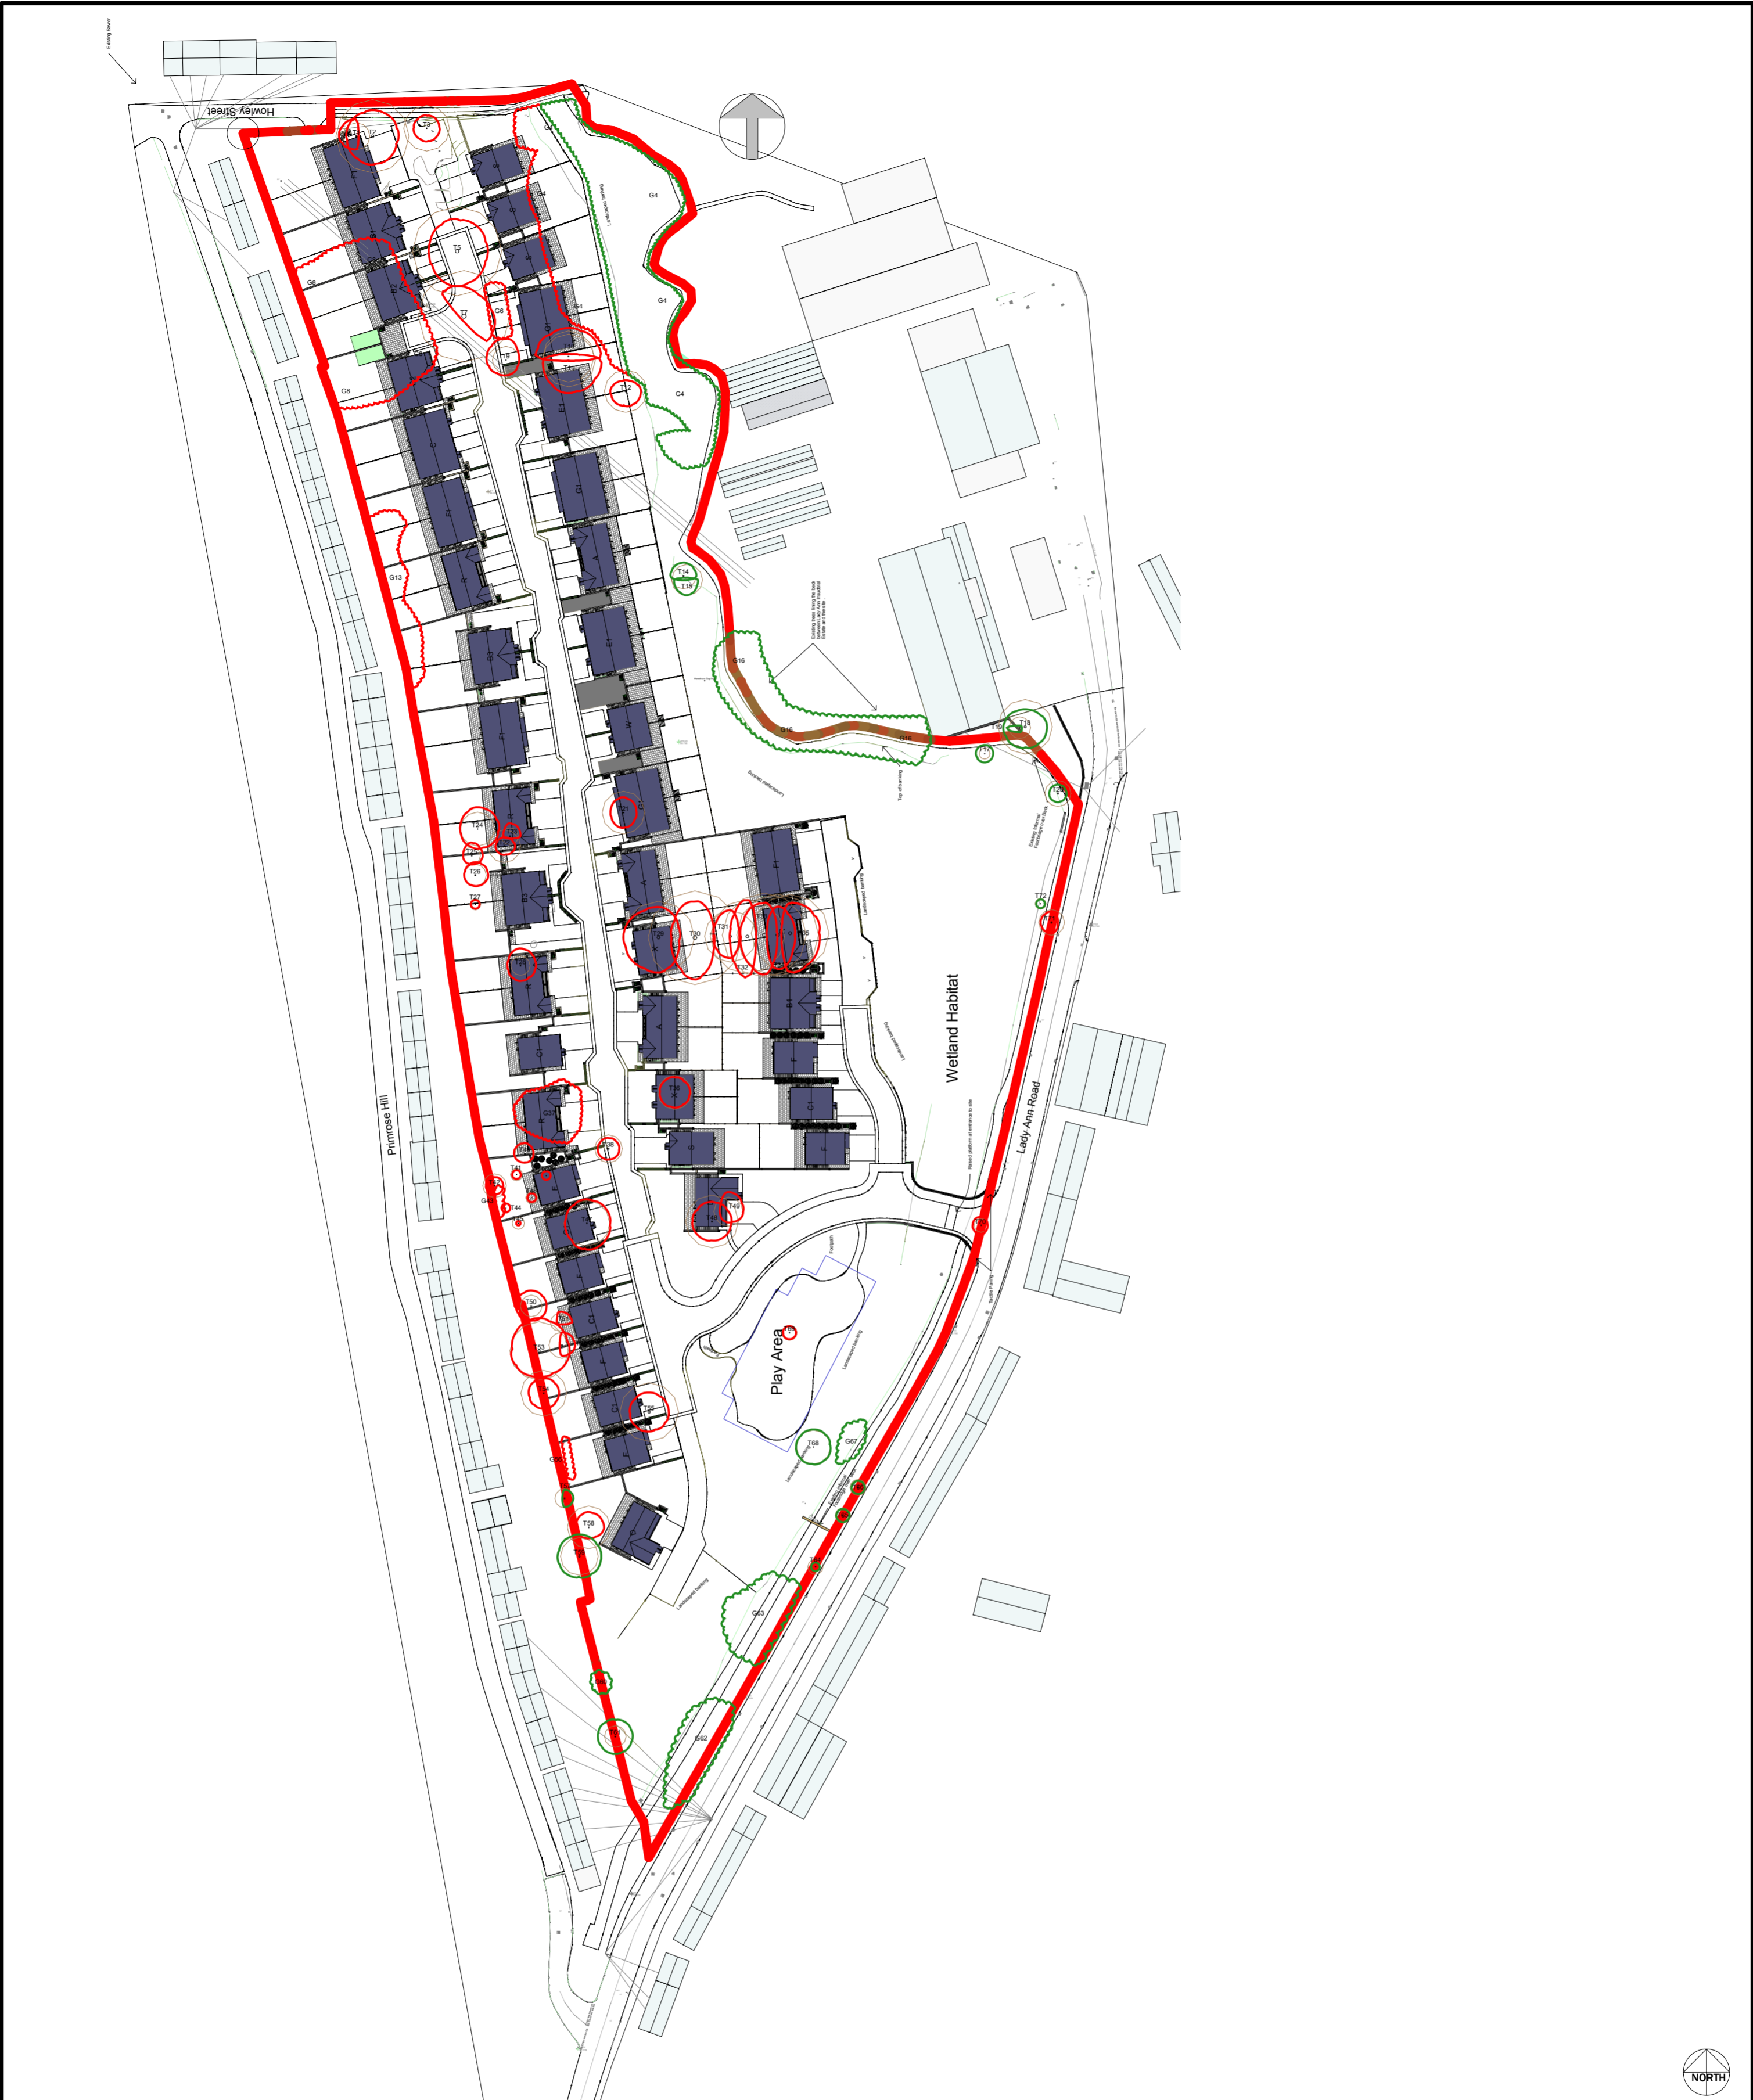
**Appendix 6:
Tree Impacts Plan**

4.2.1 From assessing the new development proposals, the removal of 40 trees and 5 tree groups will be required as they are situated in the footprint of the structure or their retention and protection throughout the development is not suitable.

4.2.2 The trees that are required to be removed to facilitate development are T2, T3, T5, G6, T7, G8, T9, T10, T11, T12, T13, T21, T22, T23, T24, T25, T26, T28, T29, T30, T31, T32, T33, T34, T35, T36, G37, T38, T39, T40, T41, T42, G43, T44, T45, T47, T48, T50, T51, T52, T53, T54, G56, T58, T69.

4.4.1 The current proposals require the removal of 7 trees protected by a TPO, that are prominent in the wider landscape with good collective amenity value, in addition to the lower value trees. As such, robust replacement planting as part of a soft landscaping scheme will be required to mitigate for the removal of these trees.
