ARBORICULTURAL REPORT

to BS5837:2012 at:

Land at:
**Lady Ann Road,
Batley,
West Yorkshire
WF17**

Reference: *AWA5179*

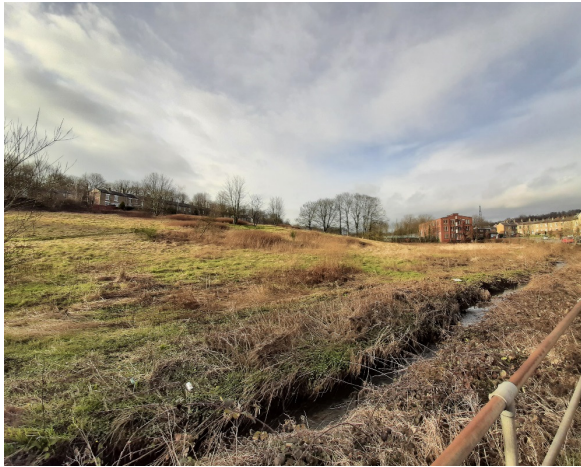
Photo 1: The site, as viewed from Lady Ann Road at the east boundary

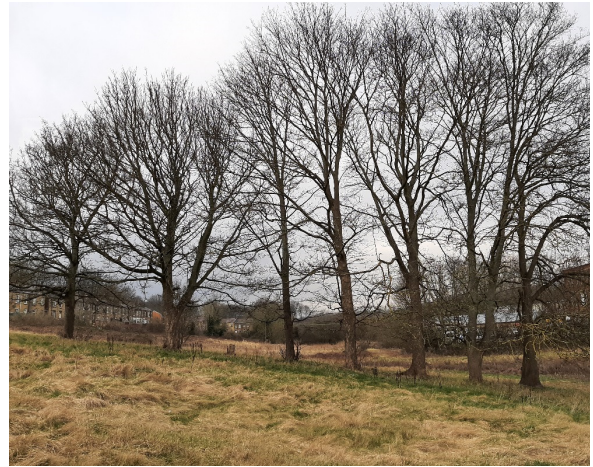
- 3.2.7 The most significant trees on site are trees T29 to T35, a linear group of mature Sycamore and Ash situated in the centre of the site. Collectively, these trees are a prominent landscape feature, that typically have good long-term value and collective amenity value. Of these trees, T32 and T35 have defects that may limit long-term value.

Photo 2: T29 to T35, prominent trees on site

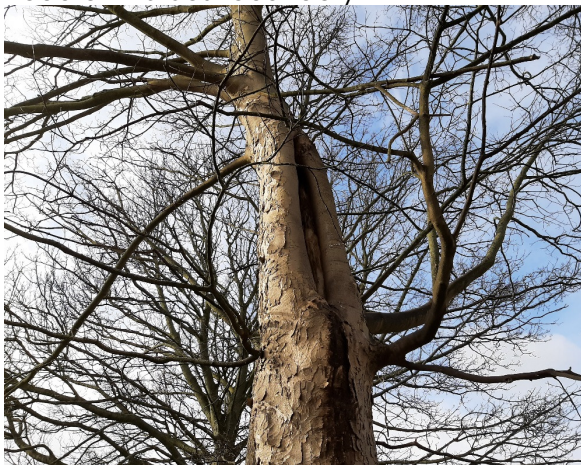
- 3.2.8 T32 has a large, open cavity (2m long, and 200mm wide) at the eastern aspect of its stem, approximately 3m from ground level. There is evidence of strengthening reaction growth at the edges of the cavity, indicating the tree has at least partially adapted to it; however, the defect may limit the long-term prospects of the tree. Further detailed decay detection could assess the extent of decay.

Photo 3: Cavity on T32

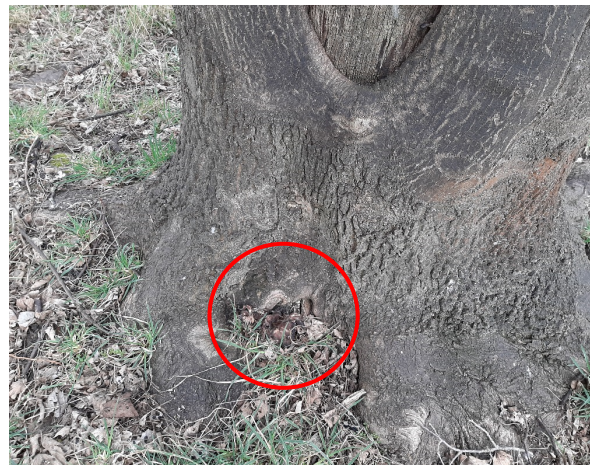
- 3.2.9 Ash T35 has bark wounds at the base of the stem, and 1m from ground level, at the west aspect. Desiccated fungal brackets were present on both bark wounds at time of survey, with surface wood being slightly decayed and with evidence of wood-boring insect activity. The damage appeared localised, with some evidence of reactive growth. However, as the stem leans slightly east, with a slightly unbalanced crown, decay on the western aspect of the stem has the potential to limit long-term value, particularly if the tree is affected by Ash dieback and its capacity to reinforce structural weaknesses is diminished.

Photo 4: Bark damage and fungal bracket (circled red) on T35

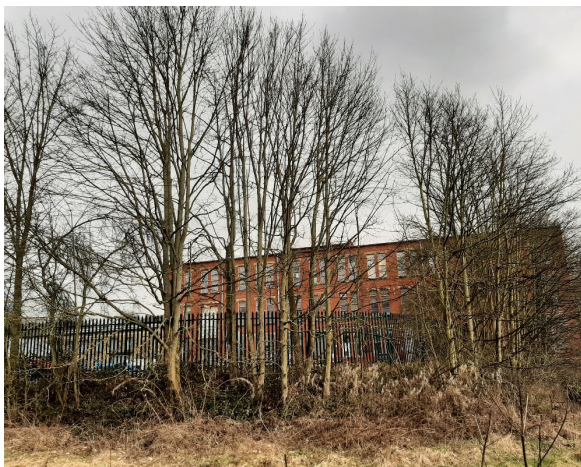
Photo 5: G16, at the eastern boundary

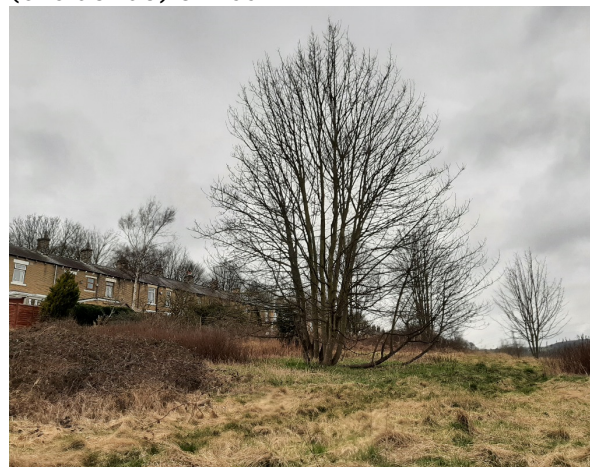
- 3.2.12 The majority of trees on site are self-set Sycamore, Ash and Willow trees. These trees are low value, with long-term prospects limited by common defects, in particular tight unions with partially included bark, and squirrel damage, while the Ash specifically will be affected by Ash dieback disease, which is established on site.

Photo 6: T47, a multi-stemmed Sycamore, is typical of the self-set trees found on site
