## **VERIFICATION REPORT**

**King James' School, St Helen's Gate, Aldmondbury,  
Huddersfield, West Yorkshire**

**Report: 574010VR**

**Date: October 2021**

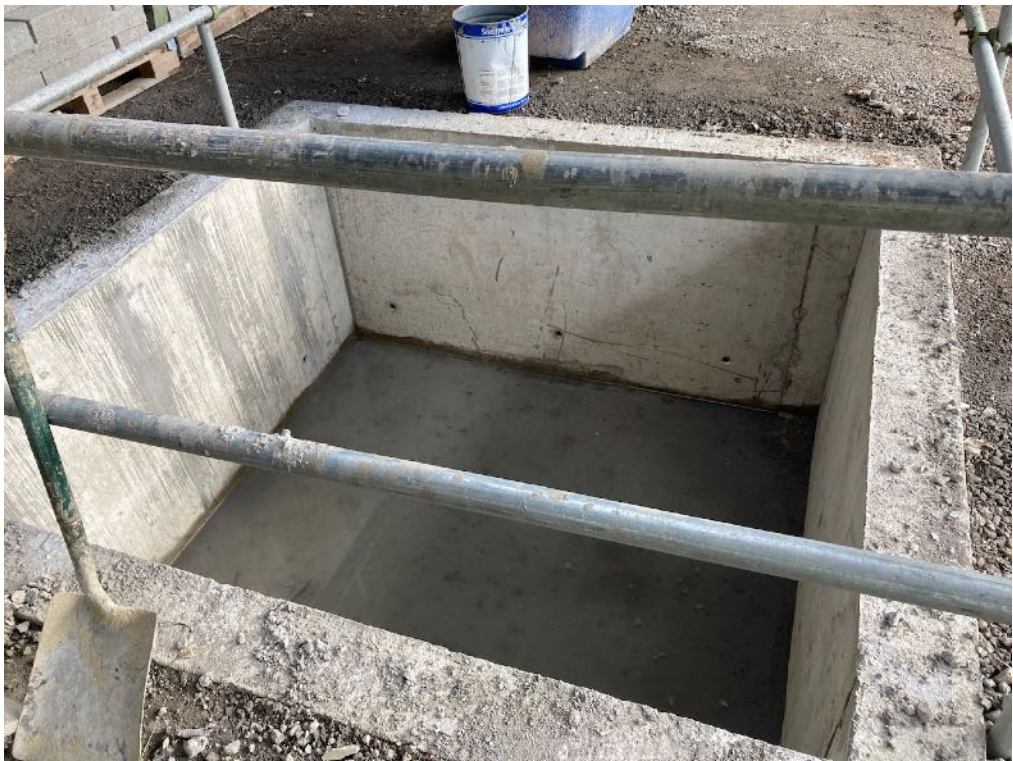
Plate 1: Lift shaft formed (11/08/2021)

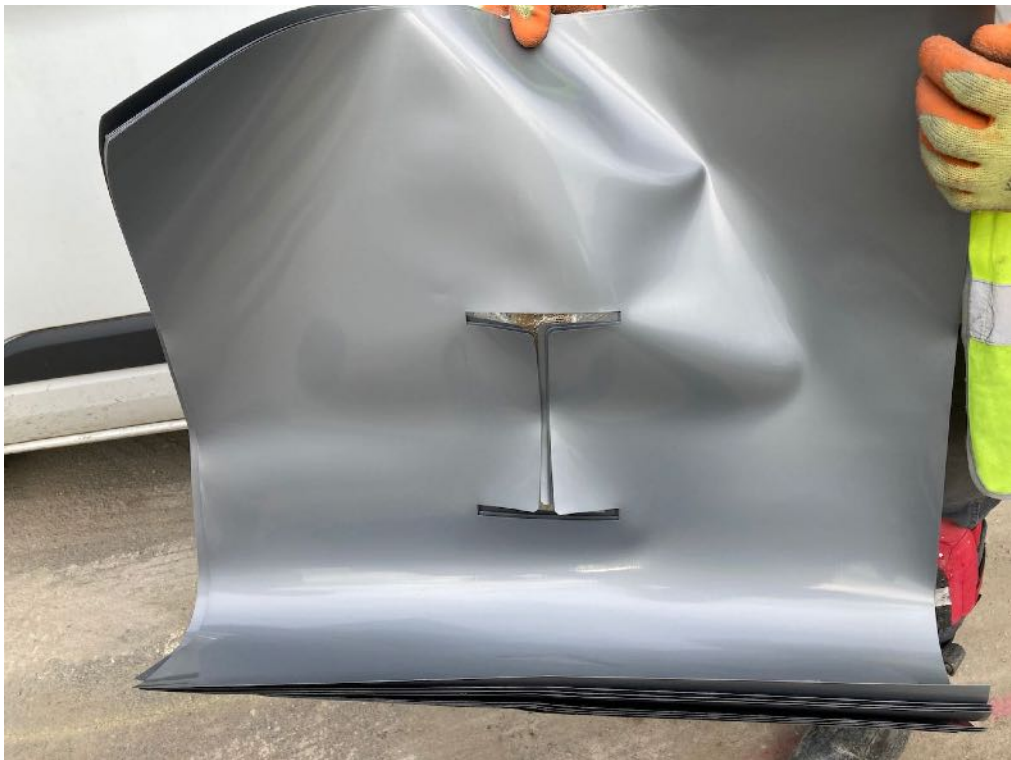
Plate 2: Pre-cut gas membrane sections for around steel columns (11/08/2021)

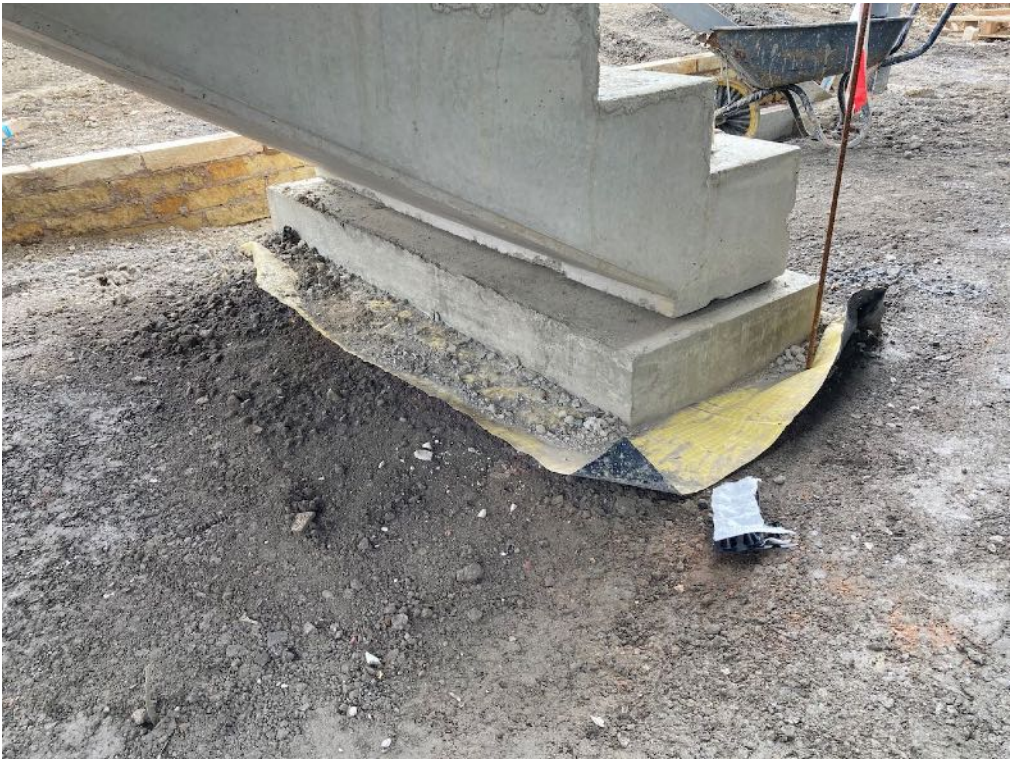
**Plate 3:** Section of gas membrane laid beneath internal concrete steps (11/08/2021)

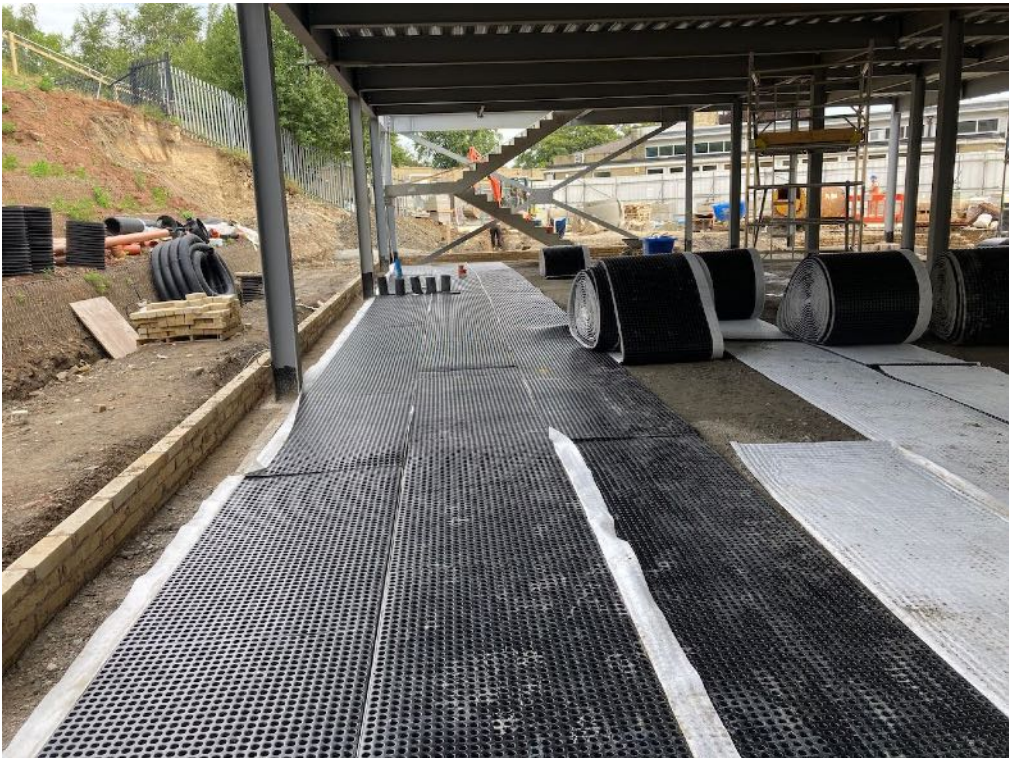
**Plate 4:** First three rows of void former laid (11/08/2021)

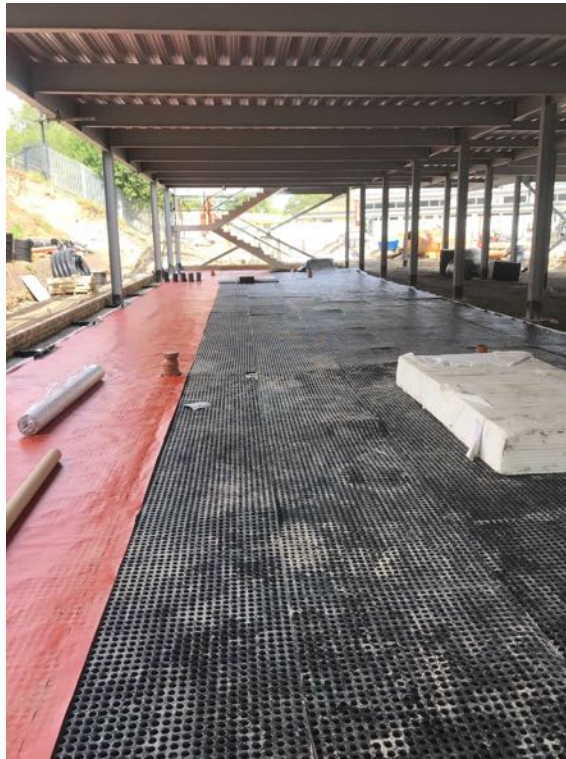
**Plate 5:** Beginning installation of gas resistant membrane (12/08/2021)

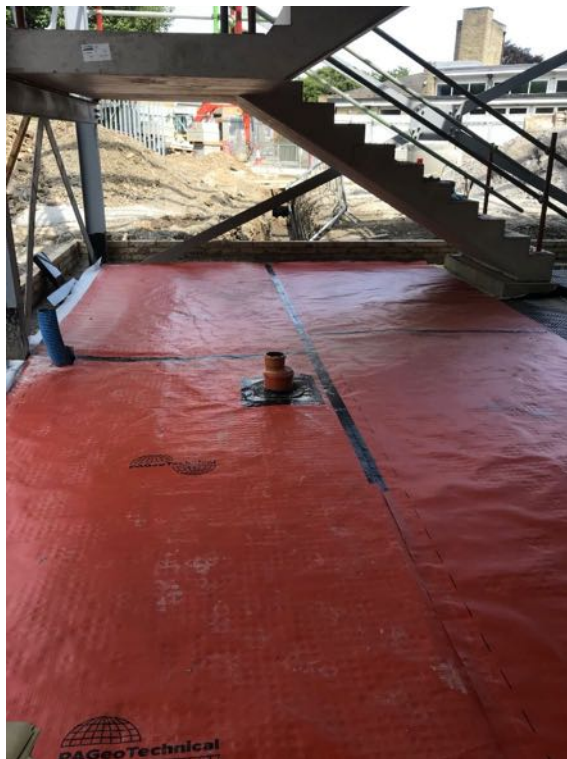
**Plate 6:** Showing detail around service entries (12/08/2021)

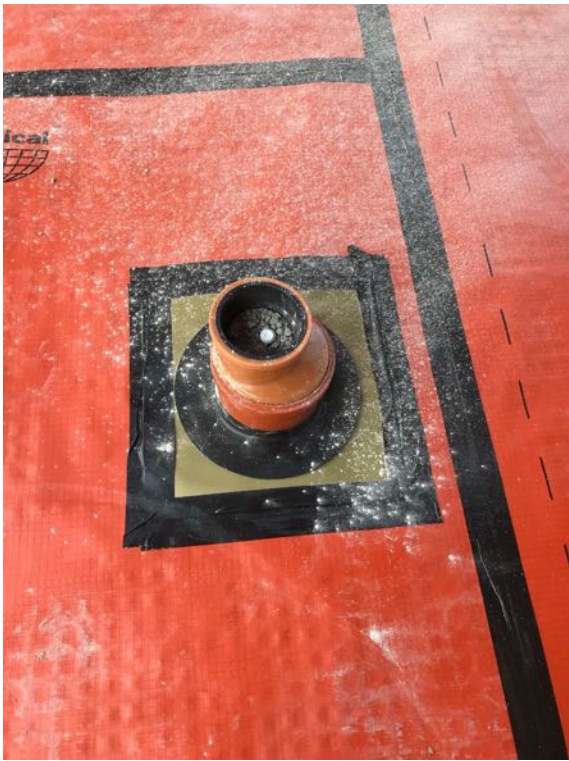
Plate 7: Close-up of service entry sealing (12/08/2021)

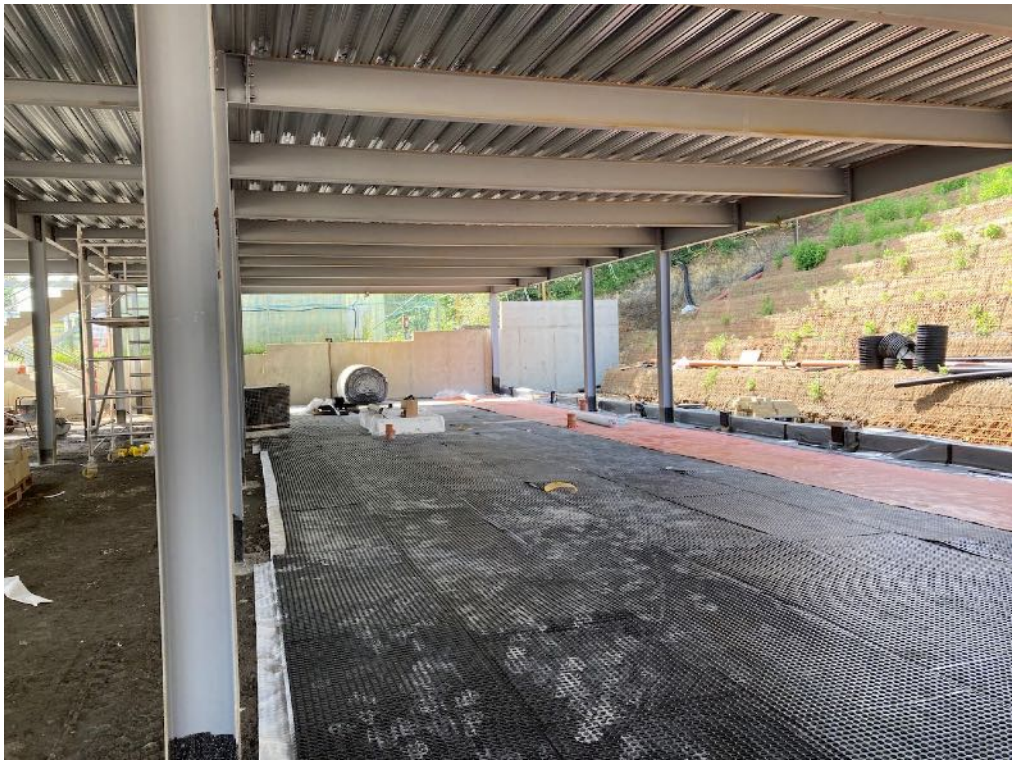
Plate 8: Void former installed across north half of building (13/08/2021)

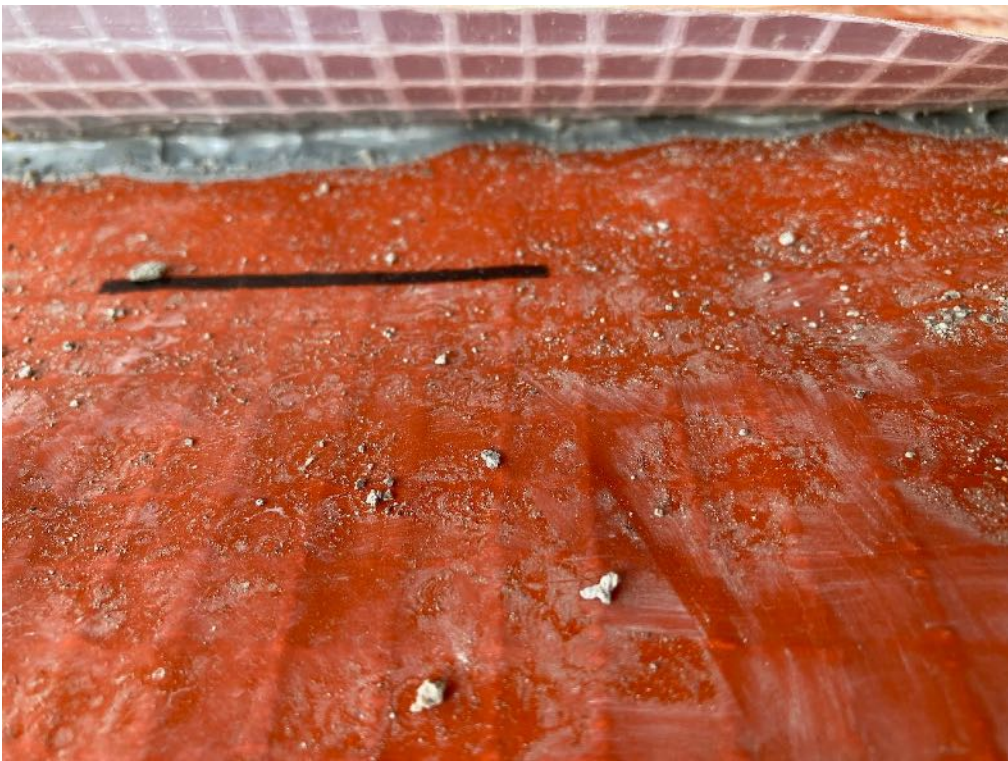
**Plate 9:** Close-up of joint sealed using SAP Butyl reinforced sealant (13/08/2021)

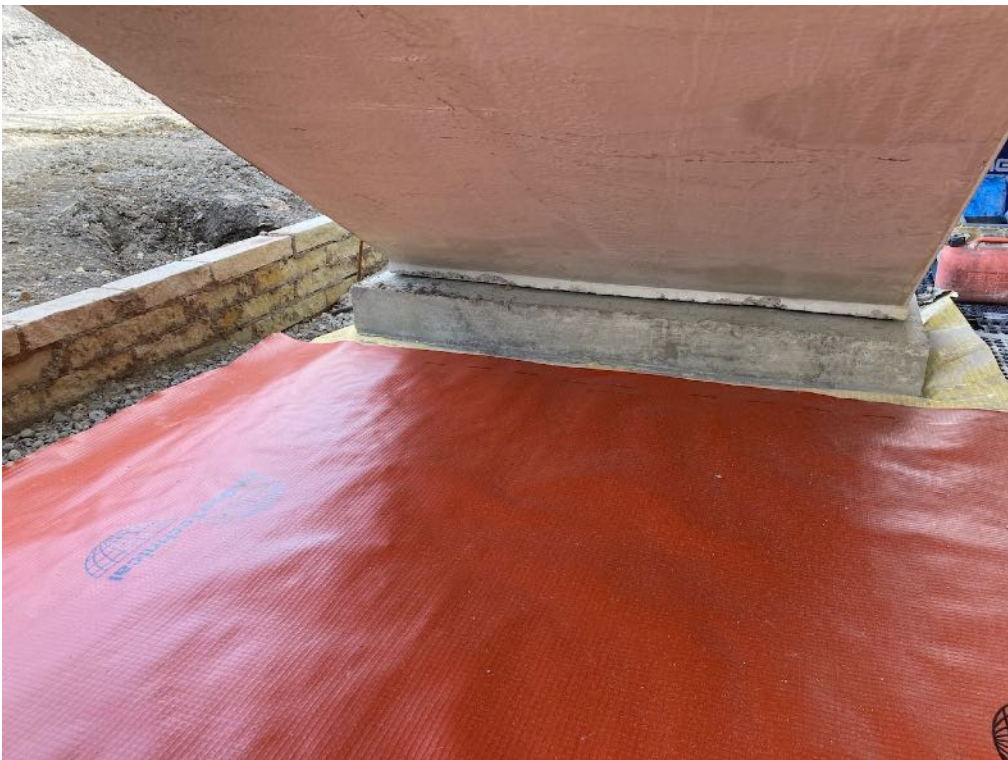
**Plate 10:** PAG membrane taken over membrane under internal stairs (13/08/2021)

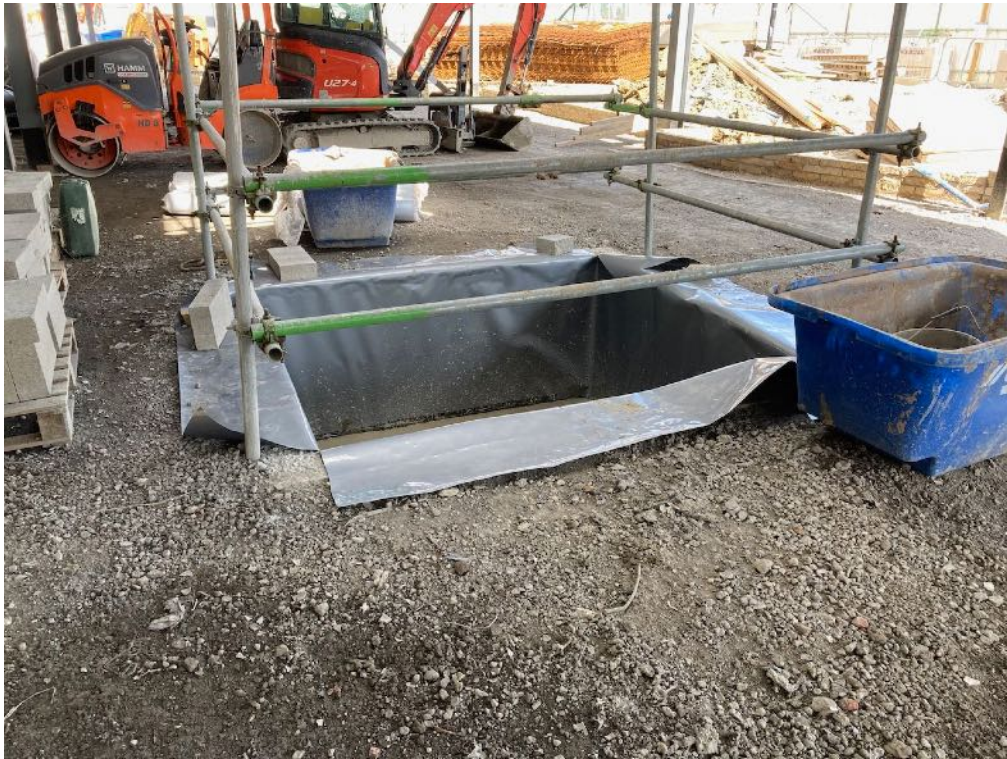
**Plate 11:** Rhinoplast membrane installed in lift pit & lapped over (13/08/2021)

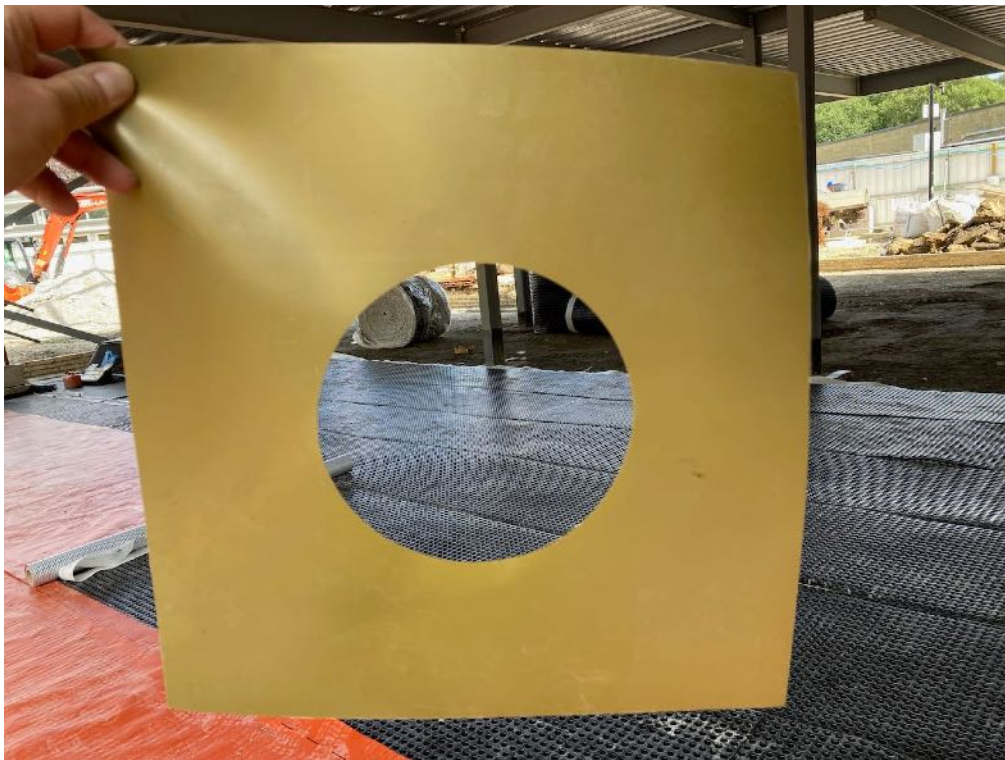
**Plate 12:** Example of pre-cut gas membrane placed over service entries (13/08/2021)

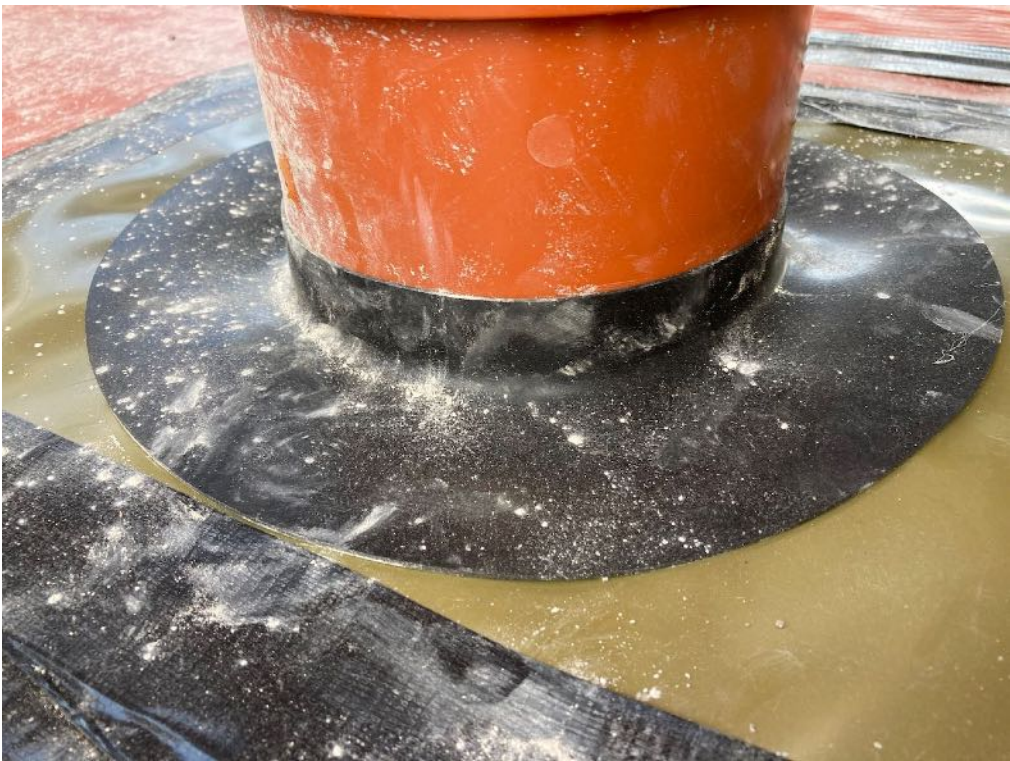
**Plate 13:** Service entry following rubber top hat & sealing (13/08/2021)

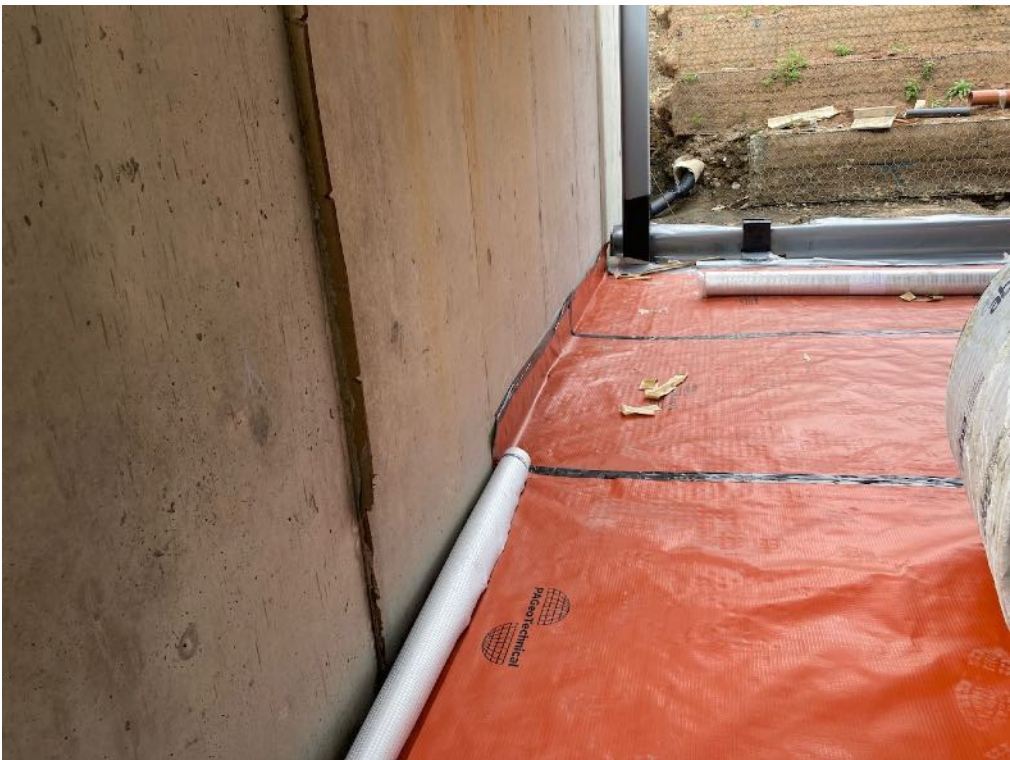
**Plate 14:** Gas membrane lapped over onto retaining wall (16/08/2021)

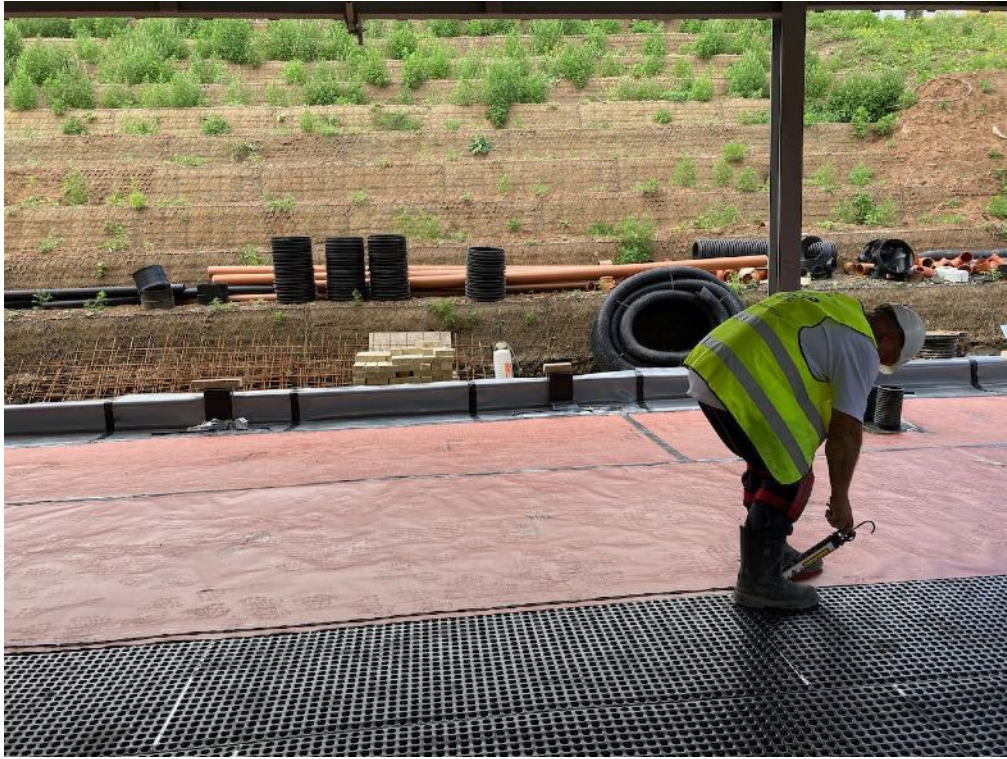
**Plate 15:** Reinforced Butyl sealant being applied along membrane joints (16/08/2021)

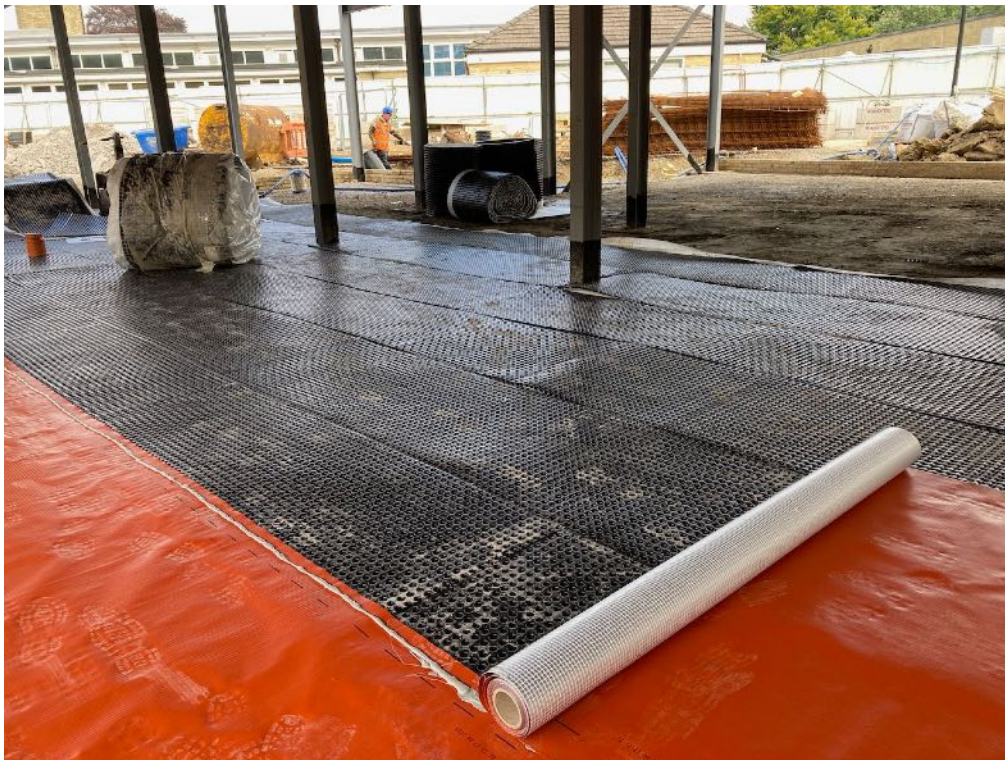
**Plate 16:** Membrane rolled out over butyl sealant (16/08/2021)

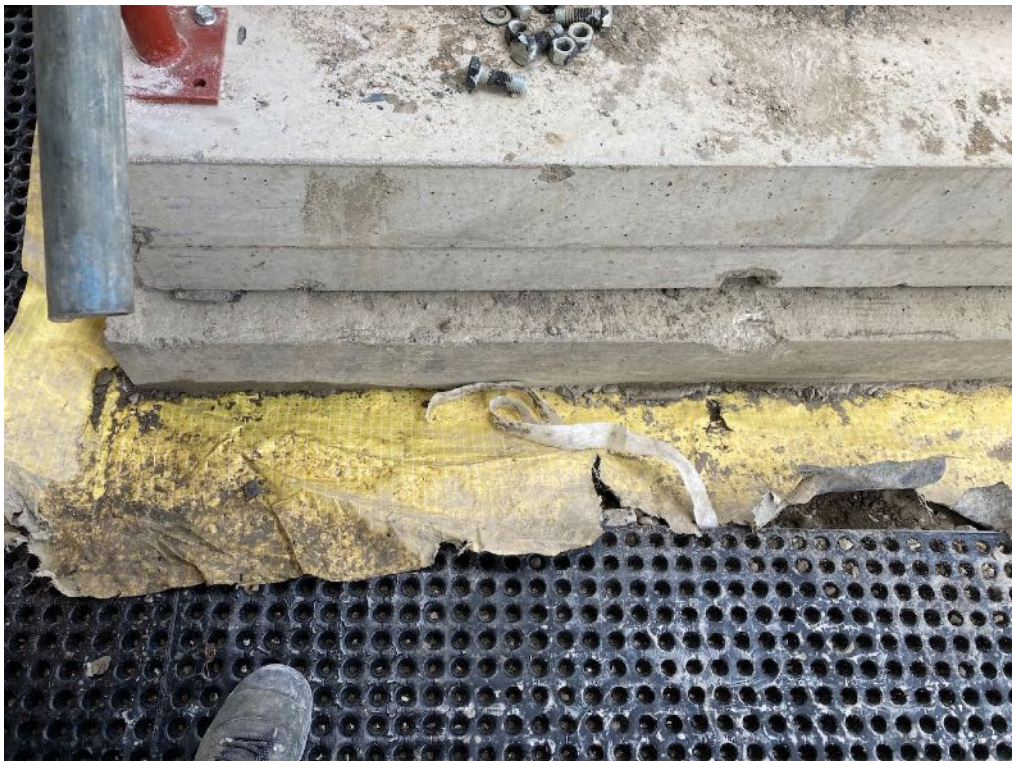
**Plate 17:** Membrane in front of NW internal staircase damage on front face (16/08/2021)

Following a site visit on 16 August 2021, Seal-A-Pipe had to postpone installation of the remaining gas protection measures whilst the client cleared some general building materials from across the southern part of the new building before the void former and gas membrane were installed. This was done to avoid the potential for follow-on damages to the various components of the ground gas protection system once installed. During this site inspection visit it was noted that some of the gas membrane in front of the north-eastern internal concrete stairs had been ripped. It was agreed with SAP that the main gas membrane would be sealed over this membrane and lap up the first step, onto which the ground bearing floor slab would be cast up to. This would ensure that the gas-resistant membrane effectively sealed

around the internal staircase. See Plates 17 and 24 in Appendix D. This was noted to have been implemented by the subsequent site visit on August 26 2020

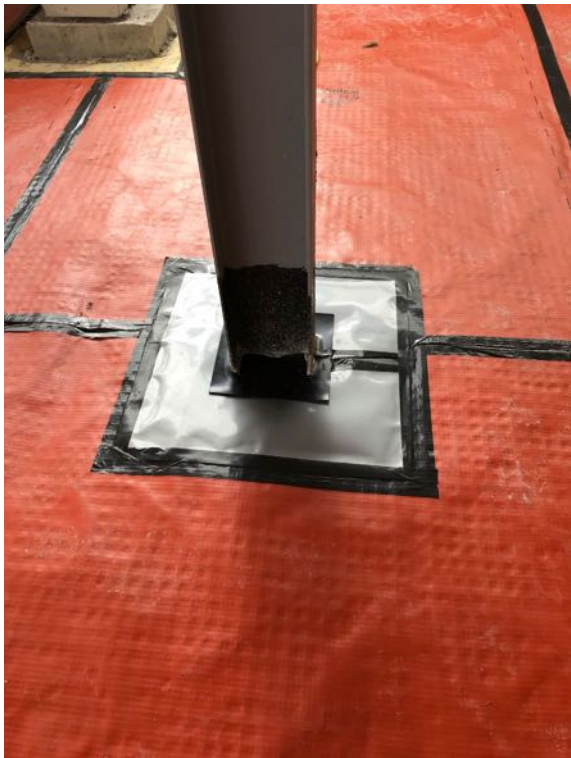
**Plate 18:** Sealing around internal steel columns (26/08/2021)

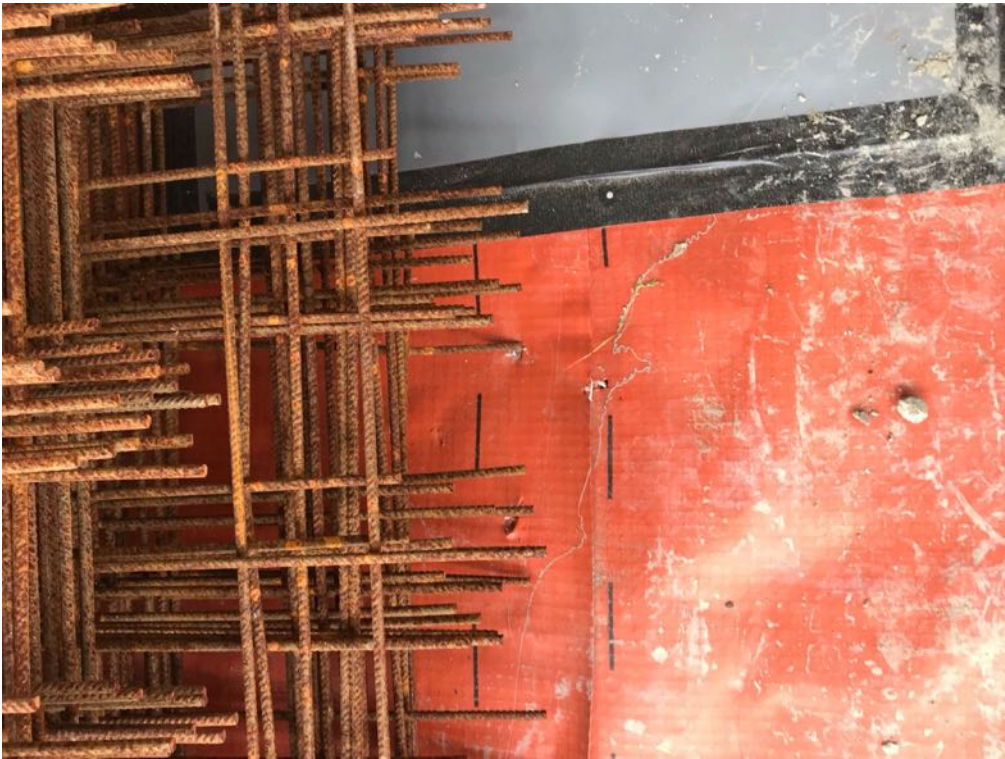
Where the mesh reinforcement for the new ground bearing floor slab had been stored, towards the east of the new building, some localised punctures were identified which penetrated through the gas-resistant membrane. These were indicative of the steel mesh having been pushed slightly once put on the ground, see Plate 19 in Appendix D. These were locally sealed using squares of the same gas membrane and sealed using Seal-A-Pipe's butyl sealant and the overlap taped down to avoid a trip hazard or the membrane getting snagged along the joint, as shown on Plate 20 in the photographic record.

As perviously outlined, the only identified defects noted during the installation of the ground gas protection system were noted during the site visit on 26 September 2021, when localised puncturing of the gas membrane had been caused by movement of the steel reinforcement mesh. Localised repairs were undertaken by the installation contractor by sealing areas of gas membrane over the identified areas of damages and no other visual signs of potential damage were noted elsewhere on the final site inspection visit before the concrete floor slab was cast.

**Plate 19:** Localised damage to membrane from mesh reinforcement (26/08/2021)

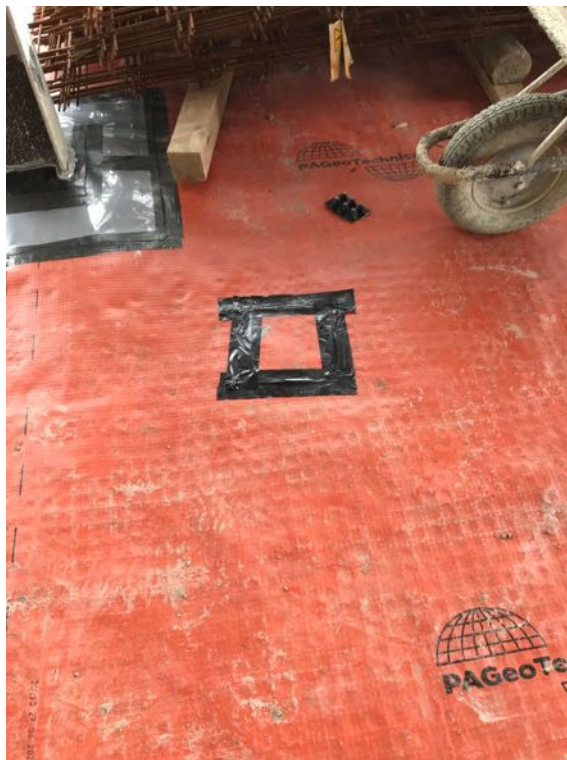
**Plate 20:** Local repair of gas membrane where scratched by mesh (26/08/2021)

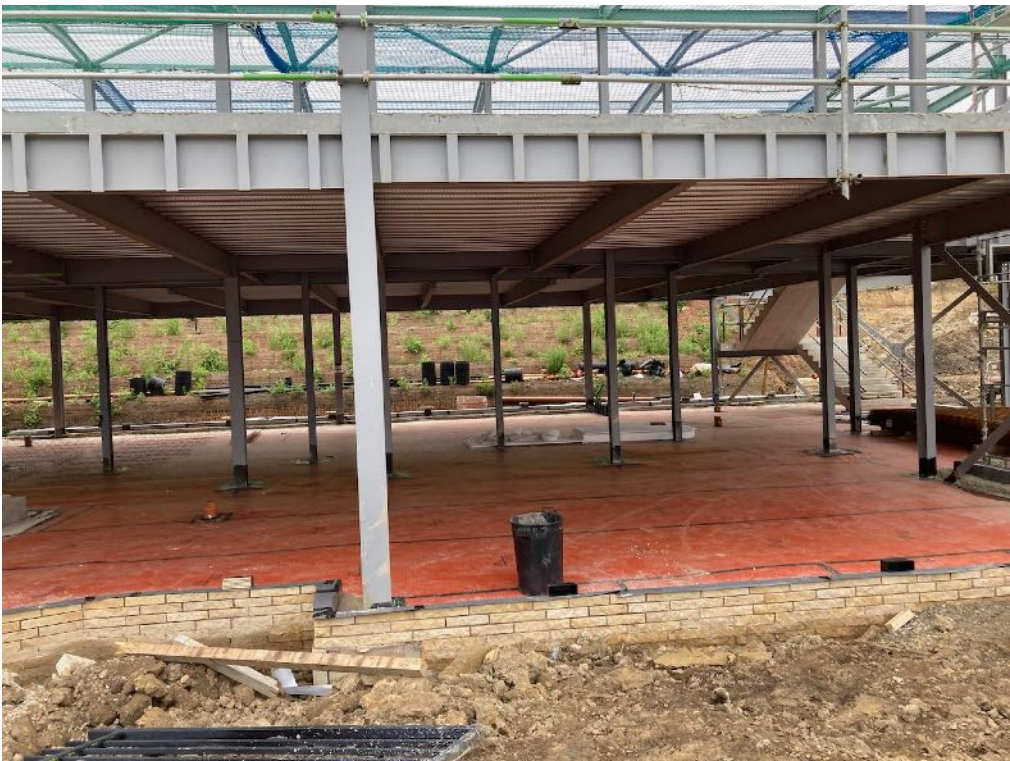
**Plate 21:** Membrane placed across whole footprint area (01/09/2021)

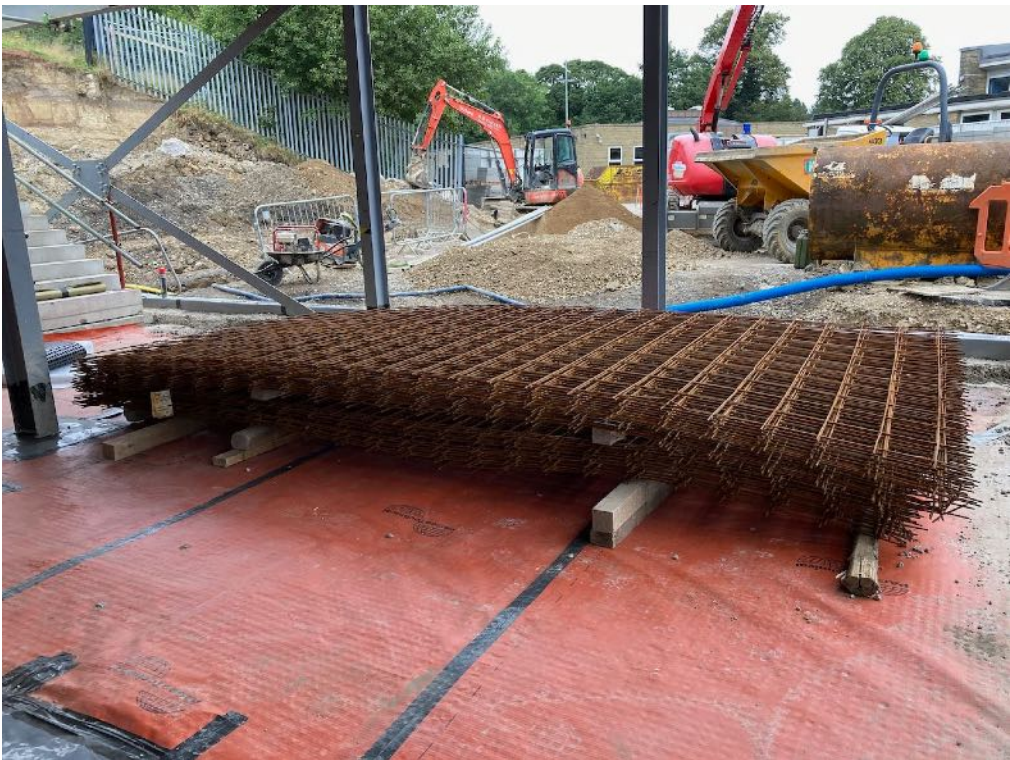
**Plate 22:** Mesh stored on timbers after previous damages noted (01/09/2021)

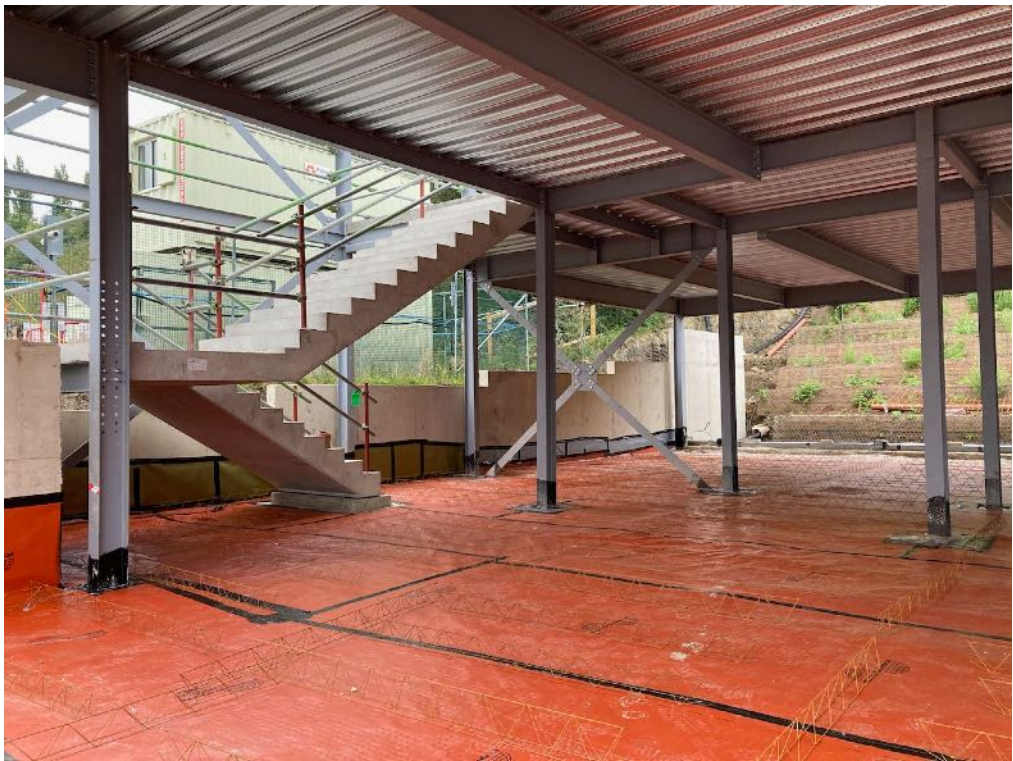
**Plate 23:** Risers for mesh reinforcement placed over membrane (01/09/2021)

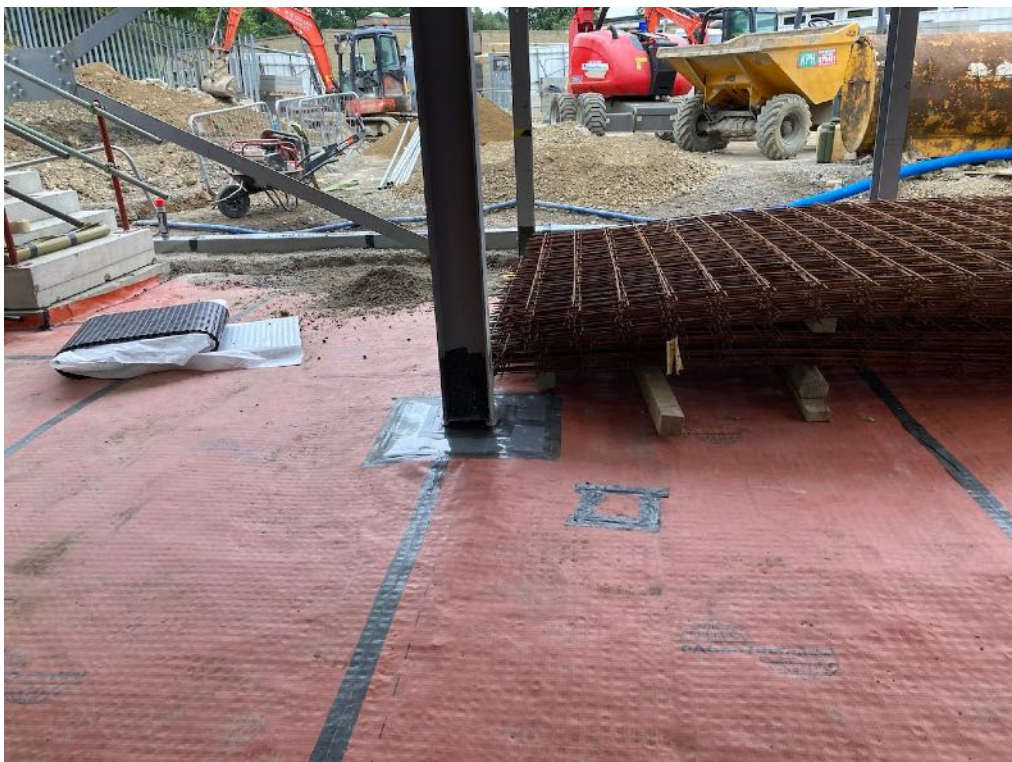
**Plate 24:** Gas membrane lapped over first step of internal stairs (01/09/2021)
