Project: **Risk Assessment of Trees**

Site: **Brooks Plantation at Australia, Wishaw Mill Rd, Meltham, HD9 4EB**

On Behalf of: **DW Woods**

Reference: **BA11118**

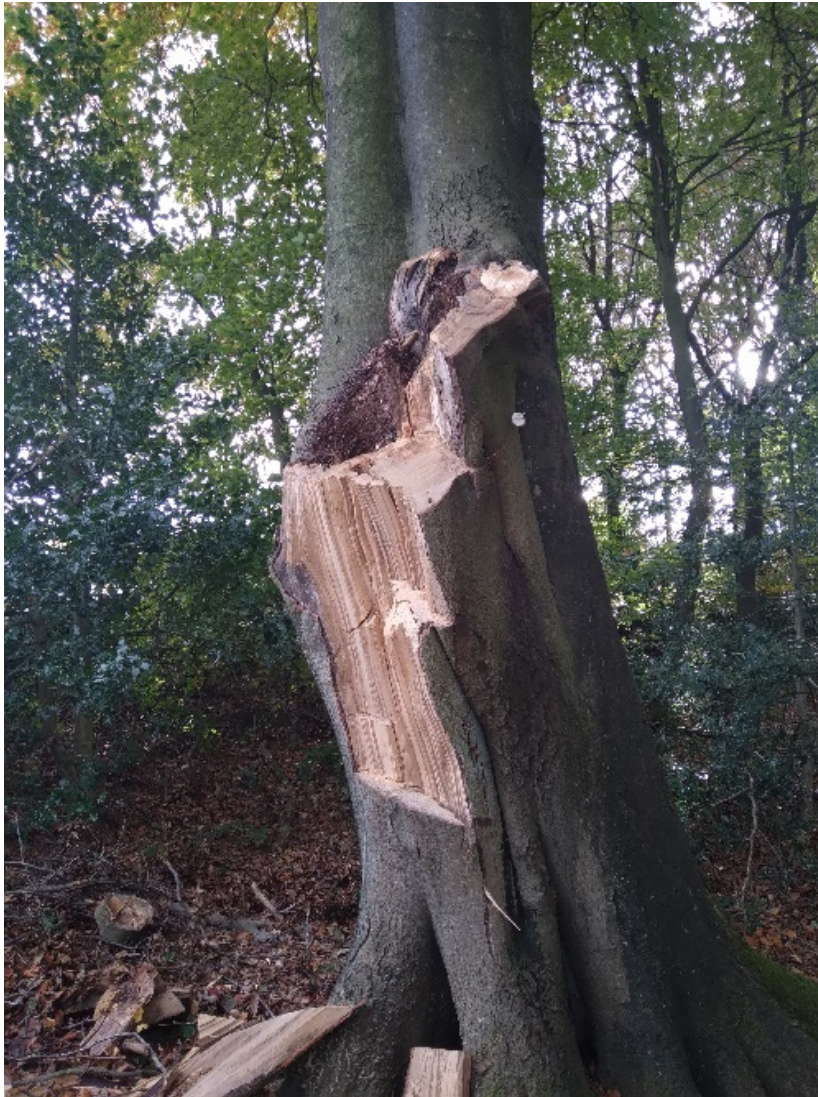
- 3.17.1 **T1972 (Beech).** This tree has recently suffered large, co-dominant stem failure which would have affected Wilshaw Mill Road. The tree is now low risk as the part likely to fail, has failed. The remaining canopy near the road has been reduced and therefore there is now little risk to the road. However, the wound that has resulted from the stem failure will, over time, be open to fungal decay and disease which may affect the trees structural stability. Due to its location, the tree may have to be removed in the future but currently presents a 'tolerable risk' to the road.

The photograph below shows the stem of T1972 and the wound resulting from the stem failure:

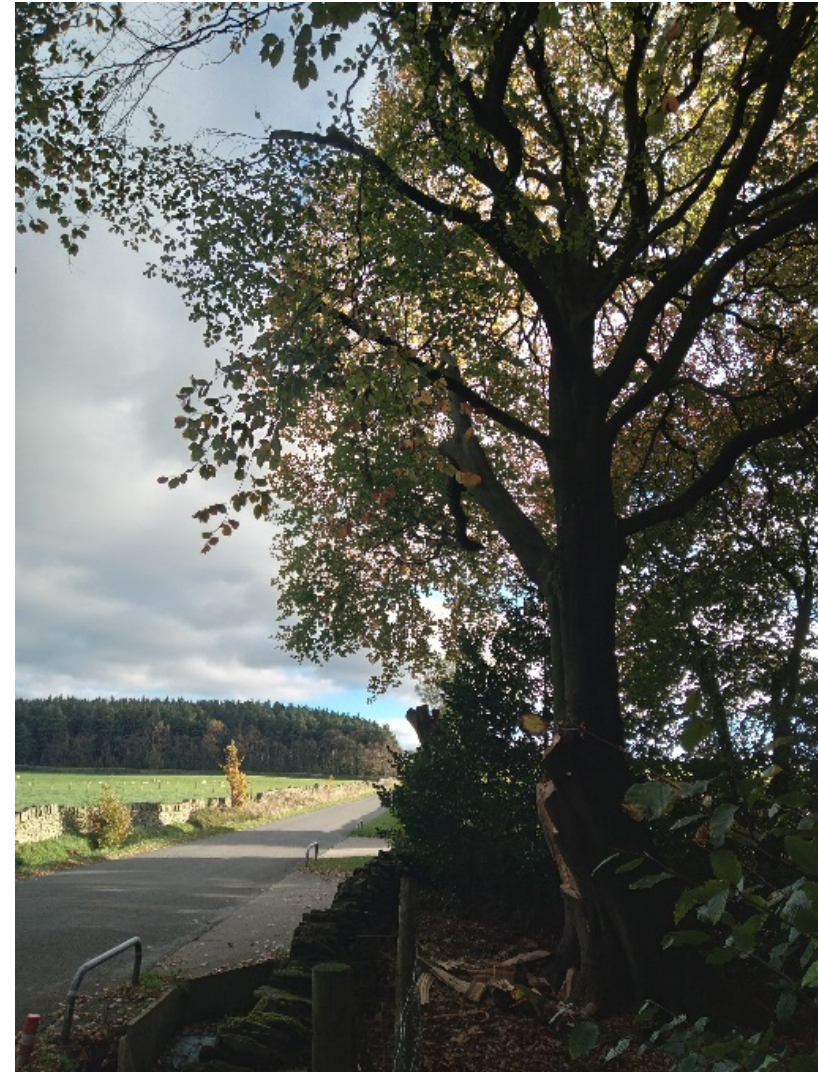
The photograph below shows the reduced canopy of T1972 on the roadside:

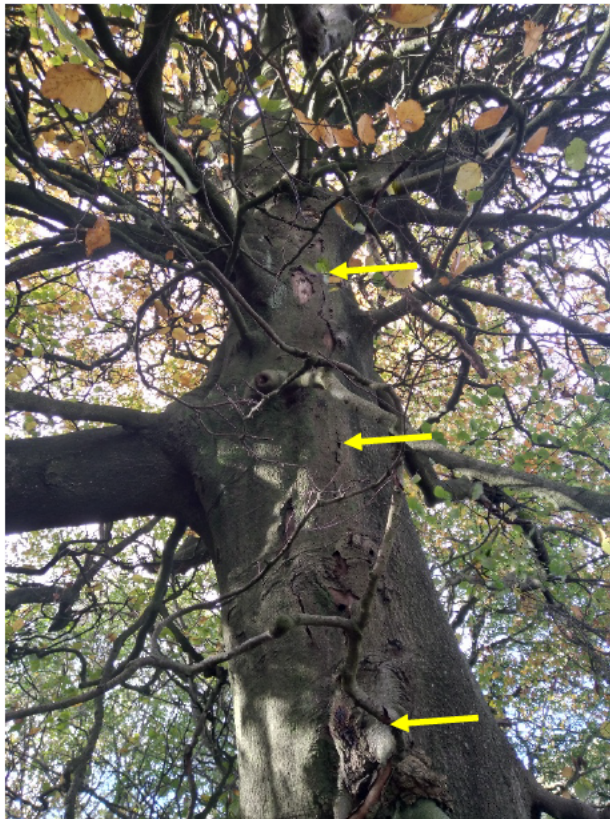
3.17.2 **T1973 (Beech).** This tree has the possible signs of Beech Bark Disease, suggested by the dark, oozing patches on the lower stem. This has led to a dysfunctional cambium column (strip of dead bark tissue) from ground level to the first two primary branches over the road. These two primary branches are also tightly included (a weak branch union). Although a low risk, it is advised that the canopy over the road is crown reduced/remodelled to reduce the risk of failure onto Wilshaw Mill Road.

The photograph below shows the stem of T1973, and the arrows show the strip of dead bark:

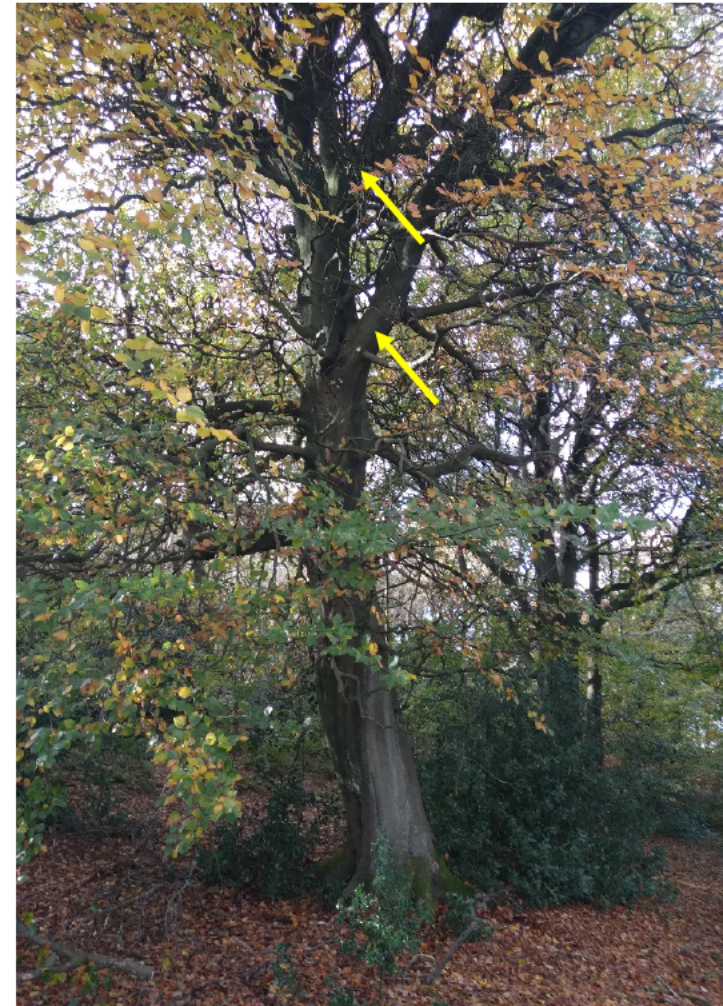
The arrows in the photograph below shows the two primary branches of concern on T1973:

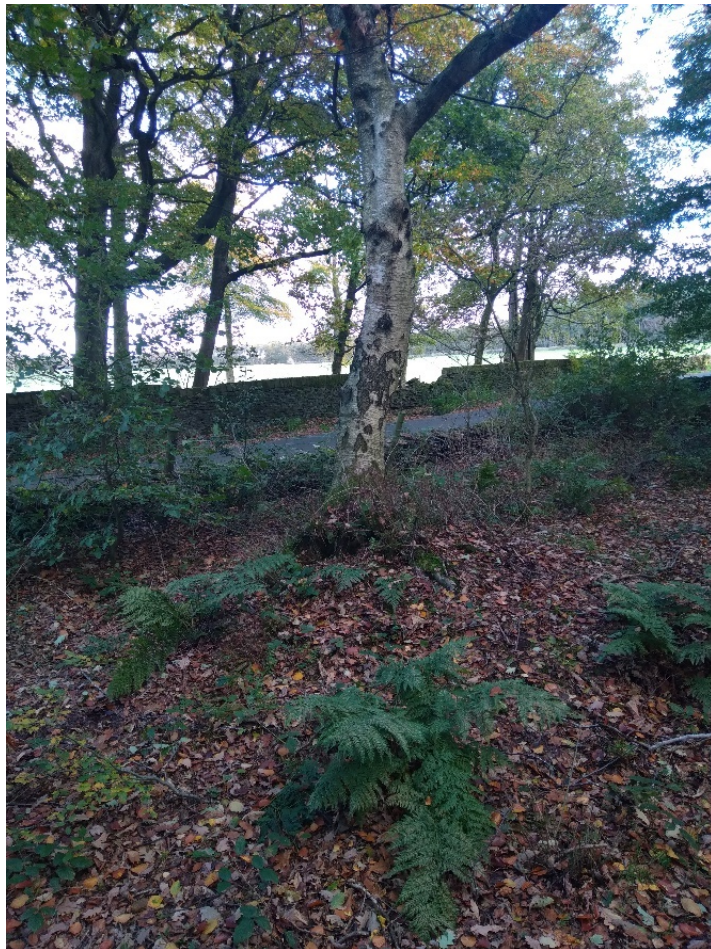
3.17.3 **T1974 (Downy Birch).** This tree has an asymmetric crown shape that is biased towards Wilshaw Mill Road. There is decay starting to form at the base and the buttress roots are exposed/lifting from the ground. It is recommended to fell this tree and allow the natural regeneration surrounding the tree to replace it.

The photograph below shows the stem of T1974:

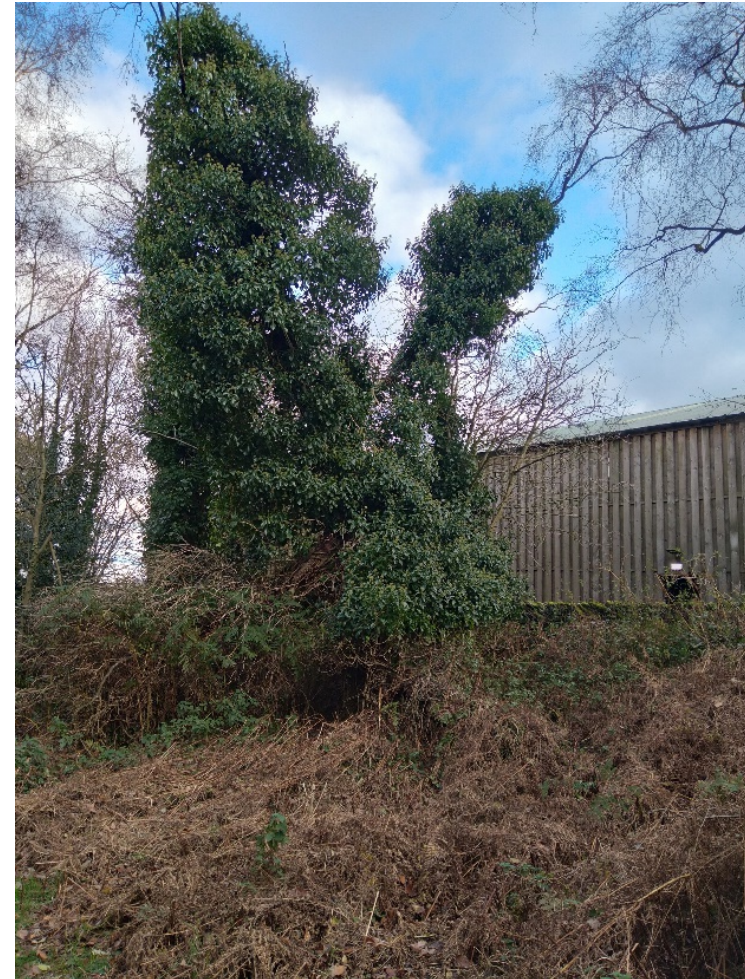
3.17.4 **G1975 (Birch & Rowan).** This small group is swamped in ivy and showing signs of advanced decline. Due to its proximity to the shed, it is recommended to fell the trees and allow the natural regeneration surrounding the trees to replace them.

The photograph below shows G1975:

| Pos | Tag No. | Species | Age | Height | Height to canopy | North | South | East | West | Vitality | Safe Life | Category | Stem Dia (mm) | No. Stems | Observations | Management Options | Risk | Priority |
|---|---|---|---|---|---|---|---|---|---|---|---|---|---|---|---|---|---|---|
| Est Pos | G1975 | Betula pendula (Silver Birch), Sorbus aucuparia (Rowan) | M | 14 | 12 | 2 | 2 | 2 | 2 | Fair | <5 | U | 350 | 1 | Branch failures visible. Canopy swamped by ivy. Tree is in decline. Close to shed. | Tree felling in line with section 12.2, BS3998:2010. | Low | Within 1 year |

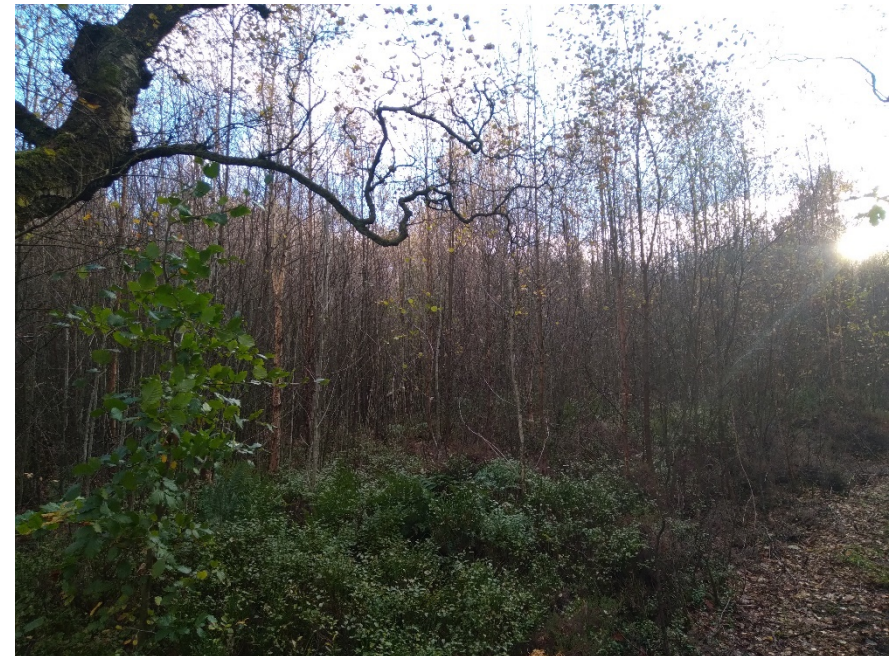
3.18.3 **Thinning of young saplings.** There is an area to the northwest of the woodland which is densely populated by Birch regeneration or regrowth from old stumps. This area would benefit thinning (removal of selected trees) to improve the growing conditions for the remaining trees and allow the area to be accessed. The Birch in this area would also be suited to coppice management where the trees are cut down to 'stools' on a rotational basis and allow to regrow multiple stemmed. This can be a source of useful material or firewood and also provide a useful habitat.

The photograph below shows the area described:

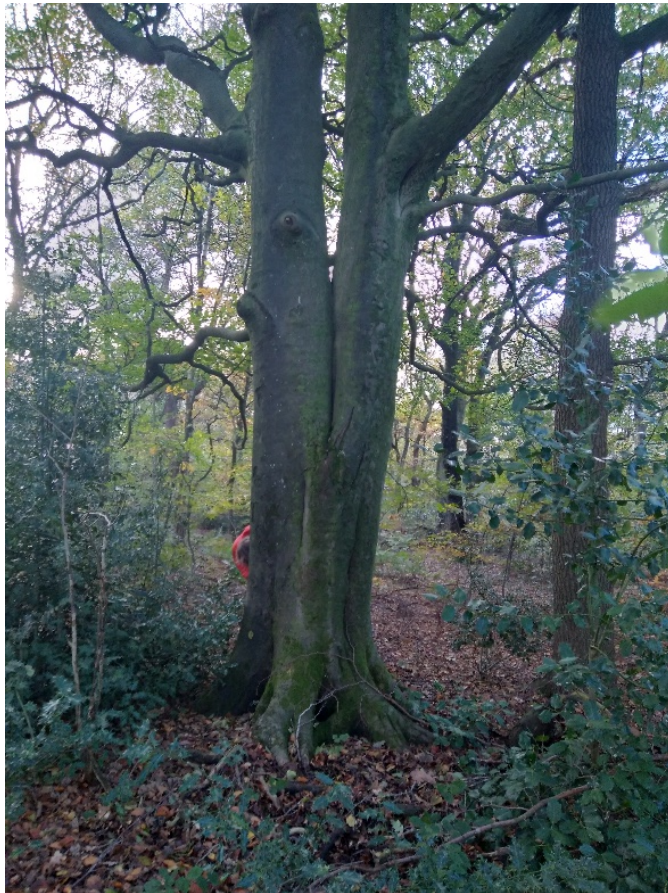
The photograph below shows a Beech tree near Wilshaw Mill Rd with co-dominant stems which may reduce its safe life expectancy:

be prudent to plan for the phased replacement of the mature trees closest to Wilshaw Road that have these defects and allow the saplings to take their place. This also has the benefit of introducing a different age class into the woodland. The following photographs are of trees with structural features or conditions that would be suitable for medium to long term replacement:

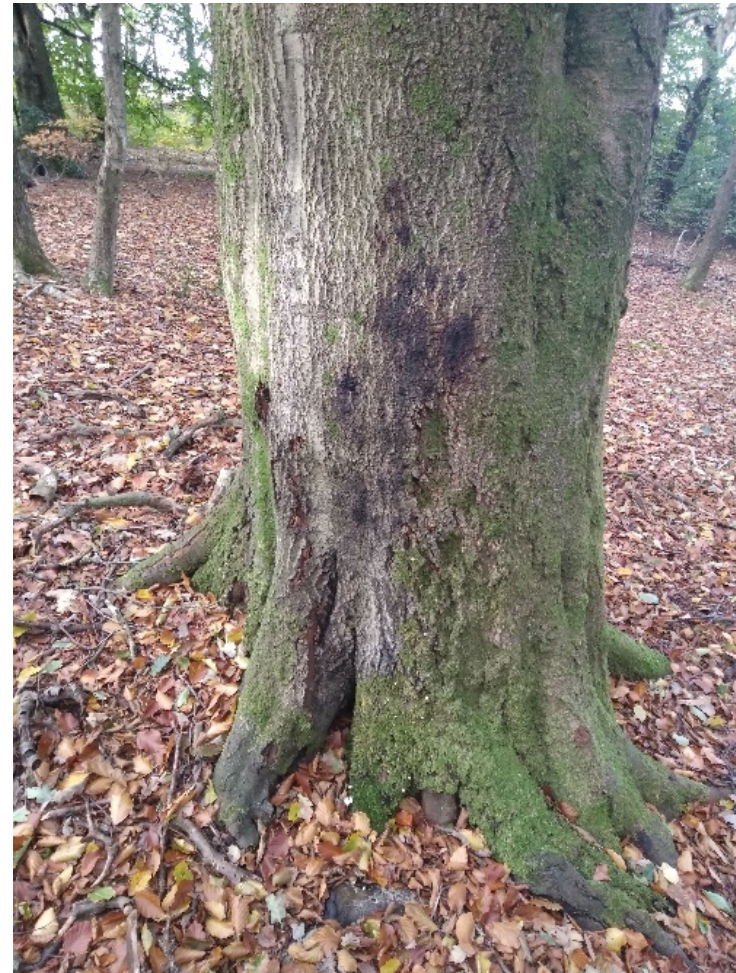
The photograph below shows a Beech tree near Wilshaw Mill Rd with oozing marks on the stem, most likely signifying Beech Bark Disease:

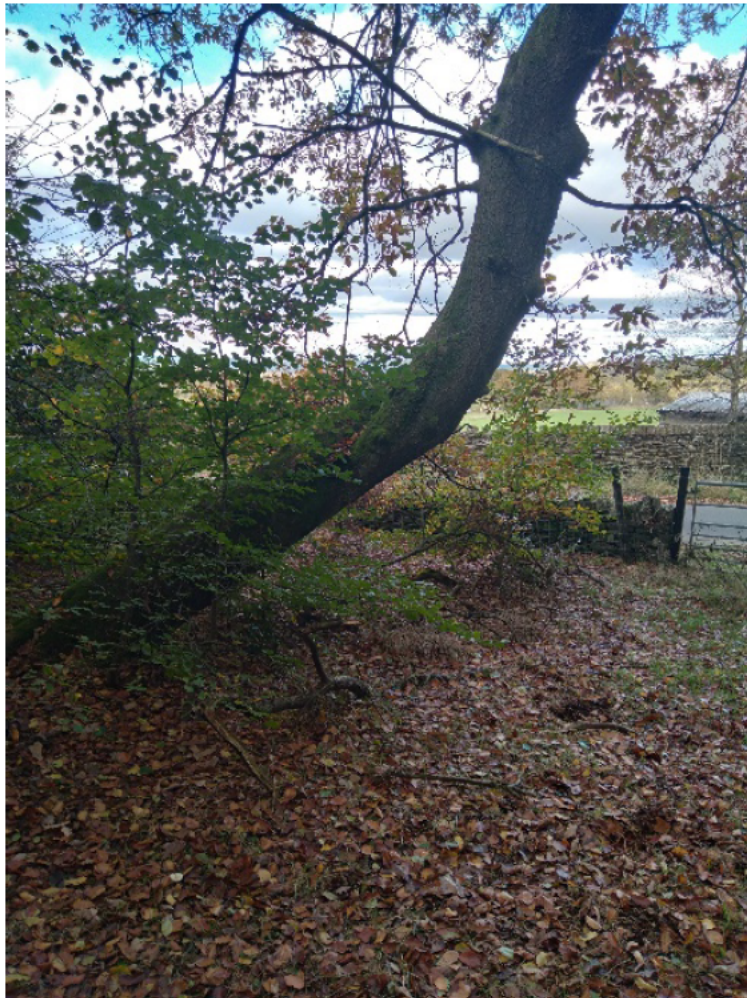
The photograph below shows an Oak tree near Wilshaw Mill Rd with a significant bend in the stem and a lean towards the road:

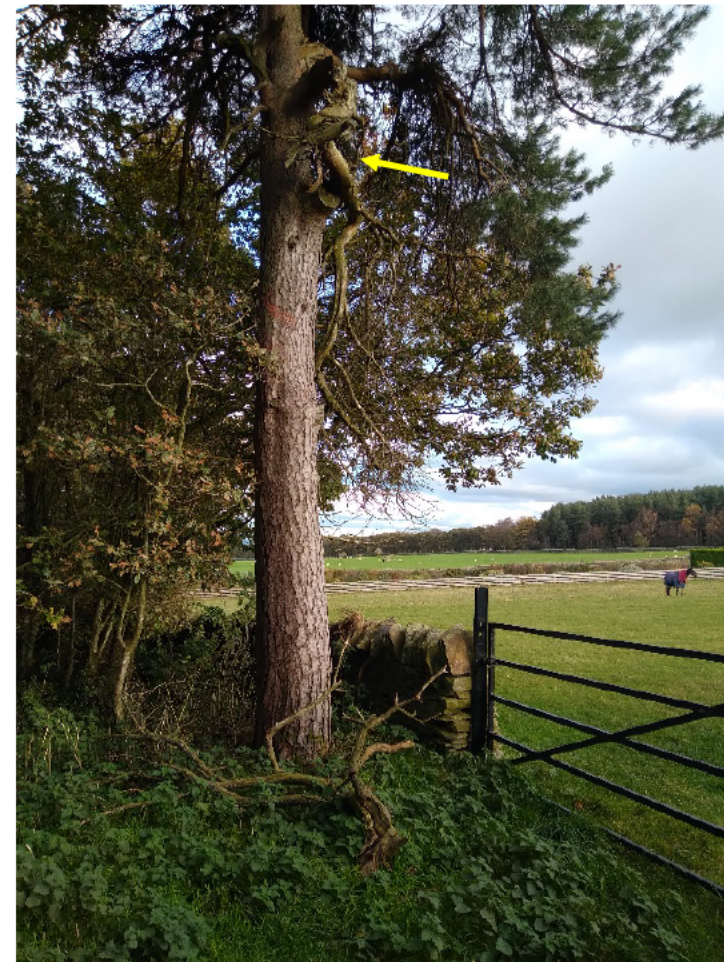
**Minor Issues:** On the southern border, halfway between the large shed and the entrance driveway is a Scots Pine adjacent to a gate. There is a medium sized dead branch hung up in the lower canopy of this tree and therefore it may be prudent to remove it if the gate is often used.

The photograph below shows the tree, and the arrow shows the hanging branch:
