Gas Membrane Installation  
Validation Report  
Holroyd Homes  
Huddersfield  
HD4 7HB  
Version 3 27/09/21

## Appendix 1- Site Survey Sheets

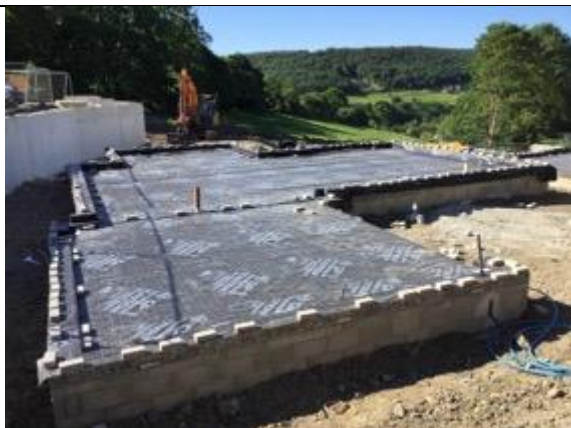
Overview photo looking at Plot 4"

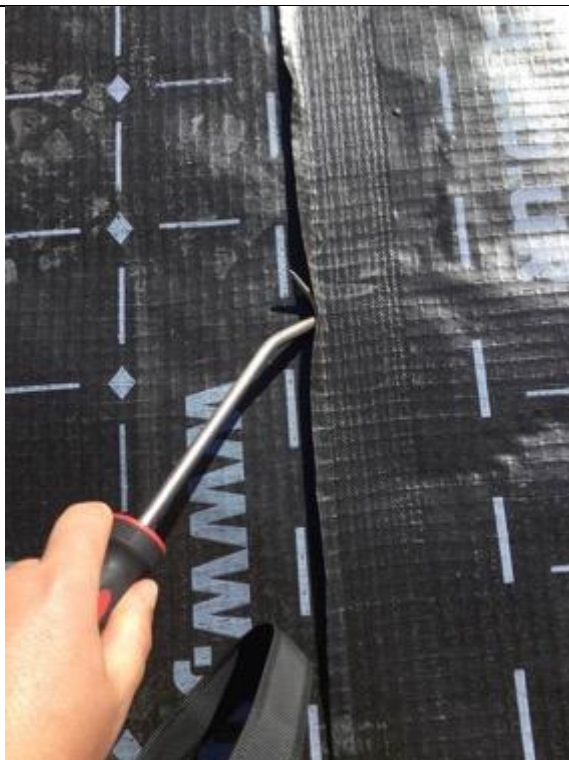
Pick probe testing carried out to the mechanical weld joint.

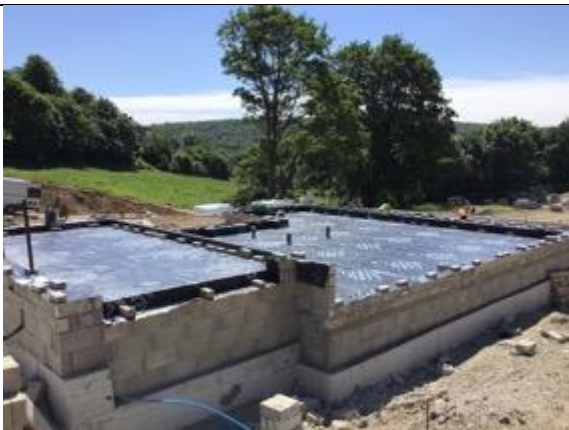
Plot 6 with integral garage full line out installation

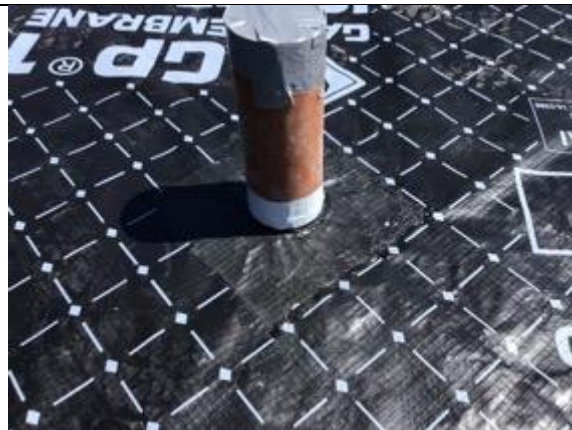
Plot 6 sealed pre formed pipe penetration top hat

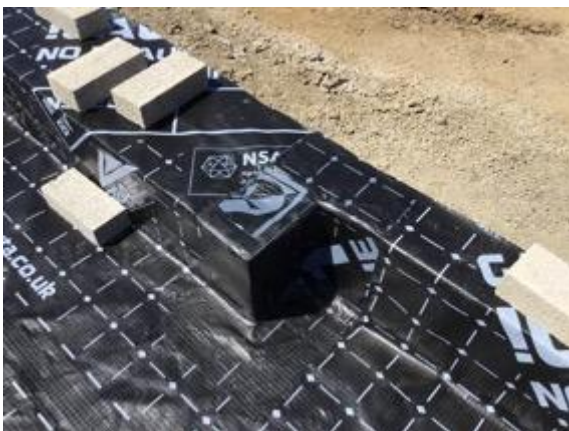
Plot 6 sealed pre formed threshold detail

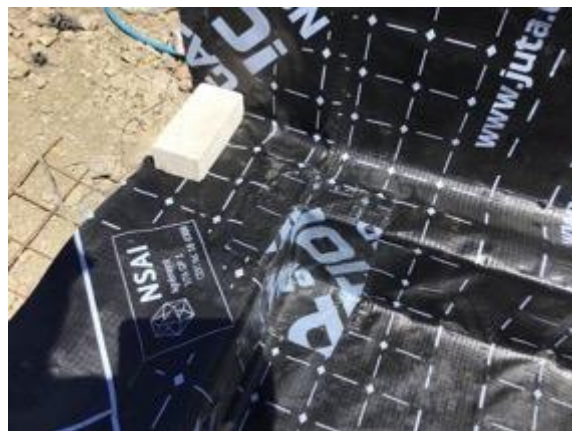
Plot 6 sealed pre formed corner detail

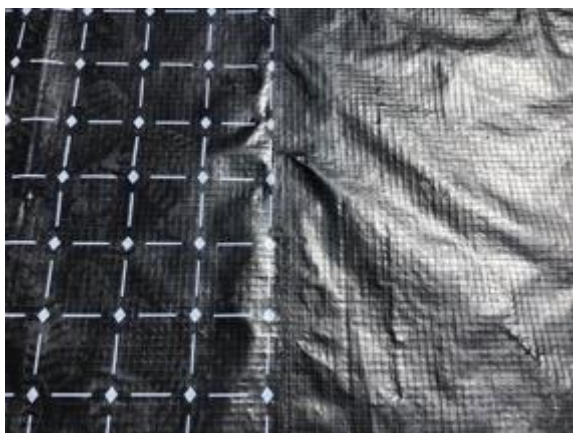
Plot 9 sealed auto weld membrane joint

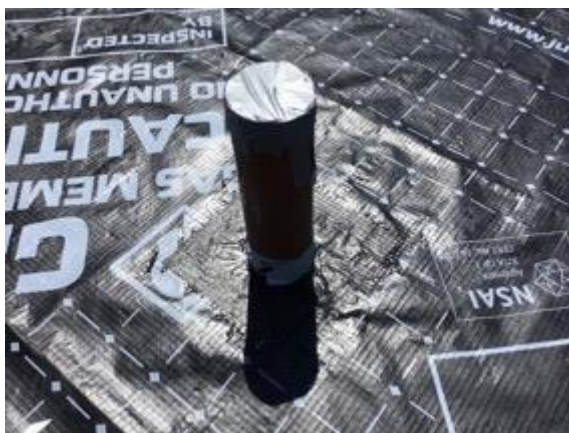
Plot 9 sealed pre formed pipe penetration top hat

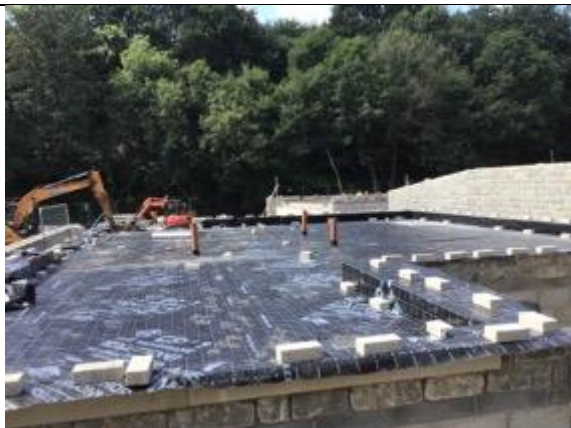
Plot 10 overview

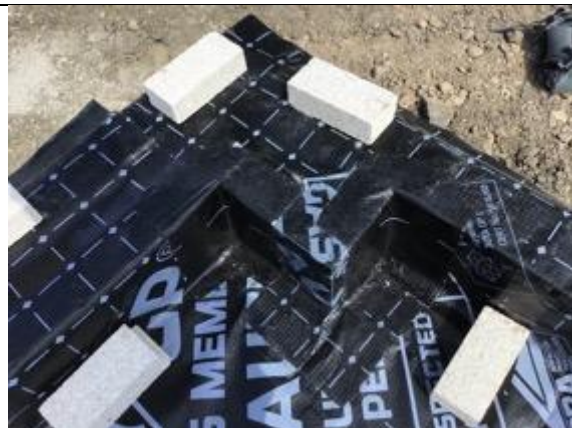
Plot 10 corner detail using preformed corners

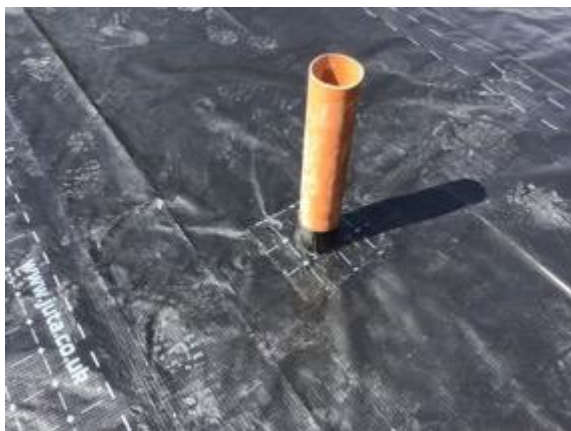
Plot 10 pipe penetration sealed using preformed top hat and SAGM

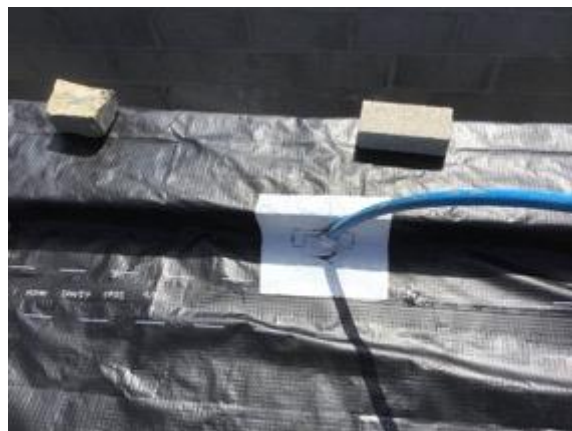
Plot 10 water pipe seal using SAGM

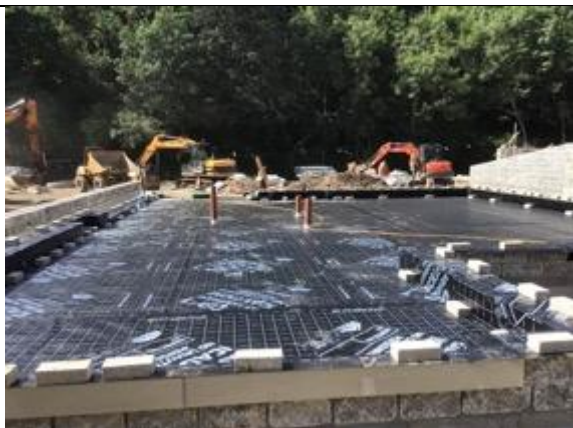
Plot 11 overview

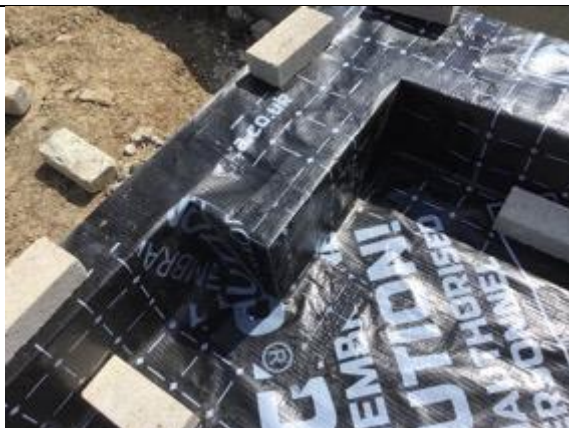
Plot 11 door threshold and corner detail using preformed corners

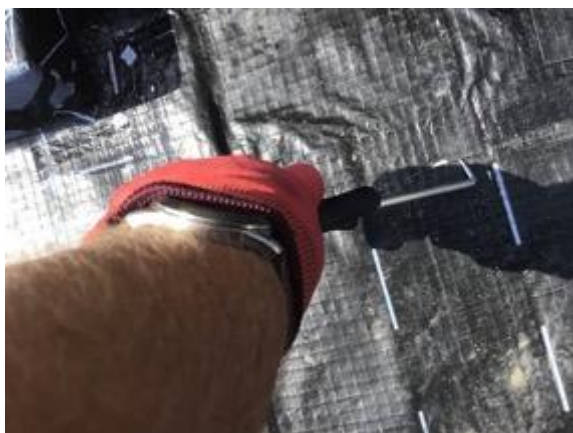
Plot 11 hand welded joint being pick tested

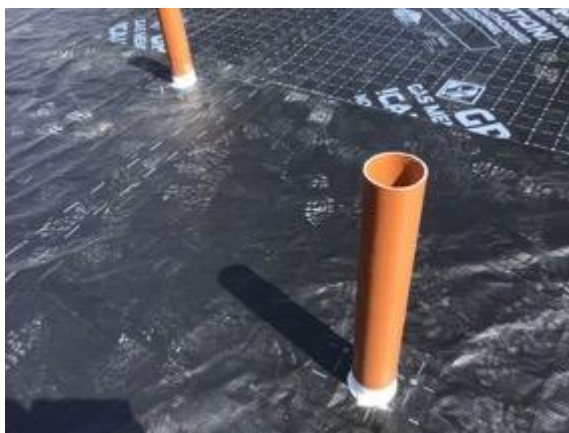
Plot 11 pipe penetrations sealed using preformed top hats and SAGM

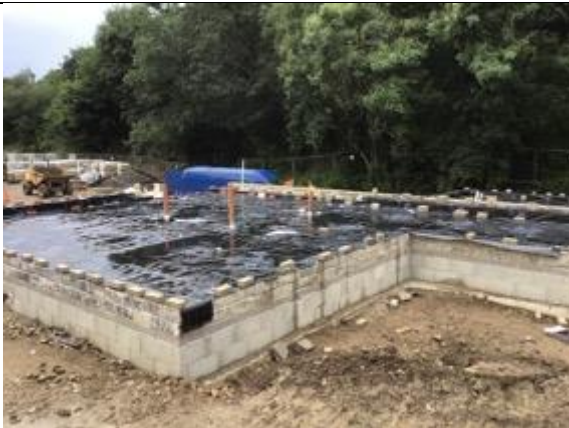
Plot 7 overview

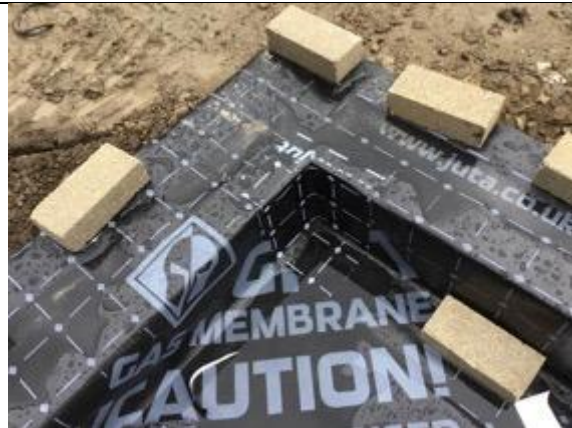
Plot 7 corner detail using preformed corners

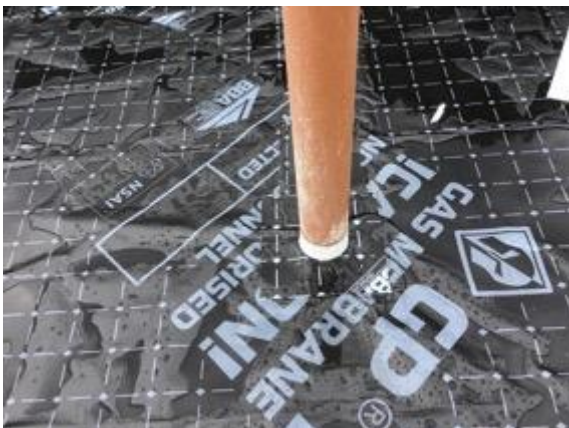
Plot 7 pipe penetration sealed using preformed top hat and SAGM

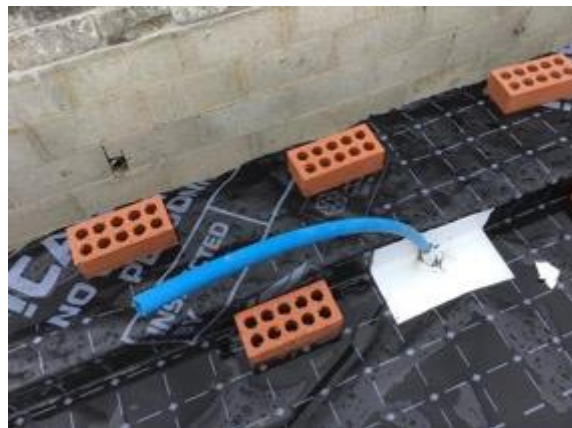
Plot 7 water pipe seal using SAGM

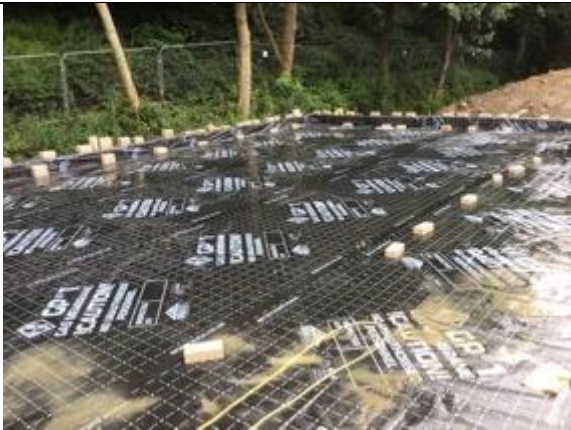
Plot 8 overview

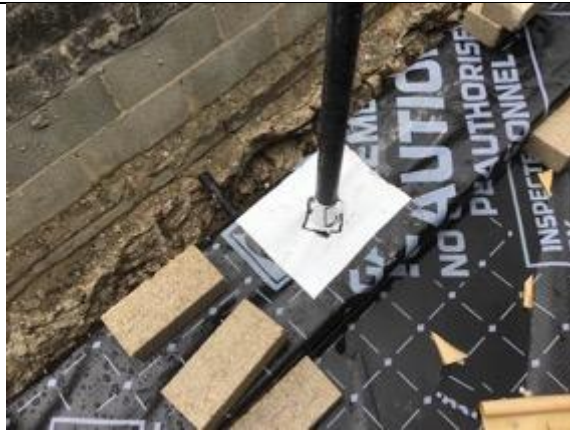
Plot 8 service pipe seal using SAGM

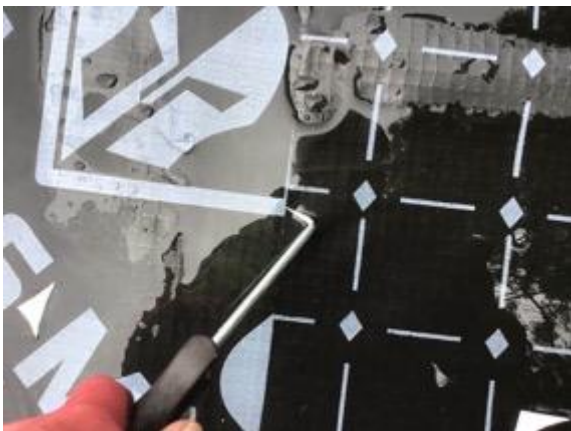
Plot 8 hand welded joint being pick tested

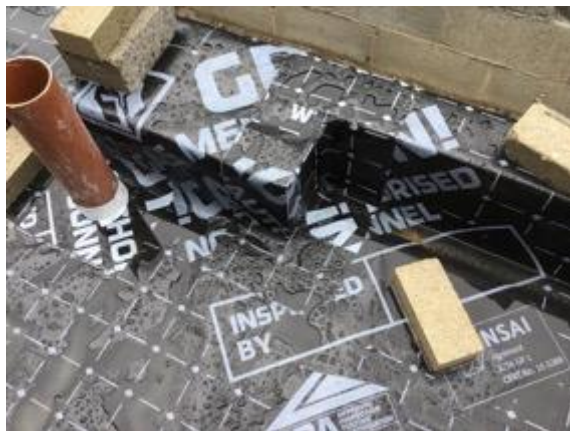
Plot 8p pipe penetration sealed using preformed top hat and SAGM and door threshold using preformed corners
