# THE GEORGE HOTEL, HUDDERSFIELD STRUCTURAL CONDITION SURVEY

Revision P01  
Date 28/09/21  
Made by Stephen Twentyman  
Checked by Paul Maddison / Fay Newham  
Approved by Niall Meyers

Ref 1620012540-RAM-ZZ-XX-RP-S-001

To carry out a structural visual inspection and report on the current condition of the Grade II\* Listed George Hotel, Huddersfield. The defects identified and recorded will focus areas and locations for further investigations and inform proposals for future remedial measures

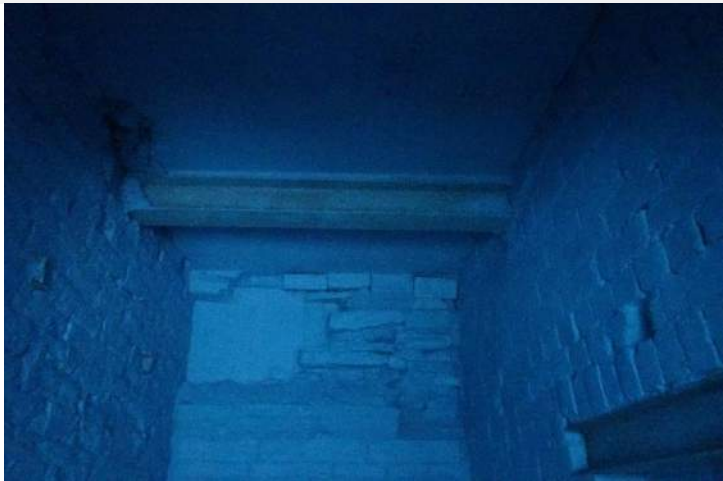
**99A-07**  
**Dry rot and exposed reinforcement**

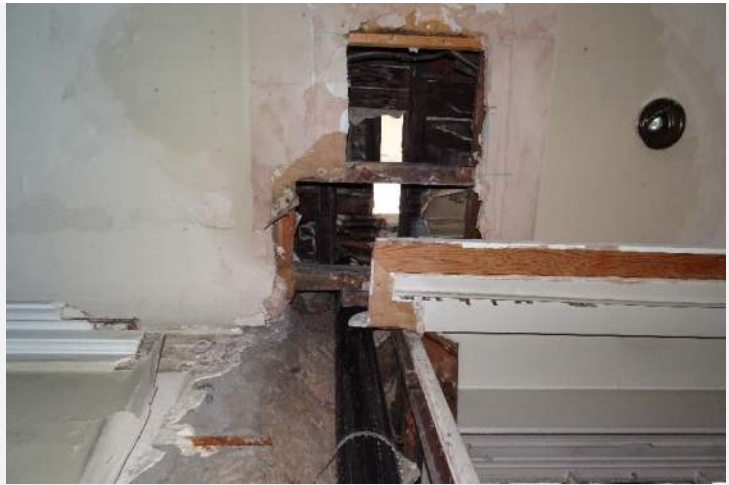
**00A-03**  
**Water staining in ceiling**  
**finishes**

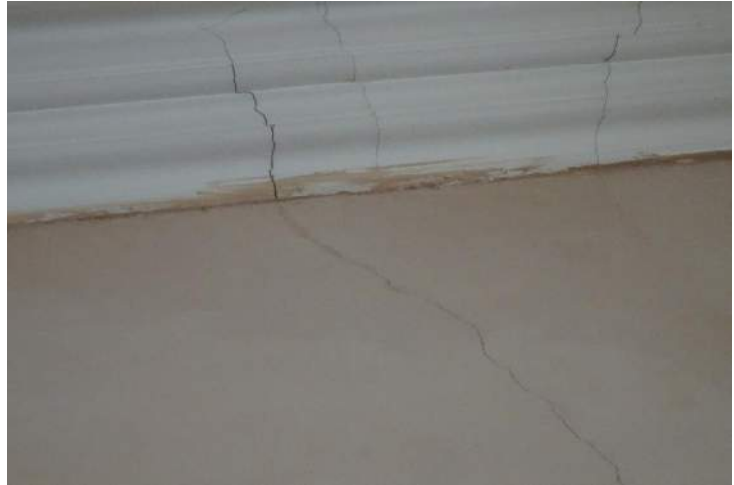
**1.4 SECOND FLOOR**  
**LOCATION**  
**REFERENCE**  
**02A-01**  
**Cracks and mould in**  
**cornice finishes**

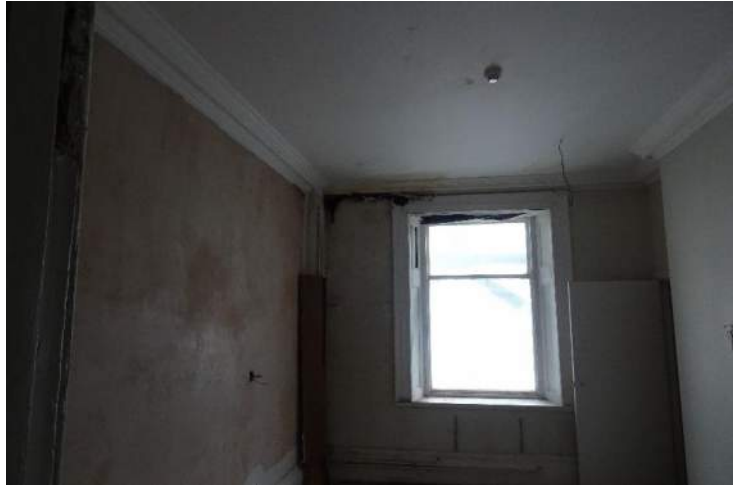
**02A-06  
Diagonal hairline cracks  
in plaster finishes**

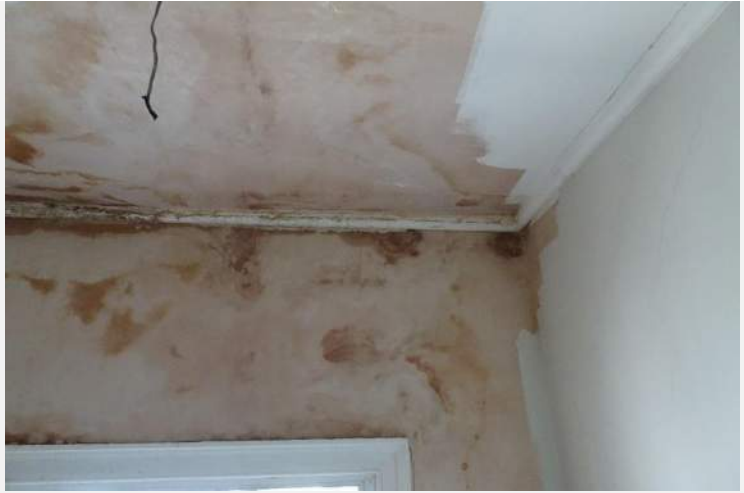
**03A-01  
Vertical crack in plaster  
finish**

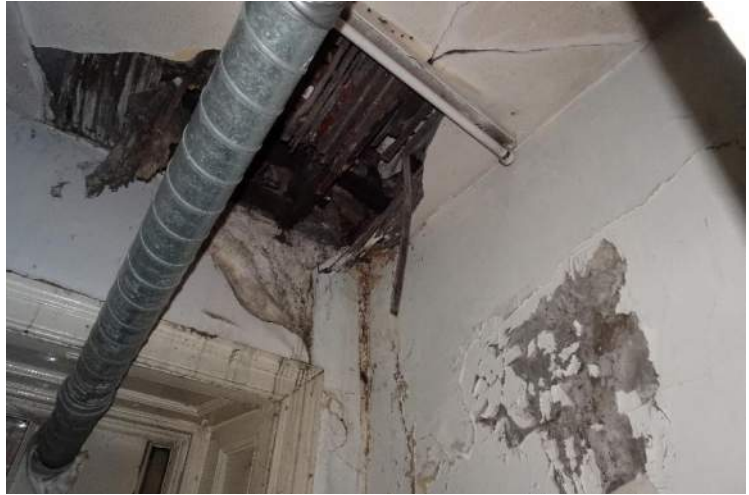
**03A-02**  
**Dry rot and water**  
**ingress in corridor**

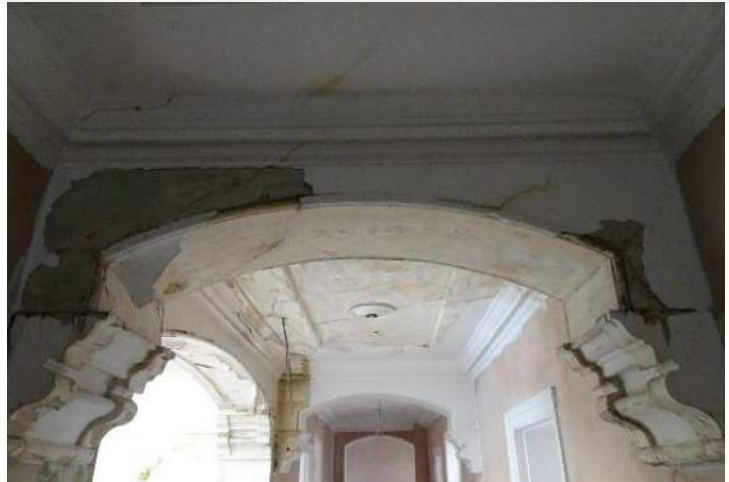
**03A-05**  
**Failed finishes beneath**  
**structural beam**

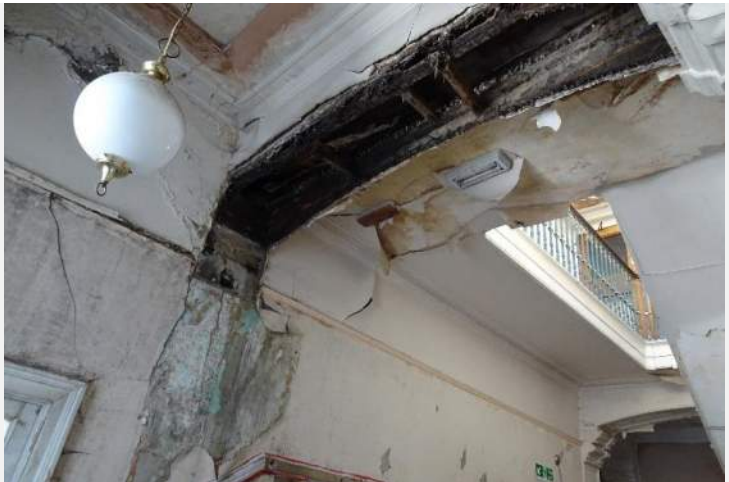
**03A-05**  
**Cracks and failed plaster**  
**in staircase walls**

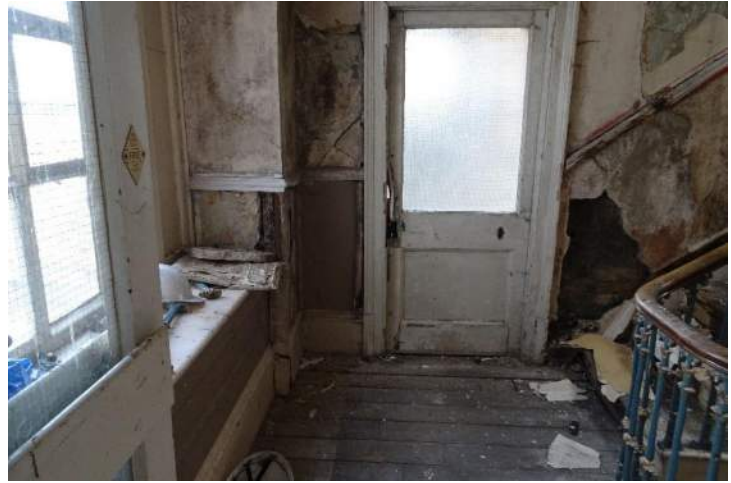
**03A-06**  
**Failed finishes in corner**  
**of room adjacent to stair**  
**core**

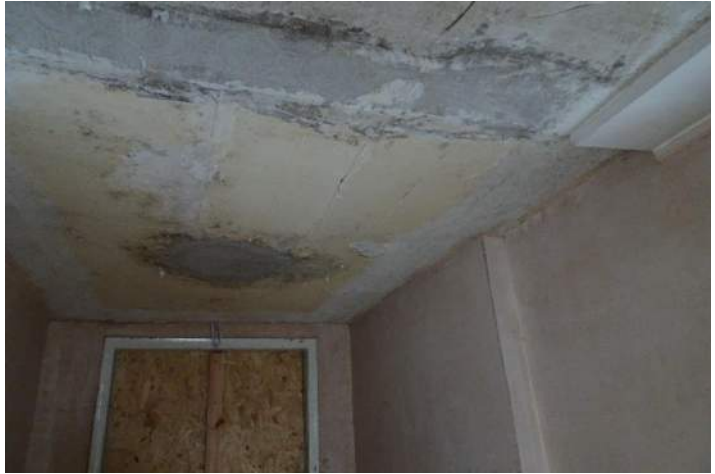
**04A-03**  
**Cracking, peeling and collapsed finishes**

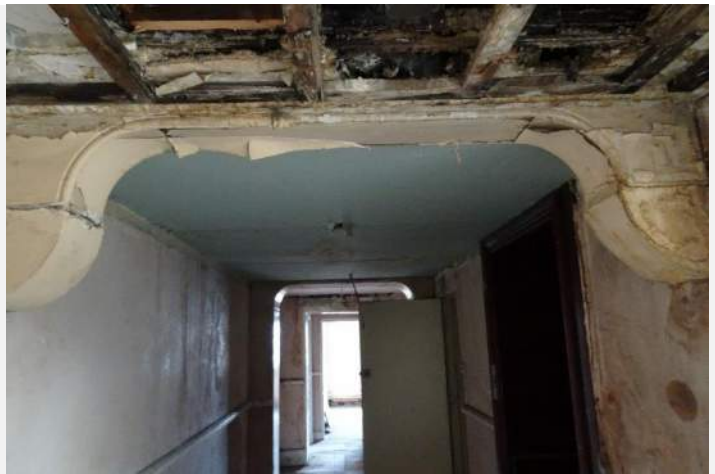
**04A-05**  
**Water ingress and failed plaster finishes**

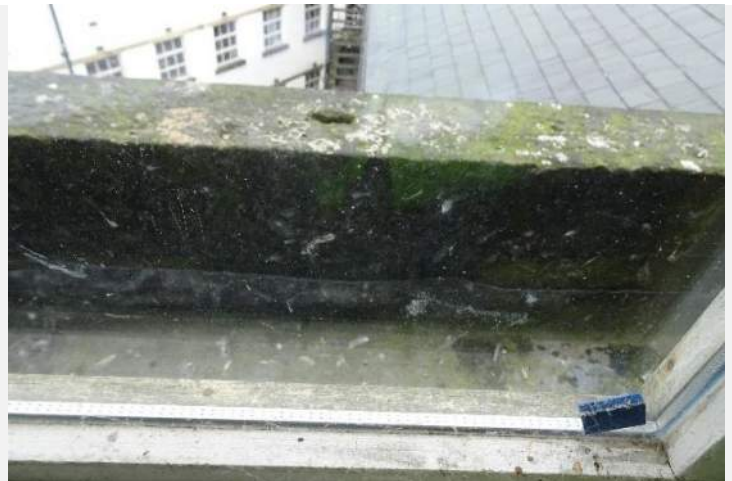
**Stonework detailing  
deterioration**

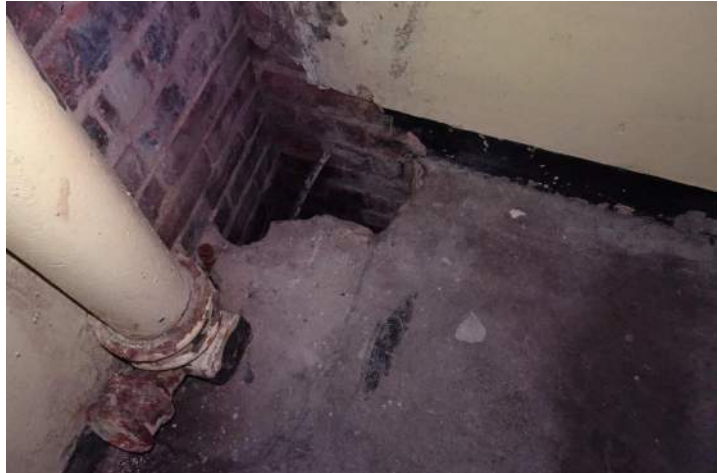
**00B-01**  
**Cracked slab adjacent to existing hole**

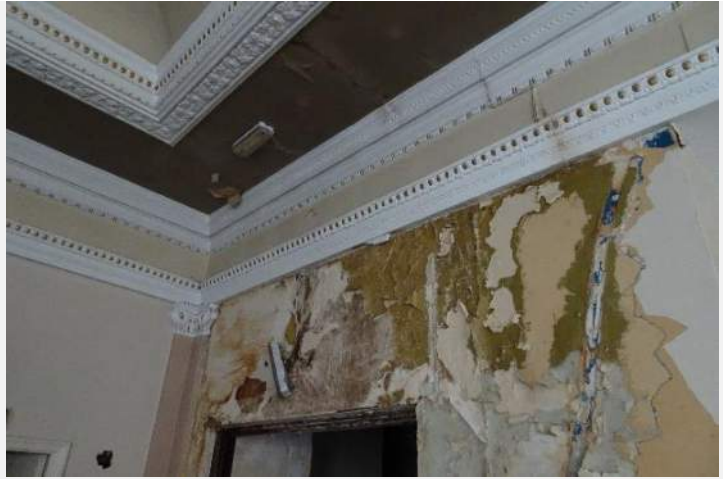
**01C-01**  
**Peeled finishes and stained wall. Wall appears to be bowing locally.**

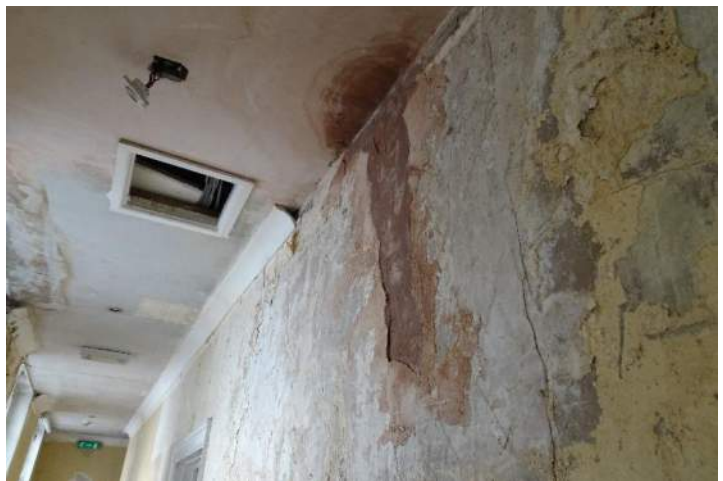
**01C-01**  
**Peeled finishes and staining**

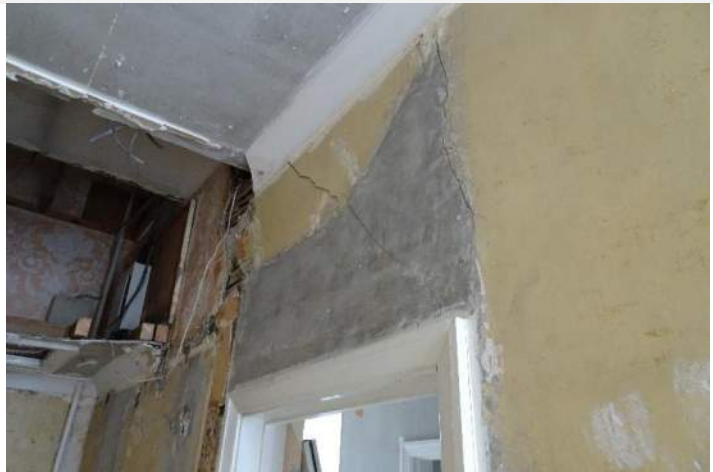
**01C-02**  
**Finishes separating**

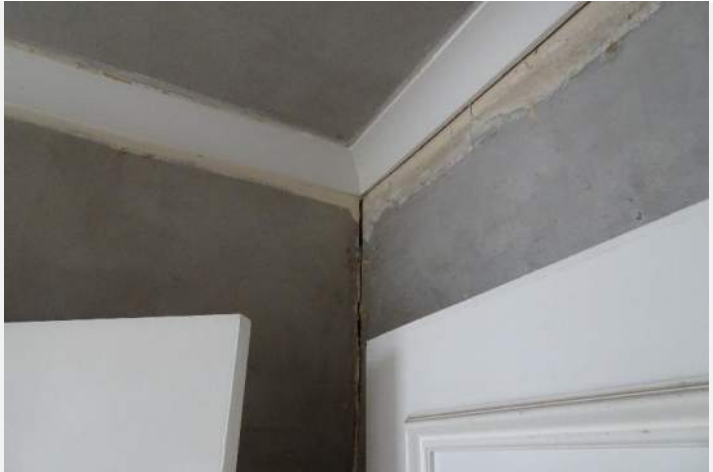
**01C-03**  
**Wide vertical crack visible in finishes**

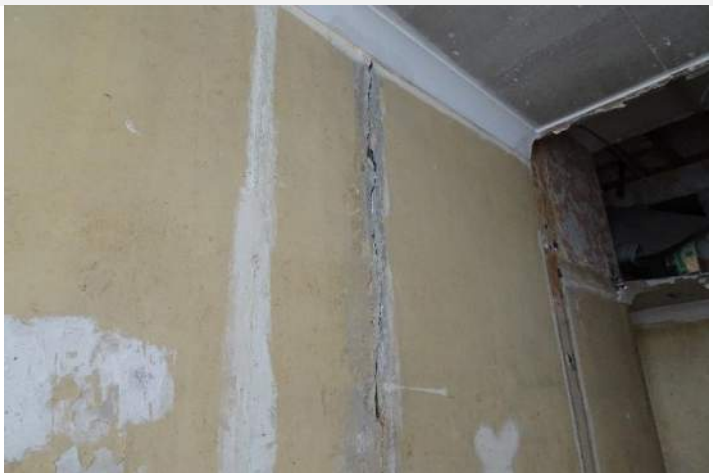
**01C-03**  
**Significant water ingress and cracking of finishes at end of corridor doorway**

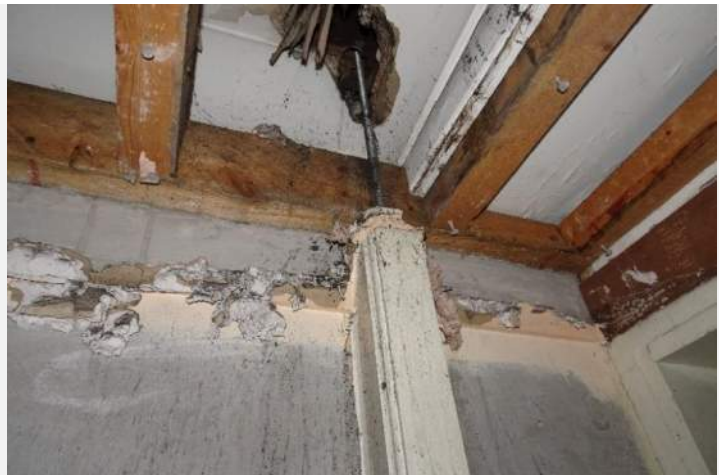
**02C-01**  
Water ingress I toilet  
with cracked lintel

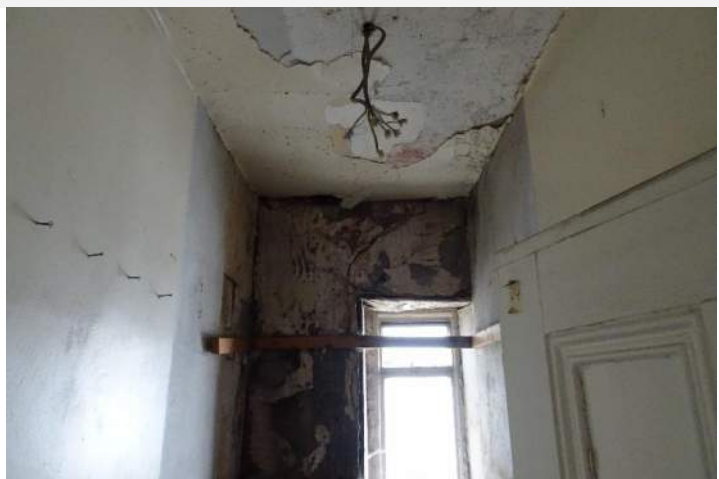
**02C-01**  
**Water ingress, staining and cracks adjacent to internal courtyard door.**

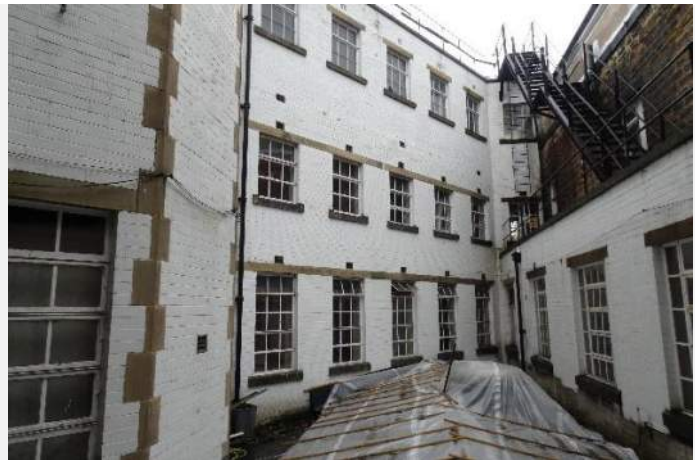
**Eastern Elevation**  
Vegetation and algal growth in damp areas, some cracks forming in masonry mortar joints
