Heritage Statement

Name: 11, CROSS CHURCH STREET

CROSS CHURCH STREET 1. 5113 (West Side) No 11 SE 1416 NE 2/420 II GV 2. Early C19. Hammer-dressed stone. 3 storeys. Moulded eaves cornice. Continuous sill bands. 2 ranges of sashes, one with glazing bars. Original rainwaterhead and downpipe

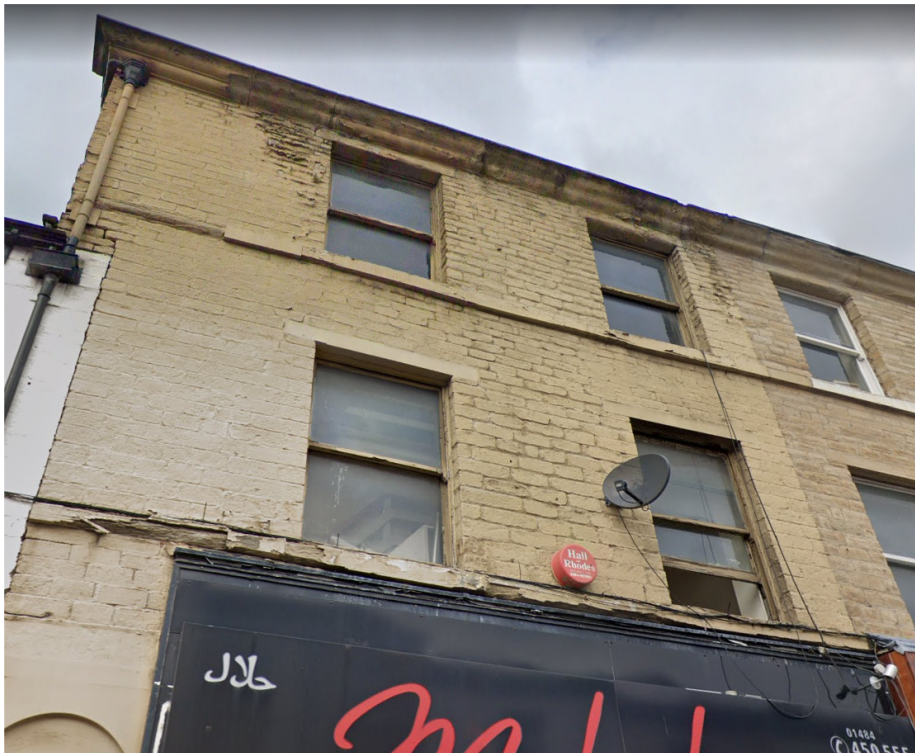
External

Externally the Sash windows are still present which look like they would need some treatment finish on their to stop the wood from deteriorating.

The stone cills below the widow have collapsed over time and does look in need of repairing

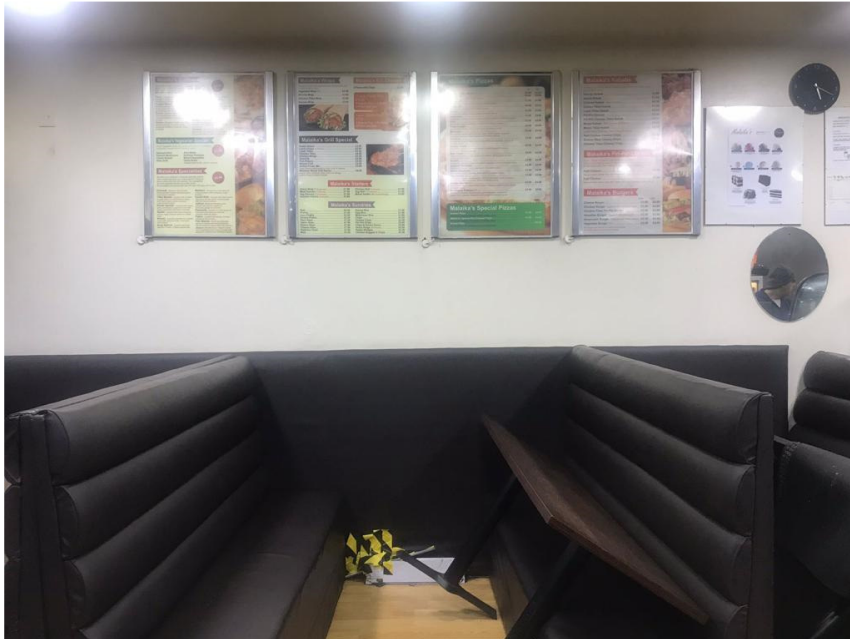
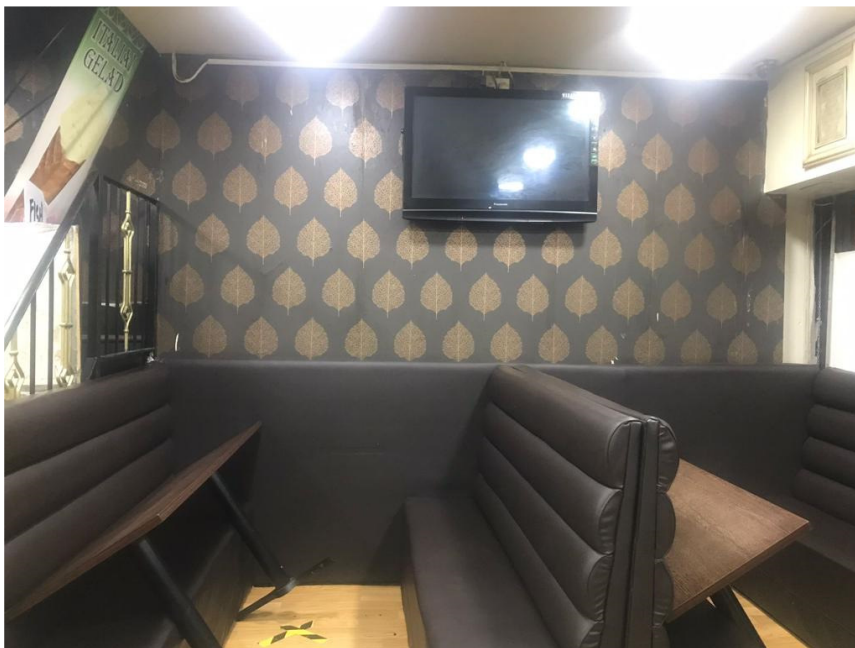
Ground Floor

On the ground floor there is no skirting and cornice present. No suspended ceiling was present which indicates over a period of time the old features within the property has been removed

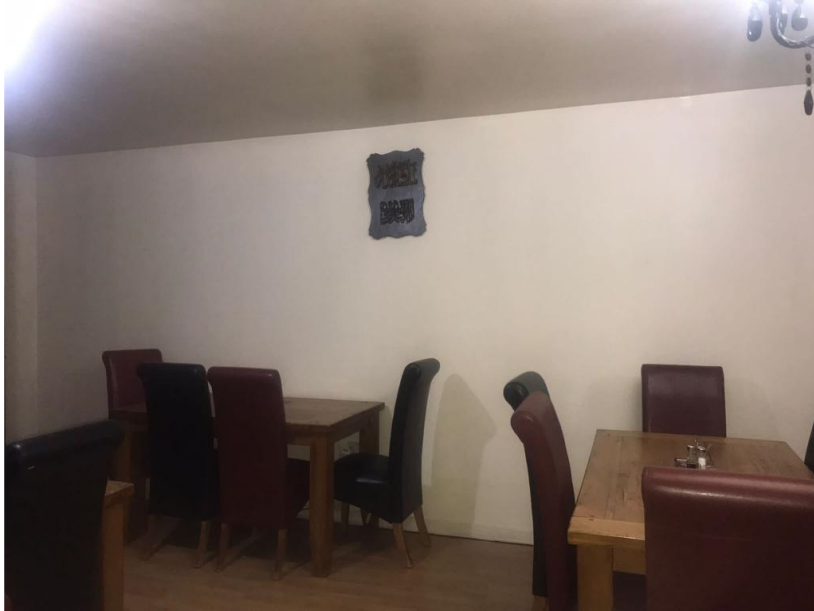
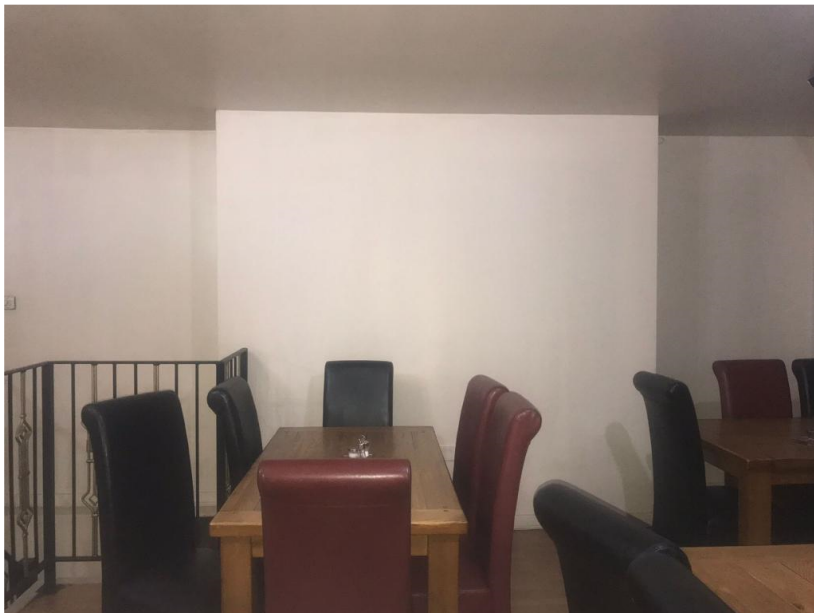
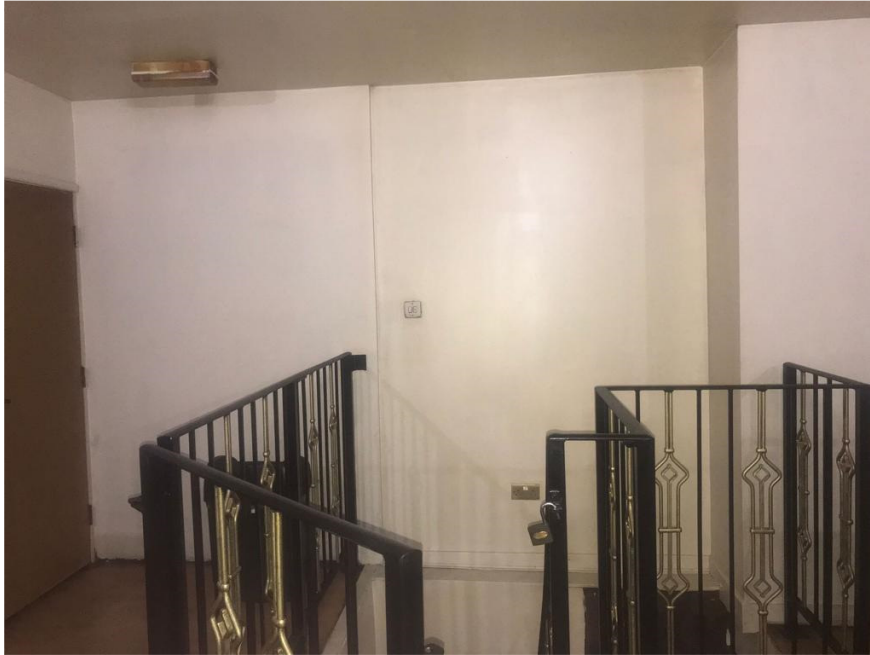
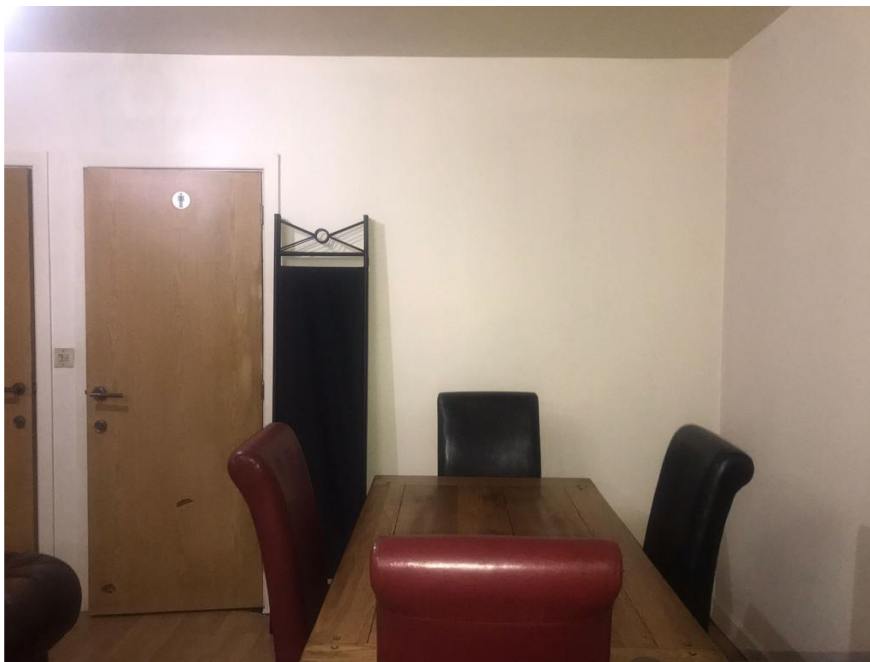
First Floor

The First floor is a open plan with a modern steel staircase going from the ground floor to the first floor. There is no skirting or ceiling cornice present modern architrave have been used around the new doors. New plasterboard has been used on the ceiling and walls as shown in the images.

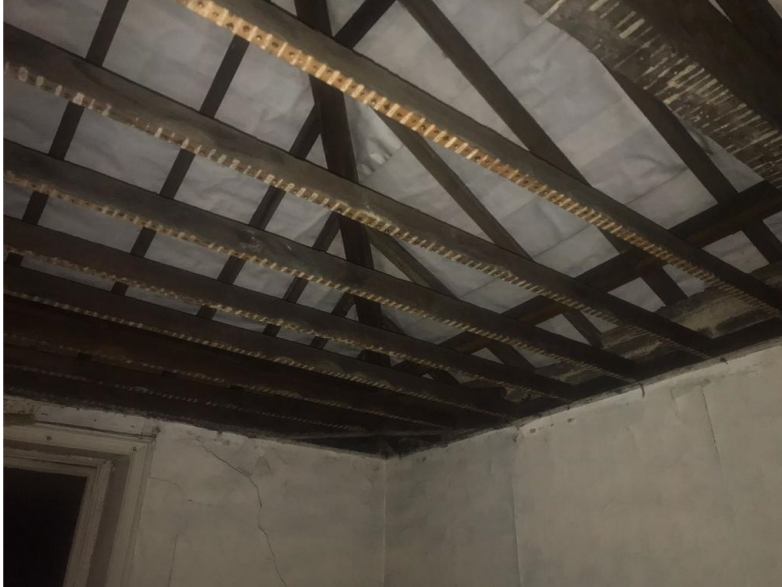
Second Floor

The second floor has a timber staircase with no handrail as you can see from the images there is no cornice present
