Our ref: 20\_017 SR 01

**4 THONG LANE THONGSBRIDGE  
STRUCTURAL INSPECTION OF DEFECT TO NORTH BOUNDARY RETAINING WALL**

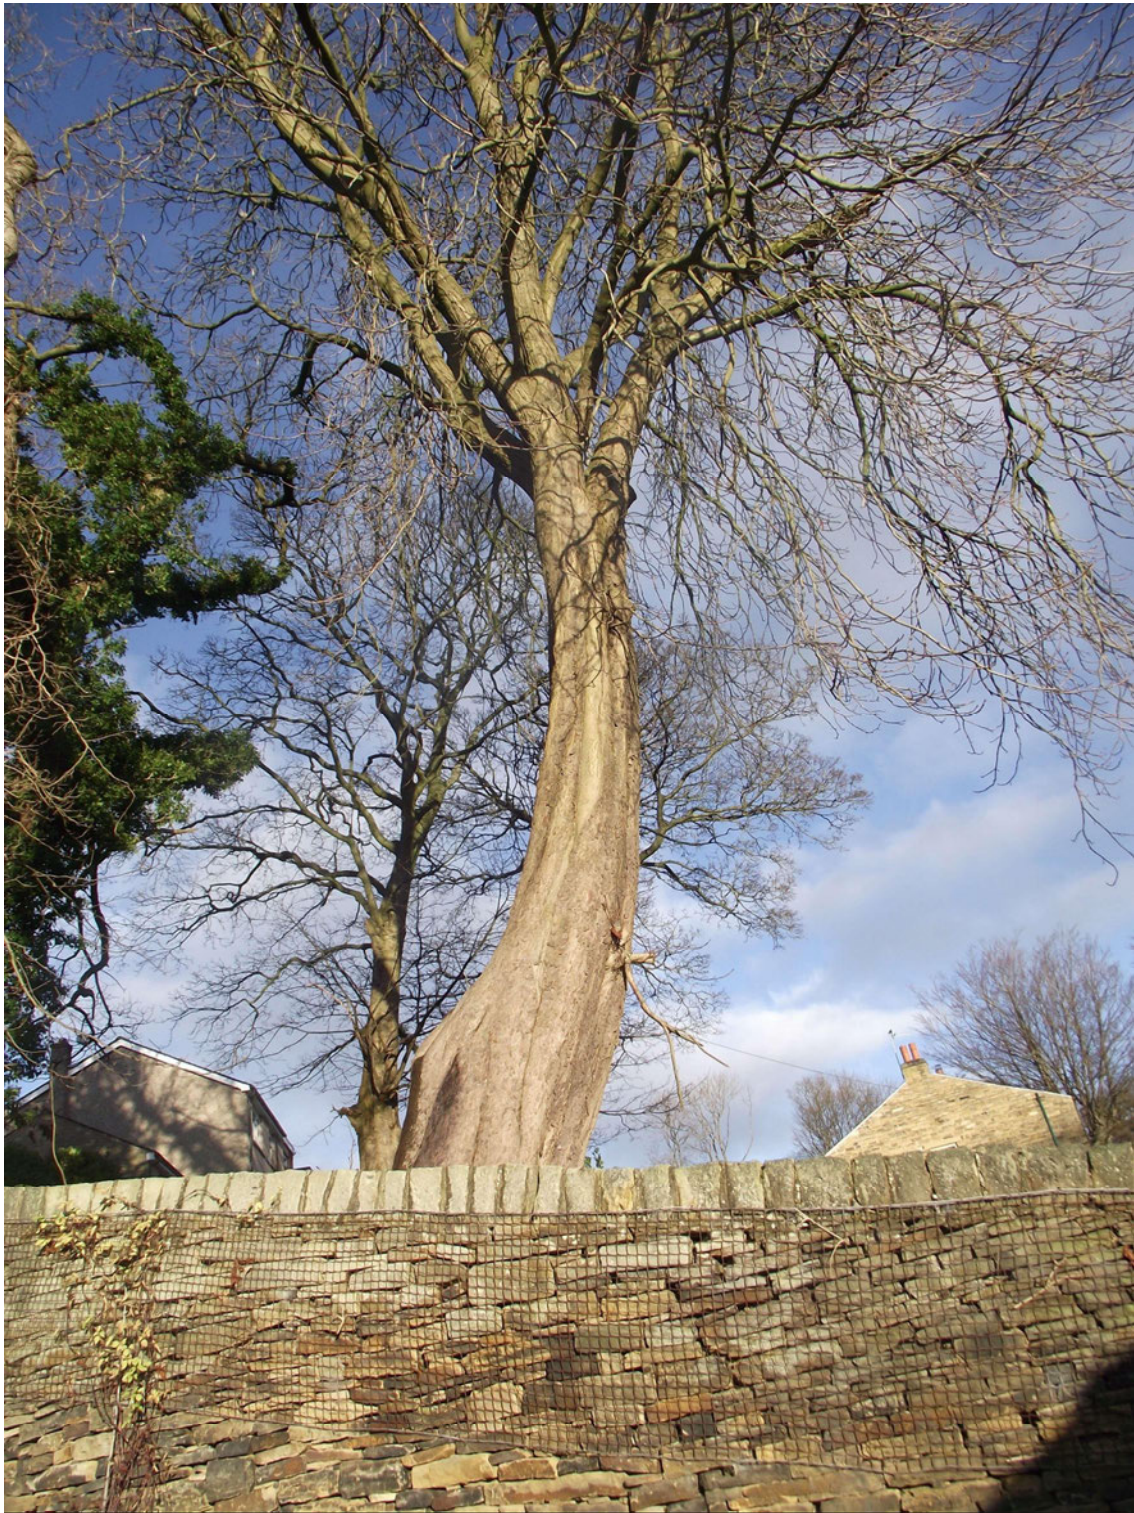
The length of wall that has suffered the significant defect is coincident with the position of a mature broad leaf tree to the neighbouring North side of the wall. The mature tree is in very close proximity to the subject wall, with the closest part of the trunk within approximately 1 metre of the North side of the boundary wall.

**Photo 1** – Proximity of mature broad leaf tree to boundary retaining wall.

To mitigate risk of continued damage to any rebuilt sections of wall, further widespread damage to remaining sections of wall, and further widespread damage to the adjacent garage building, it is recommended that measures are put in place to allow for the safe removal of the tree. Safe removal of the tree prior to rebuilding the section of subject

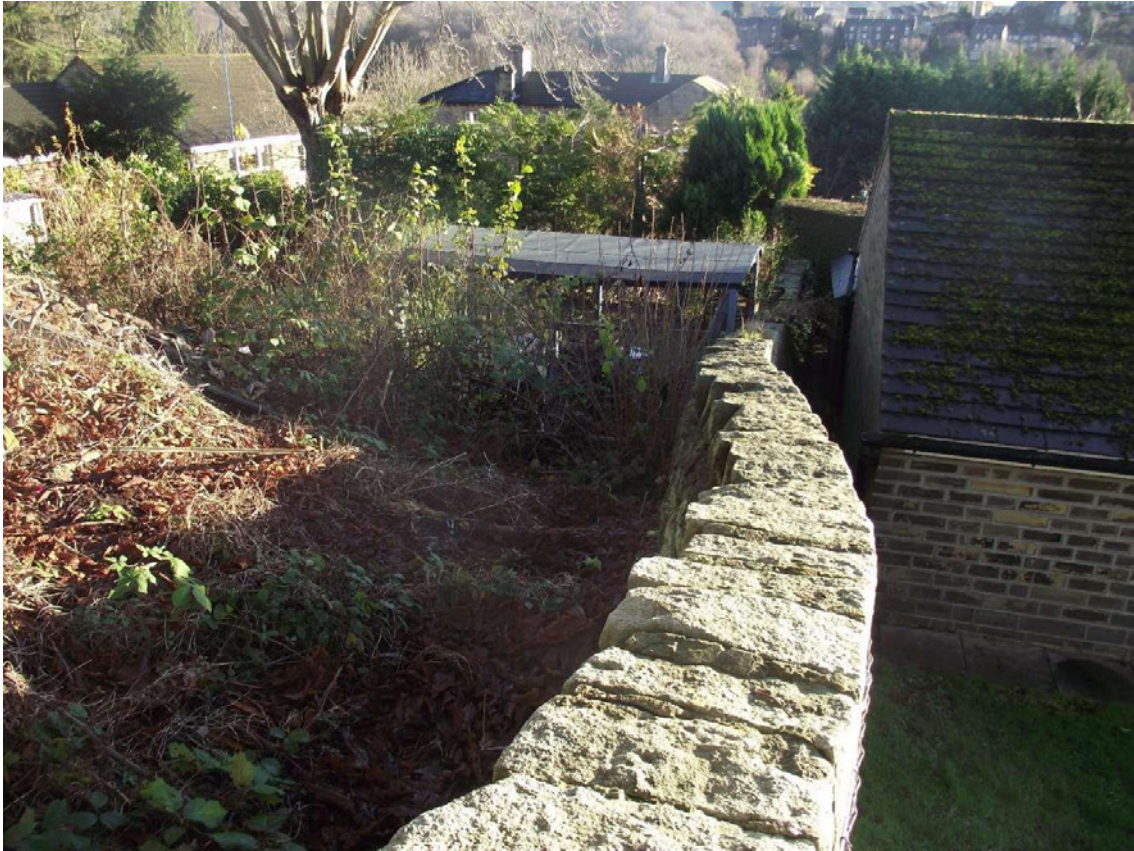
There is evidence of some lateral movement and distortion over the full length of wall. However, the movement is particularly significant and clearly visible over a length of approximately 7 metres, starting approximately 2 metres North of the existing garage West elevation, and extending towards the West boundary. Over this length there is significant bowing and outward lean of the wall; simple checks using a builders spirit level showed the lean of the wall to be in the order of 240mm over a 1200mm long spirit level. The bow in the wall is clearly seen along the coping stones of the wall (Photos 2 & 3) and is accompanied by stepped fractures in the wall and coping stone joints (Photos 4 & 5).

The significant damage and lateral movement to the dry stone boundary retaining wall over the most severely affected section of wall, is being caused by physical damage from the mature broad leaf tree within close proximity of the wall.

**Photo 2** – Lateral distortion and bow to head of wall in vicinity of mature broad leaf tree.

The section of boundary retaining wall that has experienced the most significant movement is in a potentially unstable condition and does require careful removal and rebuilding. The damage to the wall has clearly been caused through physical action from the close vicinity of the mature tree, and the tree will, no doubt, continue to present risk of continued physical damage to rebuilt sections of wall and more widespread damage to the remaining sections of wall.

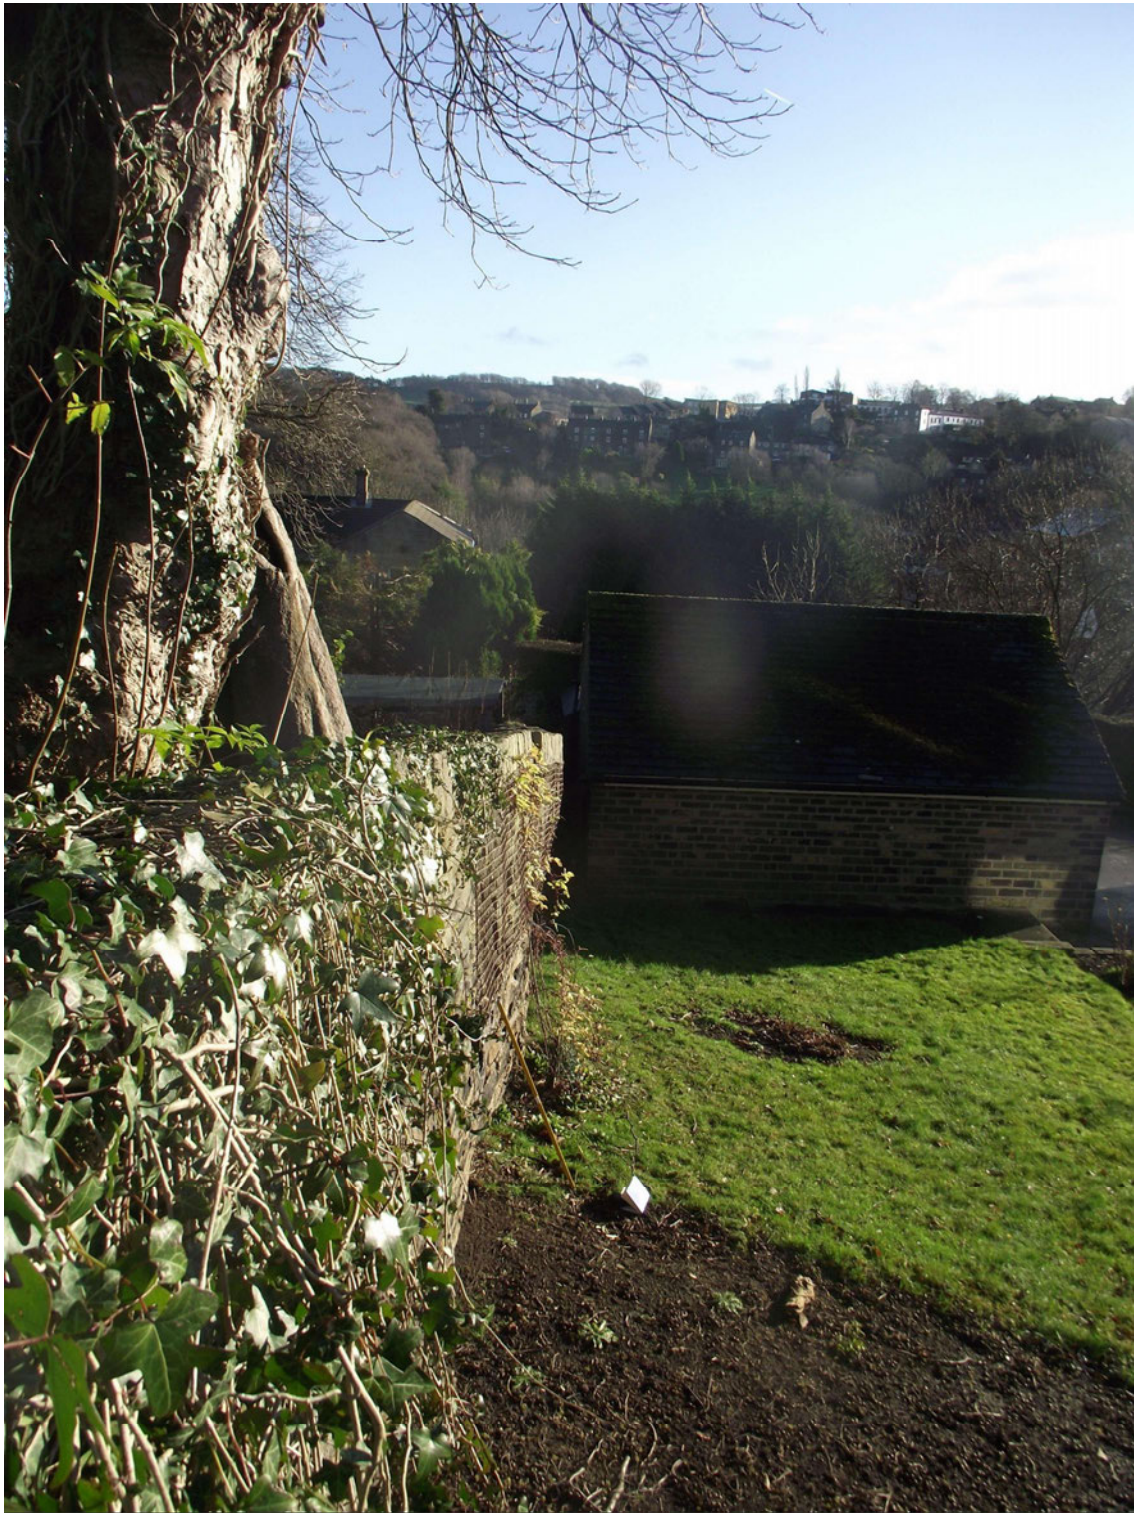
**Photo 3** – Lateral movement and distortion to existing dry stone boundary retaining wall

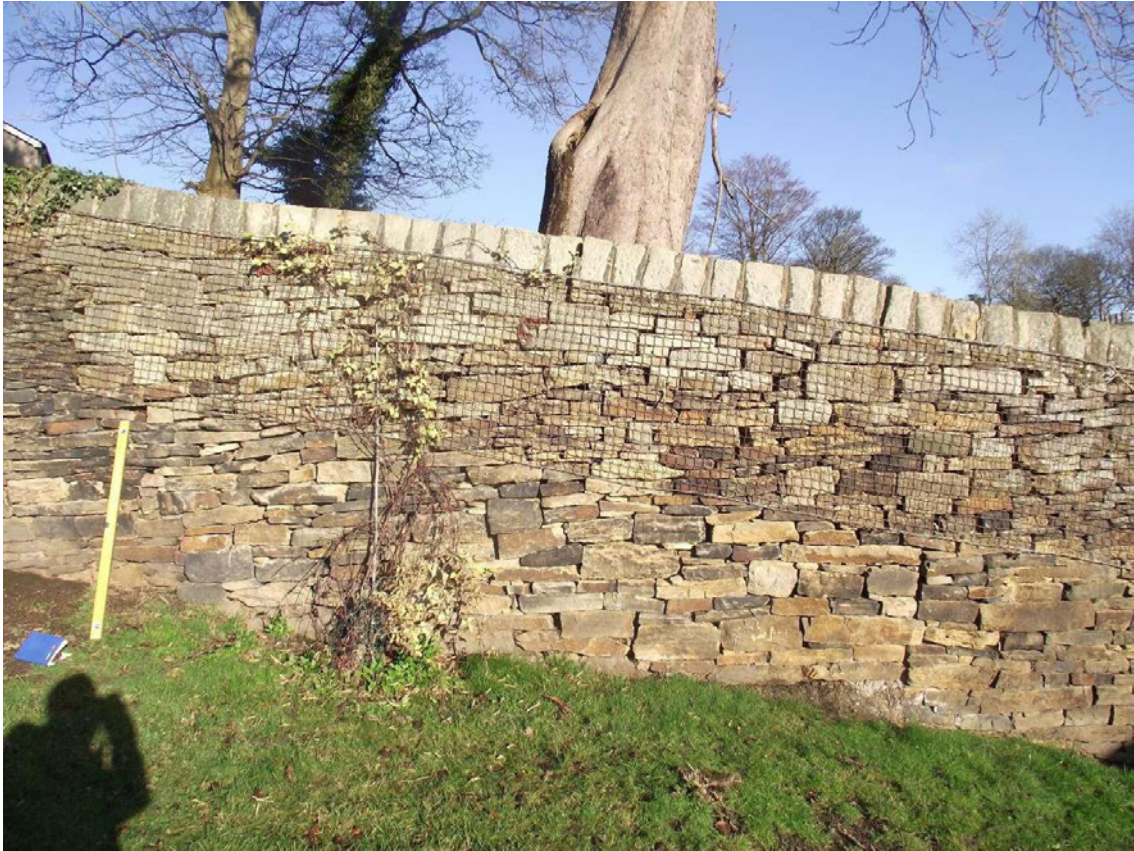
**Photo 4** – Elevation on worst affected section of wall – fractures to wall each side of mature tree.

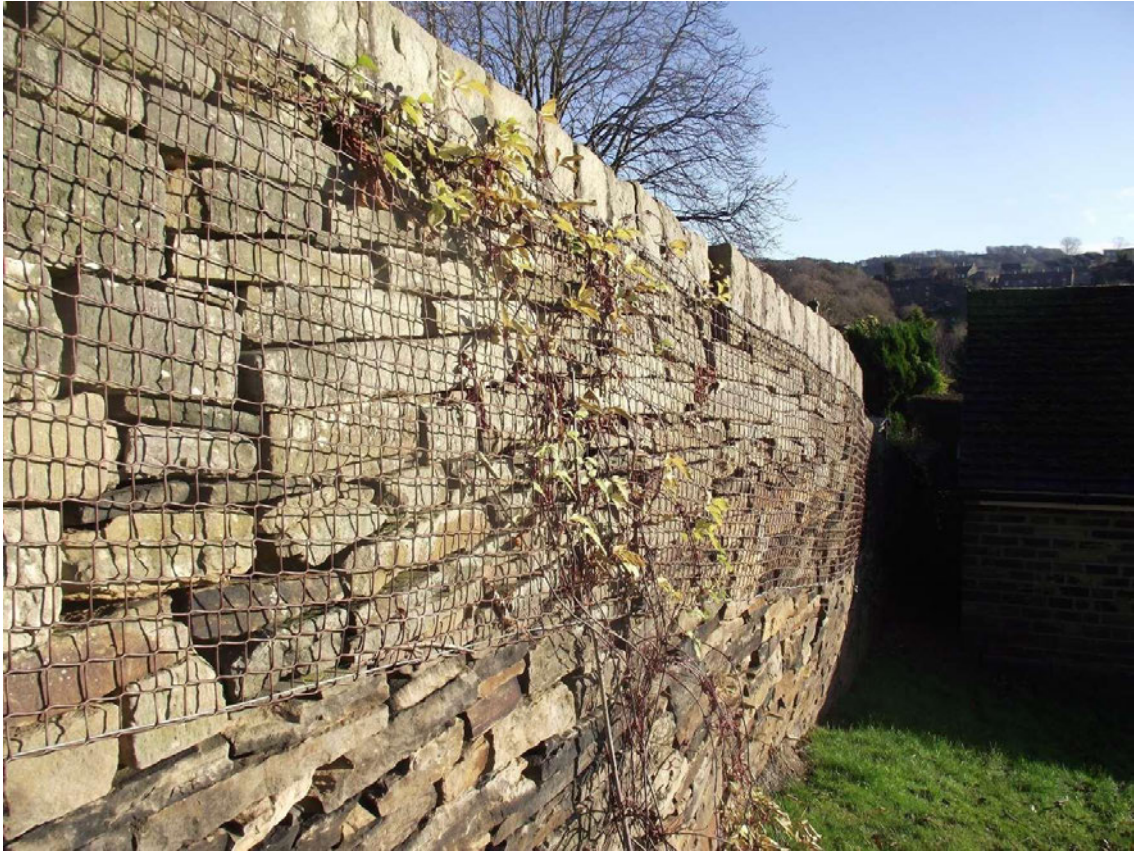
**Photo 5** – Distortion, lateral movement and fracture to existing dry stone boundary retaining wall.

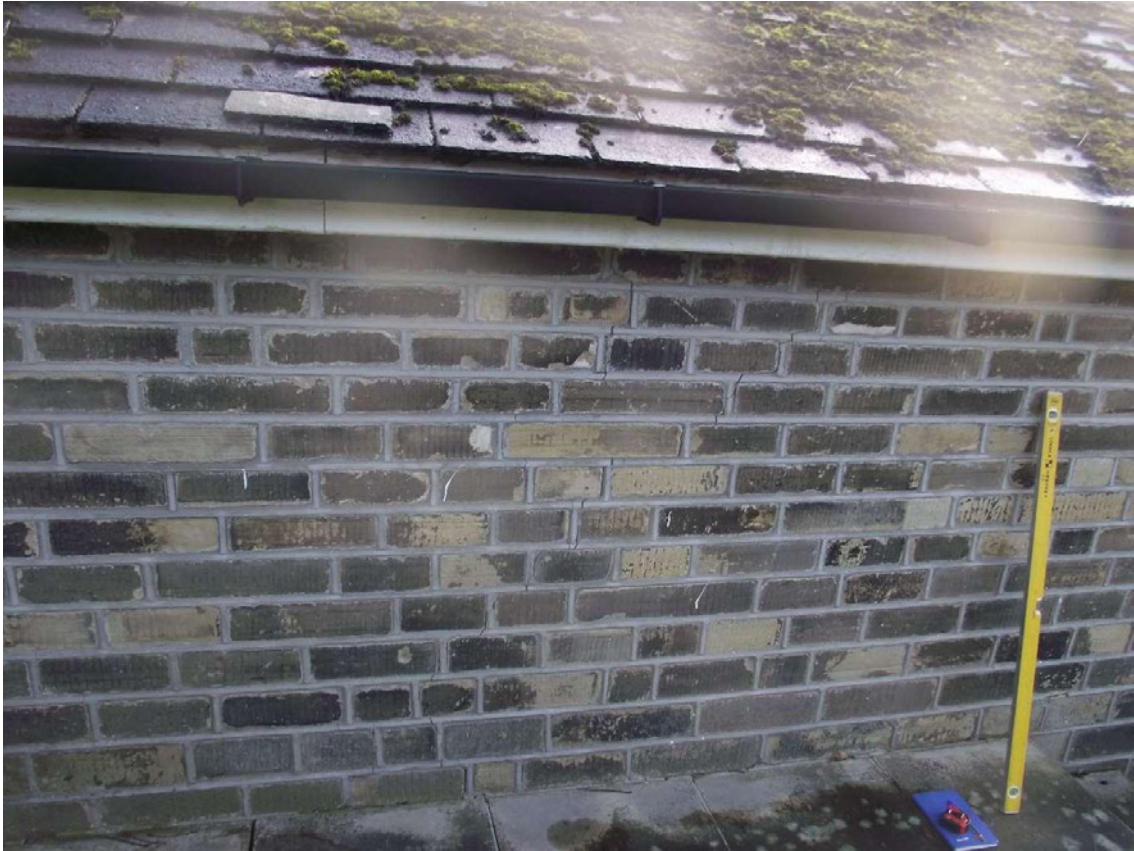
Cracking to the external wall of the West elevation of the garage was also noted during our visit to carry out the inspection. Cracking to the external, stone built leaf of the garage wall was noted over the full wall height. The raking cracking was tapered, narrowing towards external ground level and widening towards eaves; the crack positioned approximately 2 metres from the front (South) elevation of the garage at eaves level and raking away to the North towards ground level (Photo 6). Cracking to the internal, blockwork leaf of the wall was approximately coincident with the cracking to the external leaf, and widened towards wall plate level (Photo 7).

The raking cracking to the garage is characteristic of foundation movement and, whilst the exact cause of foundation movement to the garage can not be determined through visual inspection alone, it is considered likely that the close proximity of existing mature trees is at least contributing in part to the apparent foundation movement.

**Photo 6** – Racking crack in mortar joints to stone outer leaf to existing Garage, West Elevation

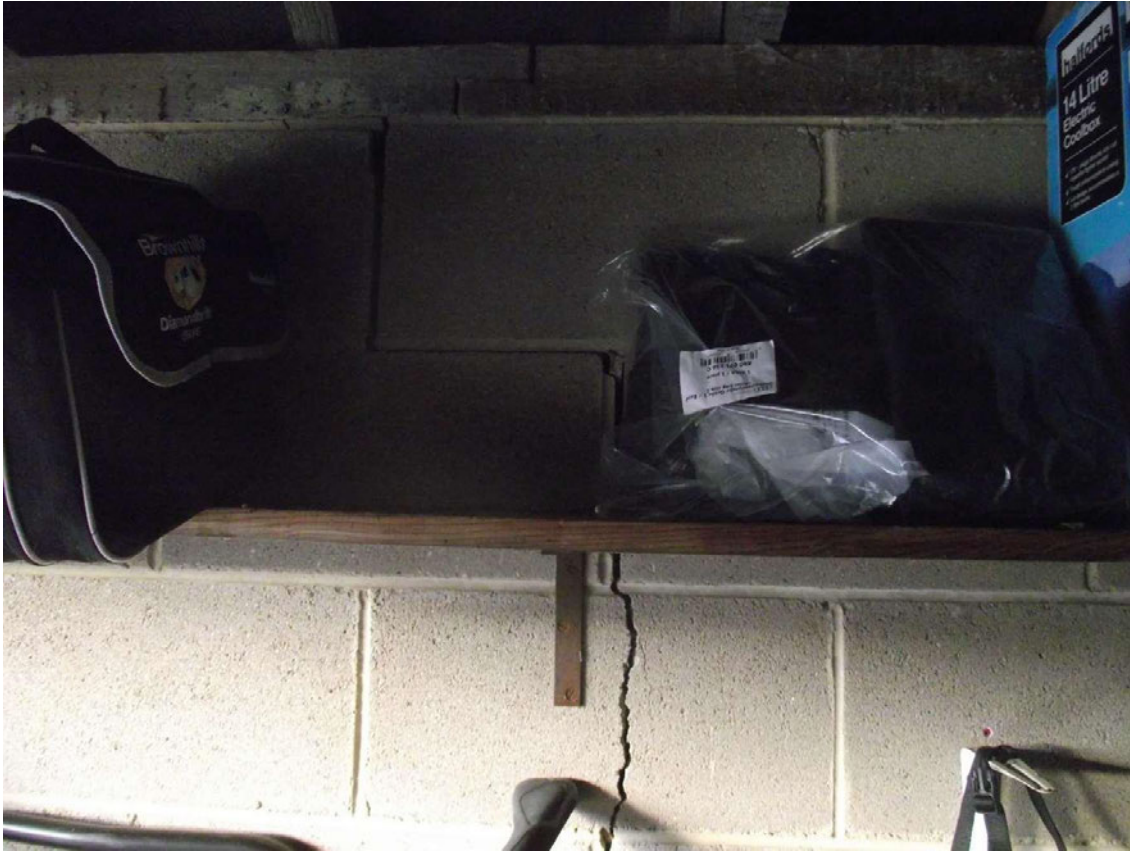
**Photo 7** – Cracking to internal leaf of blockwork, garage. Coincident with cracking to external leaf, West elevation
