## Heritage, Design & Access Statement

Project: PROPOSED WALL REMEDIATION & REPAIR

Address: Trafford House  
11 Halifax Road  
HUDDERSFIELD  
HD3 3AN

8th FEBRUARY 2022 – Revision 0

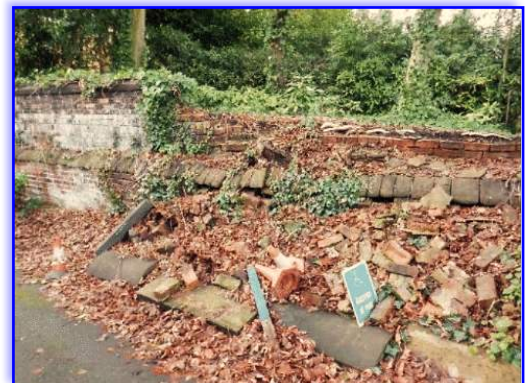
Fig. 1

A section of the boundary wall from approximately midway on its NW boundary to its end point at Halifax Road is now in a dilapidated and unsafe state, necessitating immediate

repair and remediation to avoid the loss of further sections of the wall and to prevent injury to those using the site and its neighbouring property (Fig.1).

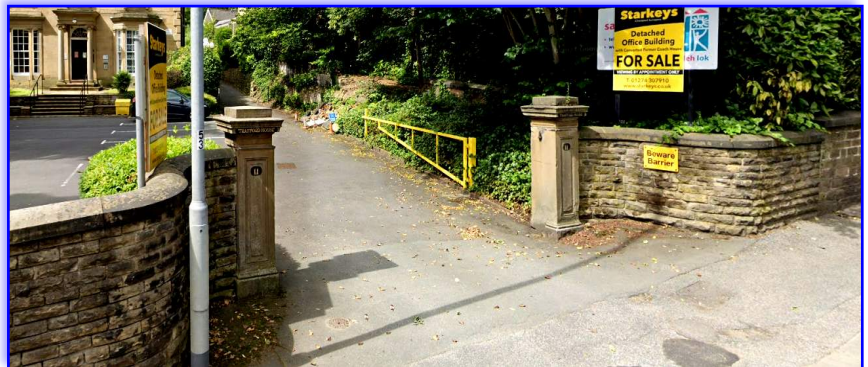
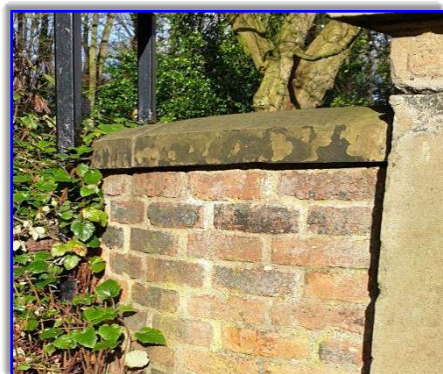
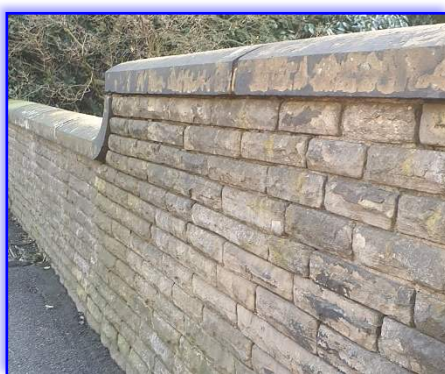
There are areas of blistering and delamination to areas of stone masonry and some loss of mortar on the outer leaf. The brick masonry of the inner leaf shows general weathering, frost damage, some sulphate crystallisation, and a loss of mortar in places. This section of walling is in good, sound condition.

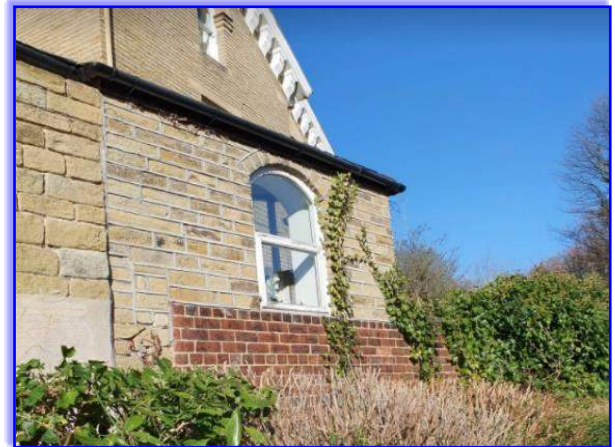
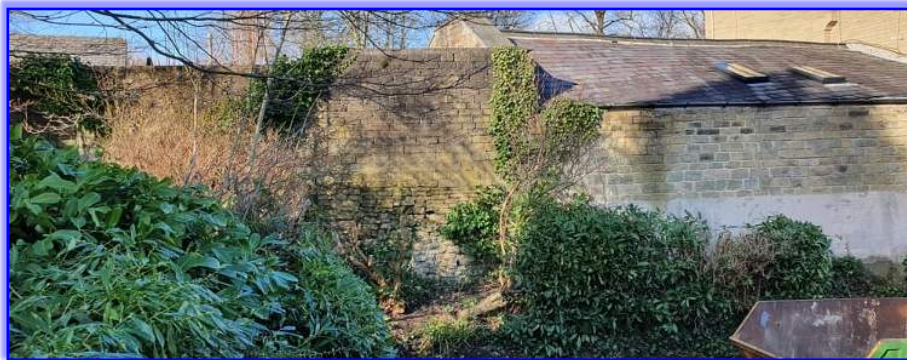
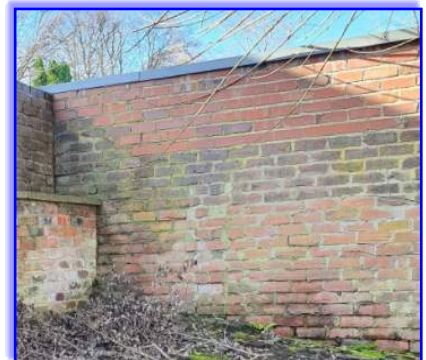
A significant portion of the boundary wall is formed by the external house walls of Ravensdeane, or by outbuildings and glasshouses within the curtilage of Ravensdeane, now demolished. These are comprised of sections of coursed sandstone and 19<sup>th</sup>C red clay brick. There are infill and repair areas of later 20<sup>th</sup>C red clay brick and sections of repair, some of which are supported with late 20<sup>th</sup>C concrete footings. Brick sections are typically stretcher bond with lime mortar, although later repairs have utilised cement mortar. Walls are finished with either tabled or shallow half-round, fine tooled sandstone coping (Figs.3a,3b,3c).

There is some blistering and delamination to stone masonry sections. Brick masonry shows general weathering, sulphate crystallisation and loss of mortar in places. This section of walling is generally in good condition.

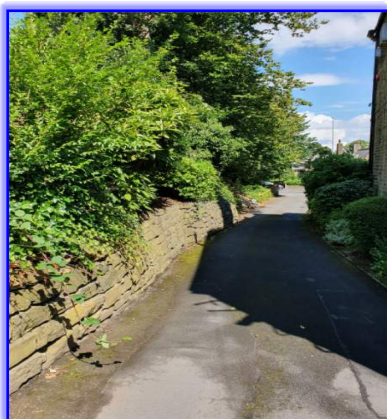
Fig. 3d

A lower section of random rubble walling, coursed in places, extends along the midsection of the driveway, retaining a planted area to the fore of the retaining wall (Fig.3d).

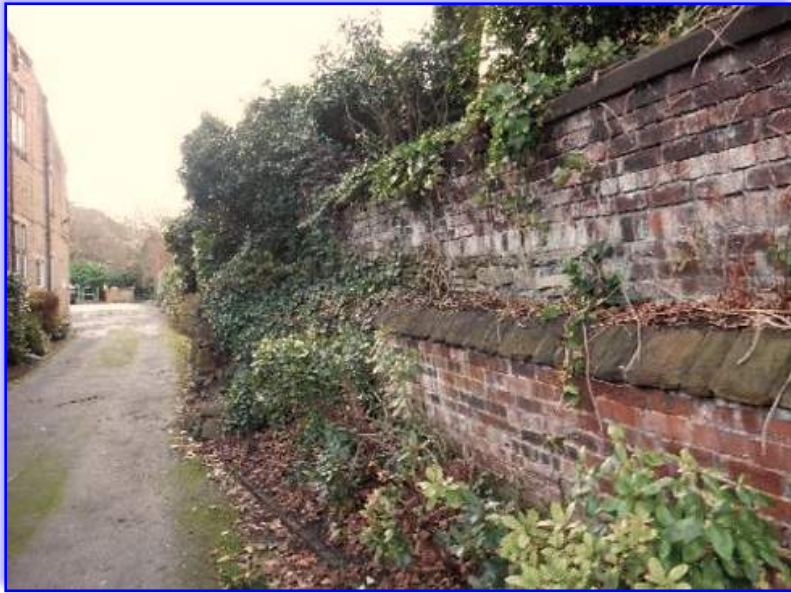
Fig. 4a

This section is comprised of a 19<sup>th</sup> C red clay brick, of variable quality and irregular bond, being a mix of stretcher and English garden wall bonds. This section forms a retaining wall for the adjoining elevated land on the Ravensdeane side (Fig.4a).

The collapsed wall section and the adjoining severely out of plumb sections must be retained in position and a new king-post retaining wall constructed immediately in front of the existing to stabilise and prop the current wall in position (where not collapsed), and to prevent further rotation away from the vertical which would precipitate further extensive collapse.

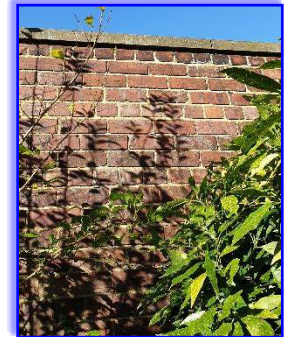
Fig. 4b

A section of this wall is of later construction for part of its length. This wall is topped with shallow half-round, fine tooled sandstone copings. (Fig.4b).

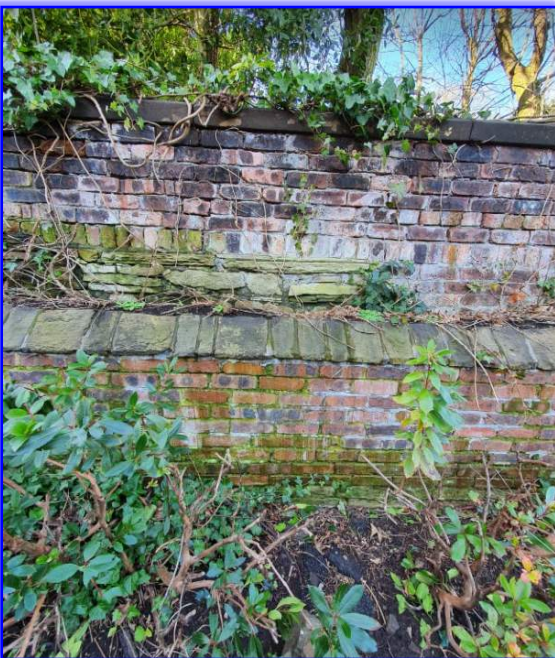
Fig. 4c

A lower wall of 19<sup>th</sup>C red clay brick forms a buttress along the length of the retaining wall and is of a different brick manufacture to that of the retaining wall. This wall is finished with gritstone saddleback coping stones (Fig.4c).

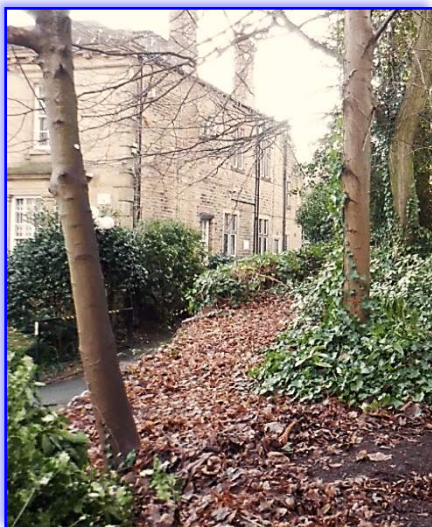
Fig. 4e

The later section of brick masonry is in good condition (Fig.4b). The original brick masonry shows general weathering, frost damage, extensive sulphate crystallisation, substantial loss of mortar in places and extensive vegetation/root damage along its length. This section of wall is in a poor and dangerous state, with sections rotated away from the vertical and at risk of collapse. A section of wall has been lost to collapse (Fig.4d). This section supports trees and vegetation on the Ravensdeane side that form part of the Halifax Road street scene tree canopy. (Fig.4e) Collapsed section viewed from Ravensdeane.
