## St Mary the Virgin, Mirfield

Dunbottle Lane Wall Design and Access Statement, Incorporating Heritage Statement

Report prepared by:

of Calls Architecture Limited

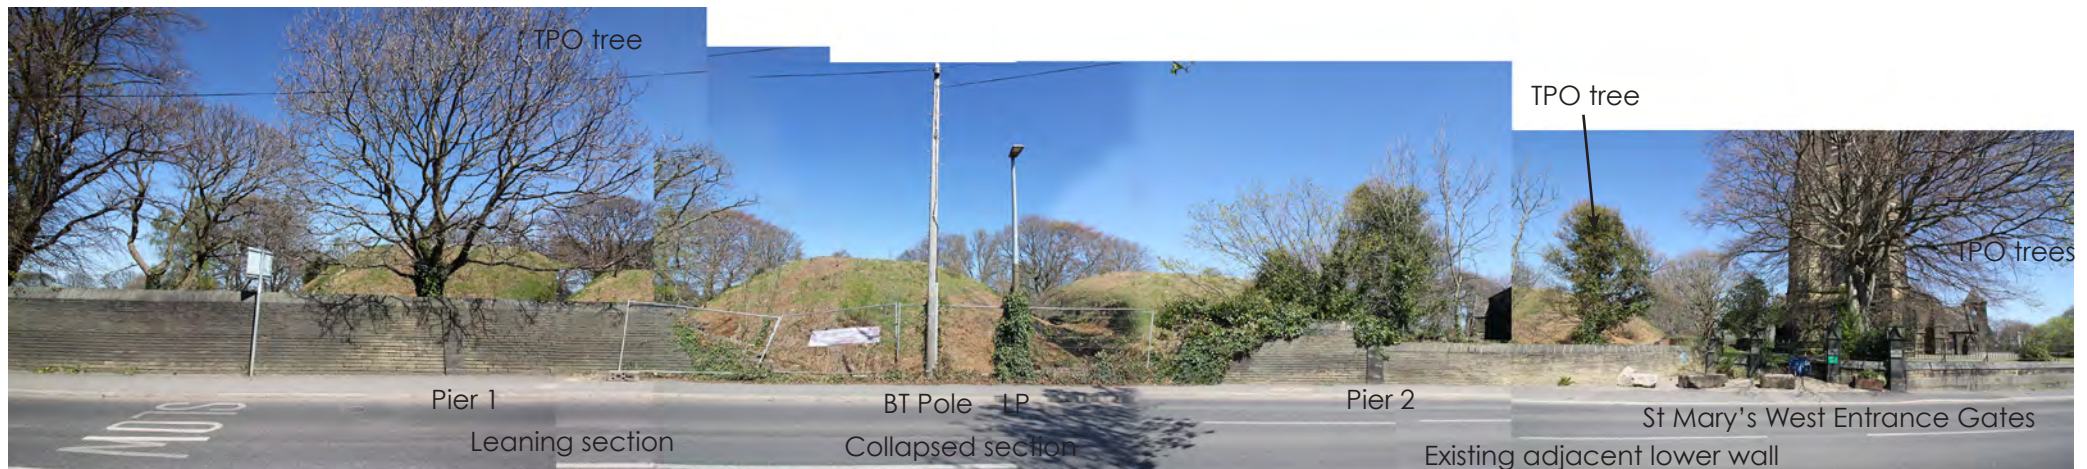
The wall southwest of the motte has collapsed down to a couple of courses above footpath level. Either side of the collapsed section, the wall has a lean towards the motte, more notably to the north end.

Undermining of the foundation of the wall has been mooted as the reason for the collapse in the past though there is little evidence of this on site and survey with a structural engineer show that the retaining elements remain intact, albeit with need for repairs, re-pointing and consolidation of the masonry. There is no evident collapse of the footpath or highway and the lamp post and telegraph pole appear stable.

There is no buttressing of what is a tall and slender wall. The wall is in an exposed part of the site. Pointing has been eroded and washed away though weathering and also particularly at lower levels by salt spray.

Vegetation growth into the joints has been significant and over a prolonged period has lead to movement in the structure of the wall base. A combination of slenderness, erosion of pointing, vegetation and exposure to severe wind are considered to be the principal reasons for collapse.

The 'temporary' Heras fencing has also now badly distorted after 13 years in place and is unsafe.

Composite photo from Dunbottle Lane, April 2021

The proposals are to rebuild the wall on a consolidated and repaired base, to a reduced height. The reduced height of the wall will be along a circa 23.6m section of the wall, stepping to ensure a minimum protection from fall of 1.1m from each side. The proposals are shown in Calls Architecture drawing no. 340. This proposal has the following benefits and enhancements:

All existing masonry will be fully re-pointed in lime mortar. Severely laminated stones will be replaced with new Yorkstone. Some exposed sections of the lower wall will be re-built to vertical. The leaning section of wall will be taken down and re-built. No below ground works or excavations are proposed.

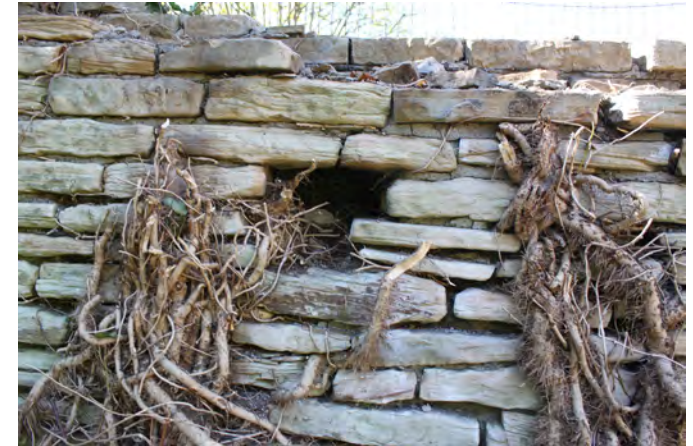
Joints are very open throughout the lower levels and in need of full, deep re-pointing and consolidation of the masonry. There are several large voids in the wall where stonework must be replaced.

Large voids, open joints and thick roots in the lower sections of the wall facing the motte

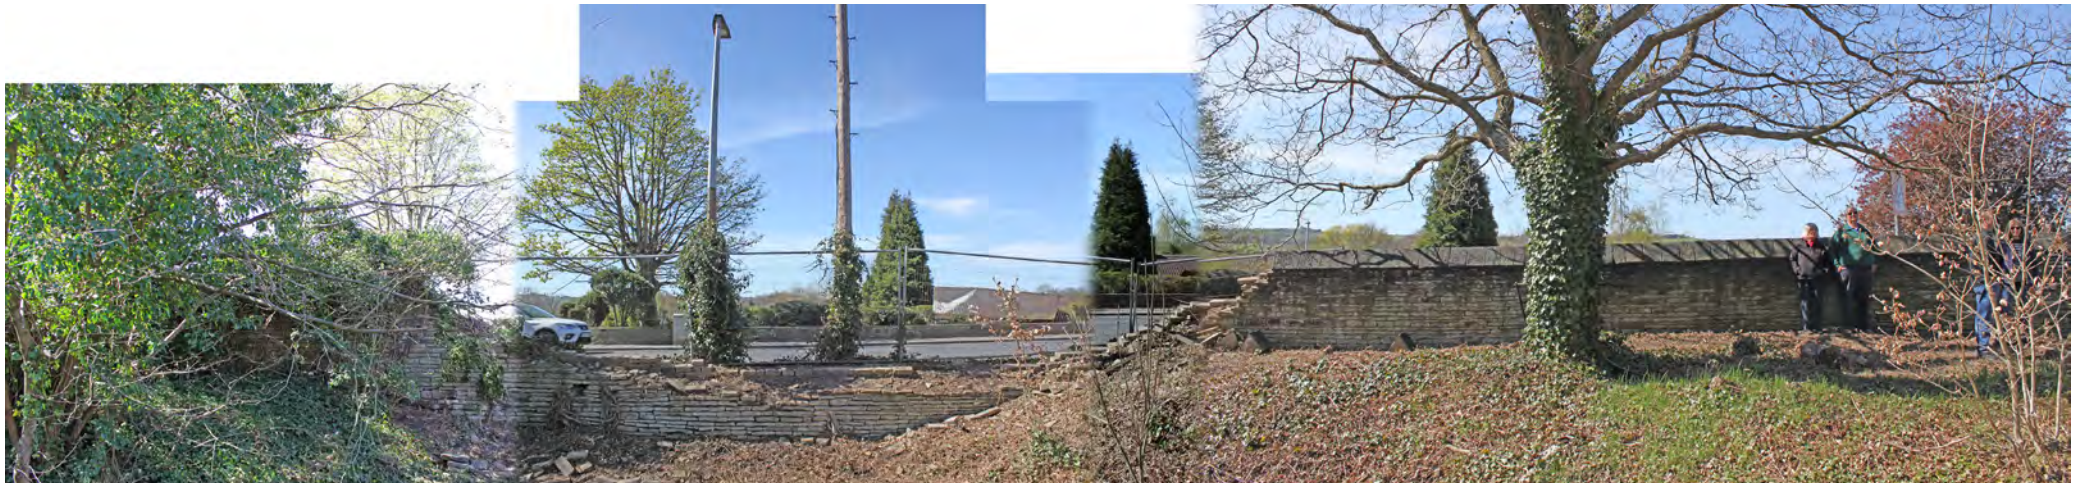
The walling below the footpath level has been significantly affected by vegetation growth with thick roots exploiting and opening up coursing joints in several areas. Prior to this recent inspection, much of the vegetation covering the wall had been removed in order to allow better access. This has been particularly helpful to review the condition of the below path walling and to allow the proposals to be considered in detail.

The top 400mm of wall behind the lamppost has a minor lean towards the motte but at the base is reasonably true. There is no substantial evidence of undermining of the walls foundation from the adjacent standing water. The condition of below ground structures has not been excavated or inspected.

Composite photo from motte, April 2021

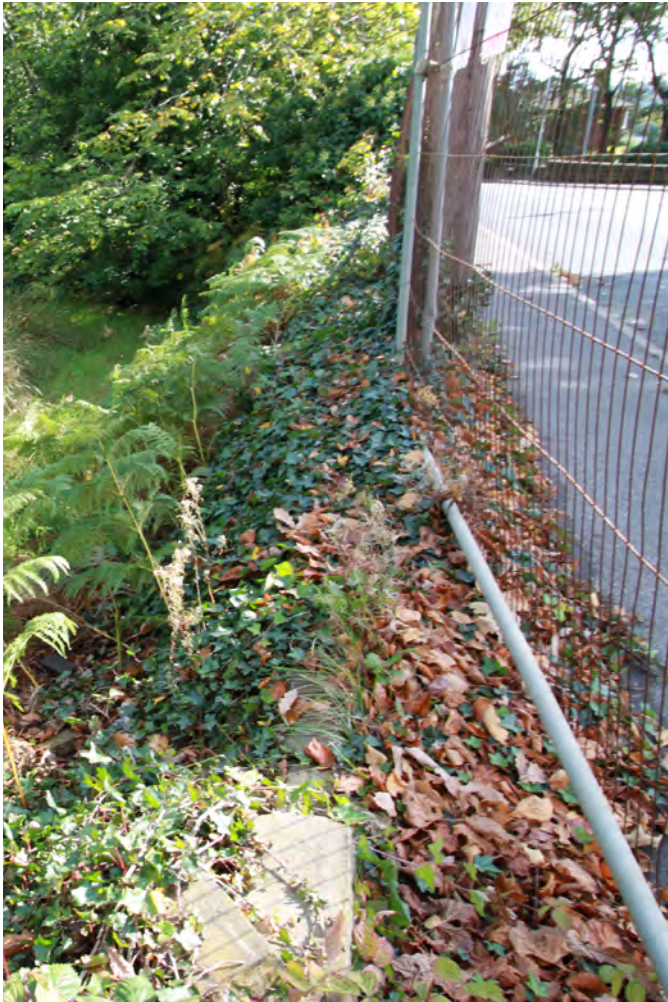
Vegetation cover to lower wall in September 2017

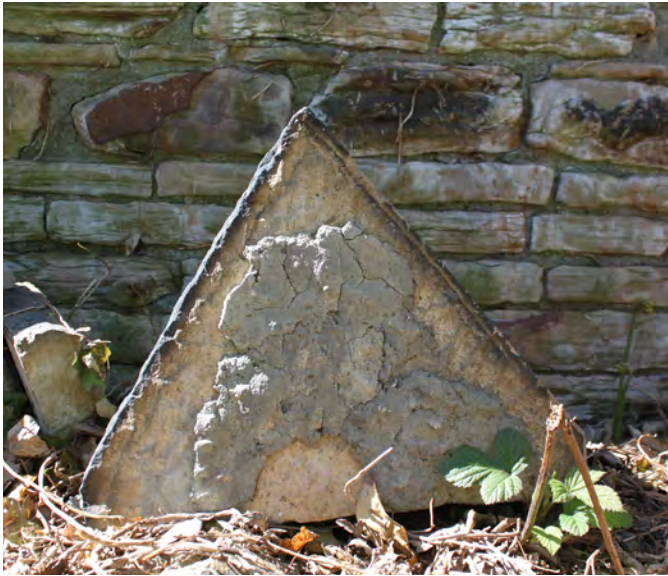
Coping profile, loose on the ground

The repairs will aim to be made up of reclaimed masonry from the collapsed wall, though the off site materials will need to be checked and it may be necessary to supplement these with new stone should there be a shortfall. The copings will be reinstated, with new stone copings to match in shape and tooling only where there is insufficient salvage. New stainless steel ties will aid stability by tying the two leaves, but will be unseen.

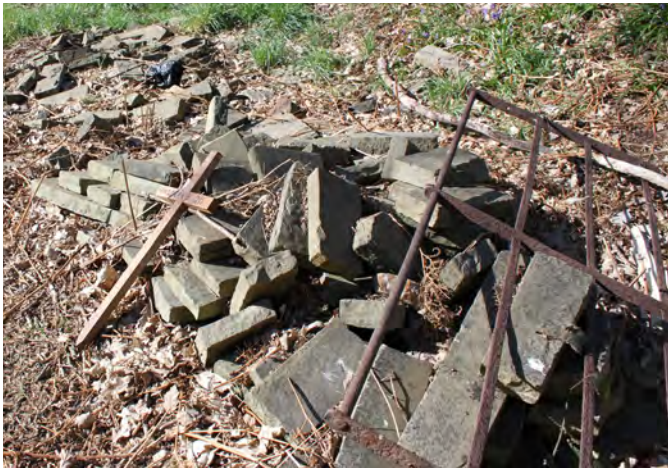
Walling stones stored in the dry ditch

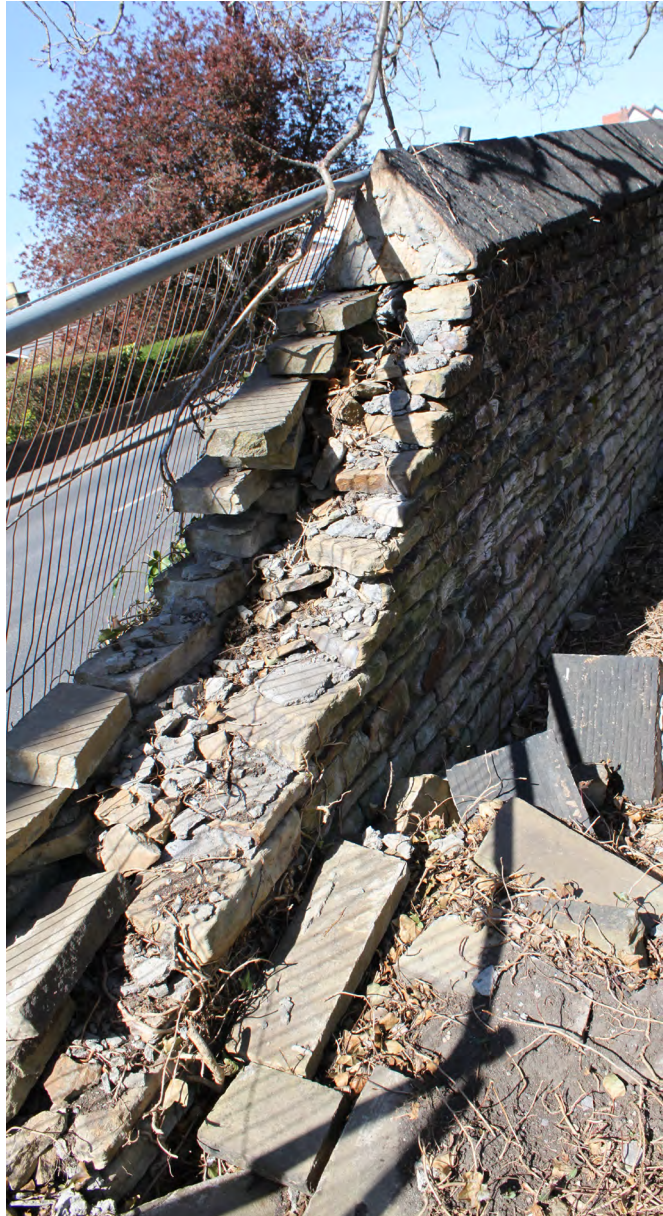
Detail of wall at collapsed end, April 2021

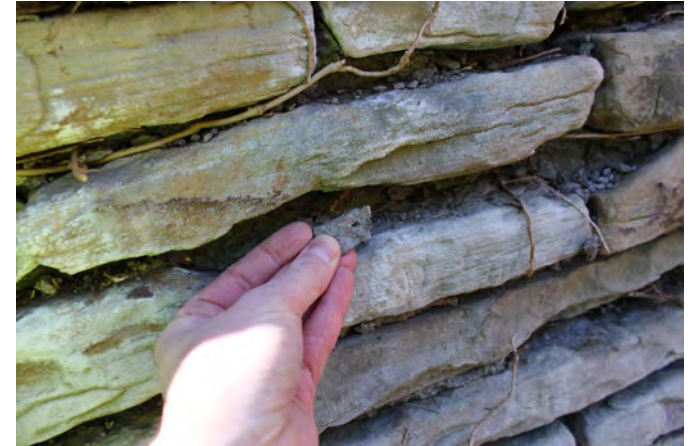
Deeply recessed joints at lower levels, loose pointing

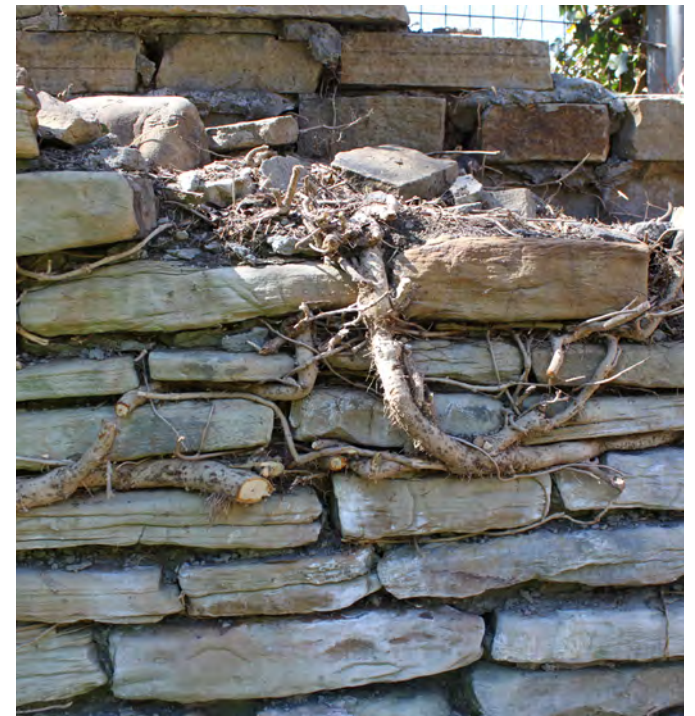
Roots have forced the stones apart in some areas.
