Gas Membrane Installation  
Validation Report  
Myra Homes  
120 Laund Road  
Huddersfield  
Salendine Nook  
HD3 3TY  
Plot 7  
Issued 10/03/22

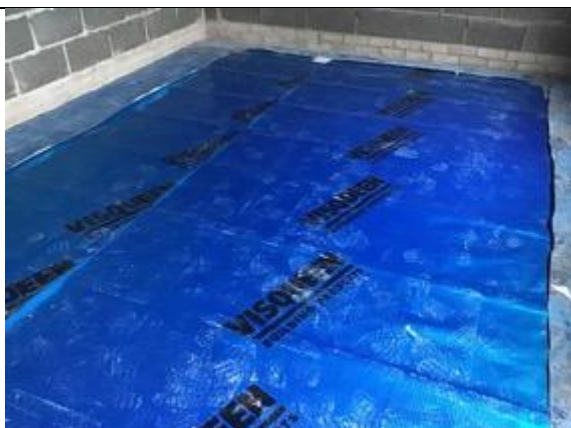
Plot 7 infill installation

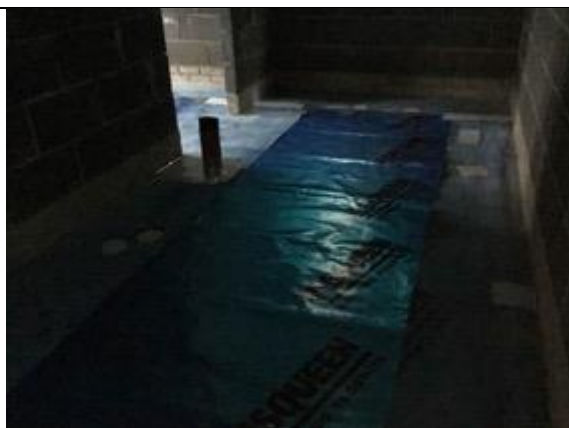
Plot 7 infill installation

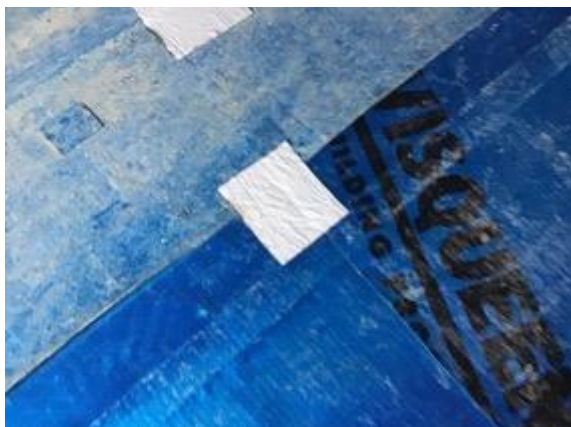
Plot 7 T joint SAGM patch

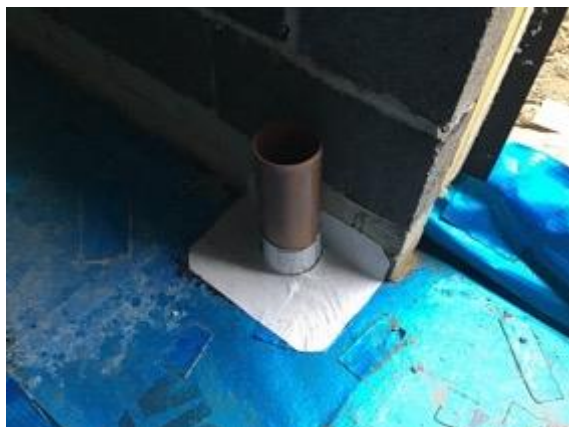
Plot 7 sealed pipe penetration
