## **Structural Appraisal Report**

**91 Dunford Road, Holmfirth**

**Report 20496-L-RP-001-R0**

**Date 28-04-2022**

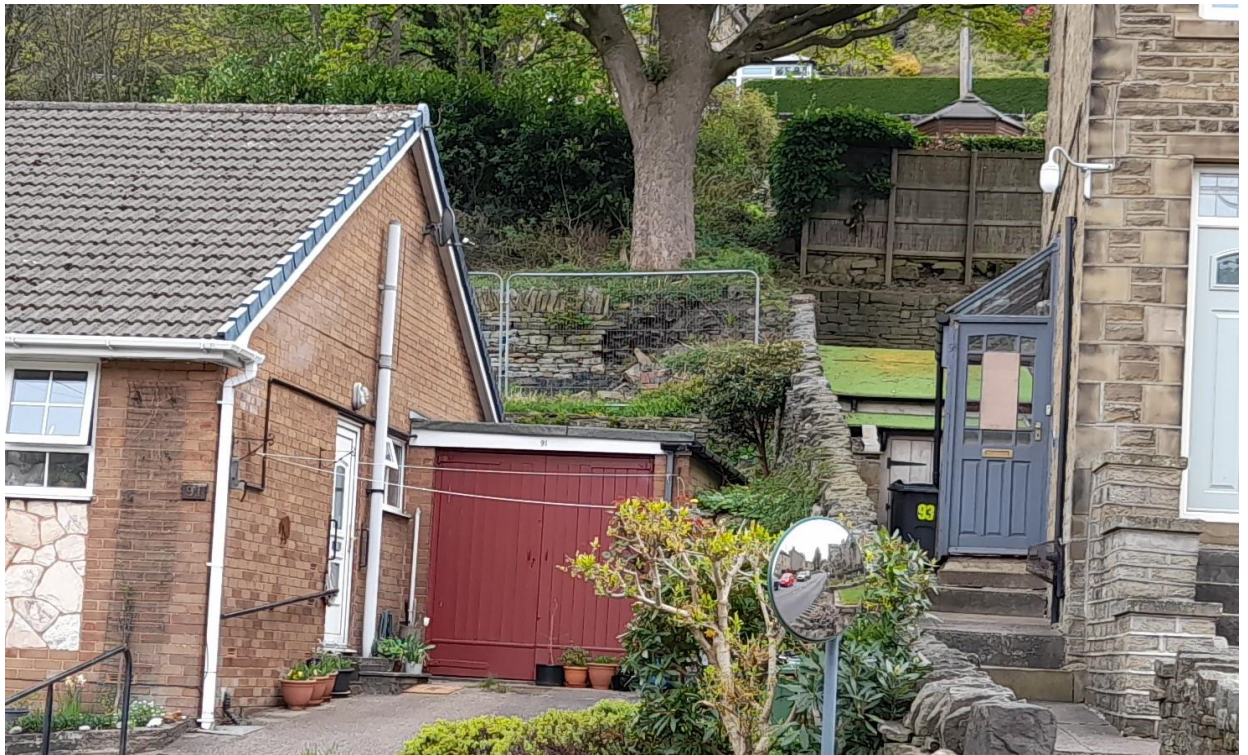
- 2.2 The rear garden is terraced such that the base of the wall is on a level area approximately 5.8 metres above road level (change in level shown in photo 1).

Photograph 1 – Collapsed section visible at rear of garden.

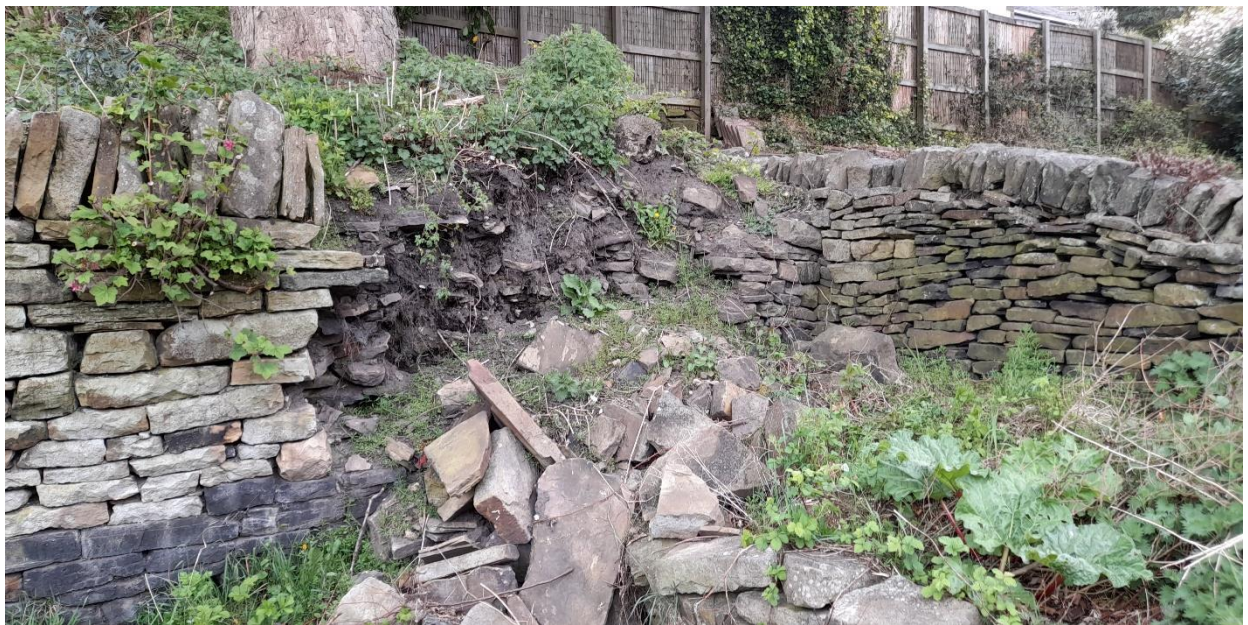
Photograph 2 – Collapsed section in corner, close up.

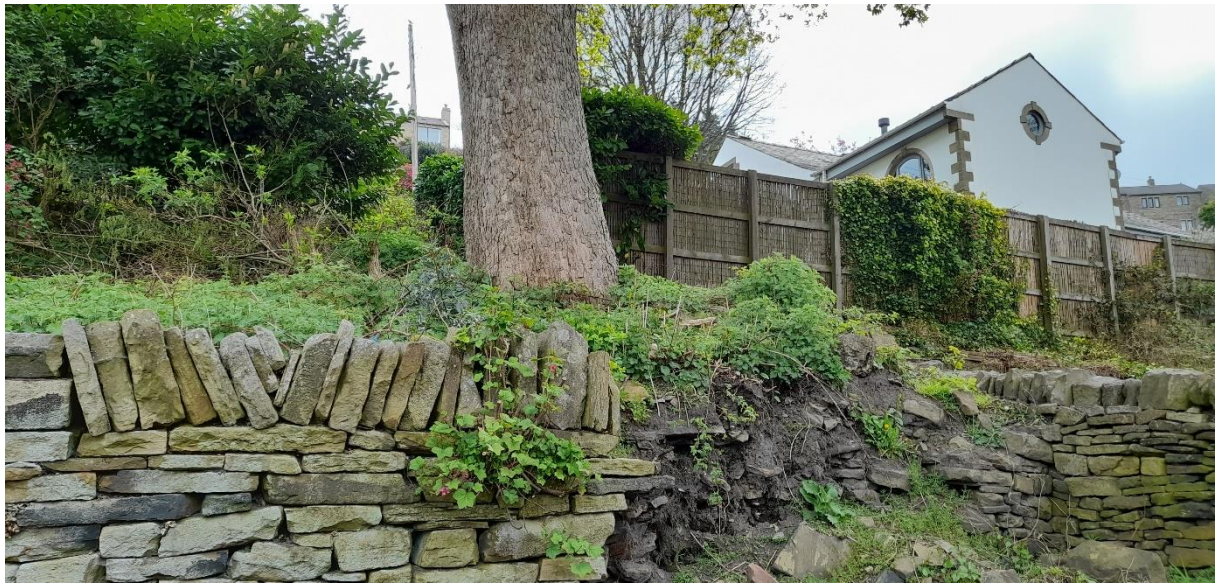
- 3.1 The most obvious feature of the boundary wall is that the collapsed section and the adjoining unstable section are in front of the tree.
- 3.2 The remaining wall, 8.0m away from the right hand edge, remains reasonably plumb.

- 3.6 The difference with the majority of the wall and the collapsed section is the added pressure applied by the tree roots increasing the lean on the wall beyond the limit of stability.

Photograph 3 – Collapsed section showing proximity of tree.

In our opinion, since it is not possible to be sure of the safety of the tree after re-construction using option 2 then we recommend that option 1 is followed. We therefore recommend that the tree should be removed prior to re-construction and that the new wall should then be constructed in line with current design loads and standards.

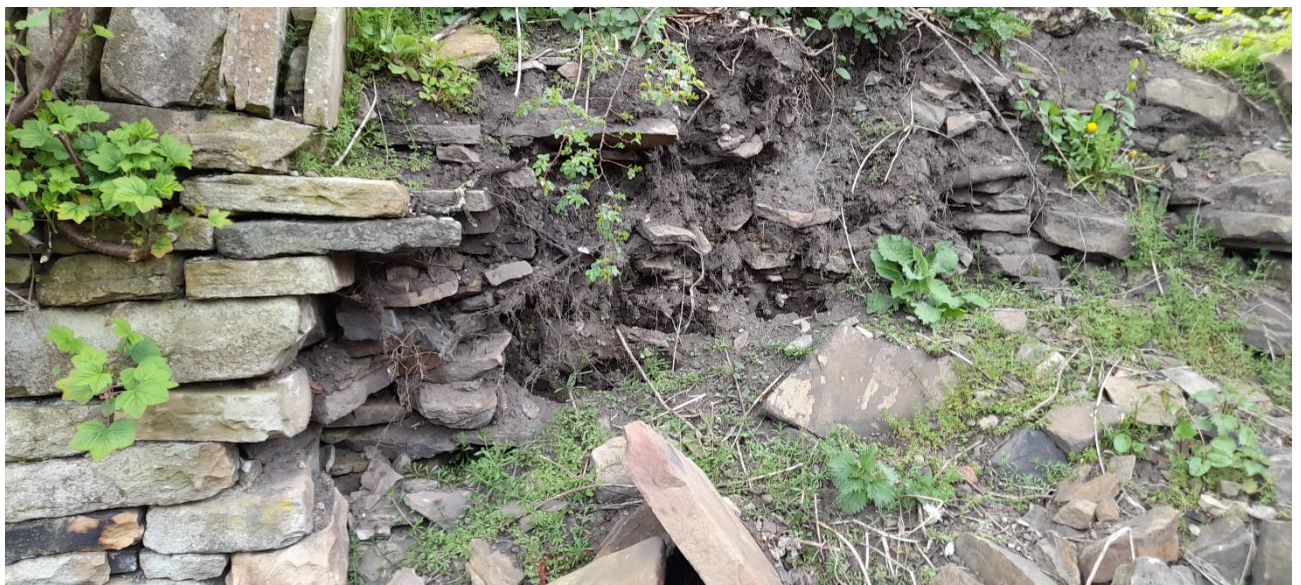
- 3.0 There were no signs of any developing structural problems on the remainder of the wall within this property.
- 3.1 It can be seen on photo 4 that there is topsoil at the rear of the wall between the wall and the tree and that tree roots are present for the full height of the collapsed area.

Photograph 4 – Enlargement of collapsed section showing root growth.

- 5.1.1 Consideration has been given to the likely causes of the collapse. While it is theoretically possible that earth pressure could be a contributing cause the evidence that the remainder of the wall remains intact indicates that this is not the principal factor.
- 5.1.2 In our opinion the collapse has been caused by the additional pressure on the wall from the roots of the adjacent tree. The additional pressure from the tree roots applied over this section only has moved the top of the wall outwards beyond the limit of stability.

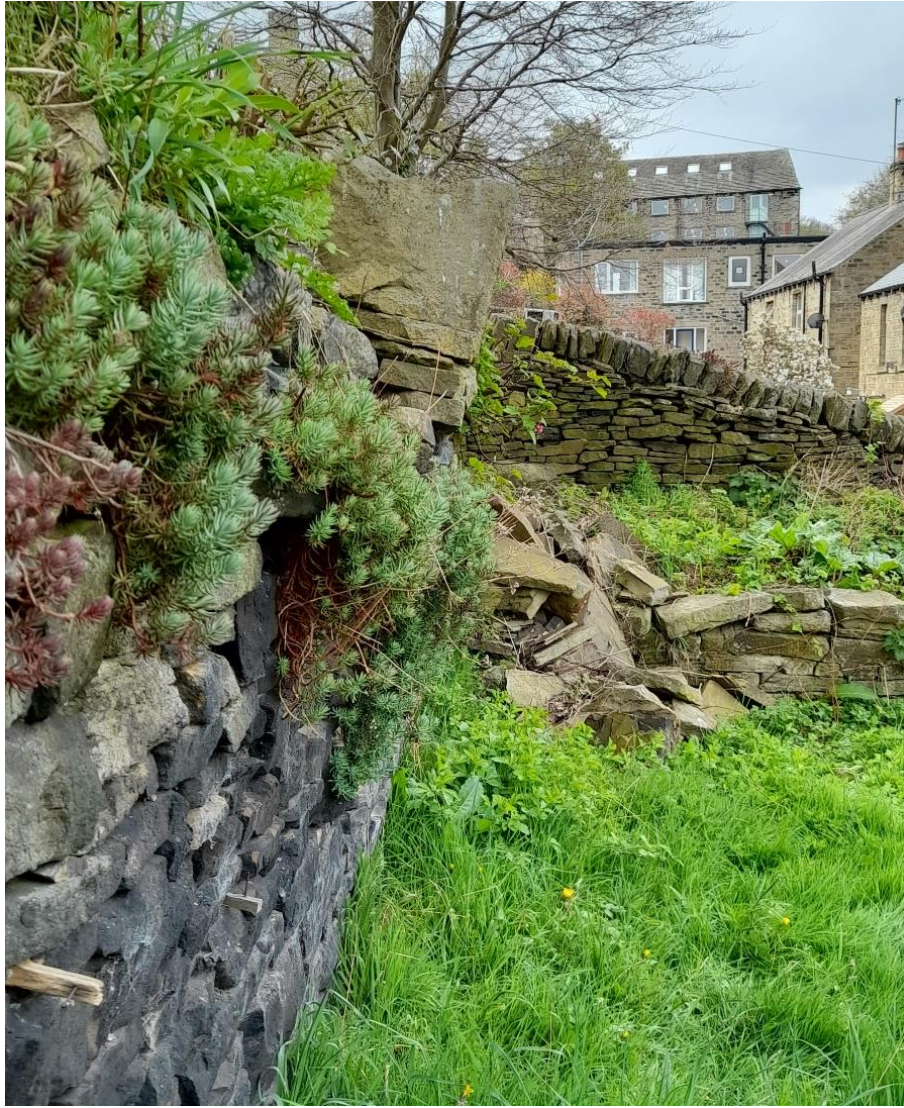
- 2.7 The area adjacent to the collapse is on average 225mm out of plumb over the height of the wall and is therefore itself in a potentially unstable condition.

Photograph 5 – Increase in lean adjacent to tree, with original line visible at left hand side of photo.
