SF2782 Rowley Lane, Lepton

ARBORICULTURAL SURVEY REPORT | BS 5837:2012

Revision D - February 2022

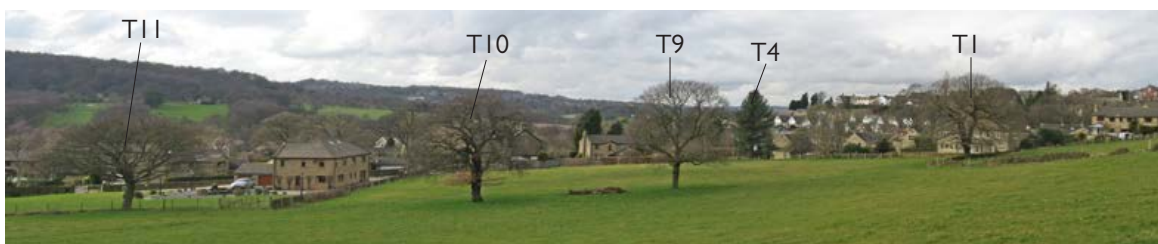
- 3.5.4 Trees T1, T9 and T10 (oak - category A) are mature trees of high quality located on the west side of the site (see photo 1). These three trees are subject to a Tree Preservation Order (ref: TPO No.02/86). Trees T4 (pine - category A) and T11 (oak - category A) are located outside the site adjacent to the western boundary. These are both trees of high quality and value, with crown spreads and RPAs which lie partially within the site boundary.

Photo 1 - Showing category A trees located on the west side of the site.

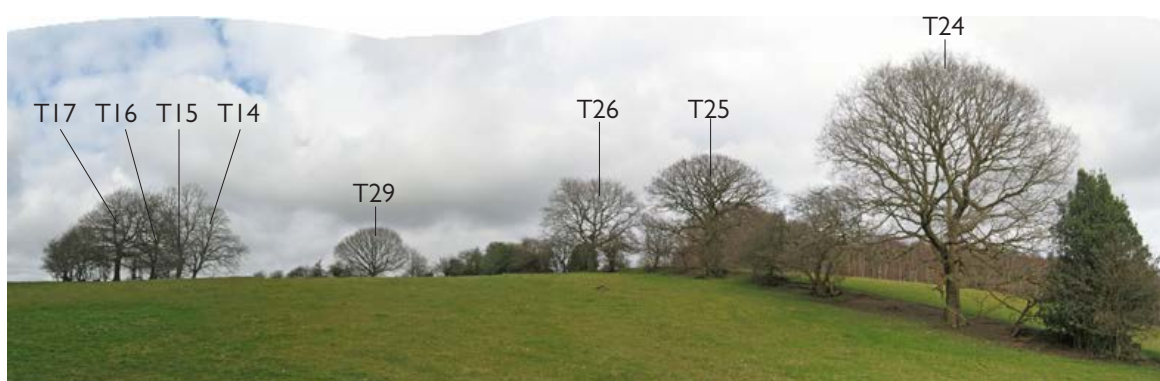
- 3.5.5 Trees T12 to T18 and T22 to T29 are located in the field boundaries and hedgerows on the hillside in the southern half of the site (see photo 2). These trees are early-mature/mature oak and ash which are mostly in good condition and are of moderate to high landscape value. There are however several trees (T15, T18 and T26 - category U) which are in poor condition, with significant defects which would make them unsafe for retention in the context of the proposed development.

Photo 2 - Showing trees located on the hillside in the southern half of the site.

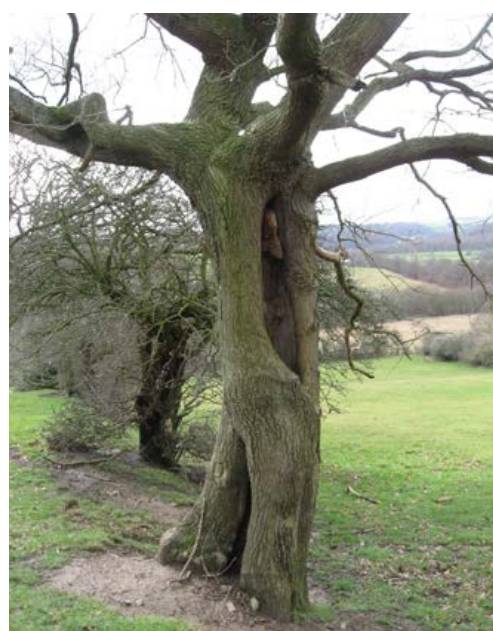
- 3.5.6 Oak tree T26 (category U) has a hollow stem with two large cavity openings (see photo 3). The tree still has approximately one third of its residual sound wood intact, which would normally be considered sufficient for the tree to remain stable, however this does not take into account the two cavity openings in the stem, which may further weaken the structural condition of the tree. Oak trees are known to gradually hollow and T26 could be left in its current land use to naturally decay and retrench, however this tree would pose a risk in close proximity to housing and we would therefore recommend the tree be removed in the context of development.

Photo 3 - Showing cavity openings in T26 oak.

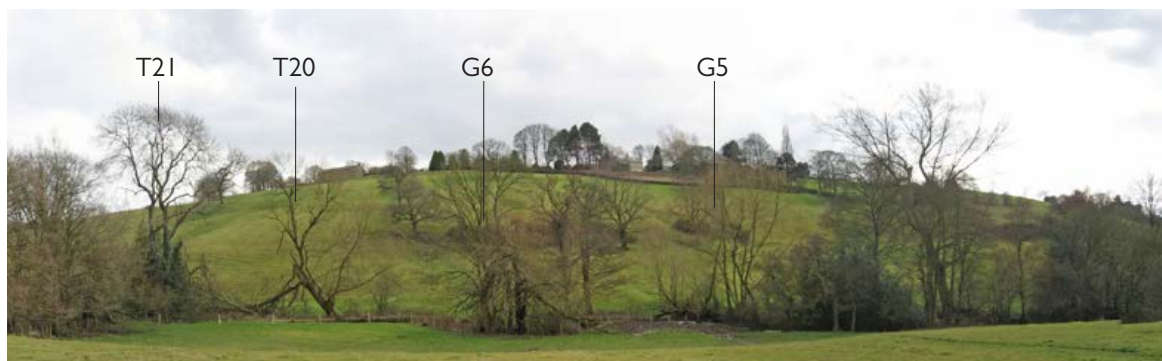
- 3.5.7 Trees T19 to T21 and groups G2 to G6 are located around the stream on the lower ground at the southern end of the site (see photo 4). These trees are mostly low to moderate quality. Some of the trees within G2, G6 and T21 (willow - category U) are in poor condition with large limbs which have collapsed and in some instances have damaged other trees and are lying within the site. Willow is a relatively short lived, fast growing species which has a non durable heartwood with poor resistance to decay and as such is prone to failure.

Photo 4 - Showing trees located at the southern end of the site.

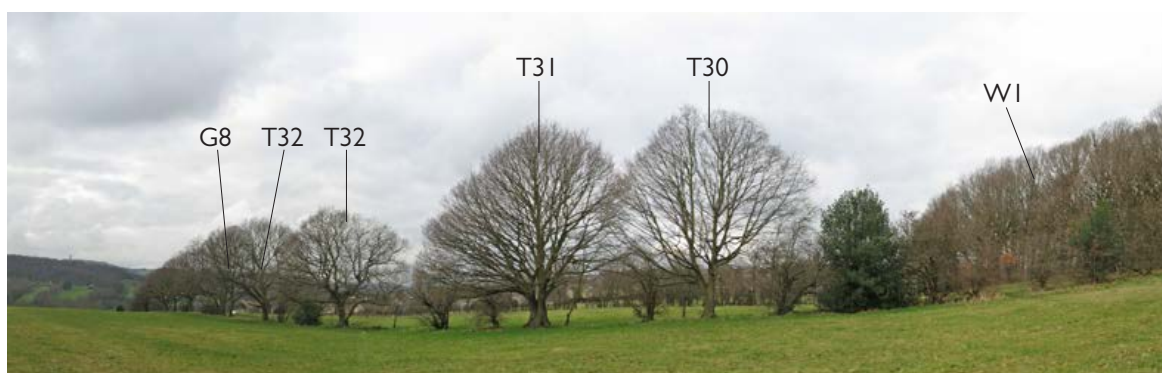
- 3.5.8 Trees T30 to T36 and G8 (oak - category B and A) are located along the field boundary hedgerow (H7) in the northern half of the site (see photo 5). These trees are mostly early-mature oak and ash which are in good condition and are of moderate to high landscape value.

Photo 5 - Showing trees T30 to G8 (oak) located in the northern half of the site.
