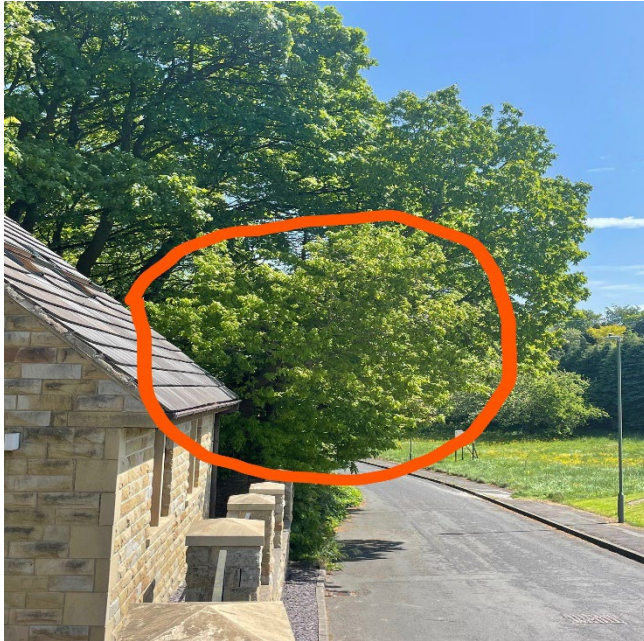
### T1 . Oak

Excessive base decay and overhang into road. At risk of falling on users of road and footpath.  
Remove and replant 1.5 – 1.8m Oak.

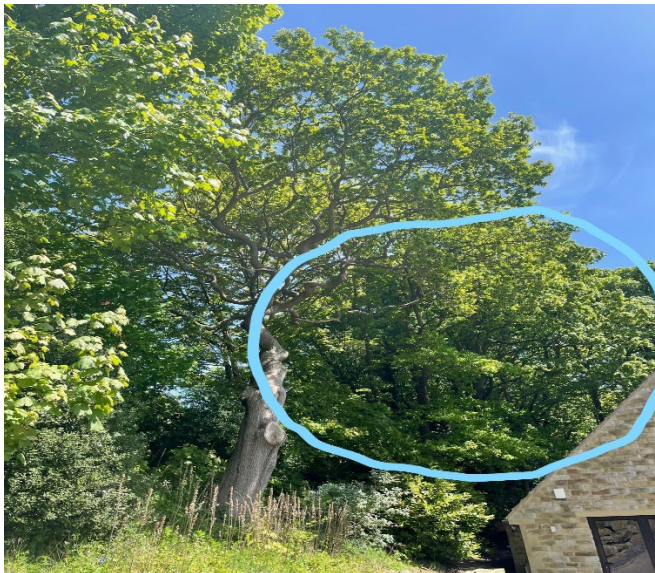
### G1. Multiple Oak

Reduction by 4m. This group of semi mature Oaks are competing for light and have grown very tall and thin. They are a danger to the existing outbuilding should they fail. They are also rooted into a steep bank.

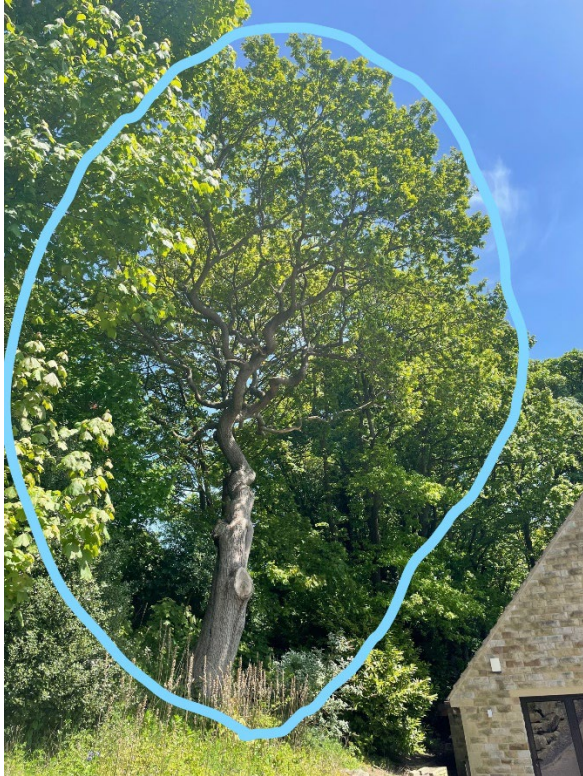
## T2. Oak

Located close to the front left corner of outbuilding. Previous pruning works are not healing, large exposed areas of cambium and a large amount of dead wood in canopy. Danger to buildings.

Remove and re plant oak 1.5-1.8m.

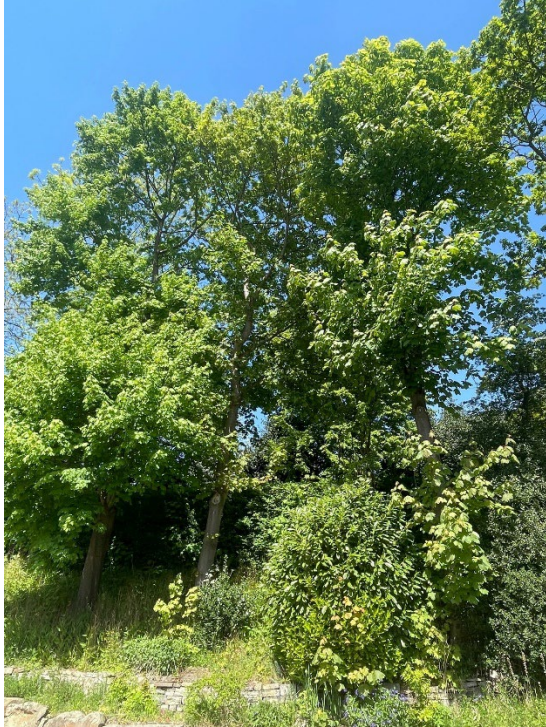
## G2. Sycamore x3

Remove middle tree. Reduce outer trees by 1/3<sup>rd</sup> or 3.5m to halt the race for light. Trees are based on an unsteady bank and are a risk during storms.

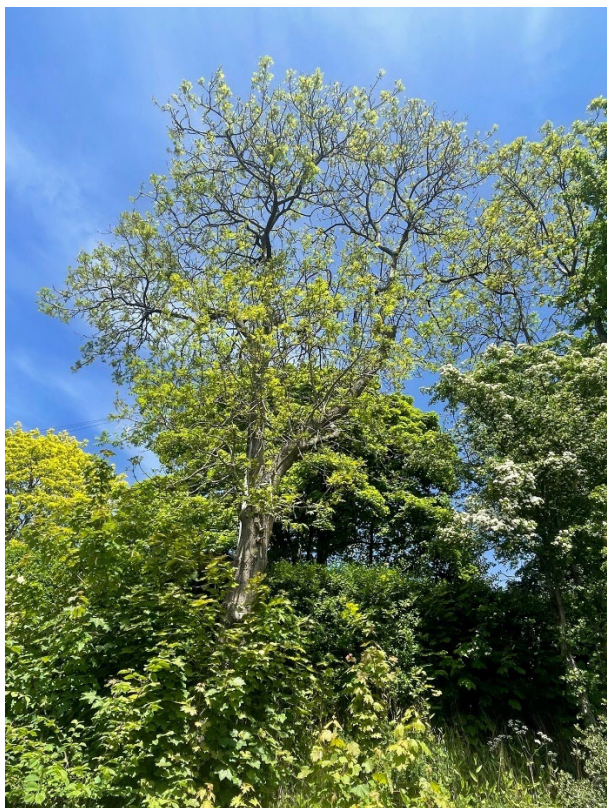
## T3. Ash

Showing signs of ADB, remove before becoming a bigger danger to occupants of main dwelling and vehicles. Re Plant Ash 1.5-1.8m
