## **Structural Report**

**Project:** 2-8 Huddersfield Road  
Birstall  
Batley  
WF17 9AA

**Reference:** B24431-JNP-XX-XX-RP-S-0001 P01

**Date:** 09 February 2021

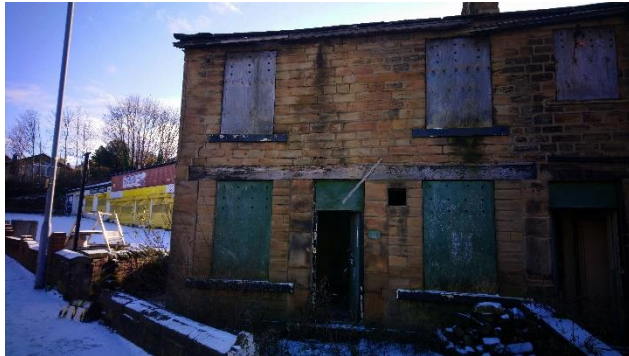
**Photo 1- Property 2**

This is the left property. There is a timber beam at lintel level spanning the full width of the property. There are two window openings at either side of the centre door that have been partially filled and smaller windows installed. The timber beam is suffering from decay. A crack approximately 40mm wide has developed to the left side of the lintel which extends up to the sill above. This crack has significantly opened over the last 8 years. Photograph 1 shows the elevation and photograph 2 is a close-up of the crack. The left corner of the elevation leans out by approximately 30mm over the first 2.4m.

The sill to the left window slopes down slightly to the right. The cellars to this property extend over half the width of the front yard (which is triangular shape). The remainder of the yard appears to be natural ground/backfill to the cellars, and this has settled. The gutter has rotted, and water has been allowed to pour down the front elevation washing out mortar.

- 7.1.2 In addition to the common defects noted in 5.1., each of the properties has specific defects.
- 7.1.3 Property No. 2 - The timber beam to the front elevation would require removal. This would involve taking down the front elevation.

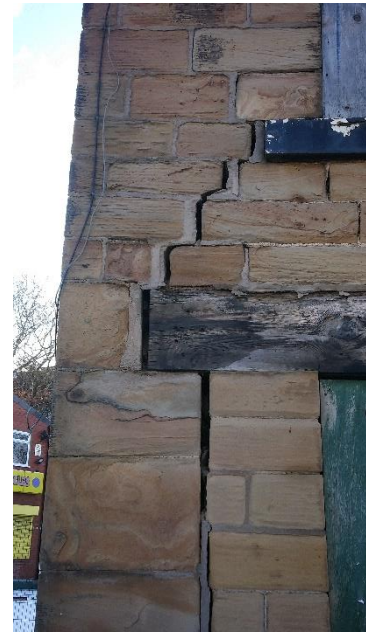
**Photo 2-Crack**

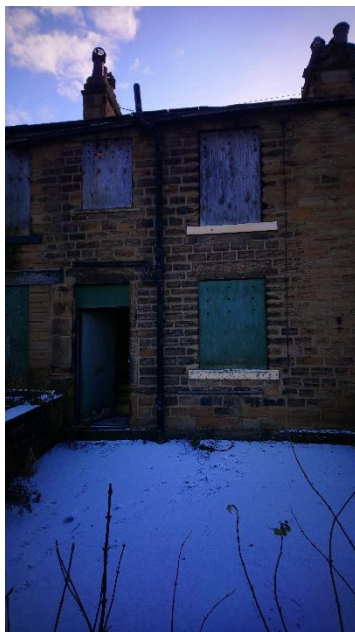
**Photo 3-Property 4**

The front elevation is shown on photograph 3. The ground floor sill was found to be horizontal. The wall is reasonably plumb. The property has been repointed in the past and most of the pointing is intact. Apart from the top three courses of stonework which appear to lean into the property, the elevation is in reasonable condition.

- 7.1.6 Property No. 4 – The top three courses of stone to the front elevation appear to have moved. In 5.1. we have recognised that the properties will require new roofs, and the top stone courses on this property and others may be loose and will require taking down and rebuilding.

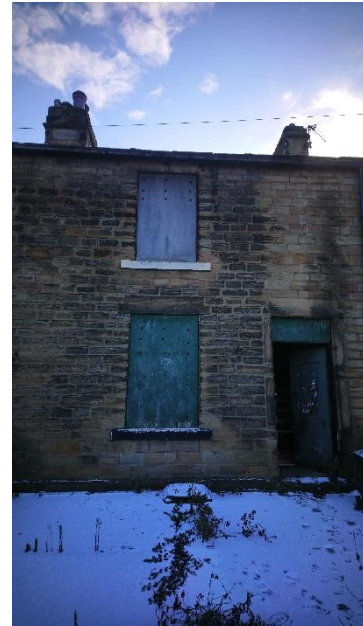
**Photo 4-Property 6**

See photograph 4. There is patch pointing around the lintel; however, the majority of the pointing appears to be relatively old. There are no significant open joints, and the wall is reasonably plumb and the sill reasonably horizontal. The jamb stones to the right side of the entrance are damaged where metal inserts holding a doorframe in place have corroded blowing off the face of the stones. There are a few open joints between this property and No. 8.

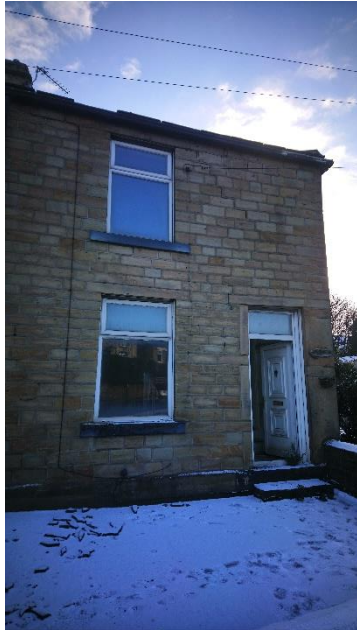
**Photo 5-Property 8**

See photograph 5. At lower level, the elevation was found to be reasonably plumb, and the sill is horizontal. At first floor level there is a crack from the left corner of the lintel to the door which radiates up to the right corner of the sill to the first-floor window. There is a further crack which appears to be relatively recent, radiating down from the right corner of the first-floor window to the right corner of the door below. This is shown in photograph 6. The lintel over the front door slopes down to the left by approximately 30mm. The lintel is also cracked where it bears onto the wall at the right side. The door threshold also leans down towards the left. This indicates significant downward movement to the left of the door. The wall below the crack that runs from the corner of the first-floor lintel leans inwards by approximately 40mm from first floor level to the underside of the first-floor lintel. The front right corner leans out towards the right.

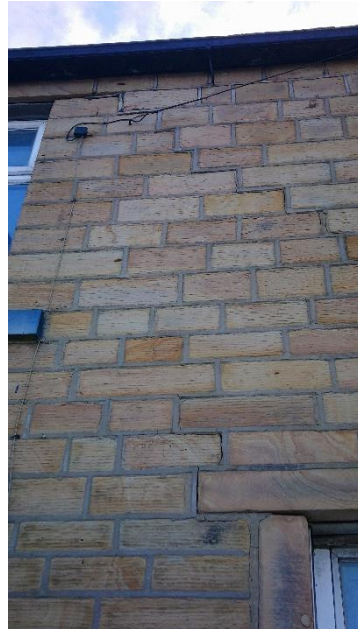
**Photo 6-Crack to No 8**

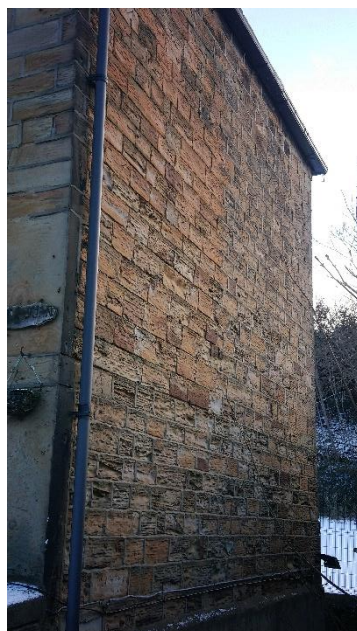
**Photo 7-Right wall**

4.3.1 From ground floor level down to basement level, the gable wall has been rendered. See photograph 7. It is noted internally that there is significant damp inside the property along this wall. There is a rainwater pipe at the front right corner which enters straight into the ground. This is possibly connected to a drain along the side of the property, which may be damaged. The elevation has been repointed many years ago; however, the face of the stones is weathered. The wall is uneven; however, there is no sign of significant bulging or leaning. The gutter has fallen away.

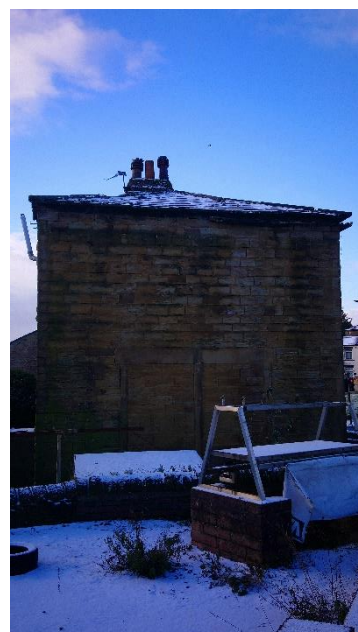
**Photo 8- Left Wall**

4.4.1 See photograph 8. Two shop windows have been infilled. The gutter along this elevation has rotted over most of its length. The sills to these blocked up windows are reasonably horizontal. The wall appears to be reasonably plumb although the mullions lean outwards.

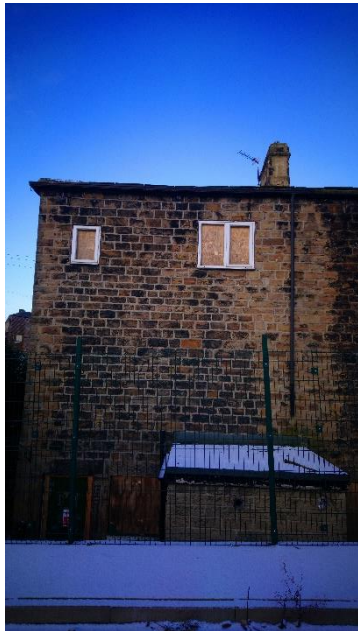
**Photo 9-Rear No 8**

The first floor and ground floor windows have been formed in this elevation using precast concrete lintels over. A soil and vent pipe exists the rear elevation and a large hole has been formed in the wall at this location (photograph 15). The wall has not been rebuilt around this opening. Where the rear wall has been broken through to form the windows, bricks have been inserted and the window openings poorly formed. The lintel to the cellar window is cracked, and the crack is radiating up from this point up to the new window at ground floor level). The sill to this basement window is also cracked on the left side. The lintel over the door has cracked, and a crack radiates up the rear wall from this point (photograph 9).

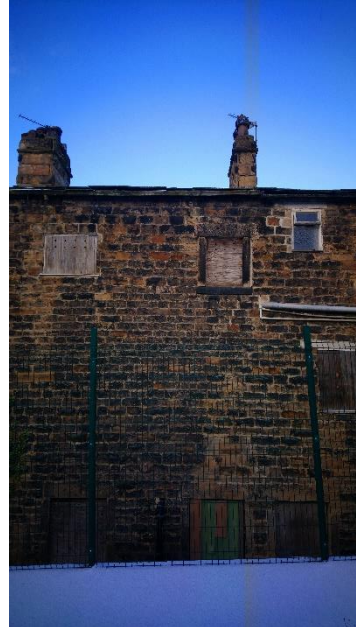
**Photo 10-Rear No 4**

There is cracking radiating from the right side of the lintel to the window when viewing the property from the rear (photograph 10). There is a further crack which has split the stone, going up the property centrally.

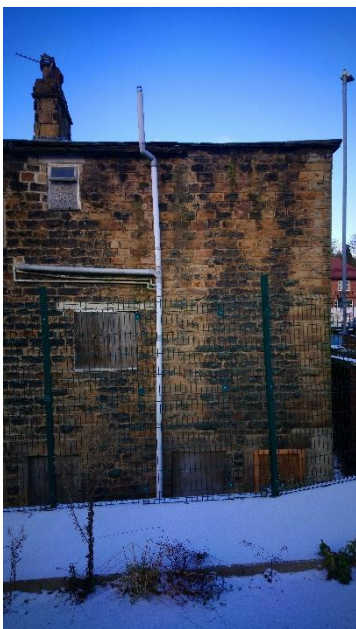
**Photo 11-Rear No 2**

This property has a small window at first floor level and one at ground floor level (photograph 11). These are a later addition and have precast concrete lintels. The gutter along the rear elevation of all the properties is in poor condition or fallen off. The elevation has not been repointed and there is loose pointing and gaps around the jambs to the windows and doors.

There is an original window directly above the ground floor door at first floor level (see photograph 11). The crack that runs between the door at ground floor level and this window is an old crack has been filled in in the past, however, has reopened over the last 8 years. The crack may have been up to 40mm wide. The lintel to the door falls down to the right by approximately 10mm, and the lintel to the window falls down to the right by approximately 15mm. There is indication therefore that some differential movement has taken place to the property.

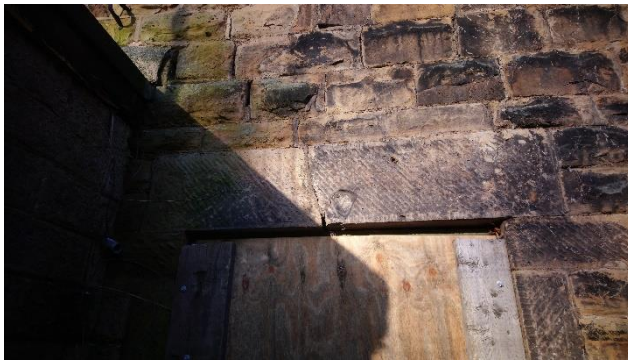
To the rear of this property is a more recent flat roof extension. The flat roof is in poor condition. This forms a room at basement level now containing the bathroom. There are no signs of significant movement (see photograph 13 and 14).

**Photo 13-Cracked lintel**

- 7.1.8 There are a number of cracked lintels and sills to the rear of the properties, and particularly to the rear of property No. 6 due to settlement. A number of stone lintels and sills would have to be replaced during any renovation works.

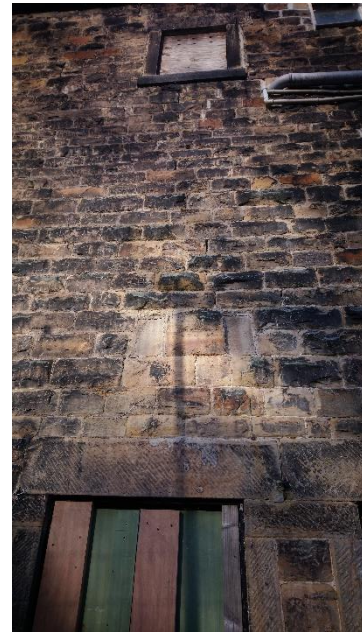
**Photo 14-Vertical crack No 4**

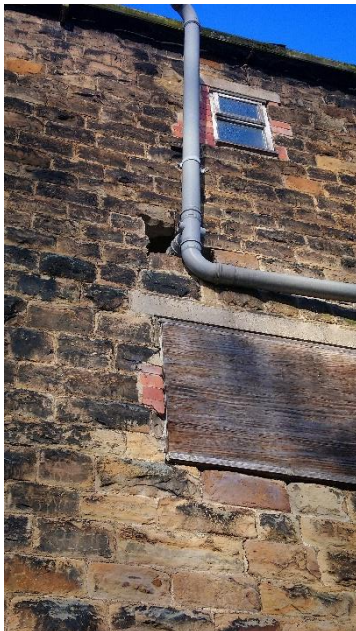
**Photo 15-Rear No 4 showing hole**

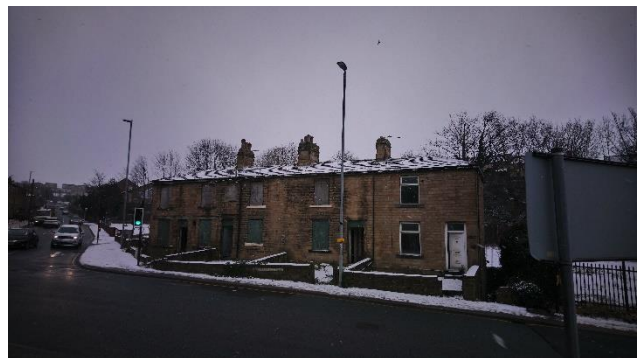
6.1.1 From street level the ridge and hip tiles can be seen to be broken and loose (photograph 16). The stone slates to the front and rear roof slopes show signs of movement and there is dipping and hogging of the roof structure in general across the four properties. Flashings around the chimney stacks require repairs and the mortar on top of the chimneys also require inspection. There are clear indications of movement over the last 8 years particularly to property 2.

**Photo 16-View to front of terrace**

- i. The roofs to all the properties are in poor condition and would require reroofing. Ridge tiles are poor or broken, battens are undersized and there are a number of principle structural timbers such as rafters and purlins that will require replacing.
