Project name:  
**15124 - 1 LEEDS ROAD**

Contractor **OCTANE DRAIN CARE LIMITED**  
 Contact: **JORDAN HARRISON**  
 Position: **OPERATIONS MANAGER**  
 Road **OCTANE HOUSE, PEACE STREET**  
 Town **BRADFORD**  
 County **WEST YORKSHIRE**  
 Telephone: **0113 2012 466**  
 Fax: **0113 2012 466**  
 Mobile:  
 E-Mail: **JORDAN@OCTANEDRAIN CARE.CO.UK**

## Inspection report

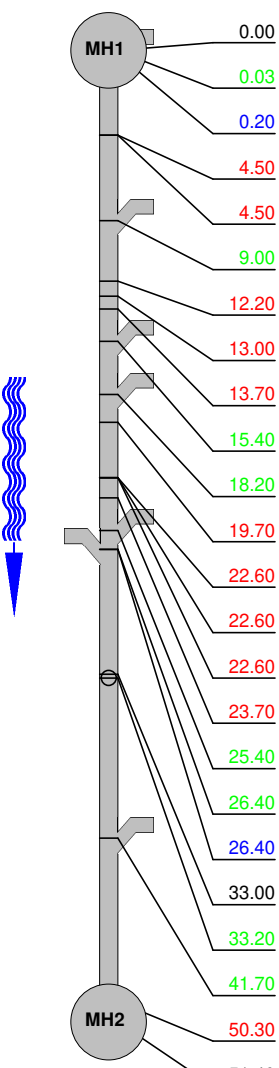
| Date:<br><b>02/06/2020</b> | Job N°: | Weather: | Operator: | section number:<br><b>2</b> | PLR:<br><b>FW01 X</b> |

| 1:400 | position | code | observation | grade |
|---|---|---|---|---|
| | 4.50 | CCJ | Crack Circumferential at joint from 01 to 02 o'clock | (Struct) 2 |
| | 4.50 | CLJ | Crack Longitudinal at joint at 12 o'clock | (Struct) 2 |
| | 12.20 | CLJ | Crack Longitudinal at joint at 11 o'clock | (Struct) 2 |
| | 13.00 | CLJ | Crack Longitudinal at joint at 09 o'clock | (Struct) 2 |
| | 13.70 | CLJ | Crack Longitudinal at joint at 12 o'clock | (Struct) 2 |
| | 19.70 | CLJ | Crack Longitudinal at joint at 12 o'clock | (Struct) 2 |
| | 22.60 | H | Hole in sewer from 01 to 04 o'clock | (Struct) 4 |
| | 22.60 | B | Broken pipe from 12 to 01 o'clock | (Struct) 4 |
| | 22.60 | FLJ | Fracture longitudinal at joint at 09 o'clock | (Struct) 3 |
| | 23.70 | FM | Fractures multiple from 12 to 12 o'clock | (Struct) 4 |
| | 26.40 | RFJ | Fine Roots at joint | (Serv) 1 |
| | 50.30 | FM | Fractures multiple from 12 to 12 o'clock | (Struct) 4 |

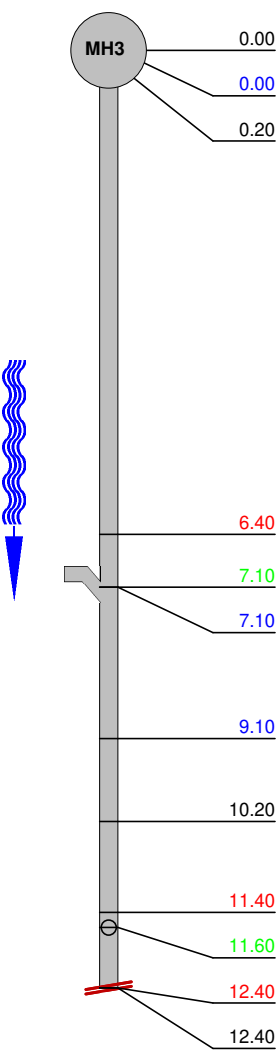
| Date:<br><b>02/06/2020</b> | Job N°: | Weather: | Operator: | section number:<br><b>3</b> | PLR:<br><b>MH3 X</b> |

| 1:100 | position | code | observation | grade |
|---|---|---|---|---|
| | 6.40 | CCJ | Crack Circumferential at joint from 03 to 09 o'clock | (Struct) 2 |
| | 7.10 | DES | Settled deposits fine 10 % cross-sectional area loss | (Serv) 1 |
| | 9.10 | DES | Settled deposits fine 20 % cross-sectional area loss | (Serv) 1 |
| | 11.40 | JDM | Joint displaced medium | (Struct) 1 |
| | 12.40 | JDM | Joint displaced medium | (Struct) 1 |
| | 12.40 | SA | Survey abandoned, Remark: DUE TO DISPLACED JOINT | (Misc) 0 |
