## FIELD HOUSE, DEWSBURY

## CONDITION SURVEY

3014/1

December 2020

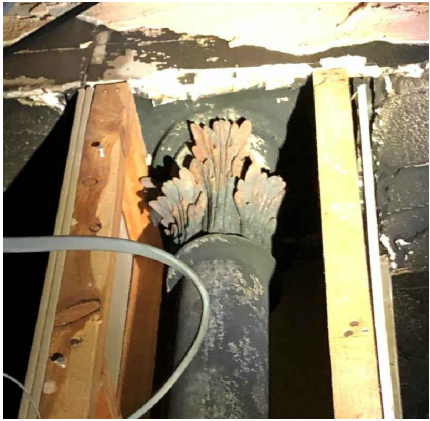
b: detail of decorative column capital

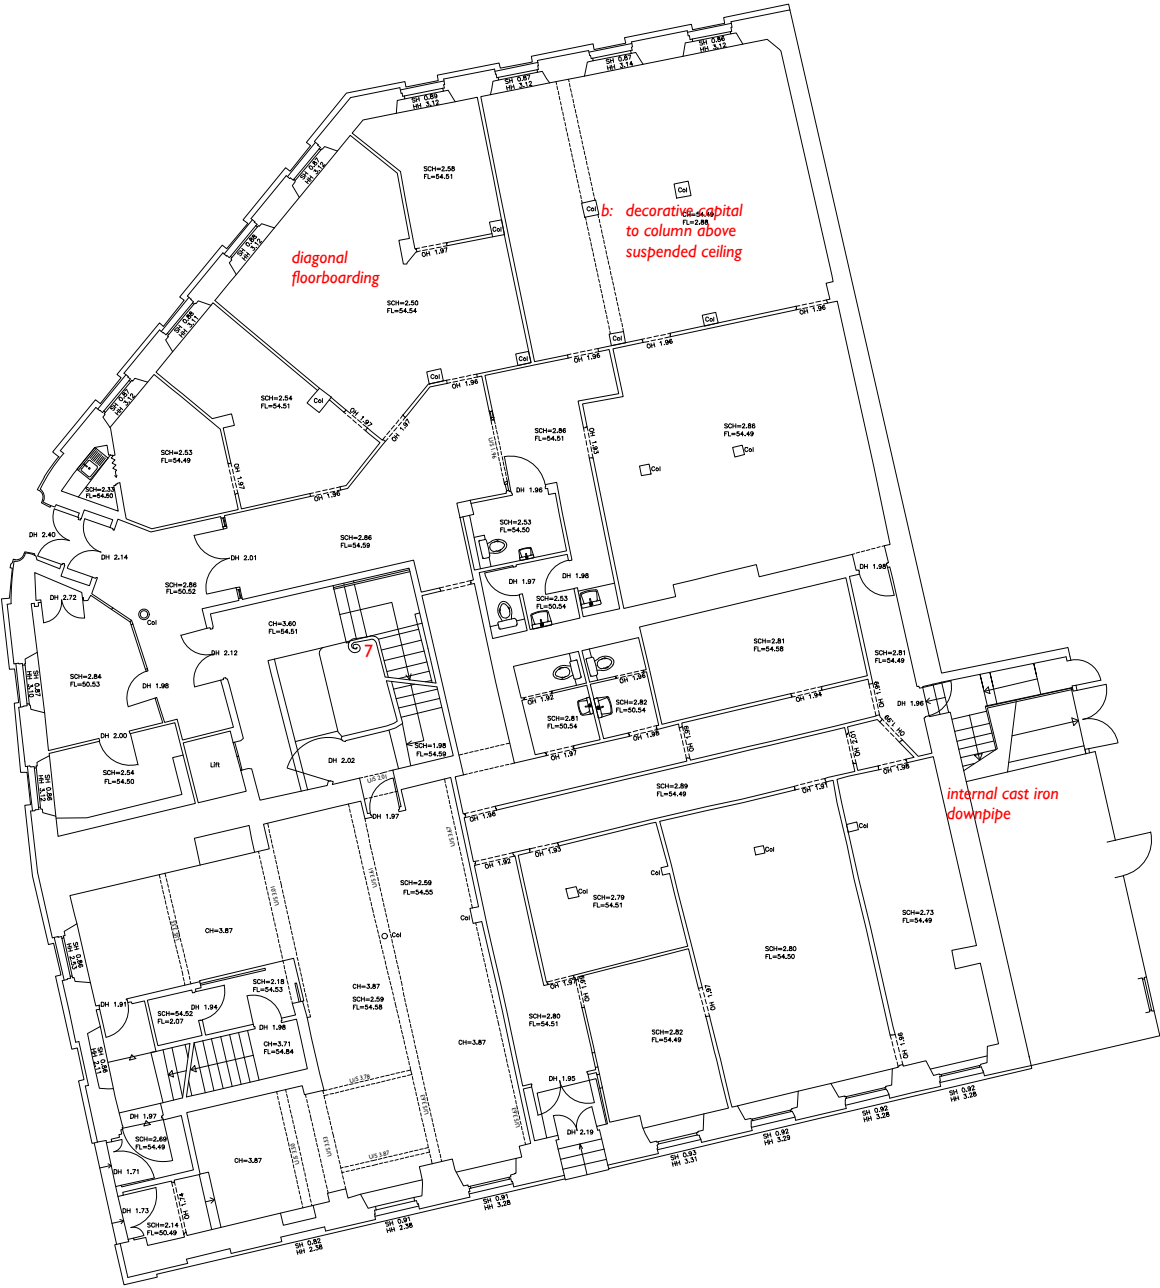
- \* Damp evident/ decayed ceiling and/or floor
- a Moisture penetration evident: check condition of internal timber lintols

- Stair**
- blocks fitted between base of balusters along landings
  - some balusters are loose
  - some flex/movement on handrails
  - latex screed on some treads suggesting uneven wear pattern
- 1 baluster has failed
  - 2 handrail on quarter landing has pulled out of wall and landing appear to have dropped
  - 3 landing bows in centre
  - 4 metal straps fitted to head of balusters and handrail on landing loose
  - 5 balusters lean into stairway
  - 6 handrail pulled out of wall
  - 7 open joint in handrail. Flex in balustrade

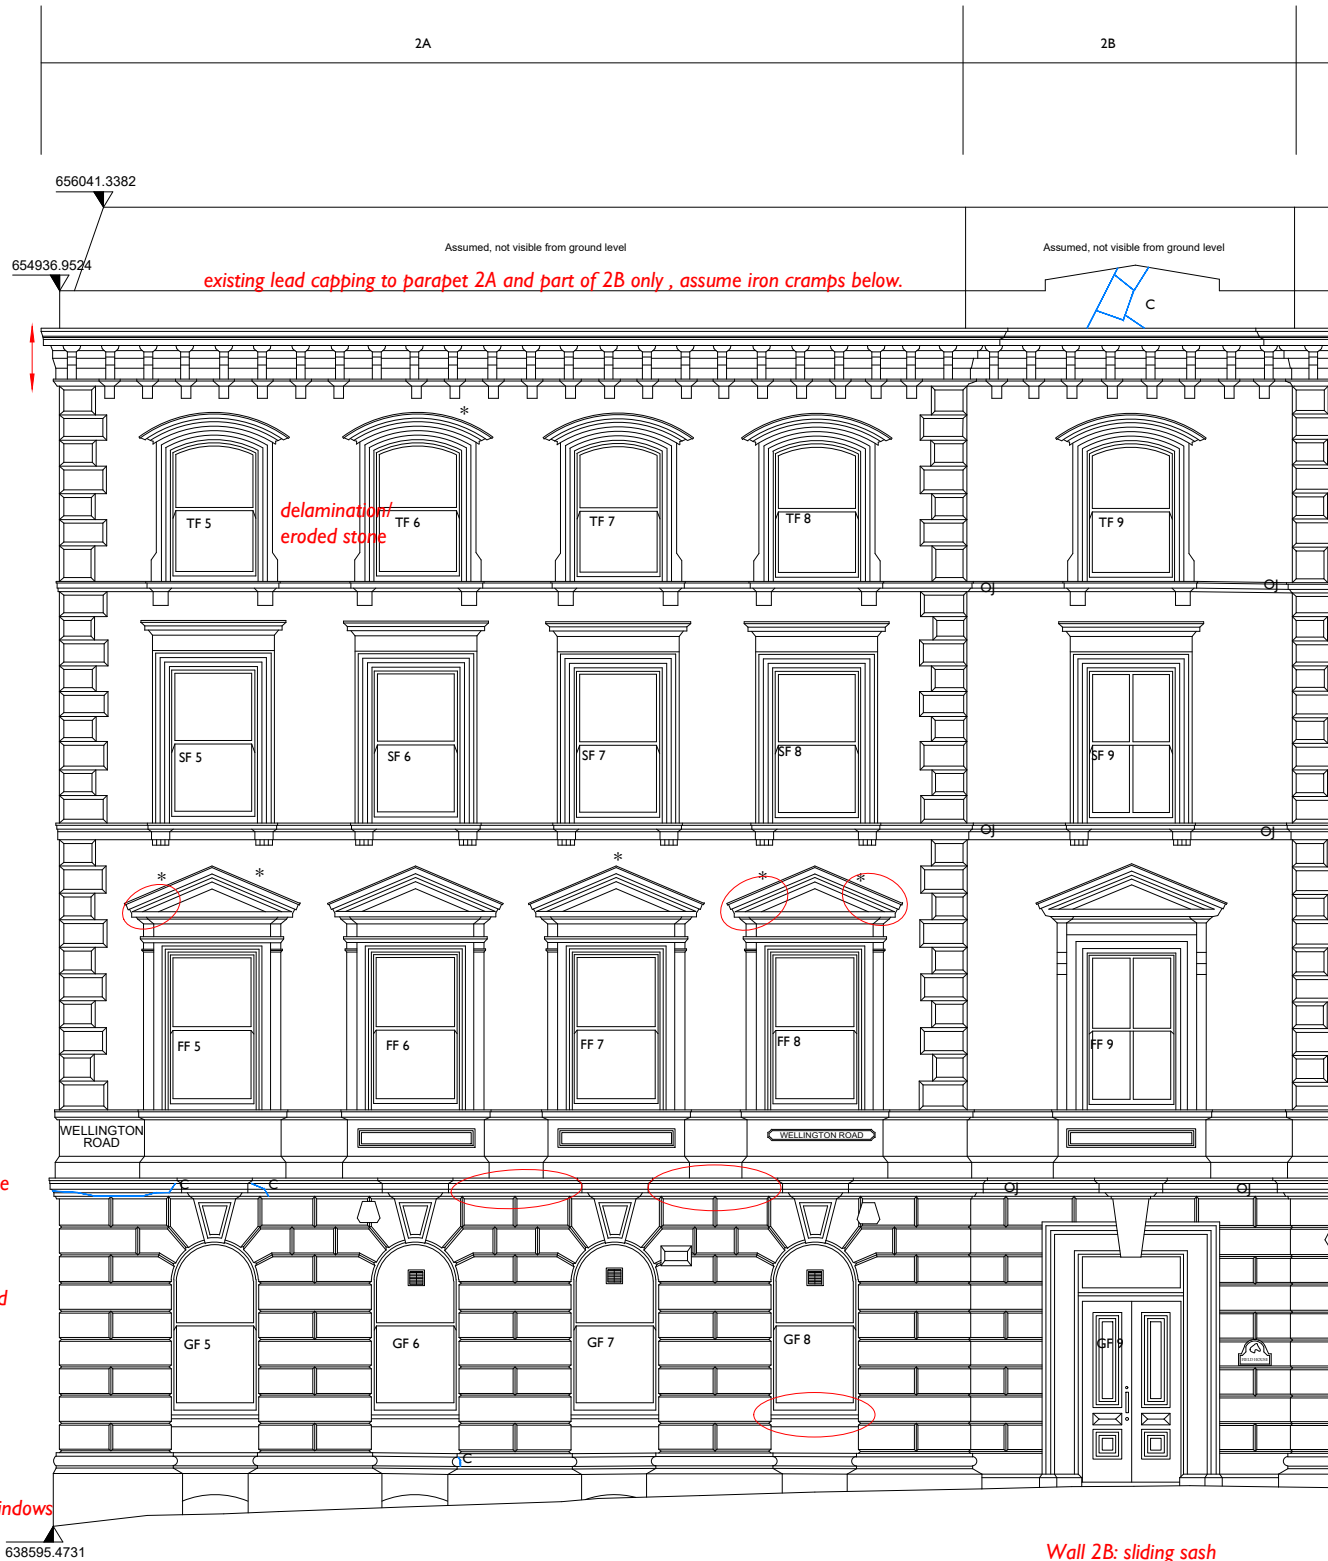
- NOTES**
- corroding iron cramps in parapet stones, resulted in extensive damage.
  - Allow for dismantling and rebuilding parapet with 10% new parapet stones, removal of iron cramps and dowels and replacement with stainless steel fixings
  - delamination to stone cill bands
  - open joints in architraves to third floor windows and eroded/delaminating stonework
  - extensive eroded stonework to stone dressings around and below first floor windows. some open joints
  - delamination/erosion of stonework to first and second floor
  - open joints at ends of GF window cills
  - delamination/erosion of quoins
  - delamination/erosion of stonework below GF windows and to RHS of GF8
  - redundant fixtures and fittings, signage and wiring

- \* corroding iron fixings visible
- missing, damaged or deeply eroded stone
- ⋈ crack
- OJ open joints
- M movement of stone architrave

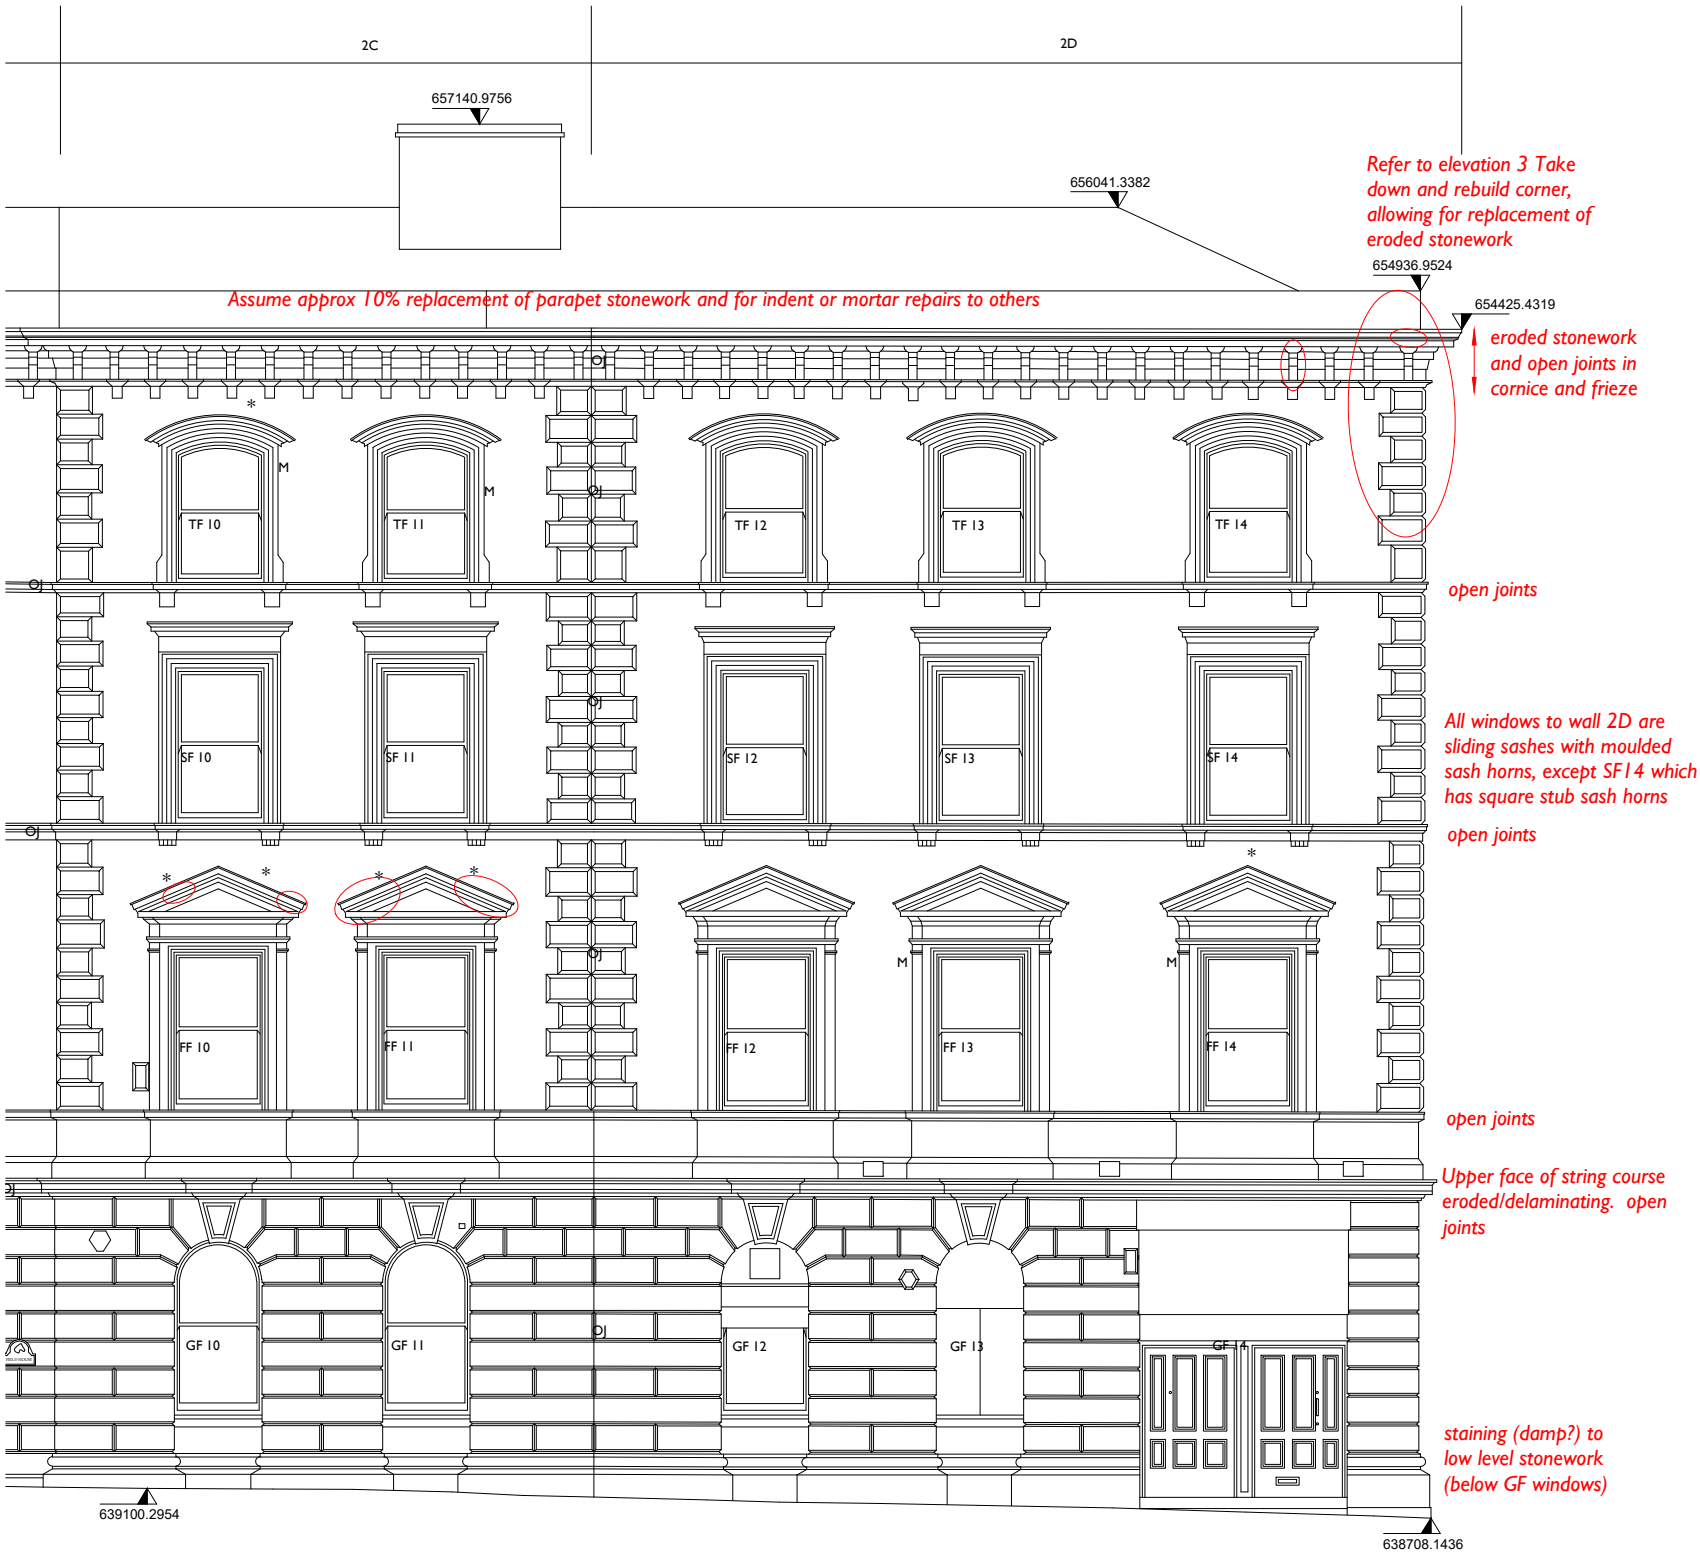
- NOTES**
- corroding iron cramps in parapet stones, resulted in extensive damage.
  - Allow for dismantling and rebuilding parapet with 10% new parapet stones, removal of iron cramps and dowels and replacement with stainless steel fixings
  - delamination to stone cill bands
  - open joints in architraves to third floor windows and eroded/delaminating stonework
  - extensive eroded stonework to stone dressings around and below first floor windows. some open joints
  - delamination/erosion of stonework to first and second floor
  - open joints at ends of GF window cills
  - delamination/erosion of quoins
  - delamination/erosion of stonework below GF windows and to RHS of GF8
  - redundant fixtures and fittings, signage and wiring

- \* corroding iron fixings visible
- missing, damaged or deeply eroded stone
- c crack
- open joints
- M movement of stone architrave

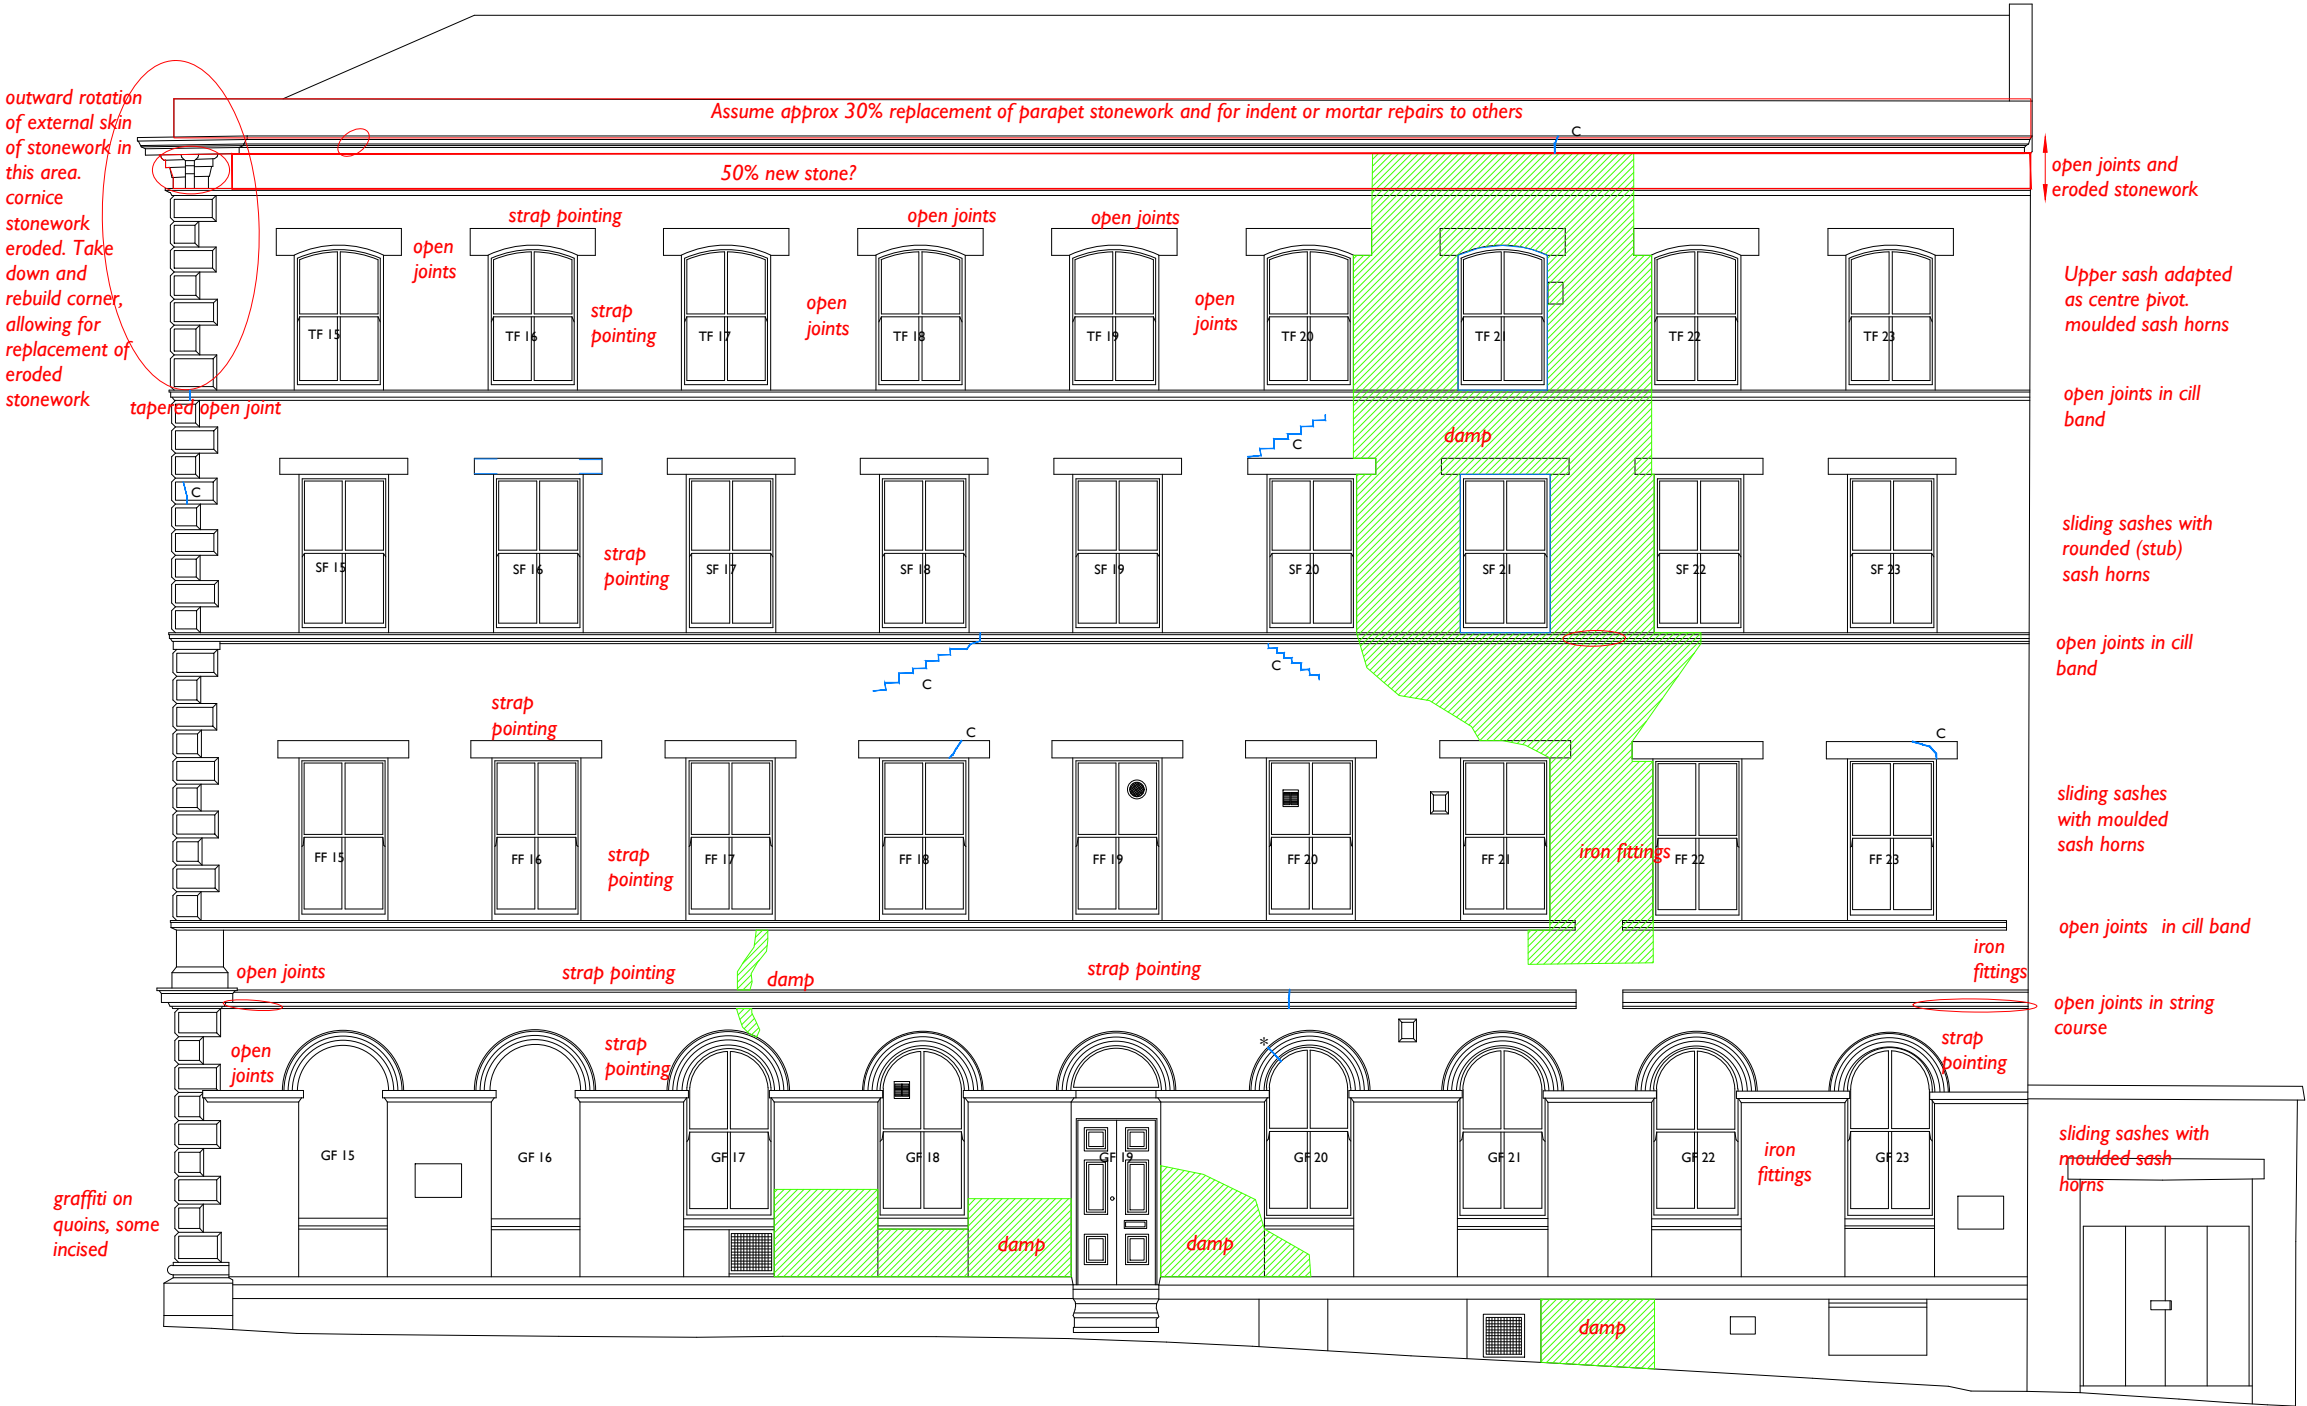
- corroding iron cramps in parapet stones, resulted in extensive damage.
- Allow for dismantling and rebuilding upper section of wall to upper string course, with 30% new parapet stones and 50% new stone below cornice, with removal of iron cramps and dowels and replacement with stainless steel fixings
- Allow for raking out and repointing whole elevation
- extensive delamination to stone cill bands
- redundant fixtures and fittings, signage and wiring

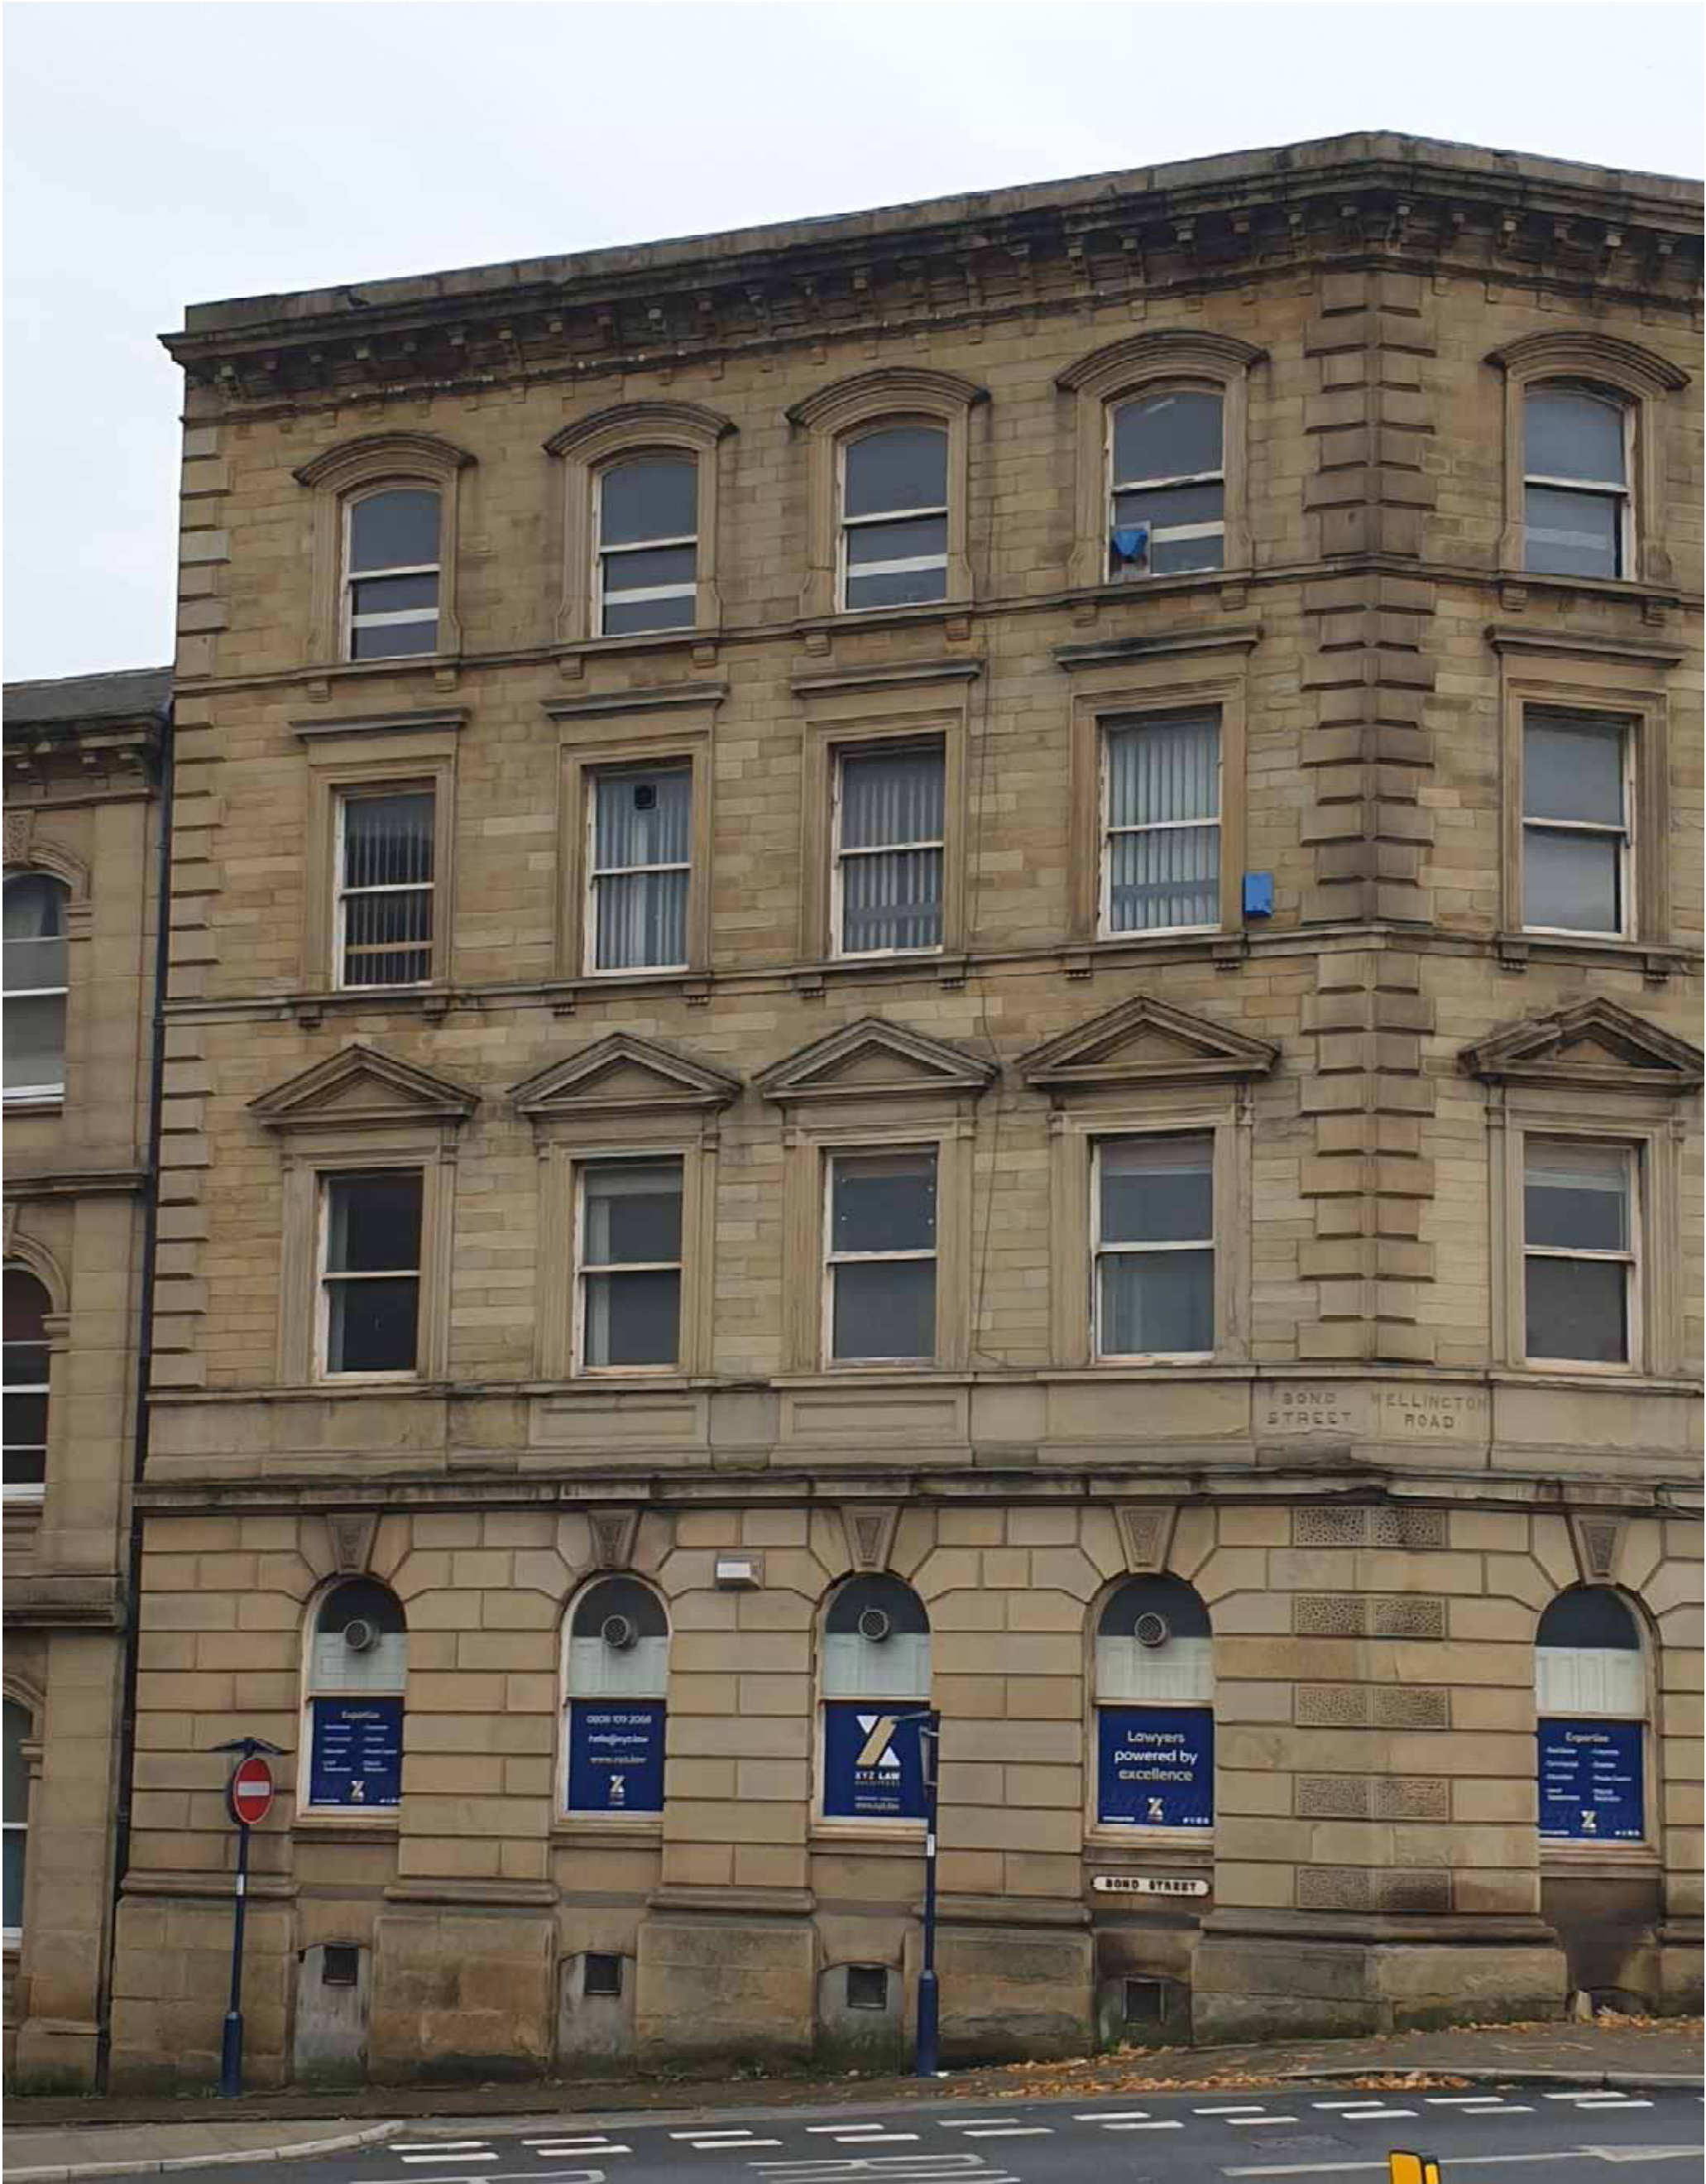
Elevation 2a

| | Description | Condition | Intervention/Repair |
|---|---|---|---|
| <b>ELEVATION 2A</b> | The external appearance of the wall is similar to elevation I. | The stonework to this elevation is poorer condition than the stonework to Elevation I | |
| | | Stonework in frieze is eroded | Mortar repairs or stone replacement will be required. If the parapet has to be rebuilt due to the condition of the inner wall padstones and or the detailing of the new roof then more extensive stone replacement will be required as many stones will not be suitable for re-use if the wall is dismantled. |
| | | Along the top of the wall all the cramps which join the parapet stones together are in poor condition. A lead capping has been laid over the top of the parapet | |
| | | Some 70% of parapet stonework above the cornice level will require repair. Perhaps 10% of the stone will require replacement. | These figures are approximate and will only be known fully once the parapet is taken apart. They relate to the entire parapet to elevations 2A through to 2D |

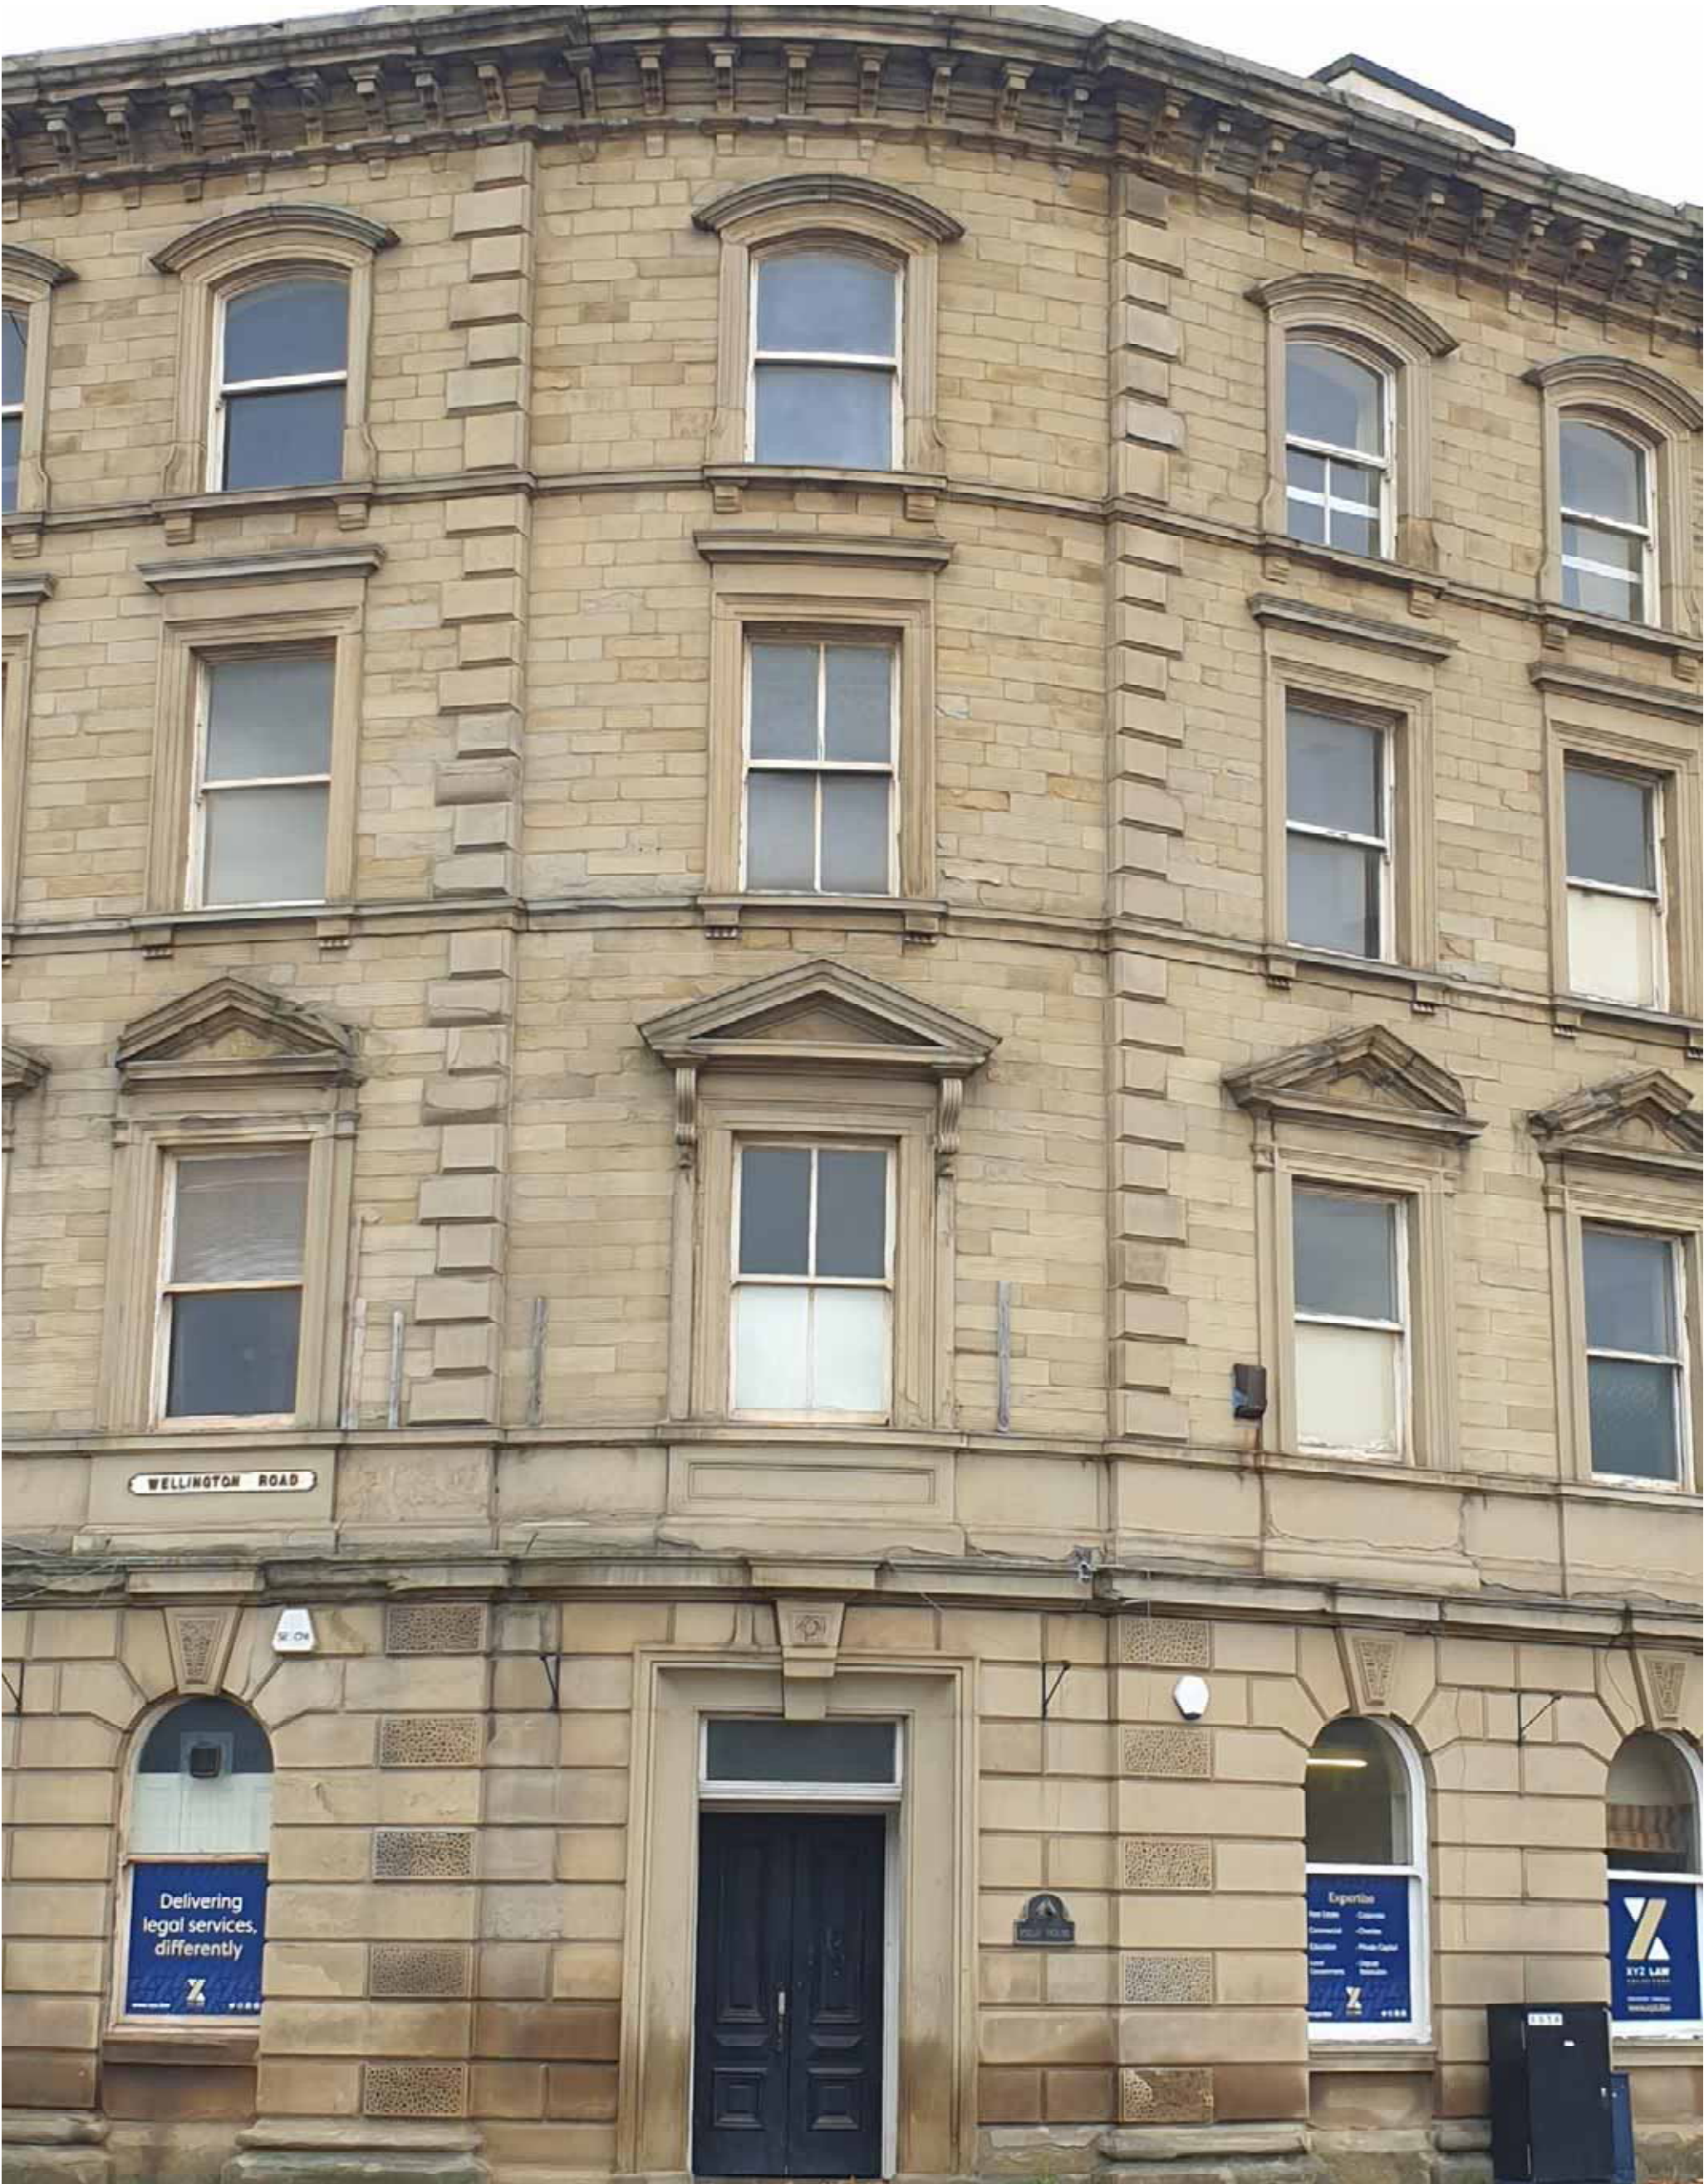
Elevation 2 c

| | Description | Condition | Intervention/Repair |
|---|---|---|---|
| <b>ELEVATION 2C</b> | Similar to Elevations 1, 2A and 2B | In a similar condition to elevation 2A | |
| | | The condition of the stonework to the parapet is poor with rusting cramps and split stones. | Replacement stainless steel cramps are required together with repair or replacement of damaged stones. |
| | | Stonework in frieze is eroded | Mortar repairs or stone replacement will be required. If the parapet has to be rebuilt due to the condition of the inner wall padstones and or the detailing of the new roof then more extensive stone replacement will be required as many stones will not be suitable for re-use if the wall is dismantled. |
| | | At least 2 of the window architraves appear to have moved outwards and these need further assessment | Structural Engineer to inspect. Allow for pinning architraves with stainless steel fixings |
| | | The first floor window pediments are severely damaged by rusting cramps which have shattered the stonework | Replace corroding cramps with stainless steel fixings and replace damaged/missing areas of stone |
