Gas Membrane Installation  
Validation Report  
Myra Homes  
120 Laund Road  
Huddersfield  
Salendine Nook  
HD3 3TY  
Plot 5

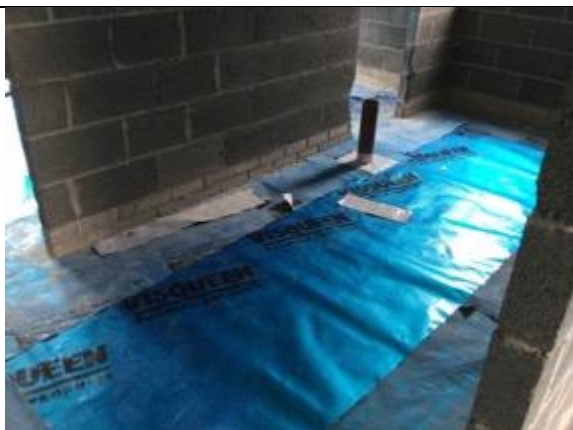
Plot 5 infill.

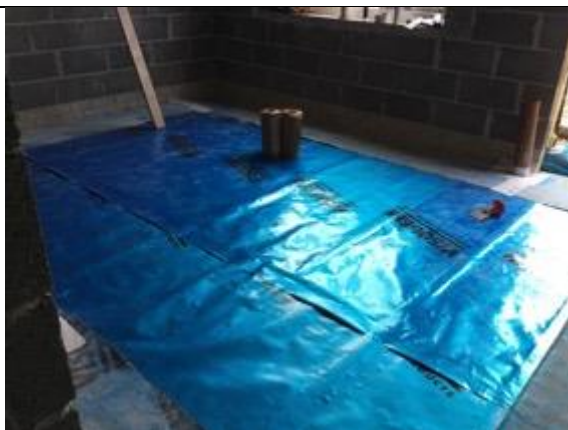
Overview to Plot 5 infill.

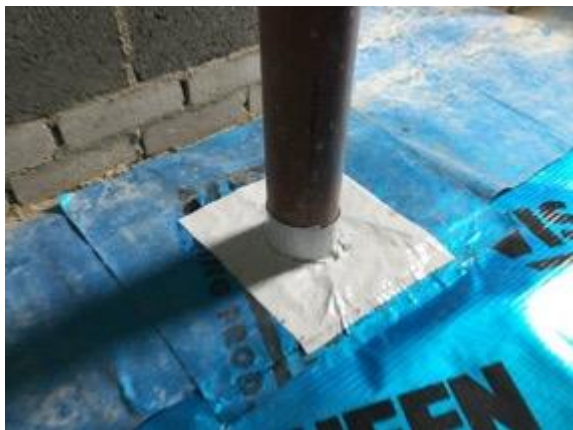
Sealed pipe using SAGM to Plot 5.

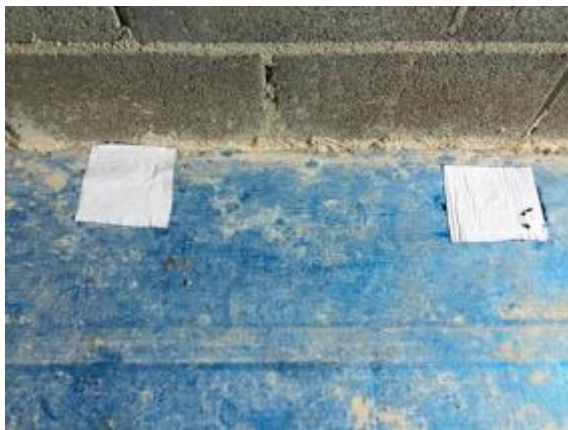
SAGM patches applied within Plot 5.
