Gas Membrane Installation  
Validation Report  
Myra Homes  
120 Laund Road  
Huddersfield  
Salendine Nook  
HD3 3TY  
Plot 6

**Photographs 08/06/2022**

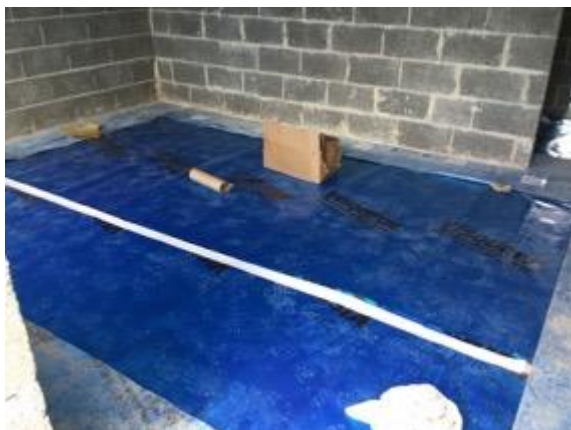
Overview to Plot 6 infill.

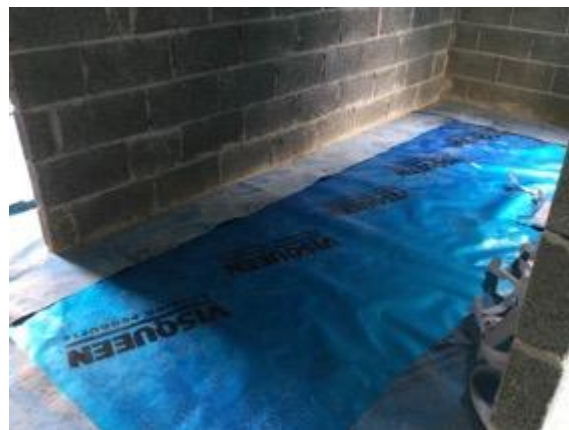
Plot 6 infill.

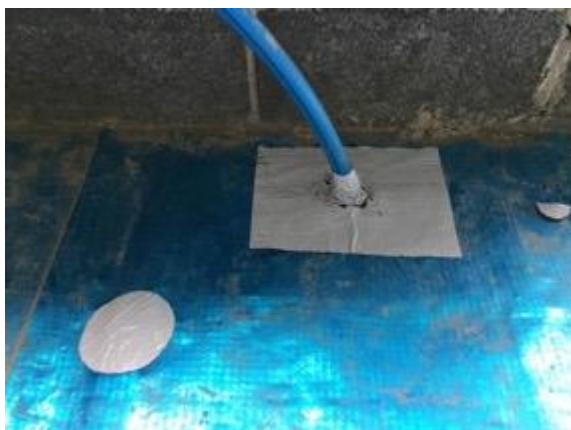
Water pipe sealed with SAGM.

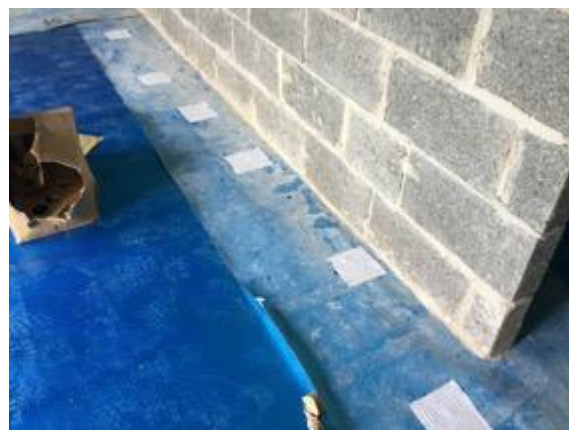
Overview showing the SAGM patches applied within Plot 6

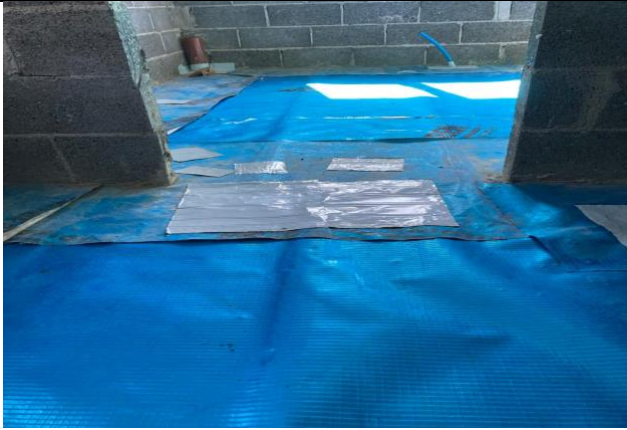
Patch Repair Entrance to Kitchen
