Client
 R Smith
 Project
 13 CUCKOO LANE
 HONLEY

PROPOSED STRUCTURAL REMEDIAL DETAILS FLOOR PLANS

Project and Drg No.	Rev
21_188_001	P2

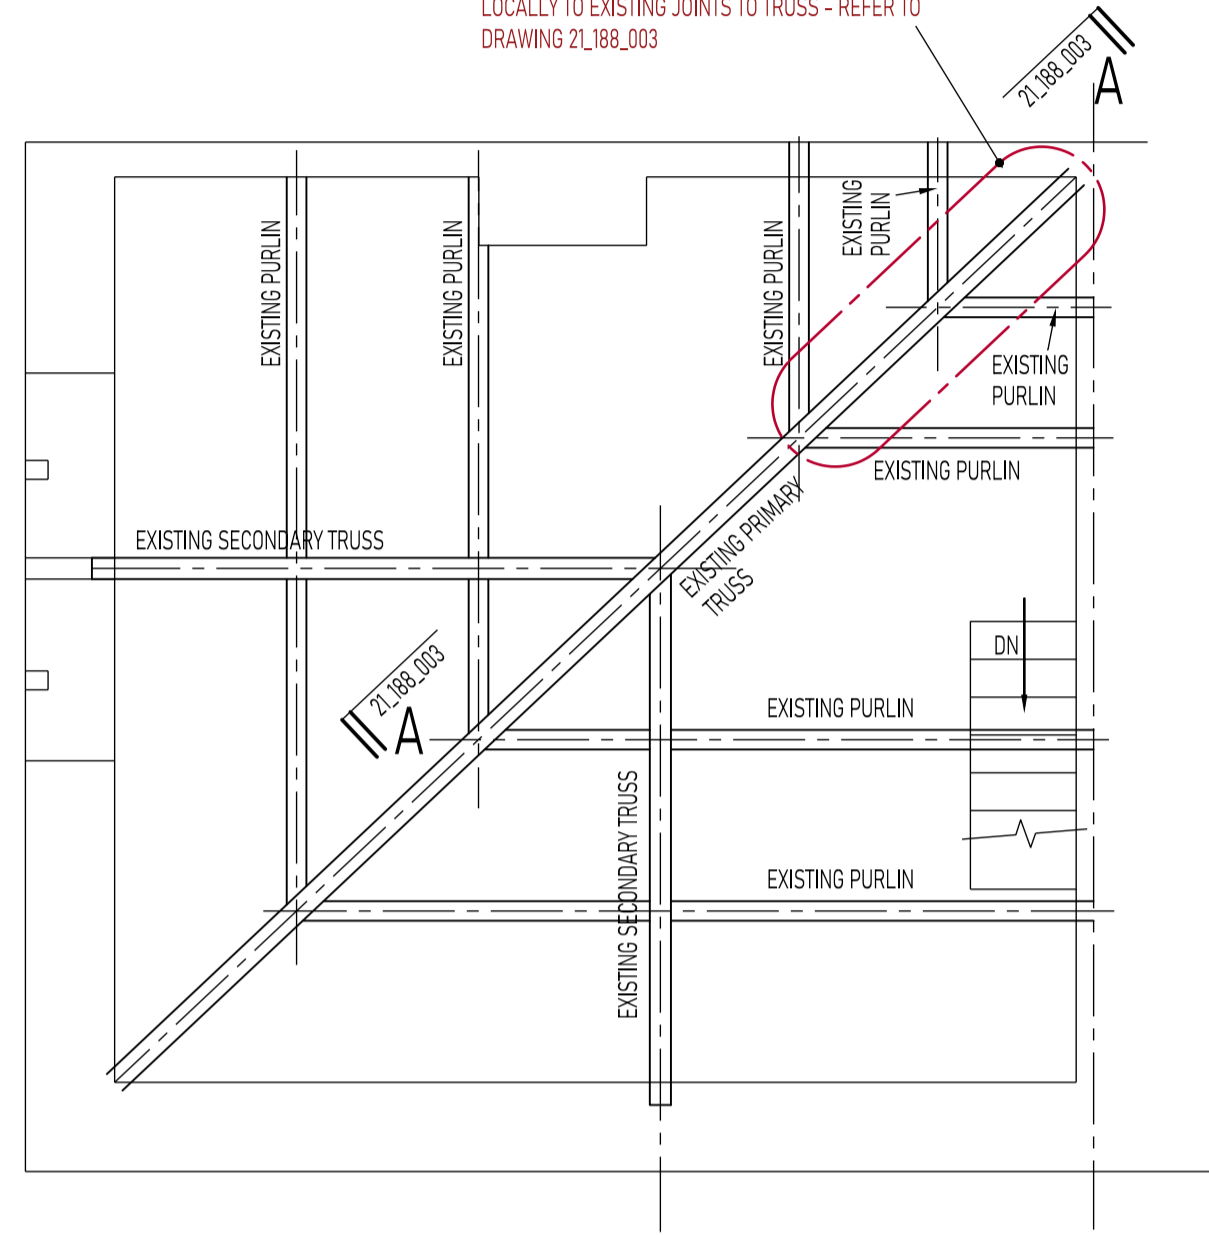
ATTIC FLOOR PLAN SHOWING STRUCTURE OVER

EXISTING TRUSS MEMBERS HAVE LOCALLY SUFFERED FROM DECAY AND WOOD BORING INSECT ATTACK AROUND HEEL JOINT, TENON JOINTS BETWEEN INTERNAL STRUTS, POSTS AND RAFTERS HAVE LOCALLY OPENED UP.
 STRUCTURAL REMEDIAL REPAIR TO BE CARRIED OUT LOCALLY TO EXISTING JOINTS TO TRUSS - REFER TO DRAWING 21_188_003

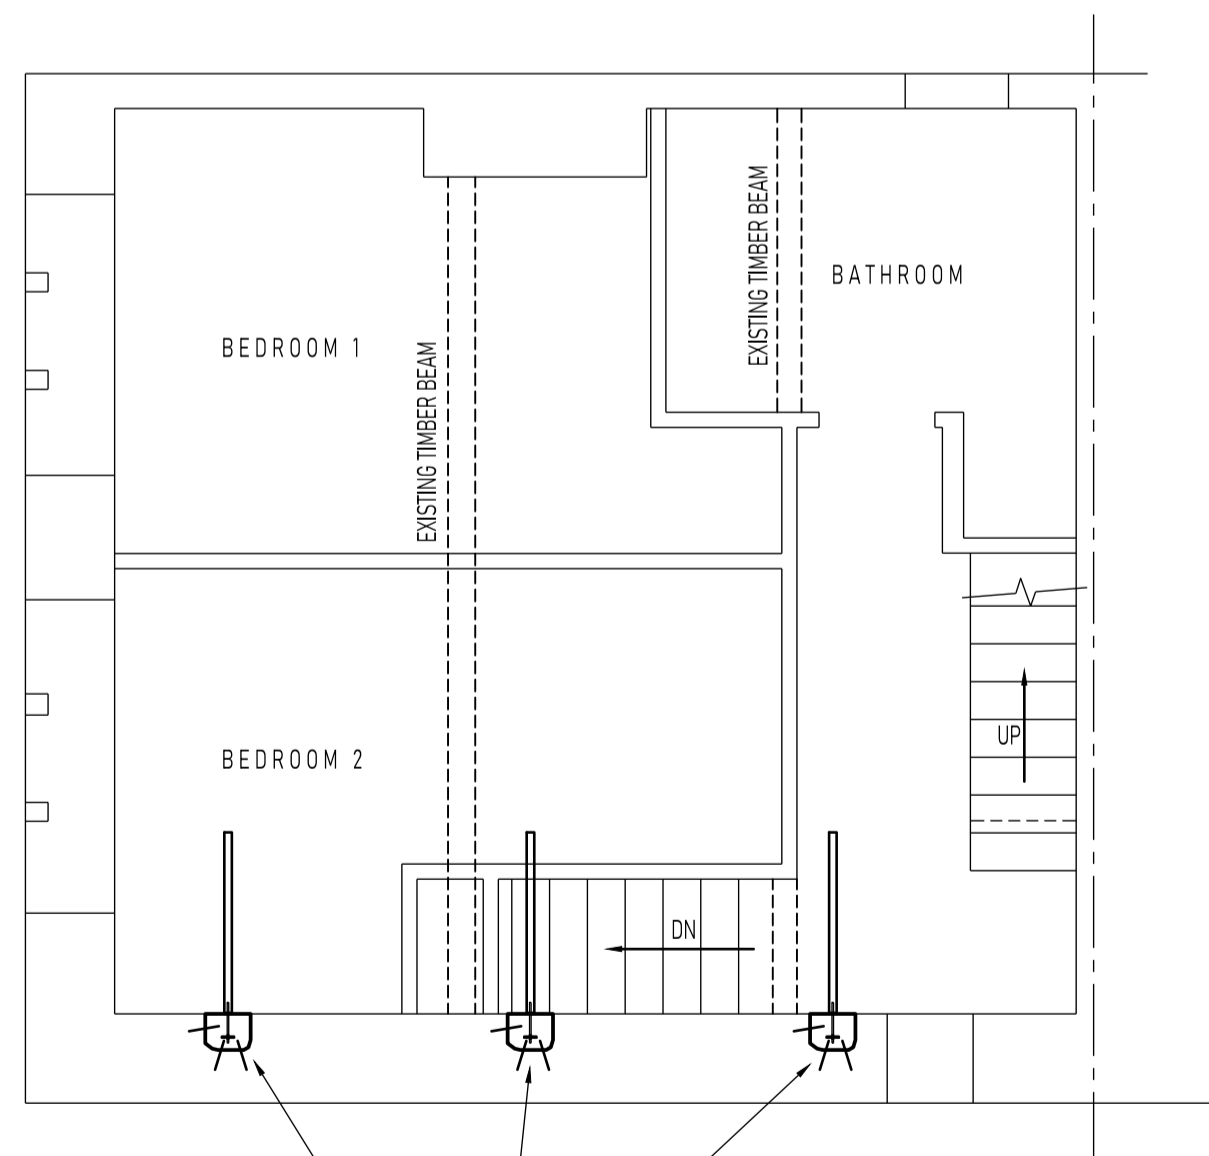
FIRST FLOOR PLAN SHOWING STRUCTURE OVER

REMEDIAL ANCHOR BLOCKS AND RESTRAINT STRAPS TO BE INSTALLED AT FIRST AND ATTIC FLOOR LEVELS. (ATTIC FLOOR LEVEL STRAPS, OVER, SHOWN ON THIS PLAN) REFER TO DETAIL 1, DRAWING 21_086_002

NOTE
 EXISTING FITTED WARDROBES AT ATTIC FLOOR LEVEL WILL REQUIRE TEMPORARY, CAREFUL, REMOVAL TO ALLOW FOR INSTALLATION OF ANCHOR BLOCKS. EXISTING WARDROBES TO BE REINSTATED UPON COMPLETION

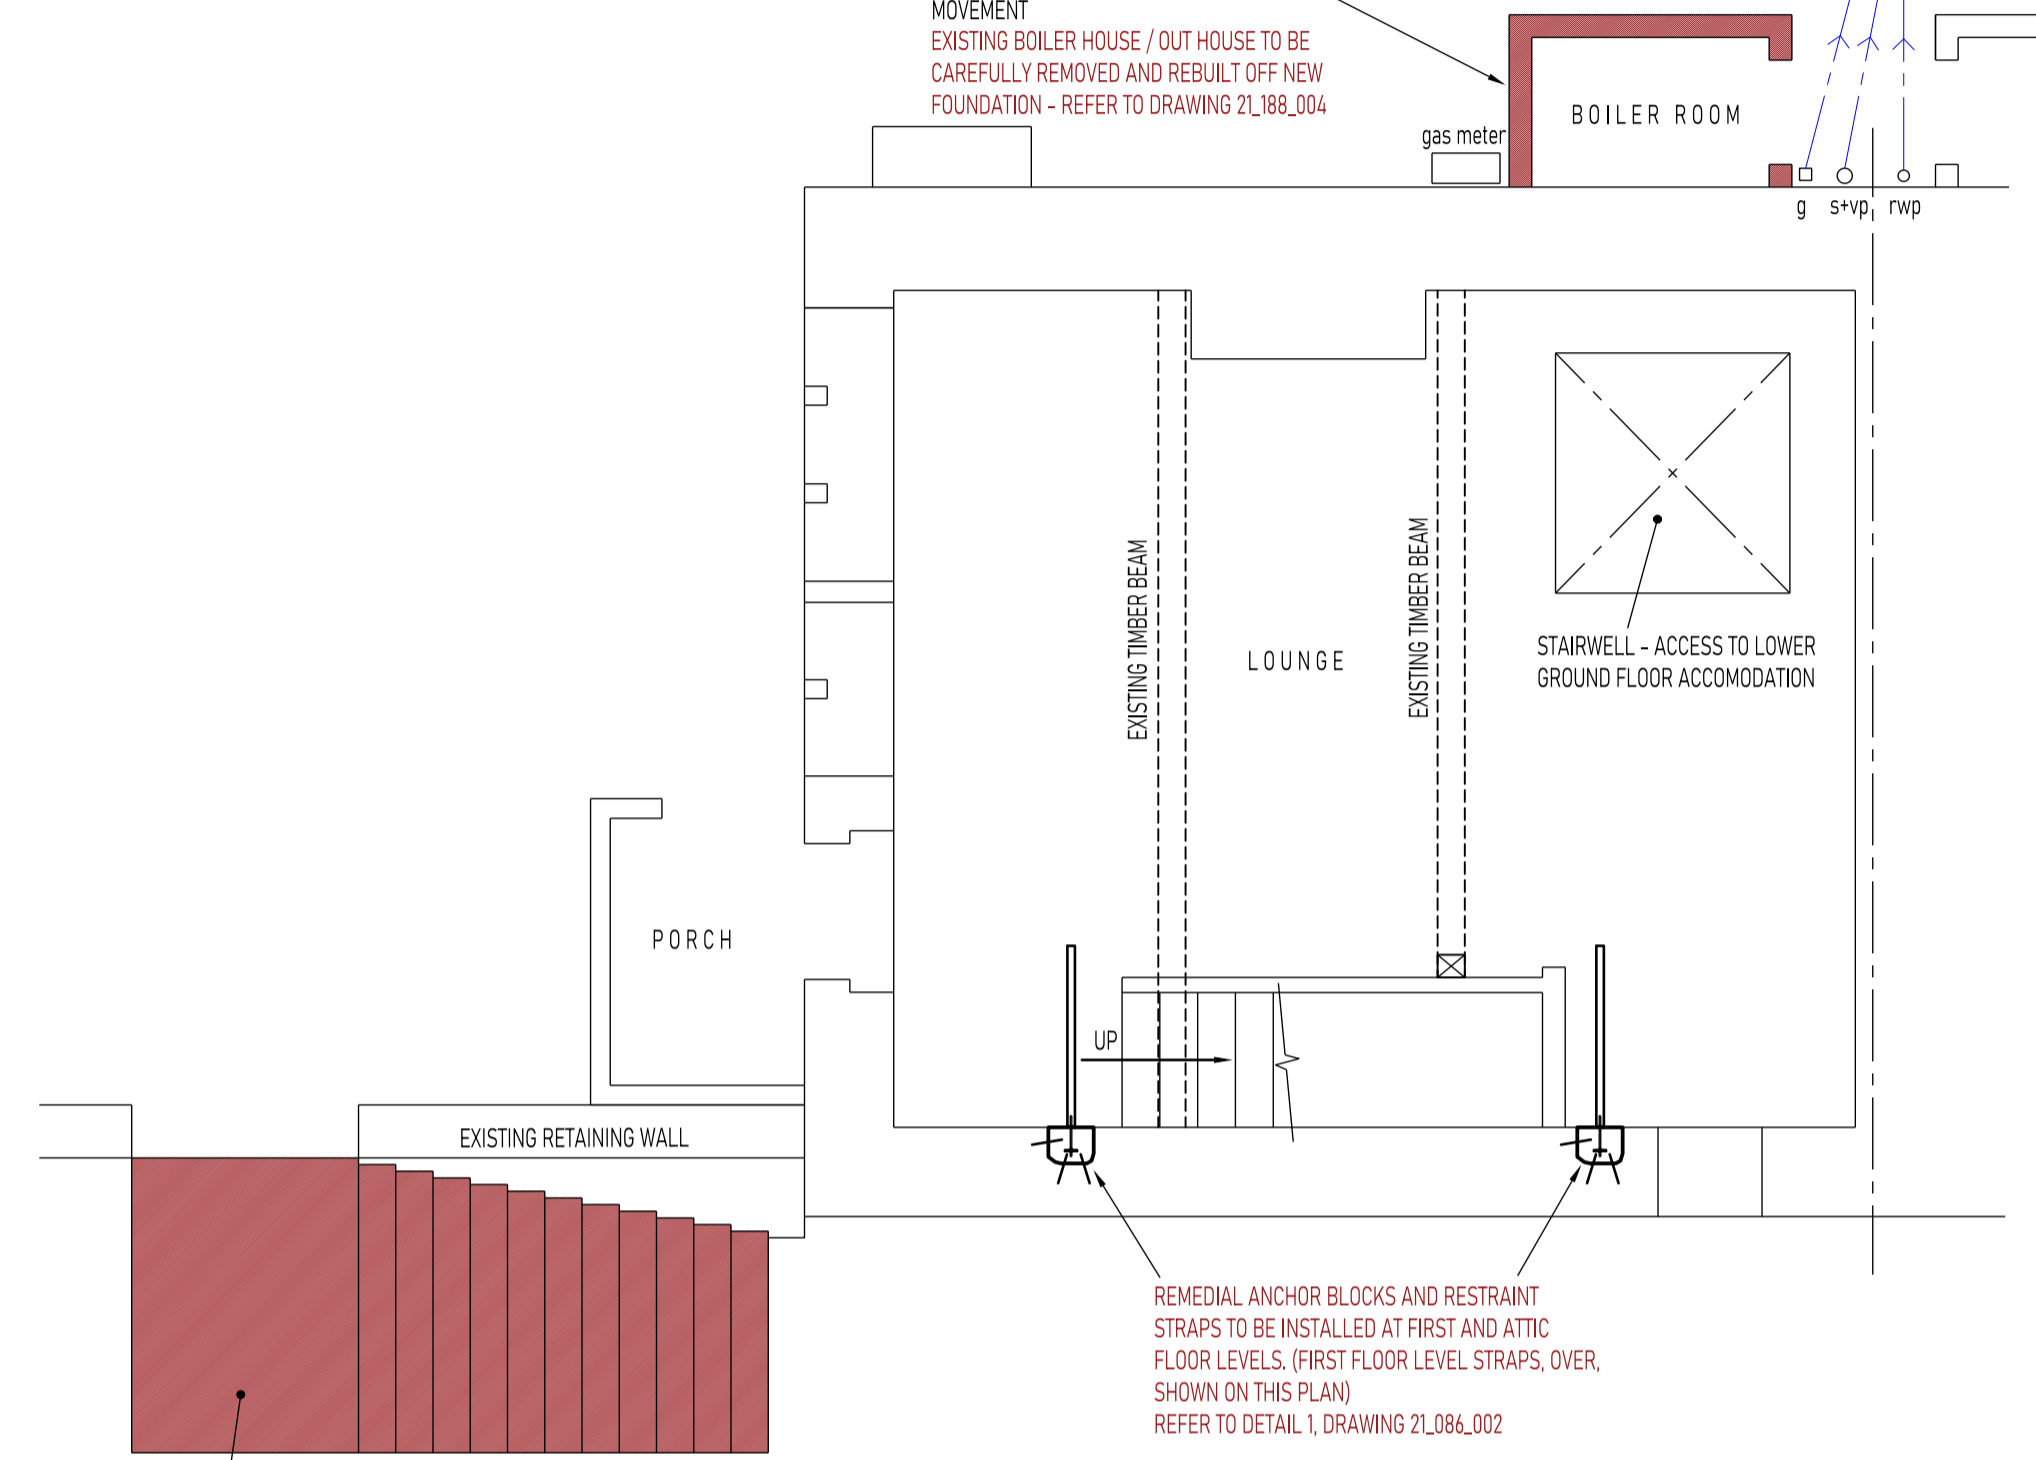
UPPER GROUND FLOOR PLAN SHOWING STRUCTURE OVER

CUCKOO LANE
 EXISTING BOUNDARY RETAINING WALL
 NOTE
 CCTV SURVEY SHOWS EXISTING DRAIN HAS BEEN CRUDELY TERMINATED WITH BRICK INSERTED IN PIPE END
 EXISTING PIPE TO BE CAREFULLY EXPOSED AND CAPPED OFF AT JUNCTION WITH MANHOLE
 EXISTING BOILER HOUSE / OUT HOUSE HAS SIGNIFICANT STRUCTURAL MOVEMENT AND EVIDENCE OF SIGNIFICANT FOUNDATION MOVEMENT
 EXISTING BOILER HOUSE / OUT HOUSE TO BE CAREFULLY REMOVED AND REBUILT OFF NEW FOUNDATION - REFER TO DRAWING 21_188_004

REMEDIAL ANCHOR BLOCKS AND RESTRAINT STRAPS TO BE INSTALLED AT FIRST AND ATTIC FLOOR LEVELS. (FIRST FLOOR LEVEL STRAPS, OVER, SHOWN ON THIS PLAN) REFER TO DETAIL 1, DRAWING 21_086_002

EXISTING STONE BUILT EXTERNAL STAIR (MODERN ADDITION) IS FAILING AND SUFFERING FROM SIGNIFICANT LATERAL MOVEMENT. STONE FLAGS TO LANDING HAVE SIGNIFICANT SETTLEMENT AND DISPLACEMENT.
 EXISTING STEPS, RETAINING WALL SUPPORTING STEPS AND INFILL TO BE CAREFULLY REMOVED AND REPLACED WITH NEW LIGHTWEIGHT STAIRS - REFER TO DRAWING 21_188_005

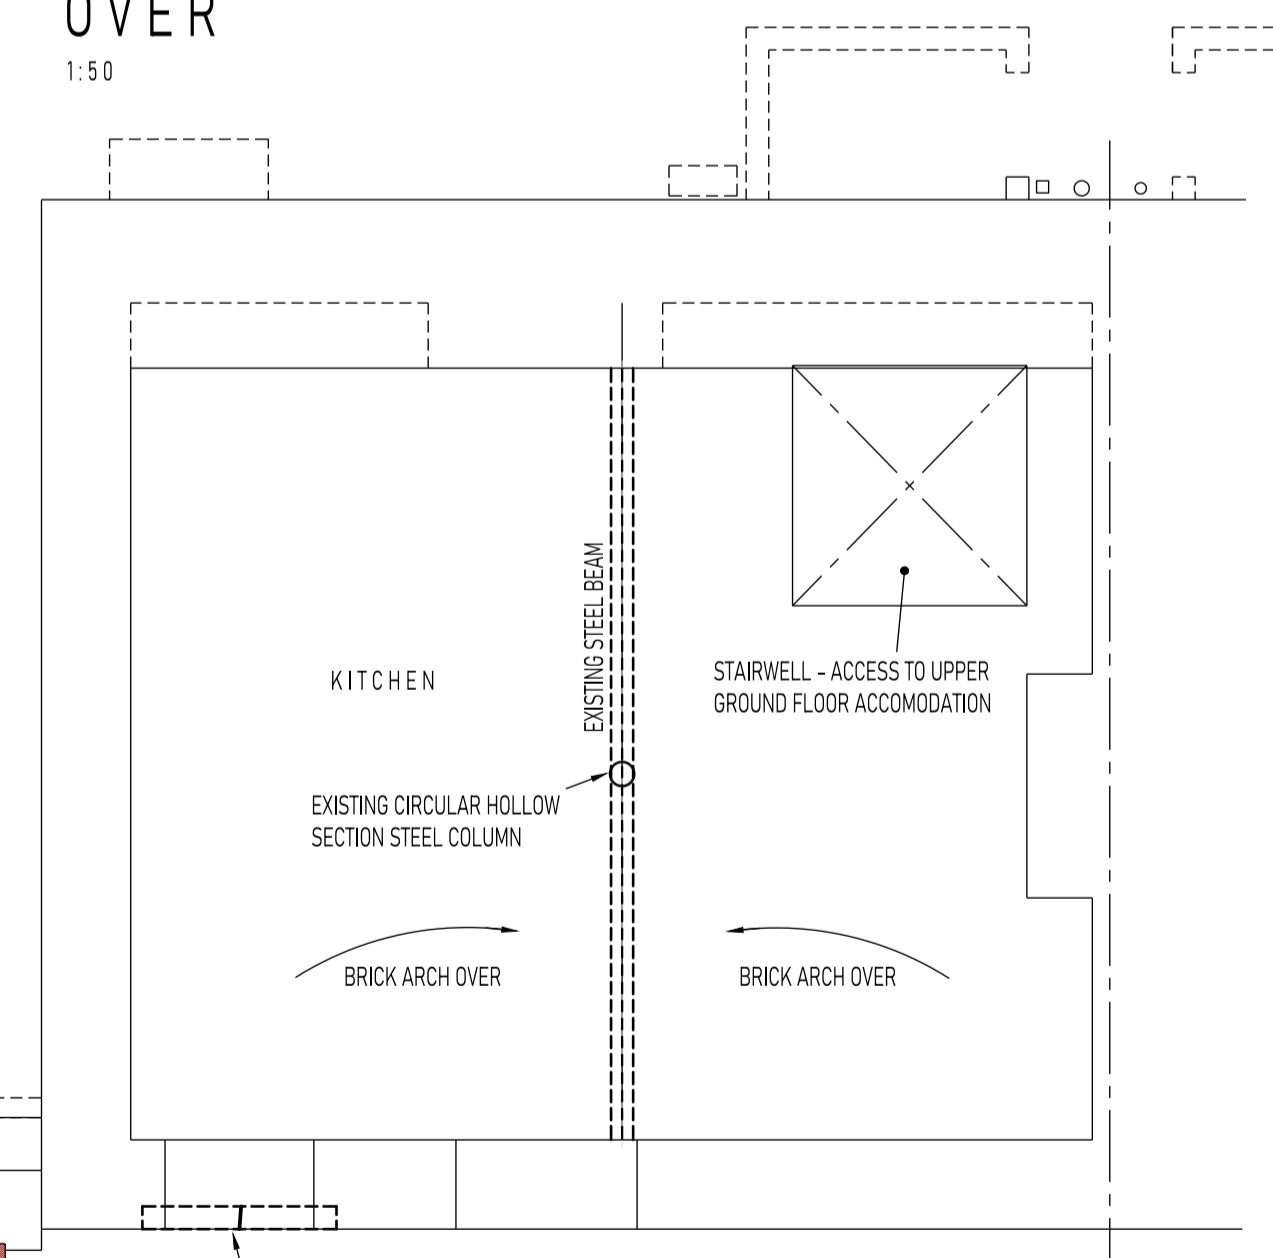
LOWER GROUND FLOOR PLAN SHOWING STRUCTURE OVER

COMPLETE FRACTURE TO EXISTING STONE HEAD ABOVE DOOR WAY (CURRENTLY COVERED BY RENDER) EXISTING WALL TO BE TEMPORARILY NEEDED AND PROPPED, EXISTING STONE HEAD TO BE CAREFULLY REMOVED AND REPLACED WITH NAYLOR R6 HI-SPEC PRECAST CONCRETE LINTEL
 NEW LINTEL TO BE COVERED IN REPLACEMENT RENDER TO REAR ELEVATION

EXISTING STONE BUILT EXTERNAL STAIR (MODERN ADDITION) IS FAILING AND SUFFERING FROM SIGNIFICANT LATERAL MOVEMENT. STONE FLAGS TO LANDING HAVE SIGNIFICANT SETTLEMENT AND DISPLACEMENT.
 EXISTING STEPS, RETAINING WALL SUPPORTING STEPS AND INFILL TO BE CAREFULLY REMOVED AND REPLACED WITH NEW LIGHTWEIGHT STAIRS - REFER TO DRAWING 21_188_005
