Design, Access and Heritage Statement

Address: 13 Cuckoo Lane, Honley, HD9 6AS

Application Number: PP-1150 9186

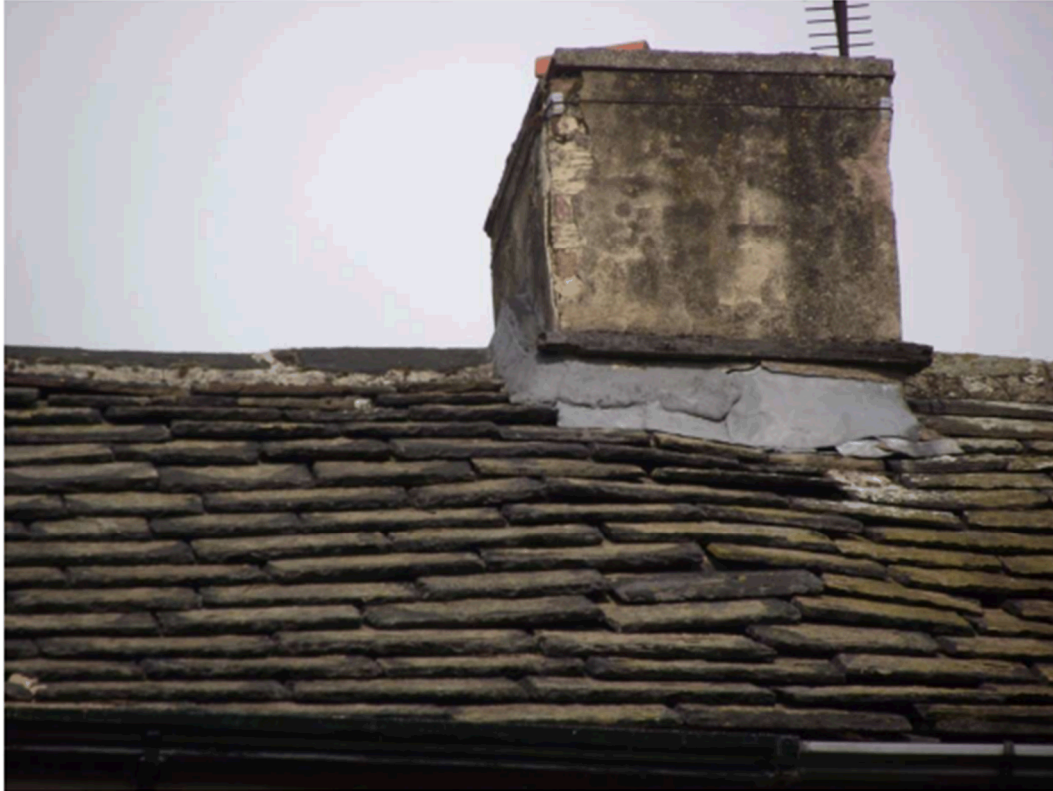
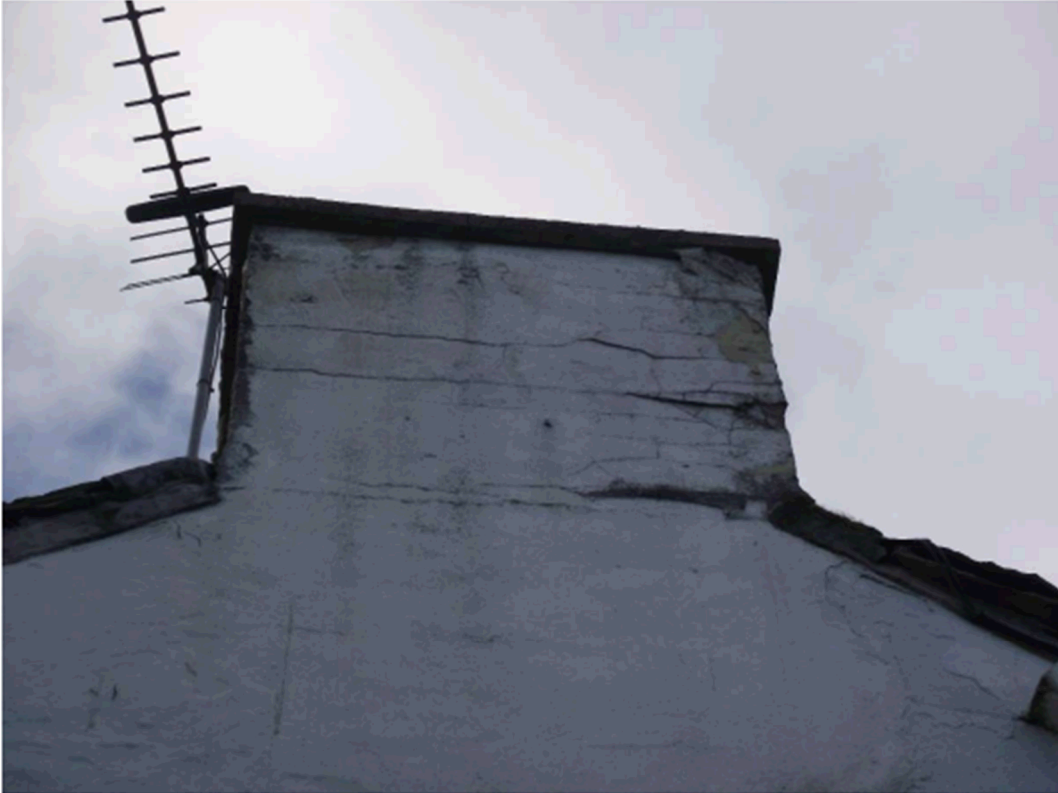
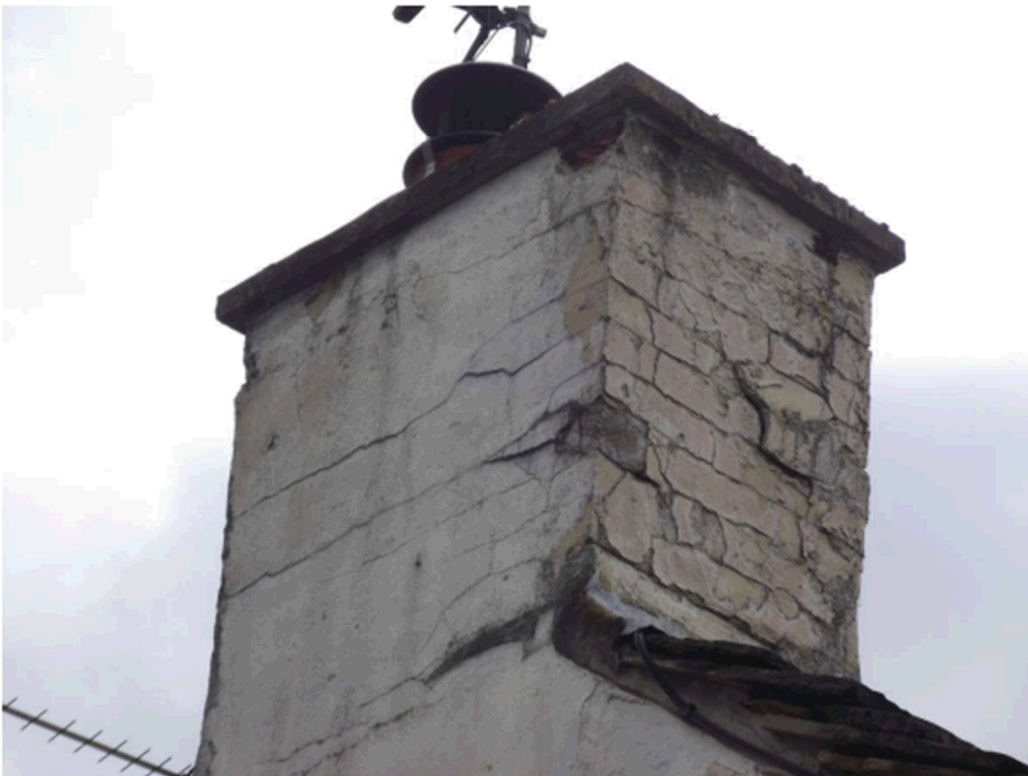
The chimneys to the front elevation and party wall both need remedial repair. It appears that the stack to the front elevation will require rebuilding due to the displaced masonry to the side and rear faces of the chimney. It appears that the stack to the party wall will require re-

rending and replacement of flashings as a minimum, but further assessment will be necessary when high level access is available to allow close inspection. Closer inspection of roof coverings, particularly those to the rear slope, should be carried out whilst high level access is available to carry out chimney repairs.

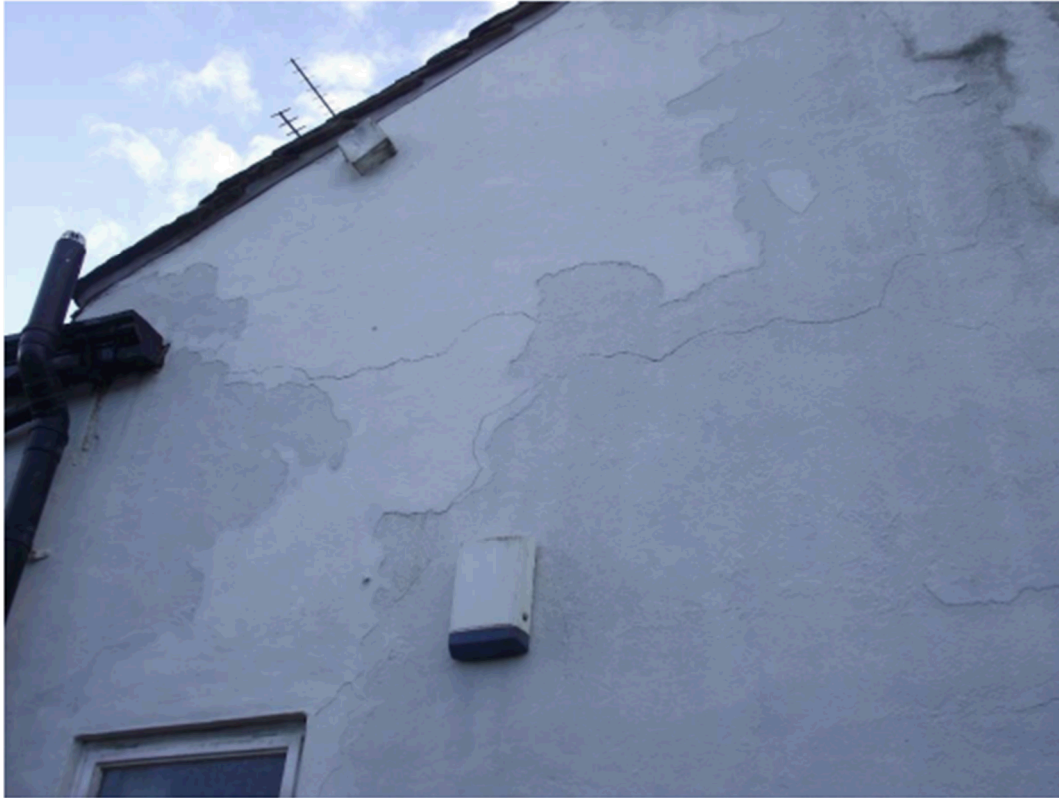
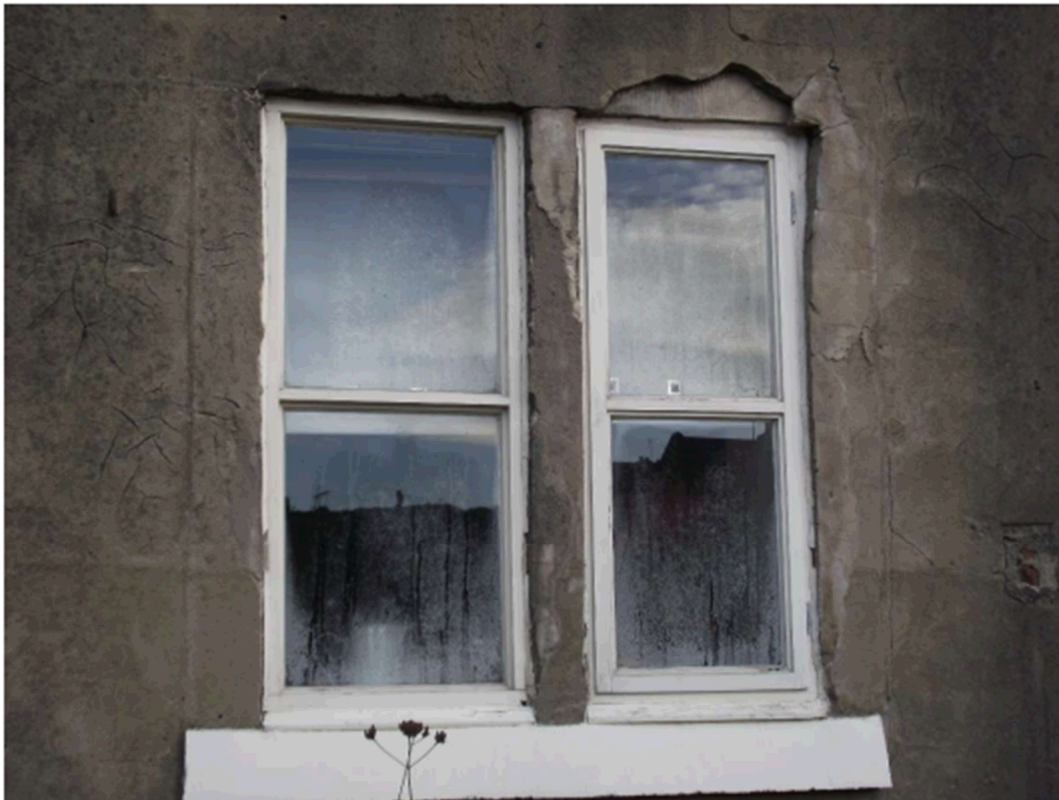
Render coverings to the front and rear elevation are suffering from random cracking and will require replacement in the medium term.

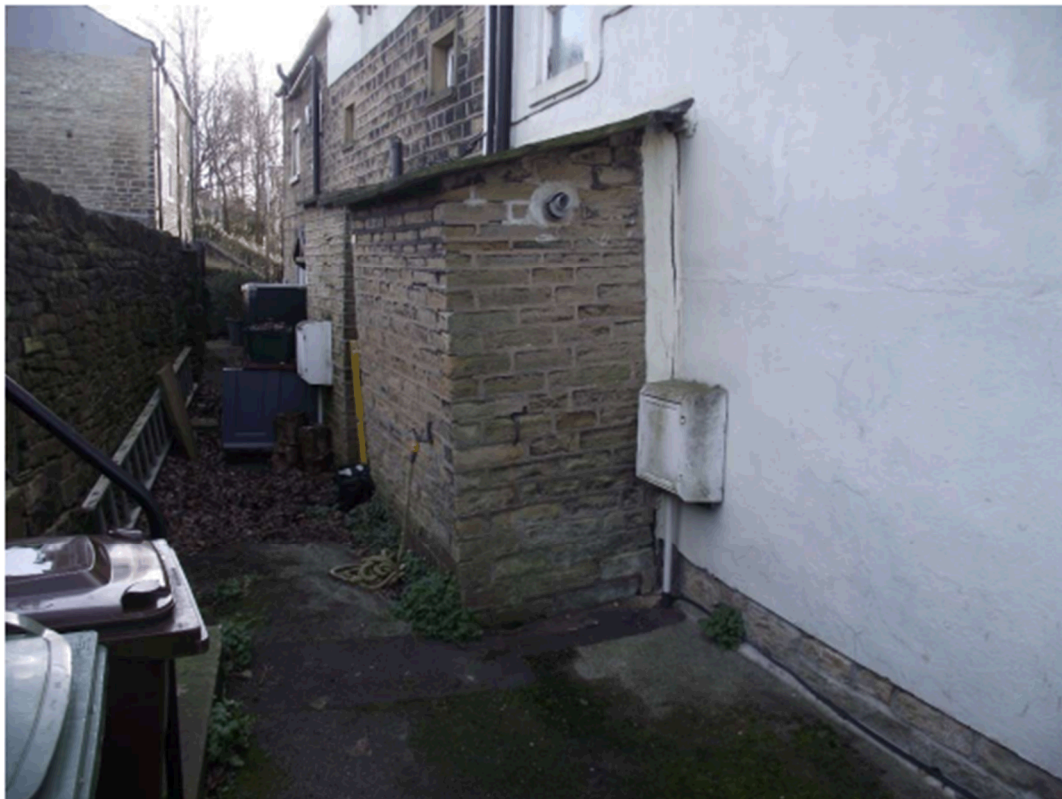
The subsidence and associated defect/damage to the boiler room to the front elevation of the property is significant and rebuilding of the external room will be necessary, subject to necessary listed building consent. The subsidence and movement to the single storey

outbuilding is clearly of longstanding, but there has been recent and continued movement of the room evidenced through the opening of infilled mortar joints between the side walls and the gable wall to the front of the dwelling. Foundation movement is likely to be due, at least in part, to foundations being constructed off made ground to the rear of the retaining wall to the front of the dwelling to form the lower ground and ground floor accommodation. The intention is to move the boiler inside and therefore making the outhouse redundant.

Carry out trial hole investigation to determine existing foundation construction, founding depth and ground conditions to help provide further comment on the likelihood of excavation of service trenches undermining existing foundations and help prepare designs for replacement foundations.

Removal and possible rebuilding the single storey boiler room will require listed building consent. The rebuilding of the boiler room is likely to require minipile foundations to allow for building above the made ground to the rear of the retaining wall. Consideration may be given to relocating the boiler to within the existing dwelling and removing the boiler room completely (without rebuilding) as a possibly more cost effective solution - again, this would be subject to necessary listed building consents.

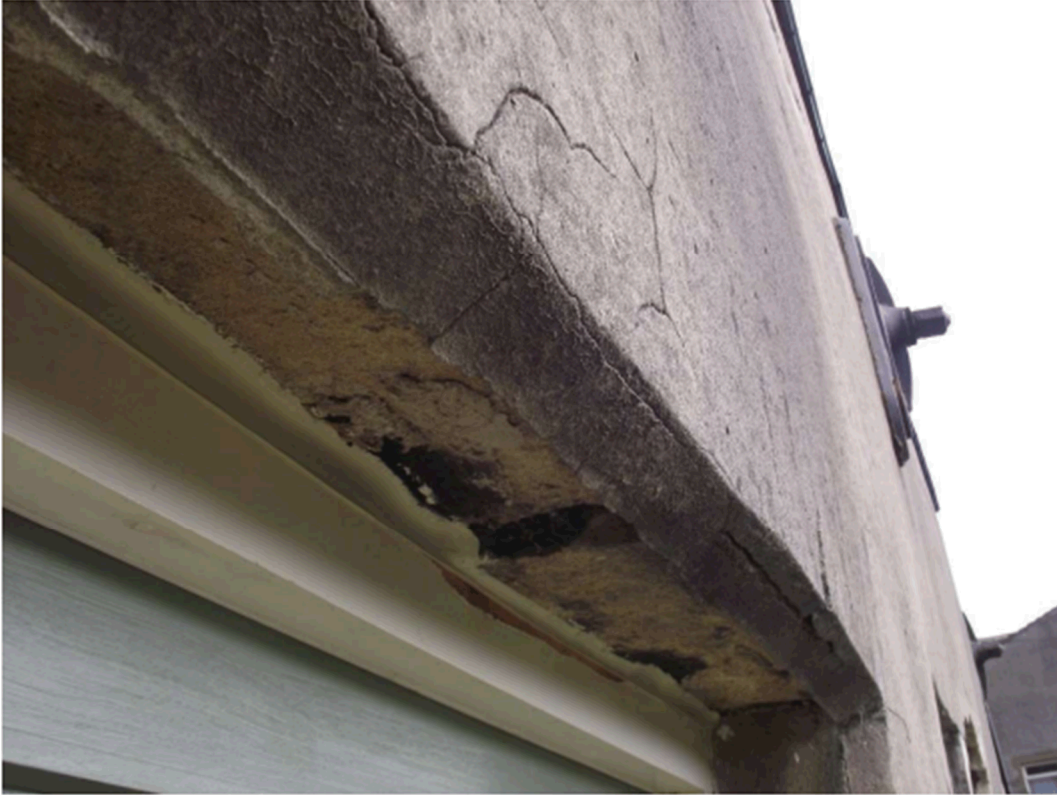
The fractured window head above the door to the rear elevation will require replacement, again subject to necessary listed building consent.

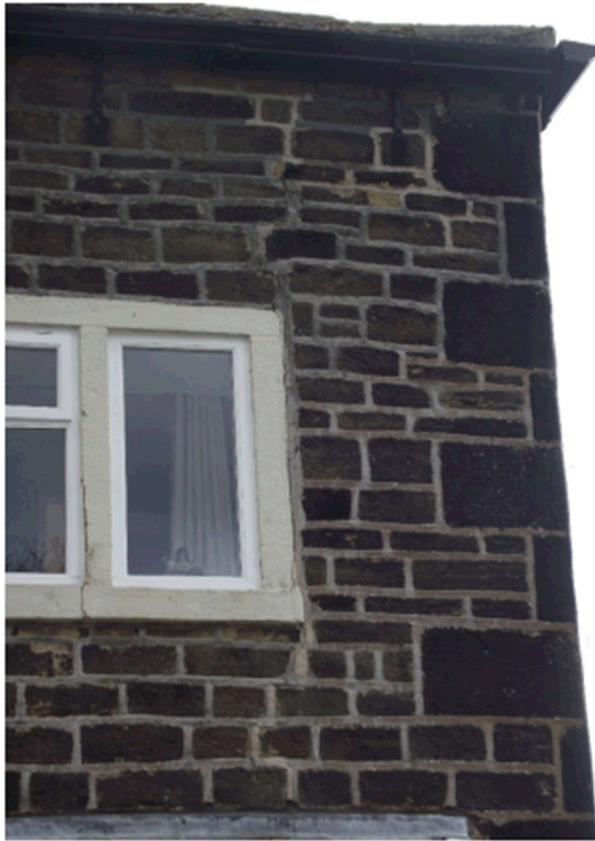
The vertical cracking to the side of the rear window reveal to the right elevation

This should be repointed with a relatively weak lime mortar following the completion of remedial strapping details as described above

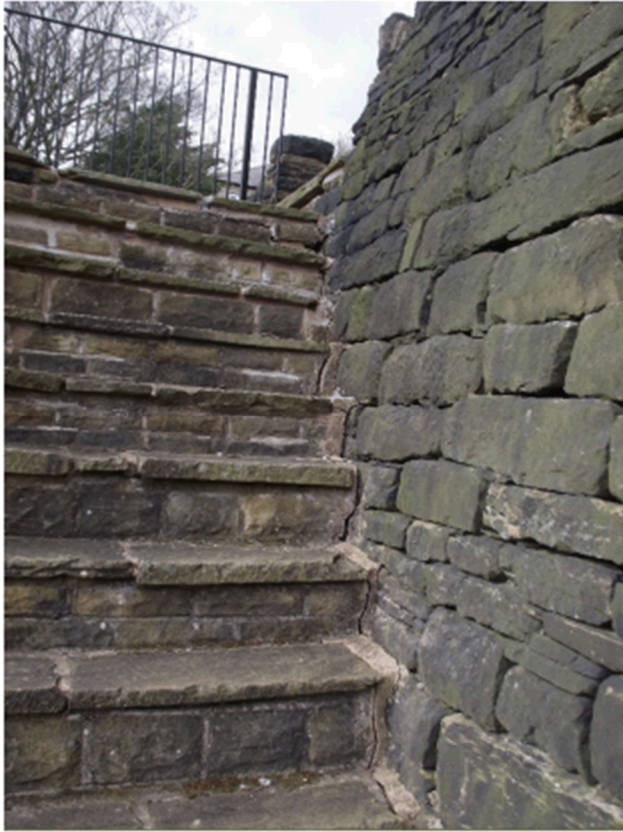
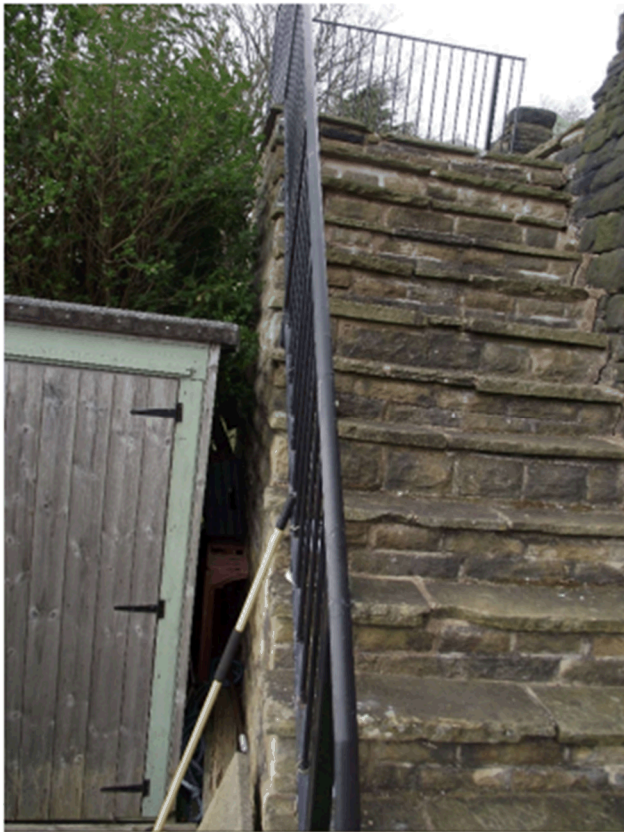
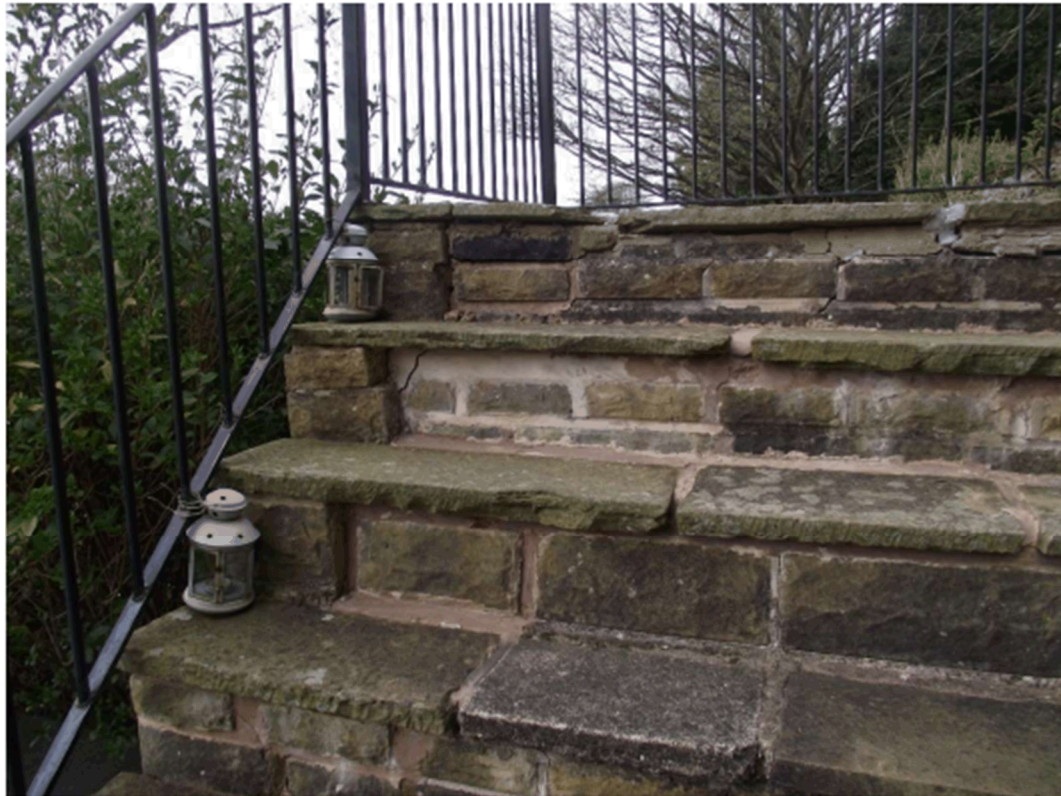
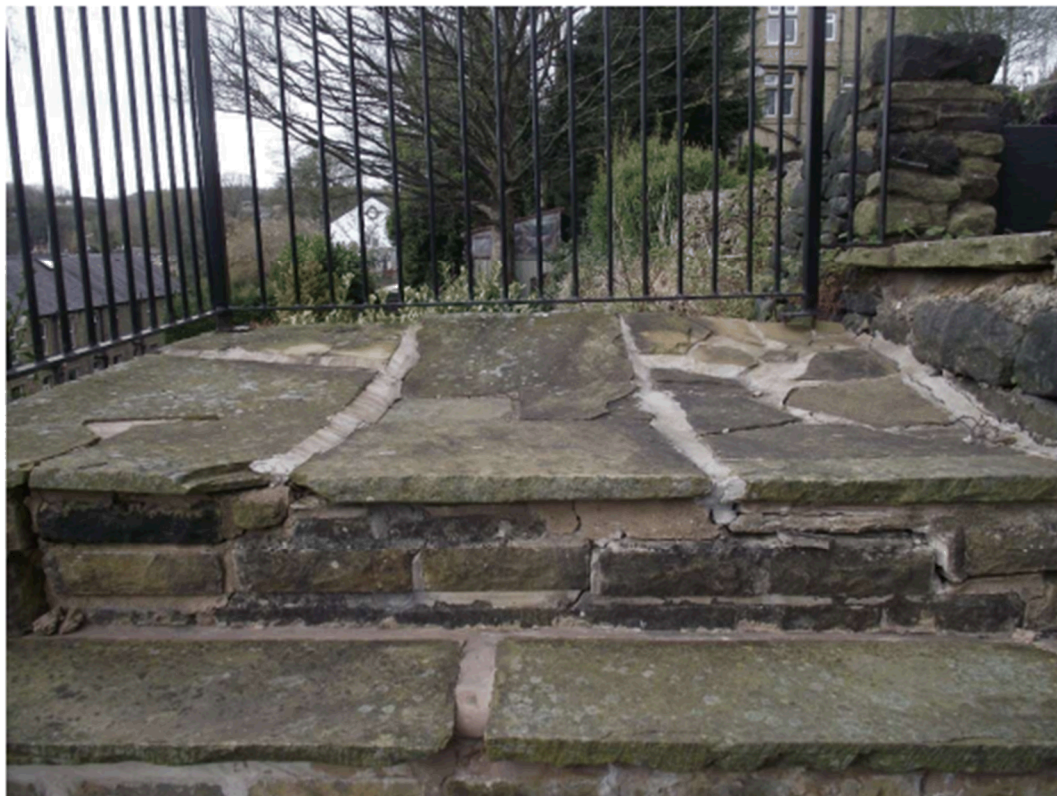
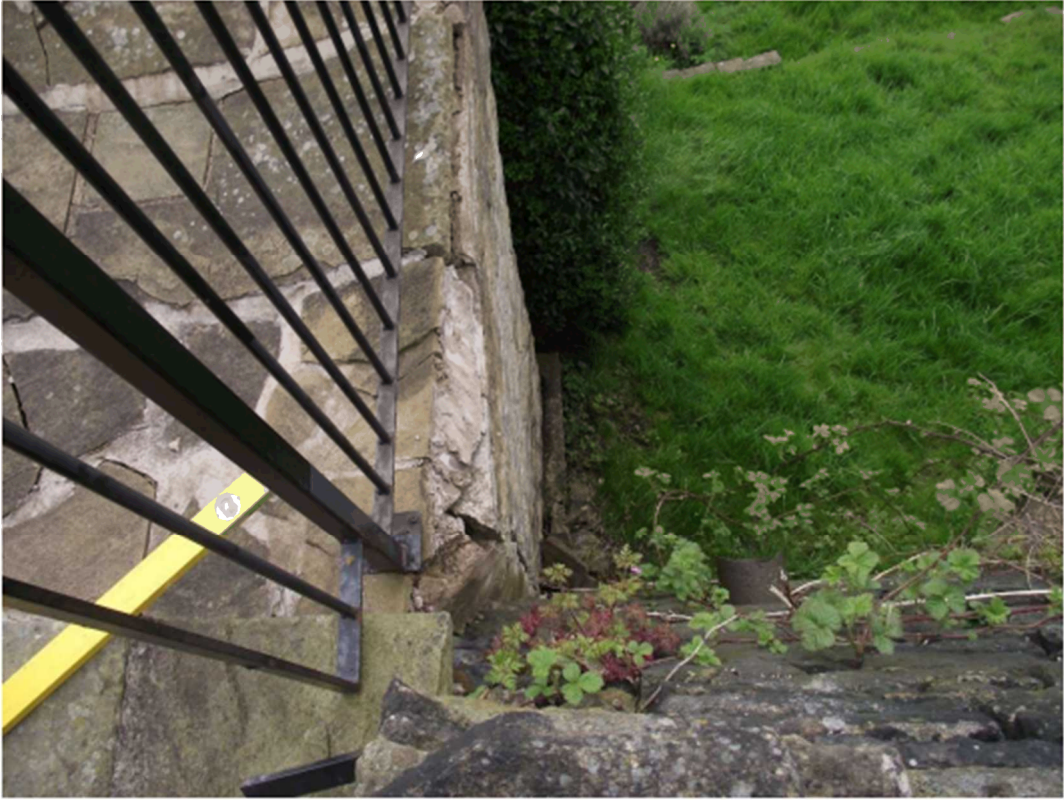
The movement and settlement of the external stone steps providing access between side and rear gardens appears to be associated with failure of retaining walls to the rear and side walls and settlement of infill material providing support to the landing and steps. The movement appears to be continuing, and the steps require removal to mitigate risk of further continued movement and, ultimately, collapse. The removal of the existing steps should be carried out with care to avoid damage to the existing retaining wall currently covered by the steps; during and following the removal of the steps, the condition of the existing retaining wall should be reviewed - if the existing historic retaining wall itself (currently covered by the existing steps) is found to be showing signs of distress or inadequacy, there may be need to carry out remedial work to enhance lateral support to the historic retaining wall. Replacement of the steps would most pragmatically be carried out with use of more lightweight construction, such as the use of simple steel steps. The use of lightweight construction, such as steelwork, will avoid the need for construction of retaining walls and associated foundations.

The movement in the external stone access steps has led to the complete failure of the connection of the base of the baluster to the handrailing at landing level. The failure of the connection leaves the handrailing unsupported, creating an inherent health and safety risk of falls from height. Accordingly the steps should be taken out of use, until remedial repairs/reconstruction have been carried out.
