Ceramic Panels – Condition Note and Repair Strategy

Job/Drawing No	Revision
IR430301-FCB-XX-ZZ-DR-A-040955	P01

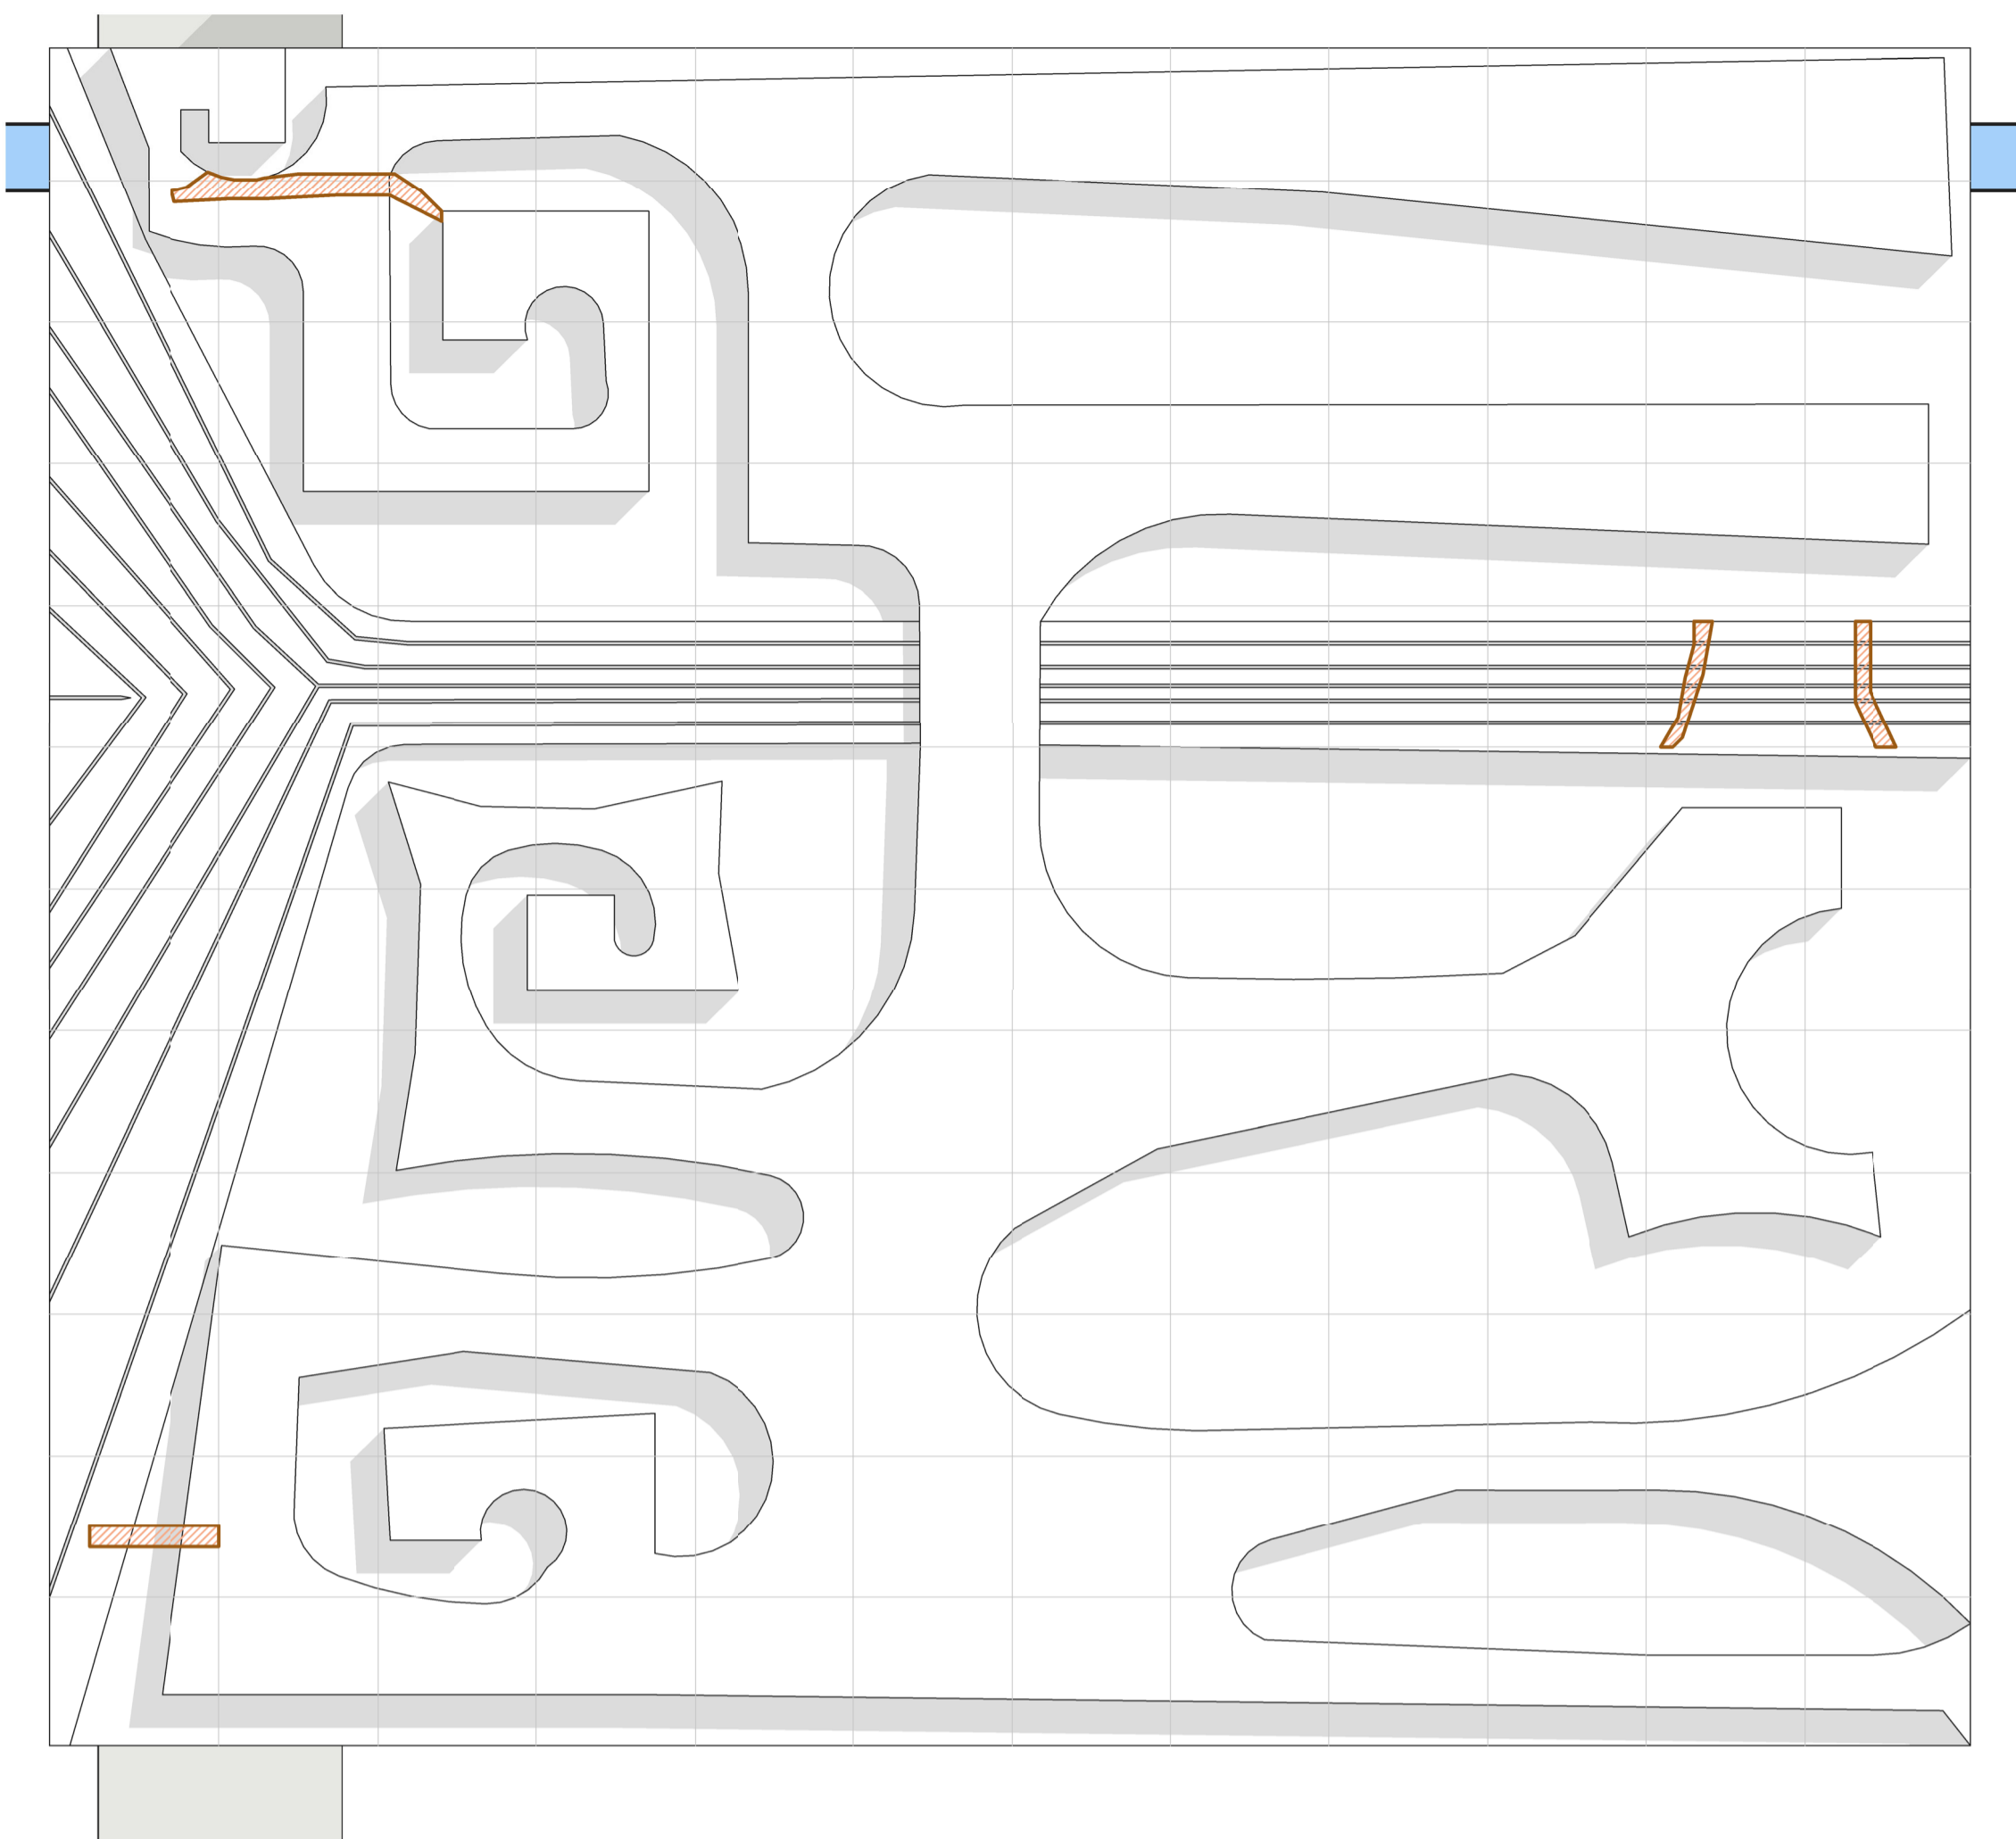
3 Main Elevation (East) - Ceramic Panel 03
1 : 20

Condition
Visual inspection has confirmed that the ceramic panels are largely in good repair with damage present but in limited volumes. There are a variety of cracks with areas of repair from different times since 1969. Many areas of cracking appear to have occurred in firing. Other cracks or broken units have been reassembled with a dark mortar like that used to bed the units. These may be units that failed in the firing or later and have been reassembled for use. A few units appear to have been mortar repaired with the mortar mixed in an attempt to match the tone of the ceramic. Some degradation in panel 10 is indicative of changes in the mix of the clay and possible lower firing temperatures. The later fabrication of this panel could offer some explanation for the difference in its condition as it is thought the original kiln had been dismantled by the time panel 10 was sculpted.

- Removal of non-original fixtures and fittings applied onto the panels
- panels to be cleaned
- failed and loose pointing to be renewed
- damaged units to be mortar renewed
- damaged unit to be mortar repaired (mix to match)
- missing elements to be investigated and where appropriate reinstated
- new lead / hard metal weathering capping to be fitted at the head

- 50% repointing
- 100% doff / thermotech cleaning
- localised mortar repairs
- 12no specialist replacement panels approx 480mm square
- remediation of corroding fixings where damage has been caused to the ceramics
