5 Main Elevation (East) - Ceramic Panel 05
1 : 20

6 Main Elevation (East) - Ceramic Panel 06
1 : 20

Ceramic Panels – Condition Note and Repair Strategy

Job/Drawing No	Revision
IR430301-FCB-XX-ZZ-DR-A-040956	P01

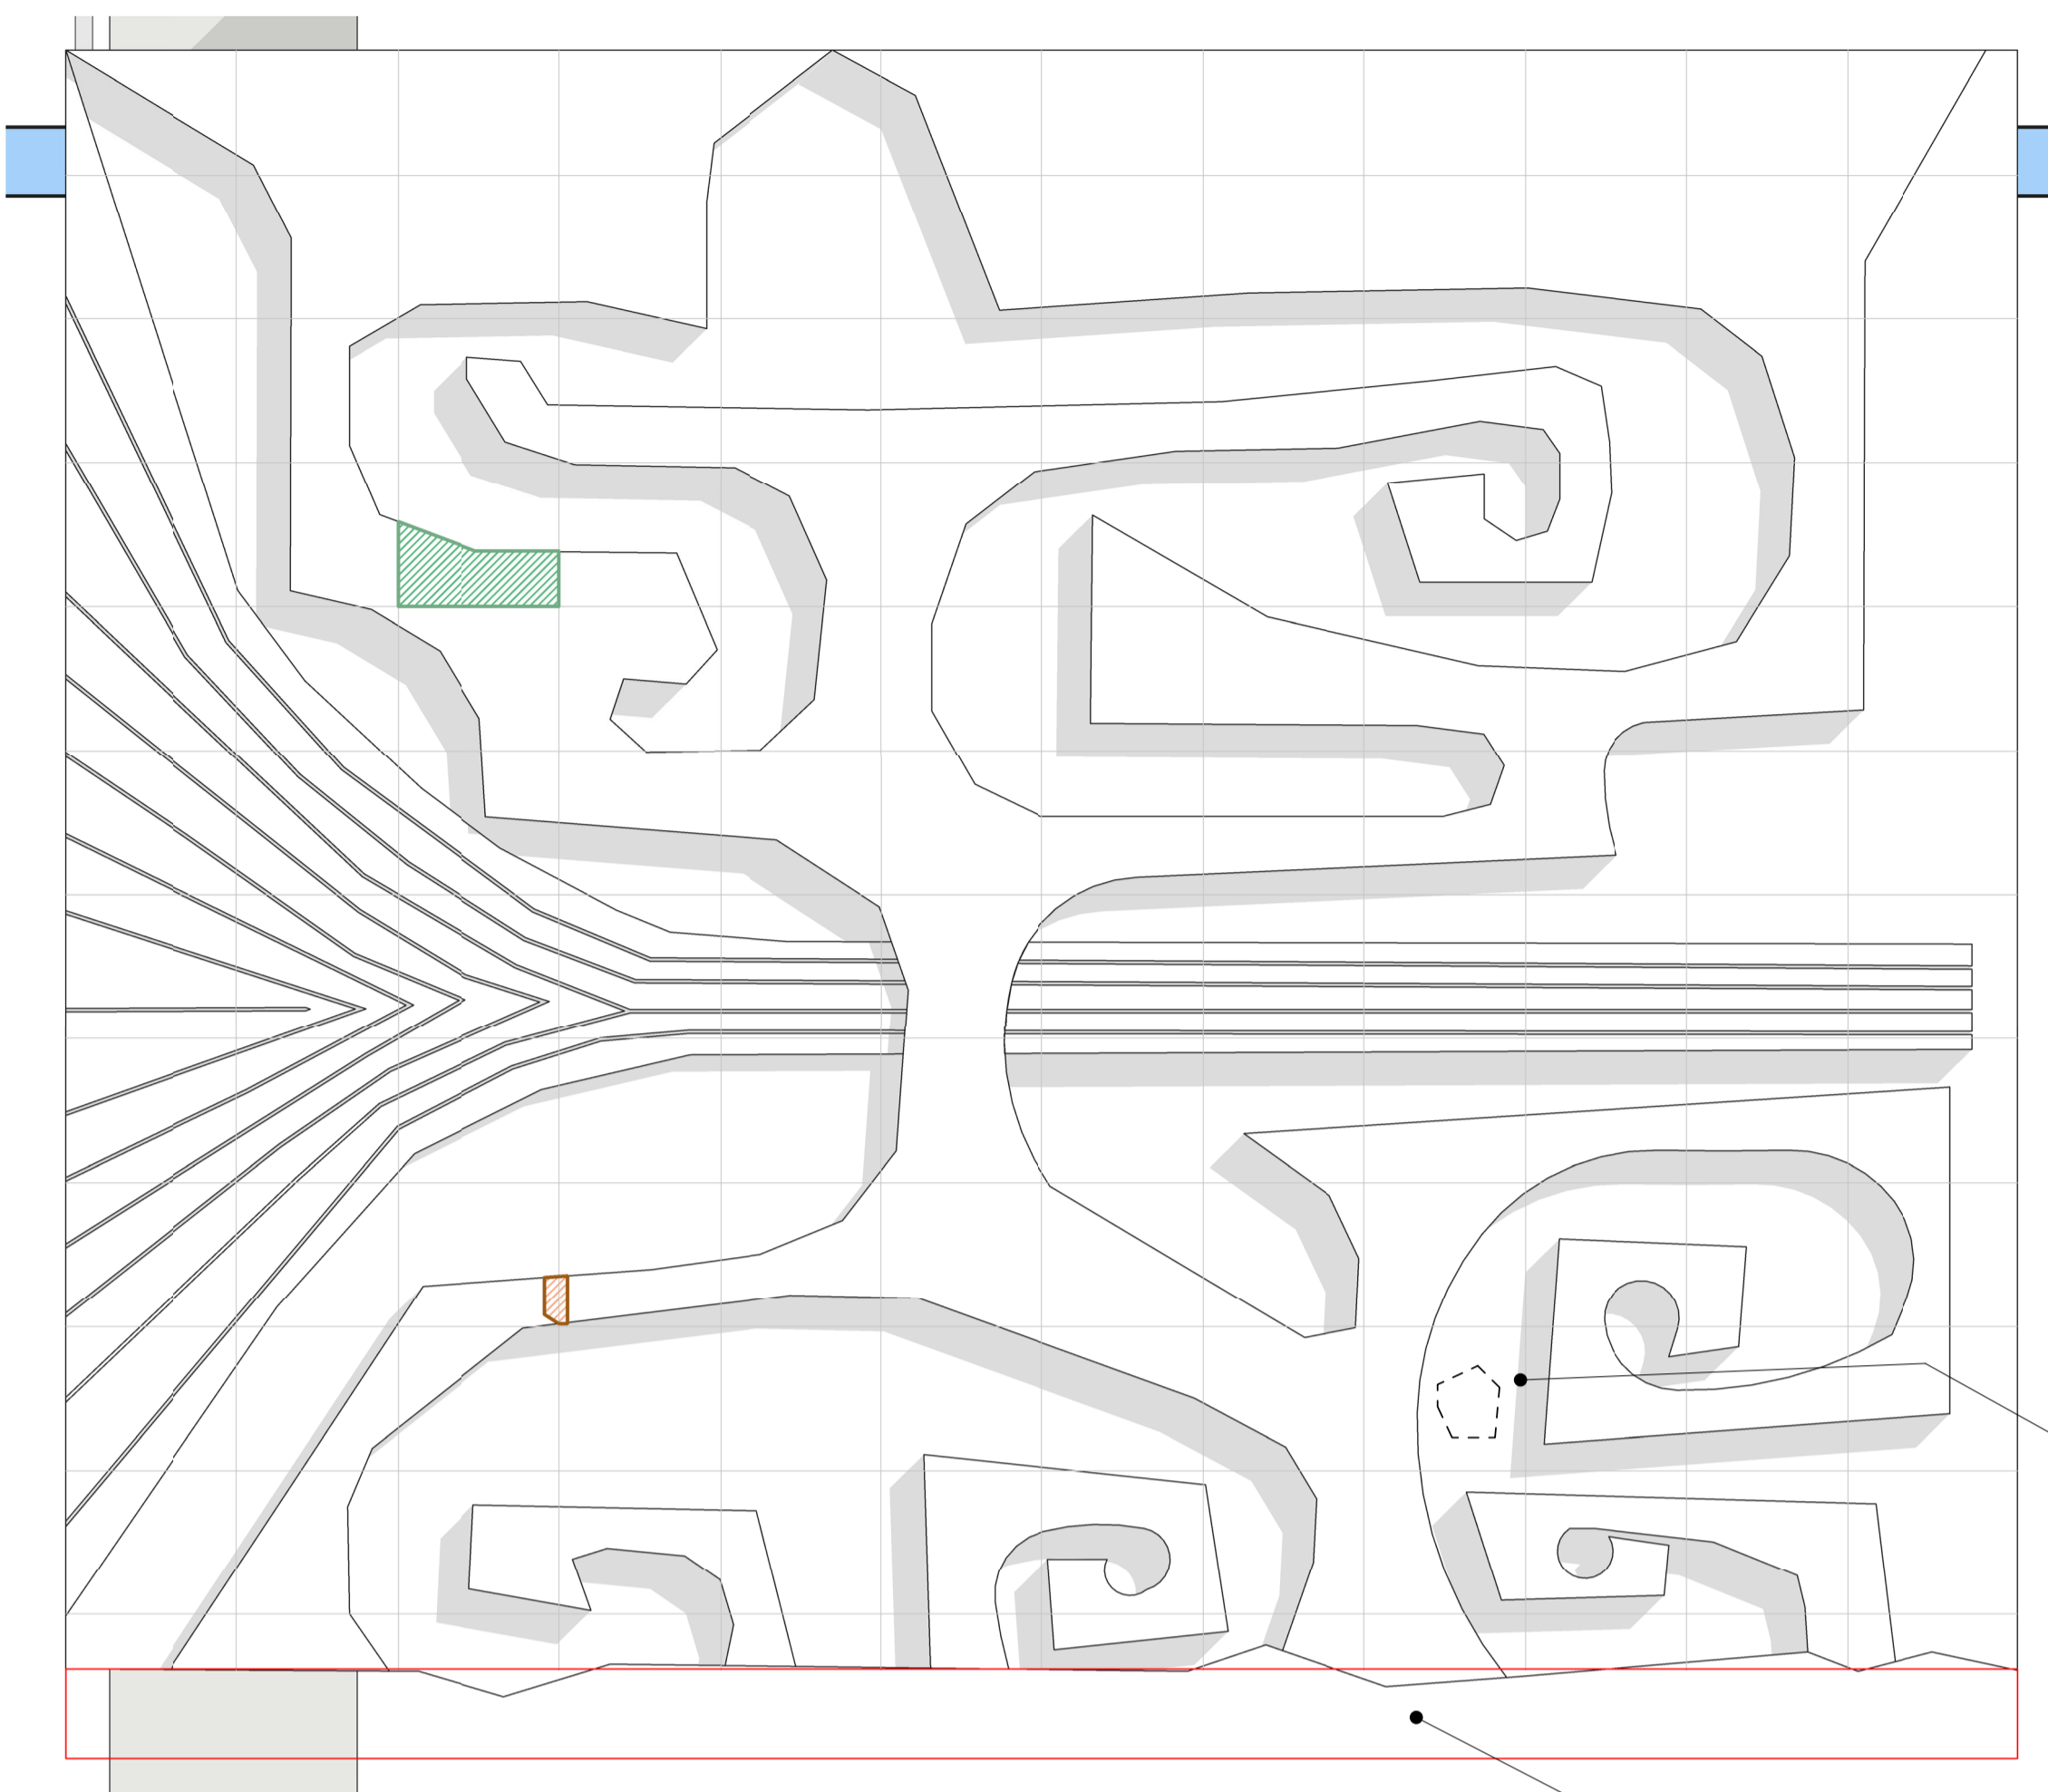
Past mortar repair - check and renew if necessary

Bottom row damaged and missing - cause thought to be the result of movement on a shelf angle - works to include for the reinstatement of these lost pieces in fire clay to match the original
