**FIELD HOUSE 15 WELLINGTON ROAD DEWSBURY WF13 1HF**

- 1.2 The site inspection was carried out on Monday 22 January 2024. The weather was dry, cold and windy.
- 1.3 The survey and report (ref SC/3121) have been carried out for YMG Construction Ltd on instructions from Mr Y Patel.

- 1.4 This schedule of condition of the flagged areas has been produced by a surveyor who has written this report for you to use to assess the current condition of the stone flag paving and identify items of disrepair.

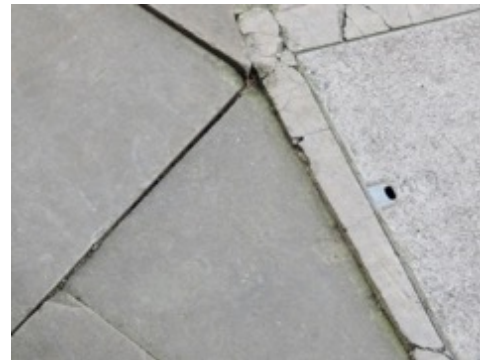
R7 – F3 and lipped.

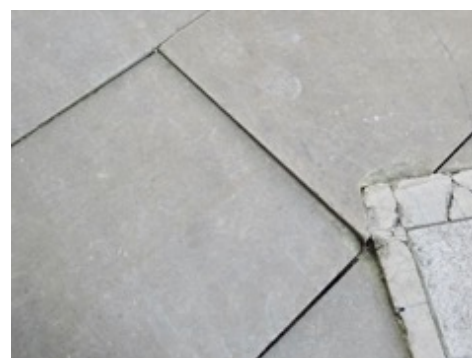
R8 – F1 Dropped

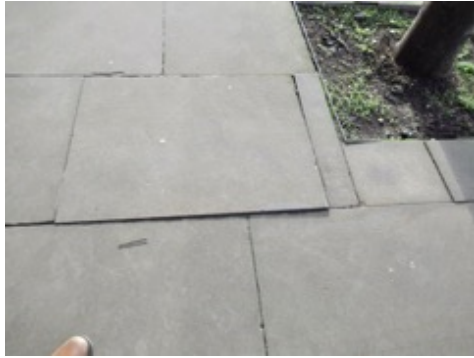
R29 – F4: Lipped
