# **ARBORICULTURAL REPORT & Impact Assessment to BS 5837:2012 at:**

***The Sycamores,  
12 Church Street,  
Golcar,  
HD7 4AH***

Prepared for:  
***Brunswick Architectural***

Reference: AWA5589

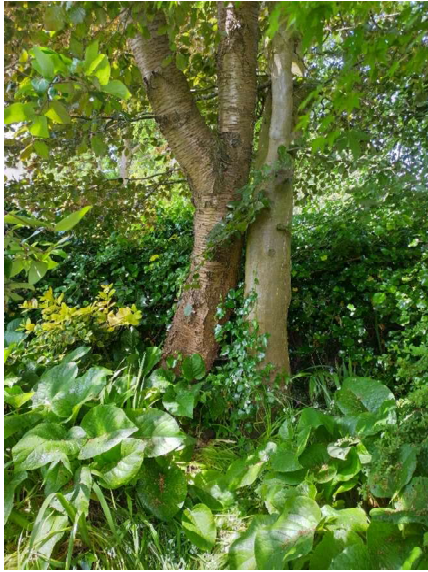
- 3.2.9 Cherry T7 and Beech T8 were growing out of the same base point and were in very close contact, which limit both of their long-term prospects. The northern crown of Larch T9 was dead at the time of the survey and as such its prospects were also limited.

Photo 1: Stems of T7 and T8 from south.

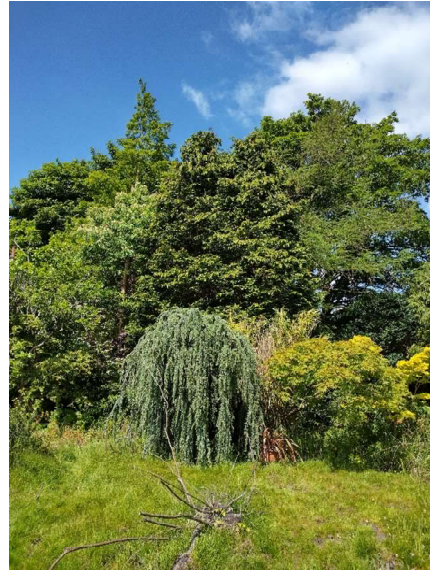
Photo 2: Rear garden from south.

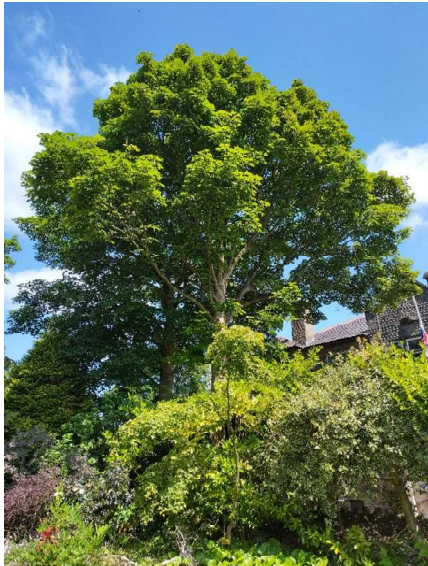
- 3.2.7 Sycamores T21, T22, T36 and T37 were the highest value trees at site, all large mature trees in good condition with good long term prospects. All four had little to no defects and provided a high level of amenity to the site and surrounding area, and as such are retention category 'A'.

Photo 3: T21 and T22 from south west.

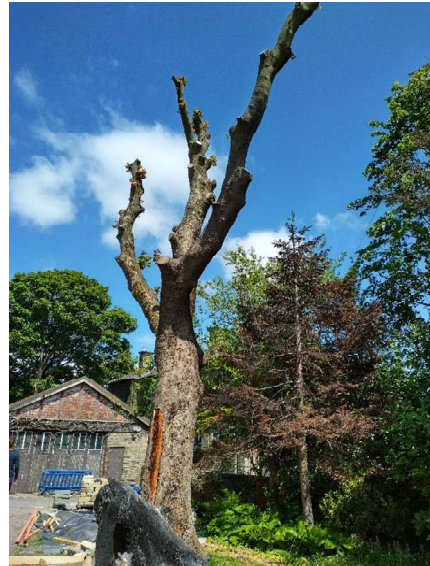
- 3.2.10 T26 is a large mature Sycamore tree which has been topped and very heavily pruned to leave no crown, only very minor epicormic growths on the stem. This tree is in poor condition and has limited prospects as a result.

Photo 4: T26 from south east.

| | Tree Species | | | Measurements | | | Crown (m) | | | | Tree Condition | | | | | Value | Management | | | | | |
|---|---|---|---|---|---|---|---|---|---|---|---|---|---|---|---|---|---|---|---|---|---|---|
| T26 | Sycamore | <i>Acer pseudoplatanus</i> | Mature | 12 | 1 | 860 | No | 12 | 4 | 2 | 4 | 0.5 | Exposed roots. Soil compaction. Root damage /loss. Damage to buttress roots. Adjacent ground works | Single stemmed. Vertical. Old pruning wounds. Stubs. Bark damage. | All absent. Pruning wounds. | Previously mature Sycamore has been topped and very heavily pruned to leave very minor epicormic growths. Building materials stored at base. | Poor | Poor | 10 to 20 yrs | Low | C | No works required |

- 4.3.2 Potentially damaging activities are proposed in the vicinity of retained trees.
- 4.3.3 The proposed new driveway is situated within the RPA of retained tree T26 and encroaches into the edge of the RPAs of retained trees T27 and T29. Cherry T27 and Fir T29 are of low value and the encroachment of the driveway into the RPAs is minor. The encroachment of the driveway into the RPA of Sycamore T26 is significant and this may have negative impacts on tree roots. In order to overcome or minimise any negative impact on tree roots a 'no-dig' geocell type method of construction with a 'root friendly' porous surface could be used for the new driveway within the RPA of T26.

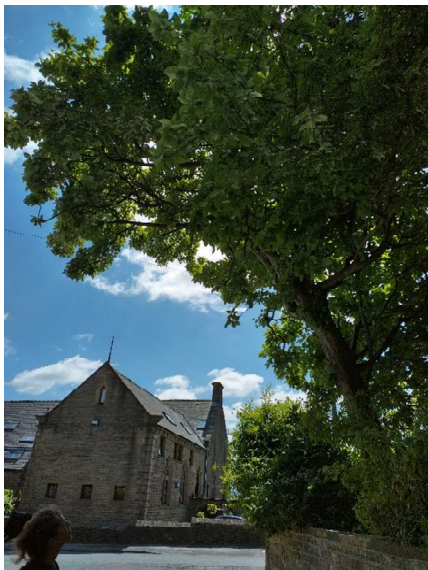
- 3.2.8 There were also several retention 'B' category trees at the site, including Cherry T7, Beech T8, Larch T9, Lime T30 and Whitebeam T33. These five trees were all early-mature to mature trees in good condition, providing a moderate level of amenity to the site and surrounding area.

Photo 5: T30 and T33 from north east.

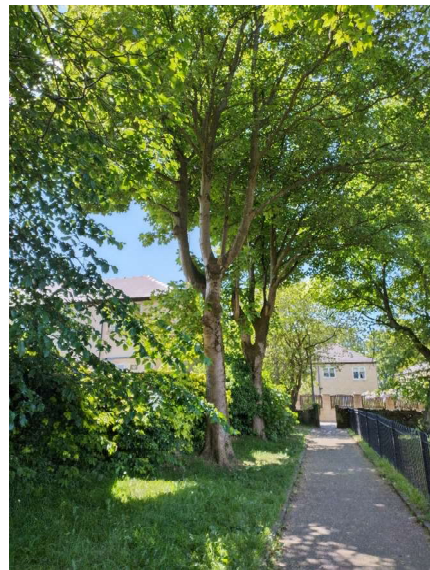
Photo 6: T36 and T37 from east.
