SF3282 Cliff Hill, Denby Dale

ARBORICULTURAL SURVEY REPORT | BS 5837:2012

Revision A - October 2022

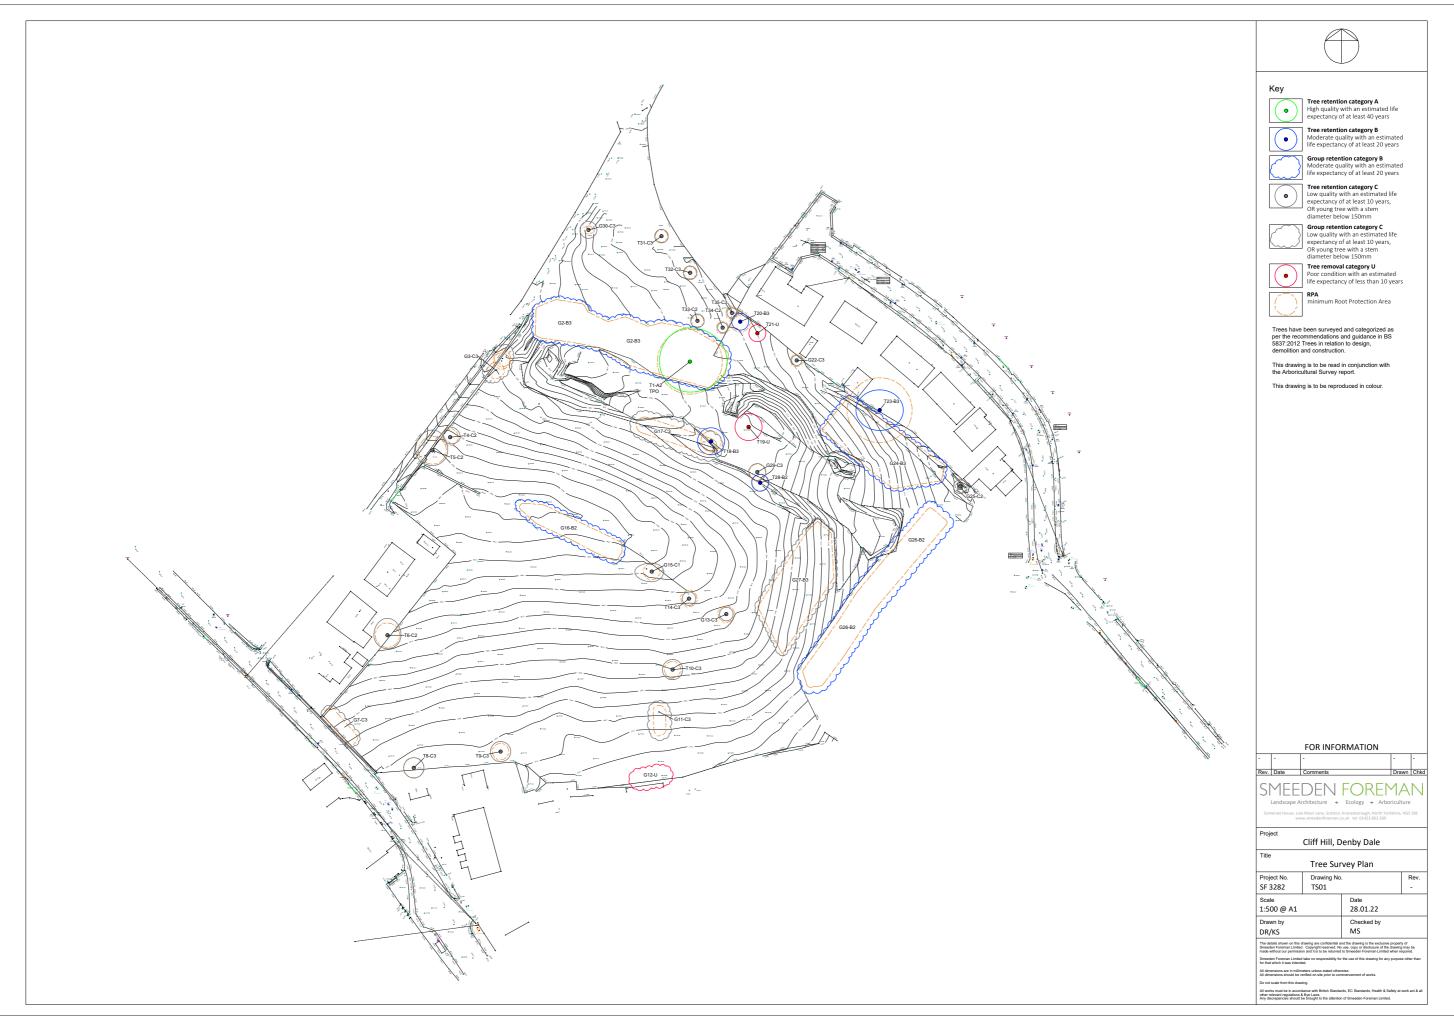
SF3282 TS01 Tree Survey Plan

- 4.1 The potential for retaining trees on a development site includes the extent of the influence of the tree at the time of survey. Consideration is also given to the effects of future growth within the context of the proposed development. In addition, the potential nuisance caused by shading to new buildings both after construction and also once trees reach their ultimate size is also considered.
- 4.2 The extent to which a tree may represent a constraint to development will depend both upon the location of the trunk and size and nature of the canopy and also the extent of the roots below ground. The tree constraints drawing (SF3282 TS01) plots the location and extent of the tree above ground.

- 5.3 The tree constraints drawing (SF3282 TS01) plots the location and extent of the tree below ground through application of the calculation provided in section 4.6 of the BS5837:2012 Trees in relation to design demolition and construction Recommendations.
