Rotary Borehole Site Investigation Report

LOCATION	Heator Lane, Cumberworth, Huddersfield HD8 8XH
ISSUE DATE	17 August 2023
FOR	Chris Hitchens
CLIENT REF.	
OUR REF.	G23200 Rev 1

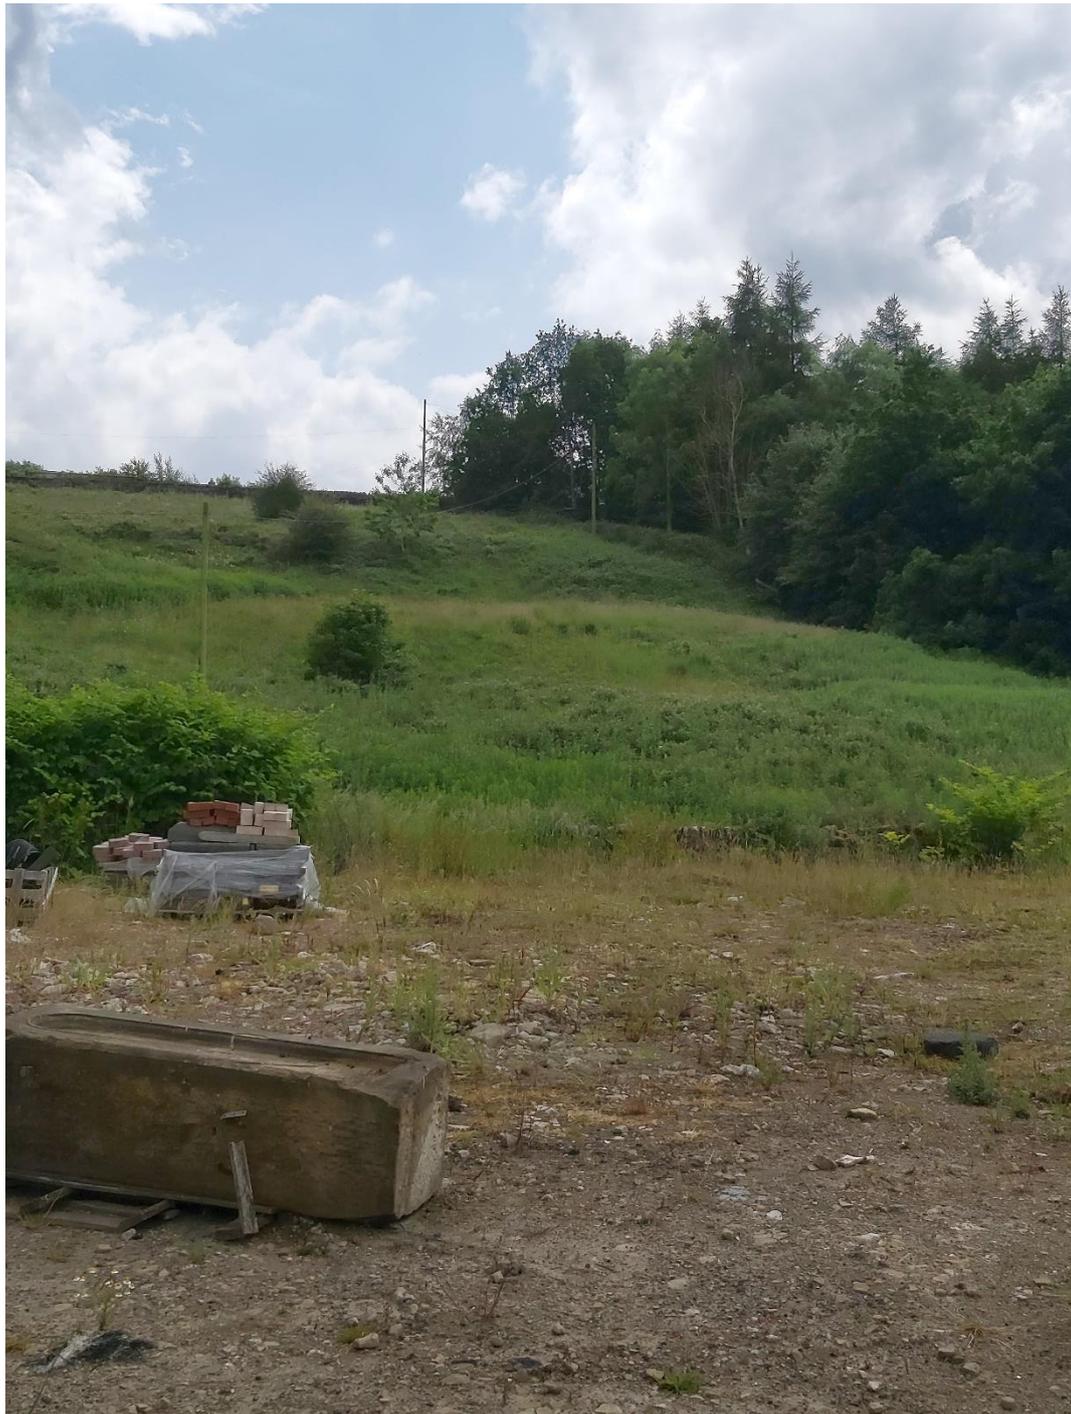
West Landslip Feature

The 1:10000 map shows ancient landslip and a spring on the hillside to the south-west and south of the site respectively. The spring appears to have dried-up a long while ago. This map also identifies the west embanked reservoir and infilled ground at the site locality. The east reservoir is no longer shown.

An image of the landslip is provided in Appendix 6. There is no evidence of recent movement of this feature, and it does not impact the current development area which lies to the east of it. The old stone boundary wall at the foot of the slip, suggests this feature has probably remained stable for over 100 years.

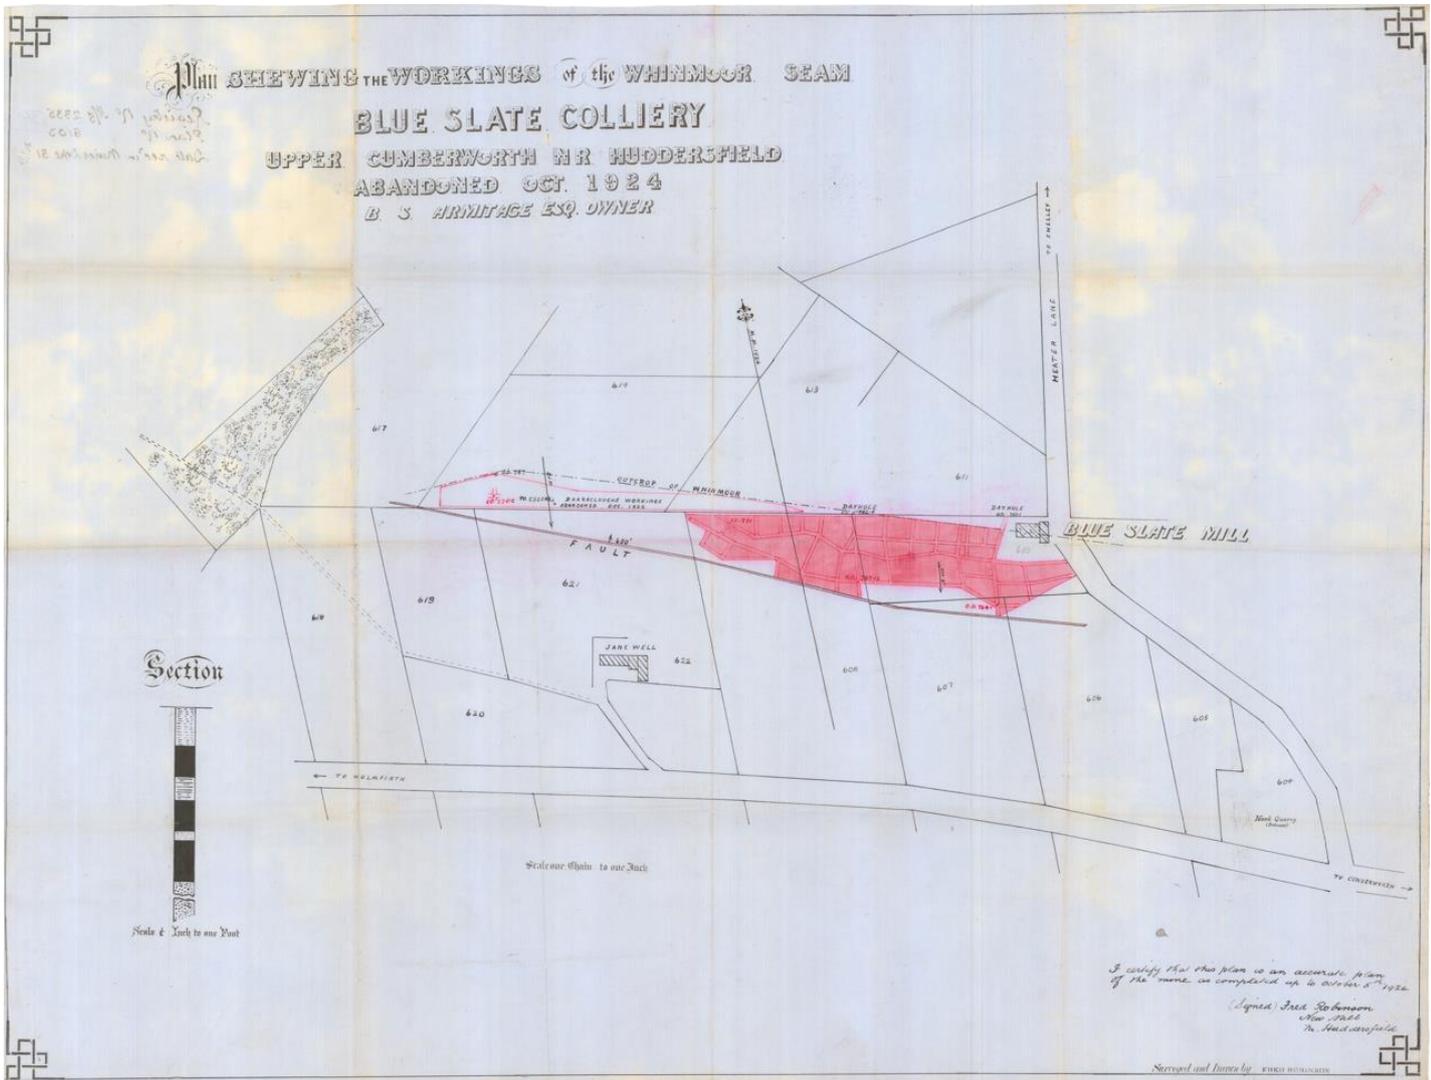
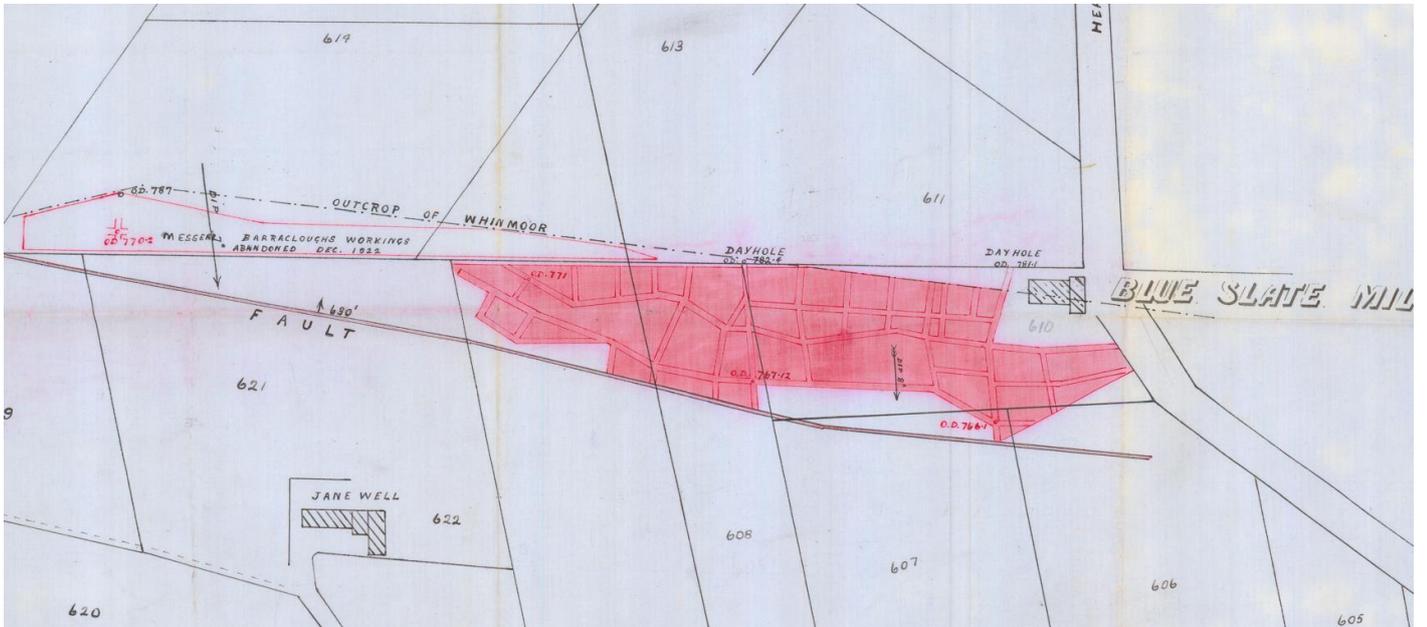
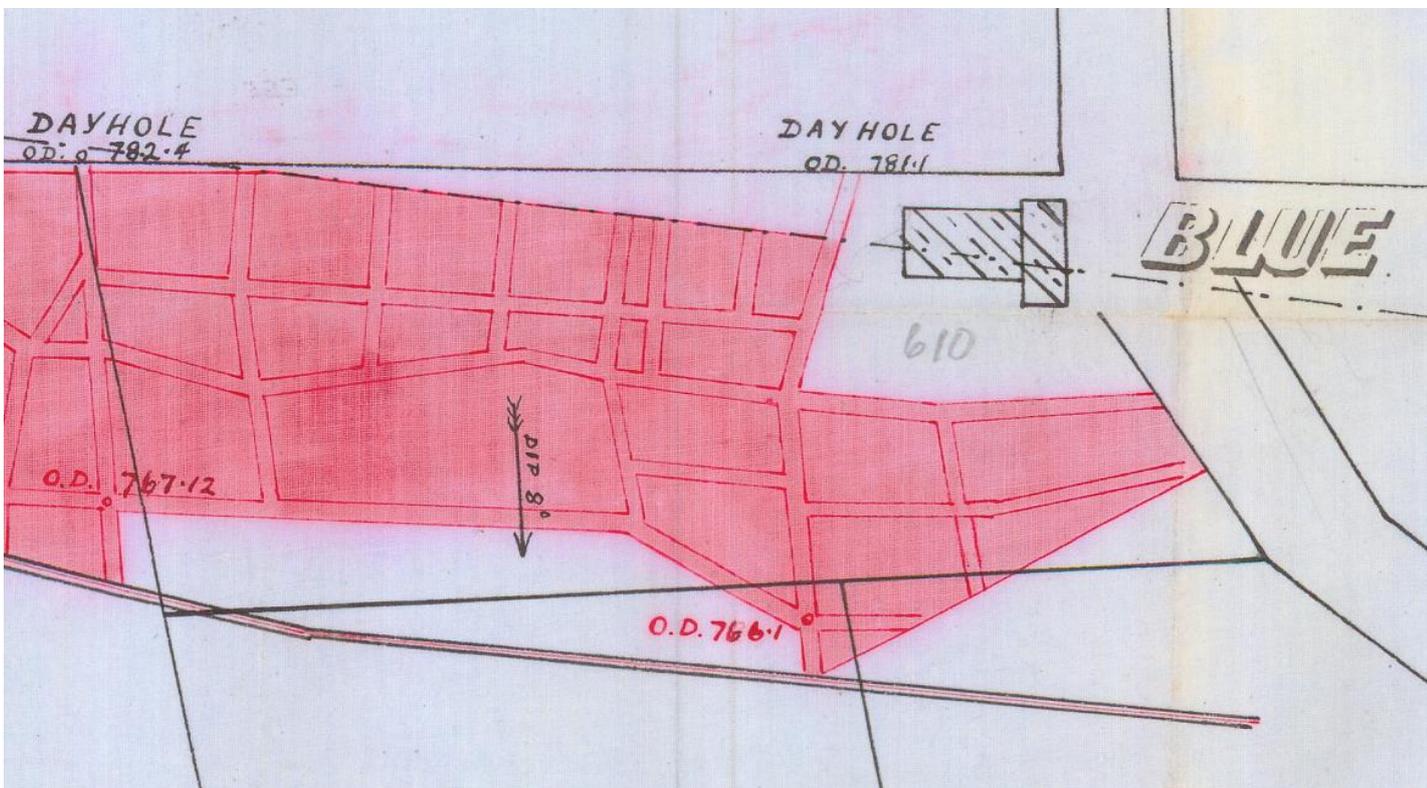
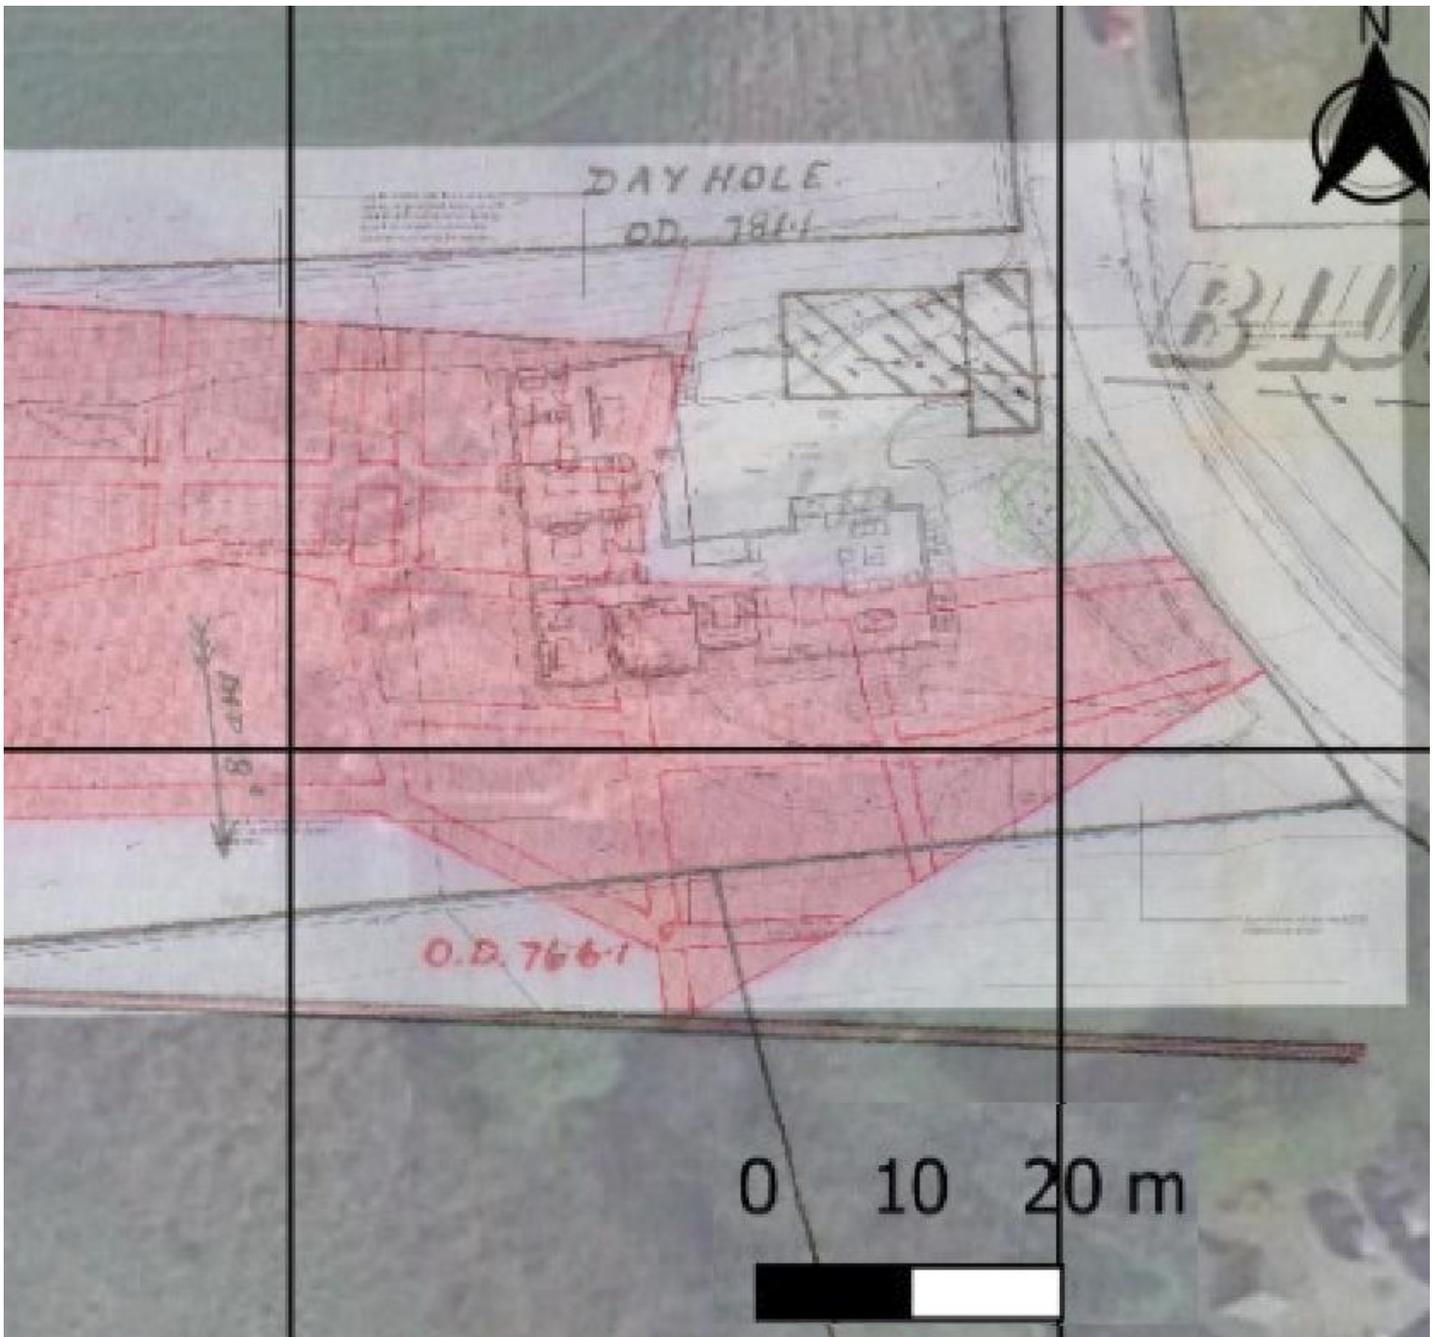
Mining Abandonment Plan

The mining abandonment plans for workings in the Whinmoor Coal (purchased from the CA by Geoinvestigate) are provided in Appendix 7. The enlarged plan shows the Day Hole/adit entry through the boundary wall at the north end of the site, connecting with a network of development mining tunnels within the Whinmoor coal seam, while the RED area shows total extraction mining (which removed coal seam left between the tunnels and ultimately removed the tunnels themselves) causing the roof - presumably in sandstone - everywhere in the RED area, to collapse on to the mine floor. Collapse is likely to have occurred soon after mining.

The BLANK area beneath the Mill building (and its yard in the north-east corner of the site between the dashed coal outcrop line and the RED worked area) is assumed to be 'coal pillar' left in place unmined to provide support to the mill. Both reservoirs were however undermined in the 1920s and are assumed to have become unused by this date, while the mill building remained of importance hence it was not undermined. The mine plan indicates the mill is 2/3rds underlain by undisturbed drift/soil and 1/3rd underlain by 'undisturbed' coal pillar. However, the pillar may have been subsequently robbed post mine closure in 1924 perhaps by local miners who originally may have worked at the Blue Slate Colliery and knew where the coal pillar lay entering the new pillar workings by unblocking the original Day Hole.

There is a problem with the 1924 survey heights shown on the mine plan which, in Geoinvestigate's opinion, should be around 10 feet lower reducing the Day Hole entrance from 781.1 feet OD/238.1m to 235m to better correspond with the recently surveyed top of the north boundary wall at around 234.5m aOD or so. However, the plans dip of 8 degrees is correct. The error is of little significance and does not detract from the high quality of the 1924 survey plan.

The faint outline of the 'L' shaped footprint of the new house is shown on the 4th mining plan in Appendix 7. This pre-drilling information shows the house straddling mined/collapsed ground and unmined coal pillar and the northern end of the building underlain by the Day Hole entrance in collapsed bedrock strata rather than drift/soil which occurs on the north side of the dashed/approximate outcrop line. The main parking area and part of the driveway are over coal pillar.

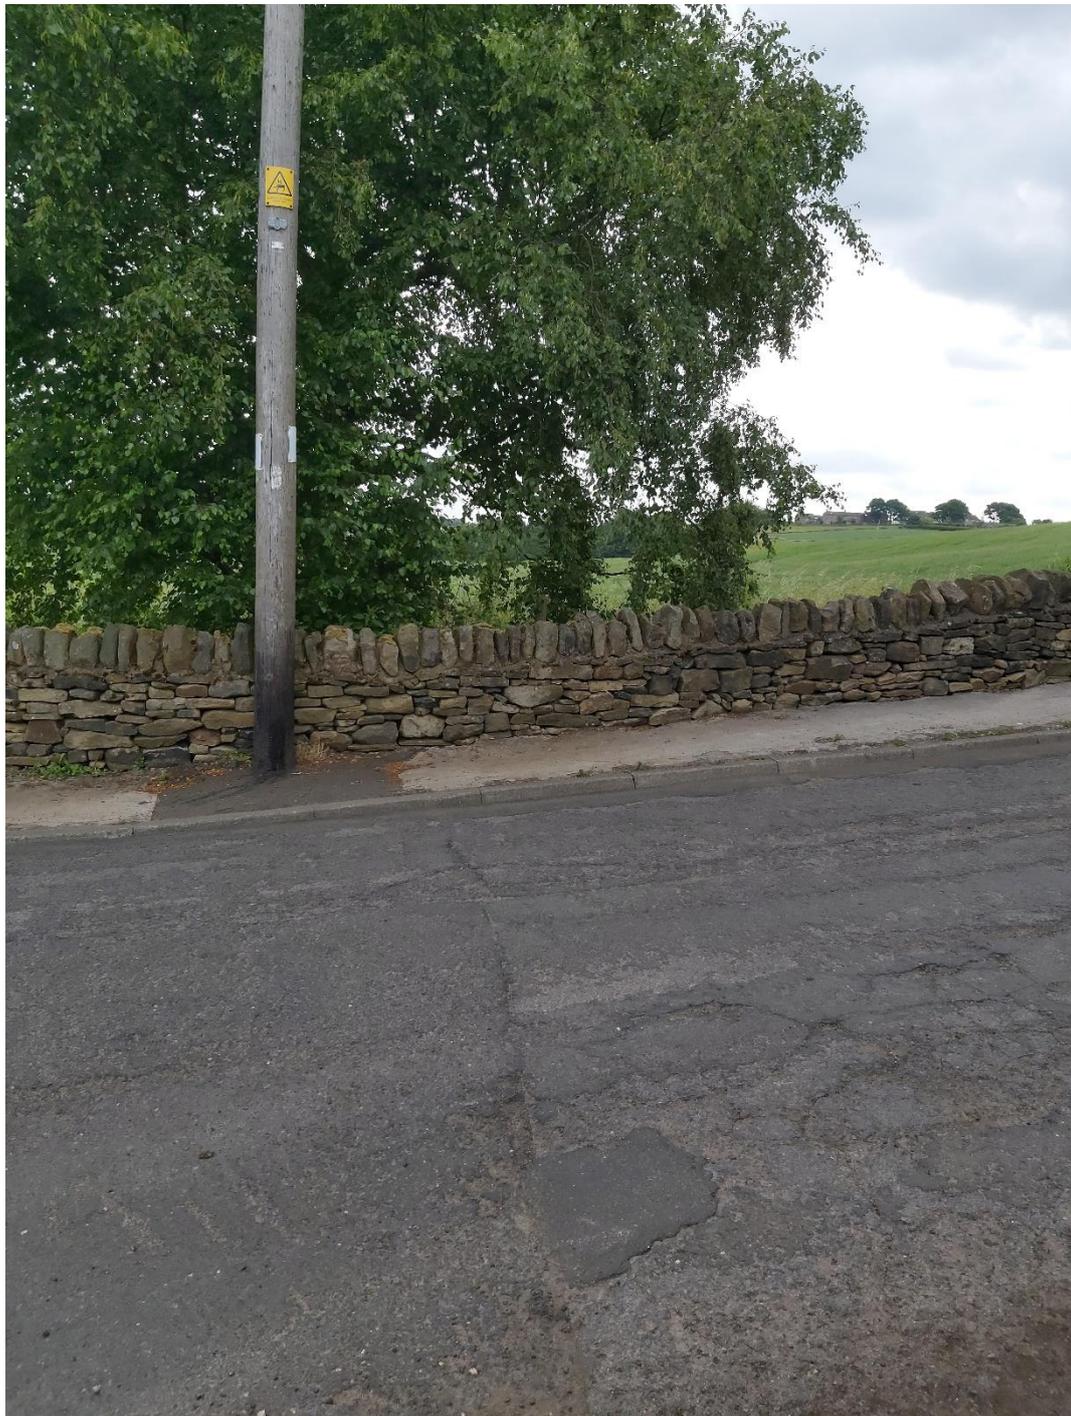
Nearby Mining Subsidence?

No obvious visible surface evidence was seen within the site of mining subsidence caused by the extensive removal of 2m thickness of Whinmoor Coal seam within very shallow depth i.e., < 10m. There is, however, possible evidence of subsidence of the stone wall on the far side of Rowgate Road opposite the main site entrance as shown in Appendix 8. If subsidence has occurred here, it is perhaps due to illicit mining as the mine plan suggests this surface feature occurs above BLANK coal pillar. However, this is speculation.

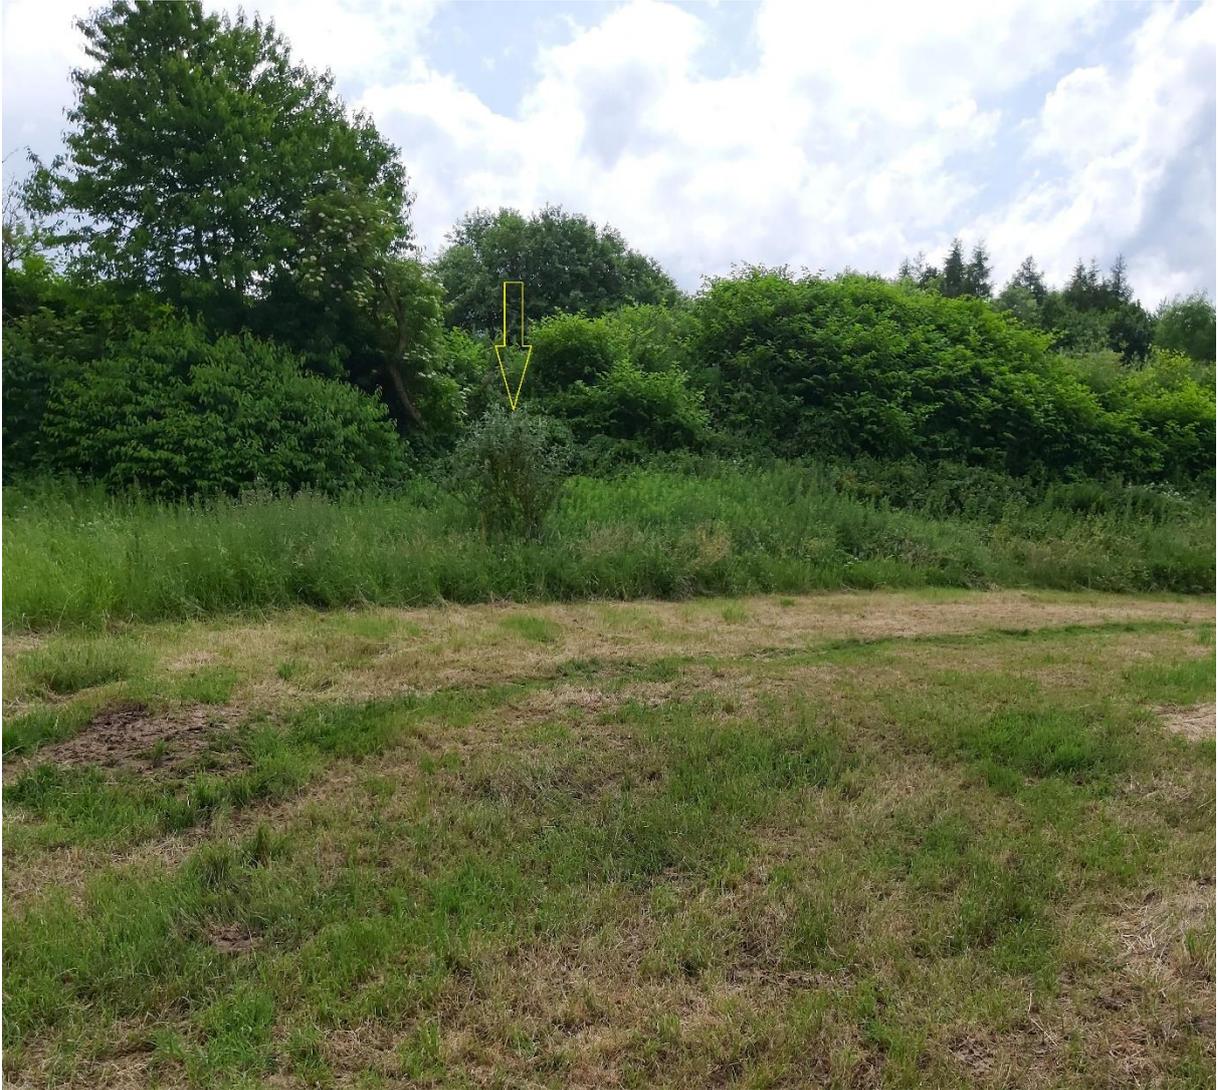
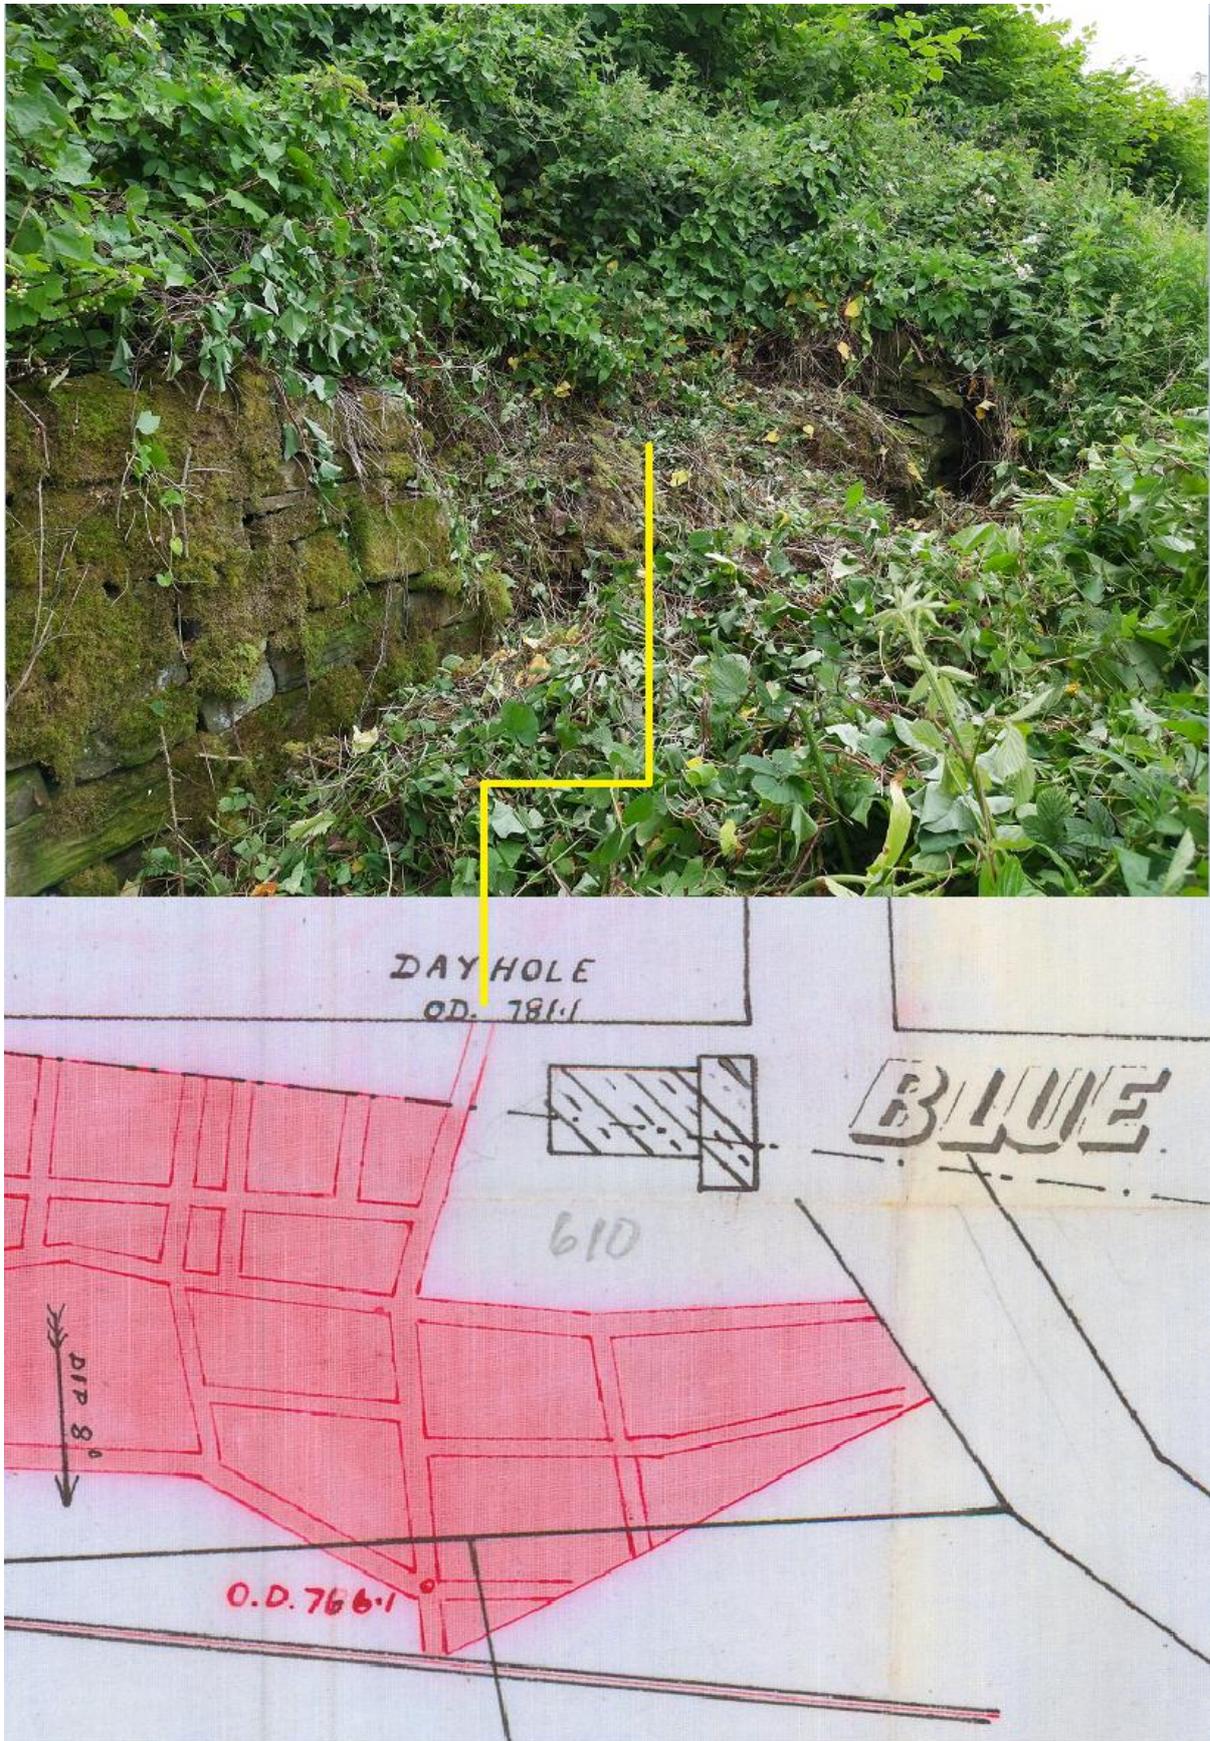
Day Hole Entrance

Using garden shears and a lopper to remove heavily overgrown vegetation at the foot of the north bank, Geoinvestigate uncovered the 'Day Hole' entrance some 21m along the stone boundary wall from the nearside of the pavement on Rowgate/Heator Road. Images of the Day Hole are provided in Appendix 9. The hole was made through old stone wall and is today blocked with a pile of boulders. The entrance is 1.80m wide.

Looking from the slope above the Day Hole entrance, its alignment was traced into the site allowing nearby borehole RH8 to be targeted with reasonable confidence to intercept this tunnel below the northeast corner of the new building. In this respect, the white safety helmet shown in amongst bushes (including Japanese Knotweed) shows the location of the tunnel entrance at the foot of the north bank.

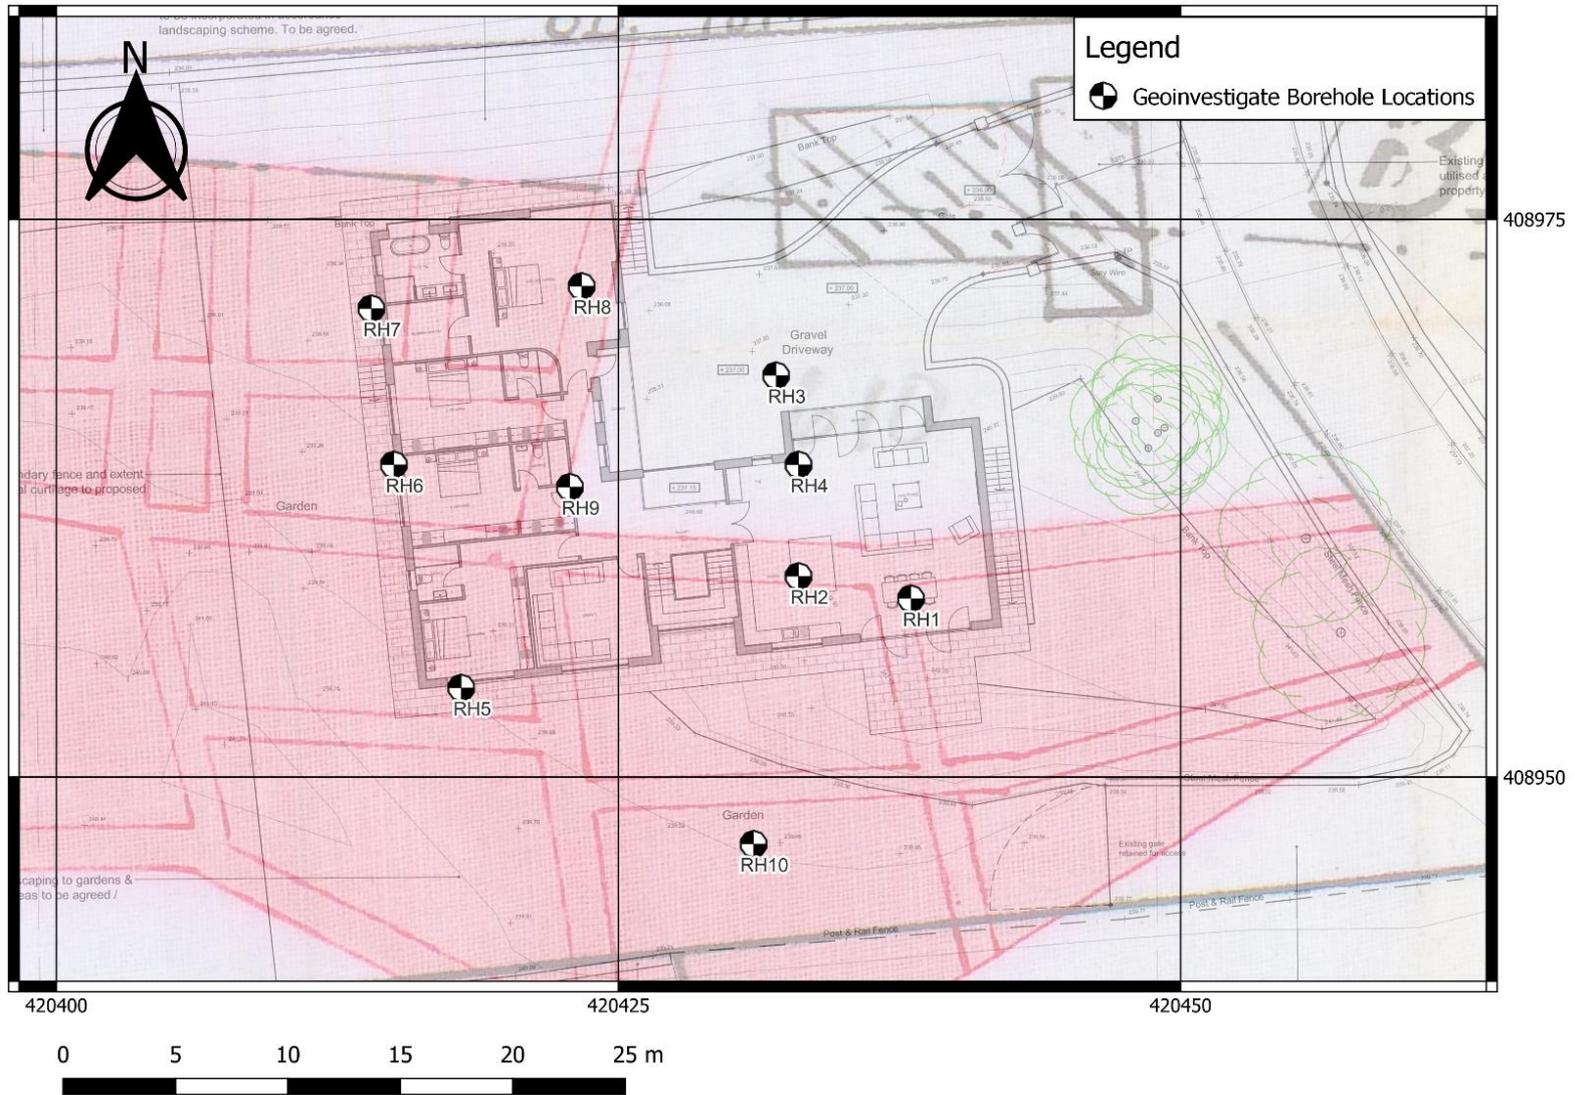
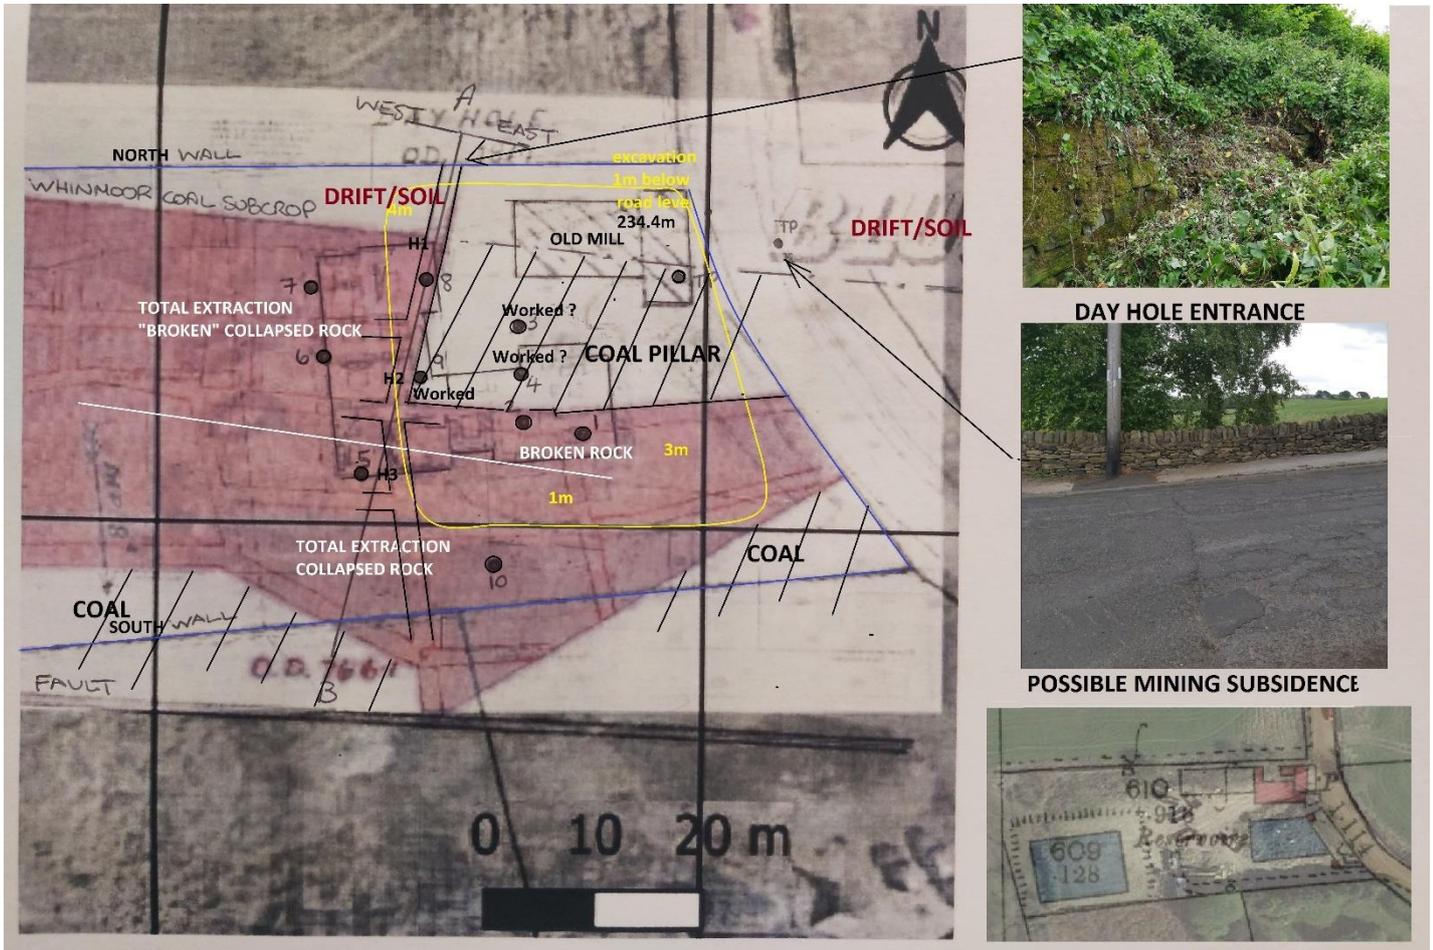
Borehole Plans & Logs

In several holes (BHs 7, 6, 9, 2 & 1) drilling located rockhead corresponding with the floor of the mine workings increasing from 6m to 8m depth from north to south across the site or falling from 232m to 230.5m aOD in this direction giving an apparent dip of 6 degrees SSW in section line with the true dip of 8 degrees due South as shown on the mine plan. As the drilling of these holes did not recognise the top of the subsided rock strata, expected to occur above the mine floor as 'rockhead' Geoinvestigate has described this zone as 'Broken' to the mine floor, in comparison to holes BH5 and BH10, which identified drilling rockhead several metres higher (around 235m aOD) - suggesting that the 'Collapsed Rock' here is more competent hence it is described as such rather than 'Broken'.

The driller identified BH8 on the line of the Day Hole tunnel as exhibiting much weaker ground conditions than elsewhere on the site, though no tunnel void was encountered, suggesting this structure has collapsed.

Based on the 1924 abandonment plan the COAL PILLAR presumed left below the mill and its yard was expected to comprise unmined coal seam. However, this does not seem to be the case as holes BH3 and BH4 in the pillar perhaps indicate partial extraction/robbing of the seam perhaps in the upper one or two layers shown in the coal section provided in Appendix 7. Whether the total extraction of the seam in BH9 is due to its closeness to a tunnel or subsequent pillar robbing is uncertain. Whether remnant coal is present in BH3 and BH4 above the bottom of the seam/mine floor, is unknown as there was no drill water return, and owing to the complexity of the ground conditions, the driller could not distinguish coal in this instance from dial pressure and water readings.

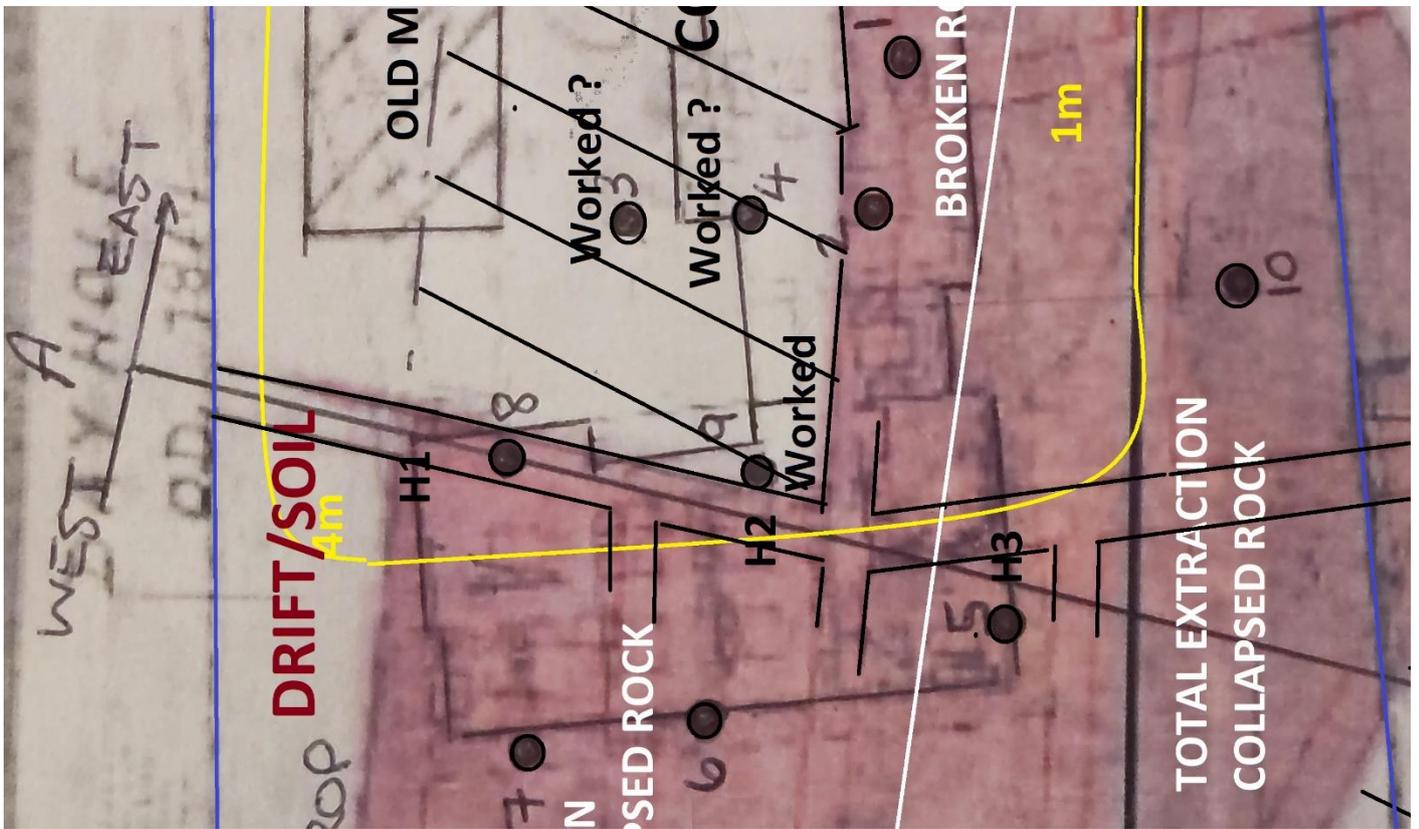
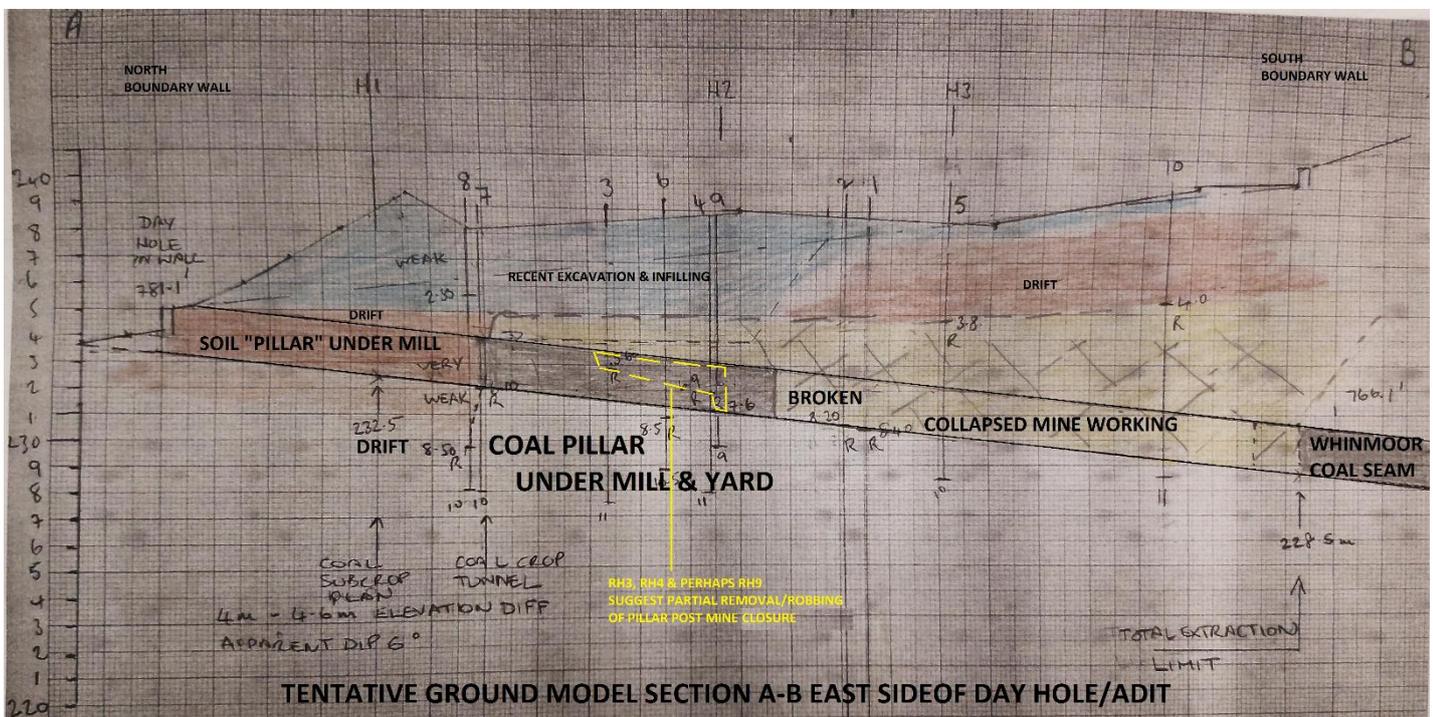
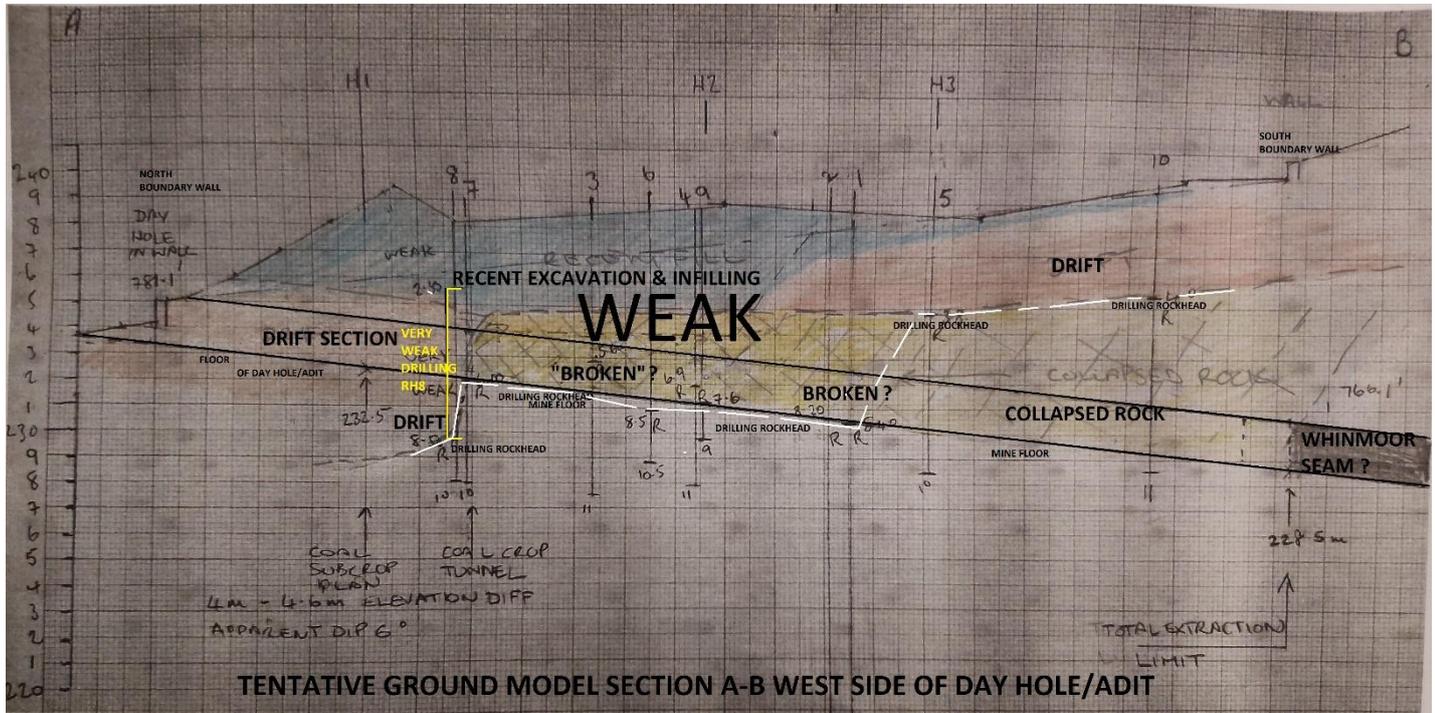
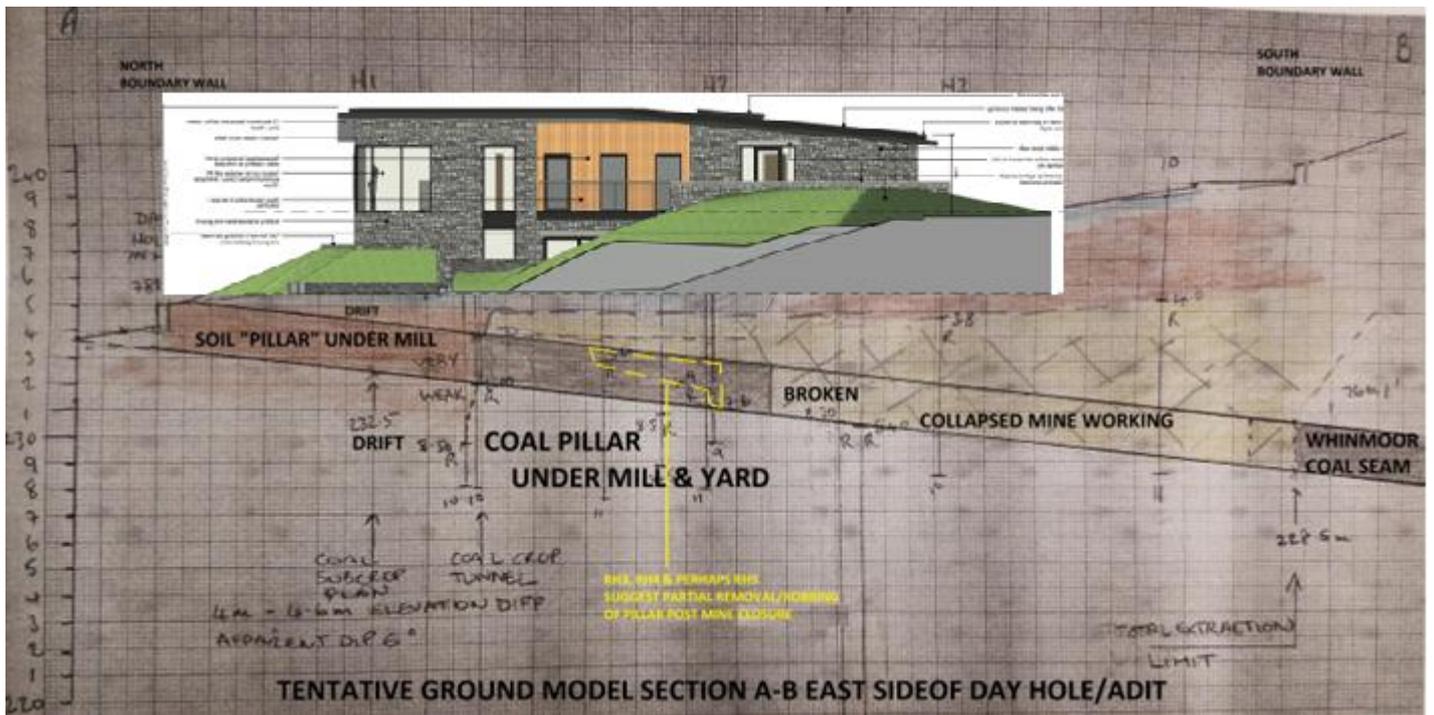
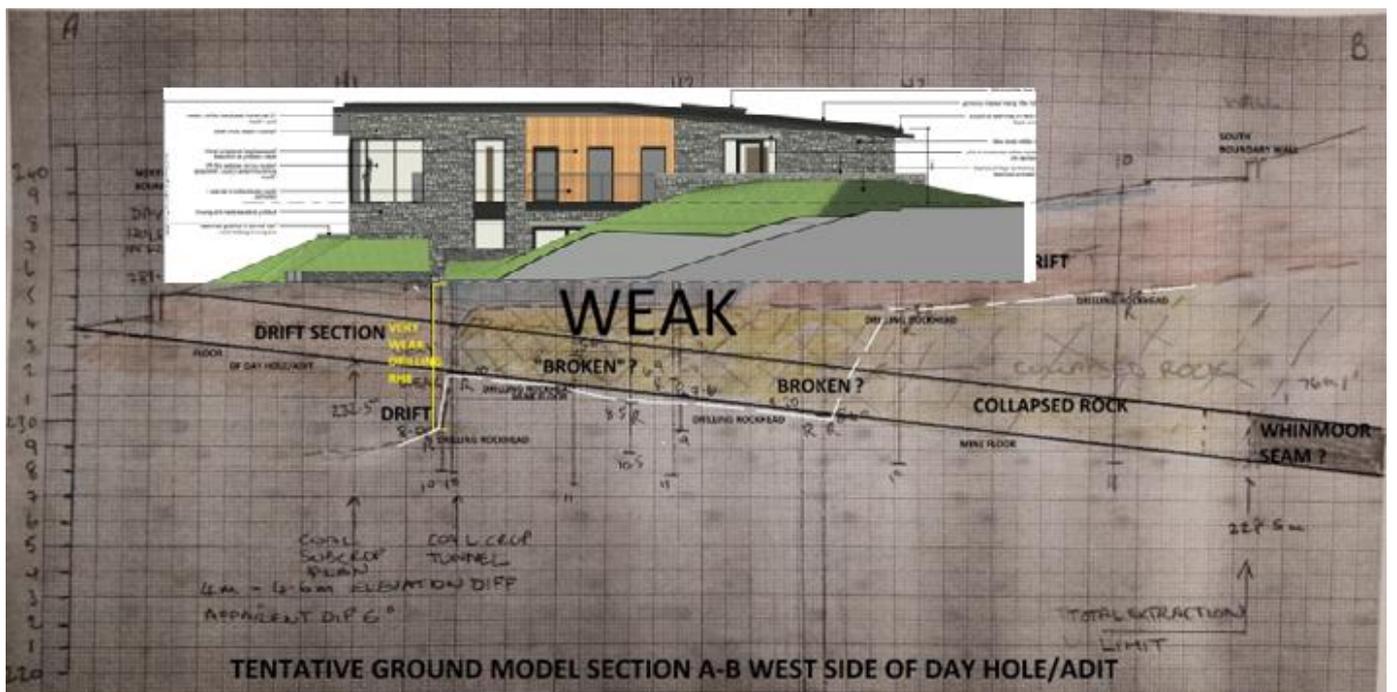
Conceptual Ground Model Sections

Two natural scale conceptual ground hazard models/cross-sections are shown in Appendix 13 looking East and West through the middle of the site along line A-B which passes through the Day Hole entrance and steeper north slope. The models are based on Chris Hitchens anecdotal recollections on recent excavation activity within the property, the mining abandonment plan, geotechnical site inspection and the results of limited probe drilling without sample recovery. Consequently, particularly with respect to the latter, additional intrusive ground investigation is likely to be required to confirm the model, particularly with respect to reliably establishing soil/bedrock depth and to check for the presence of ground contamination within the overlying made ground deposits.

The sections assume that coal pillar should be found under the northeast corner of the site as inferred (but not expressly stated) in the mining plan and that total extraction of the Whinmoor Coal has occurred in the RED area shown on the plan causing roof collapse everywhere above the mine floor.

The ground models show excavation to 3.5m to 4m depth, to install the undercroft of the new L shaped building (annotated H1, H2 & H3 on the sections) to be underlain by thin infill giving way southward to several metres of natural drift at H3, in turn underlain by collapsed broken and less broken bedrock at H2. The weakest and most variable ground being present between H2 and H1, where the north end of the building straddles haphazard coal pillar working/robbing, totally collapsed historical mine working, and very weak deep drift/soil, including caved Day Hole tunnel and recently placed unconsolidated additional slope/bank infill above the tunnel.

Mitigation measures for consideration include ground improvement by craned/high fall/high energy **dynamic compaction**, reduced energy **rapid impact compaction (RIC)** to both to proof test and collapse voids, **bulk excavation, and replacement** both to remove residual pillar coal and workings within it as well as removing collapsed/broken ground down to mine floor level or lastly treatment of the pillar and collapsed strata by **drilling and injection grouting + adoption of reinforced foundations**.

As the installation of the below ground level section of the building to a depth of 3.50m or 4.00m will mostly remove the drift/soil/made ground horizon, mitigation is required only of the mining disturbed bedrock horizon below the building's footprint. In Geoinvestigate's opinion mitigation of the building footprint could be achieved by excavation and replacement or drilling and grouting + special foundation design while grouting may be suitable approaching the main road to avoid instability arising from deep excavation here.
