Site Inspection Report

41 Lamb Hall Road

For Mr R Hossenally

1. GENERAL			
Site address	<i>41 Lamb Hall Road, Huddersfield.</i>		
Client contact	<i>Reshad Hossenally</i>	Tel:	
Client contact		Tel:	
Inspector	<i>James Dalton</i>	Competency	<i>Chartered Engineer</i>
Company	<i>James Dalton Consultants Ltd.</i>	Competency	<i>Chartered Engineers</i>
Address	<i>Three Valieys, Cold Hill Lane, New Mill, Holmfirth, HD9 7JX</i>	Tel:	<i>07784 284661</i>
Report Ref. No	<i>22088/01</i>

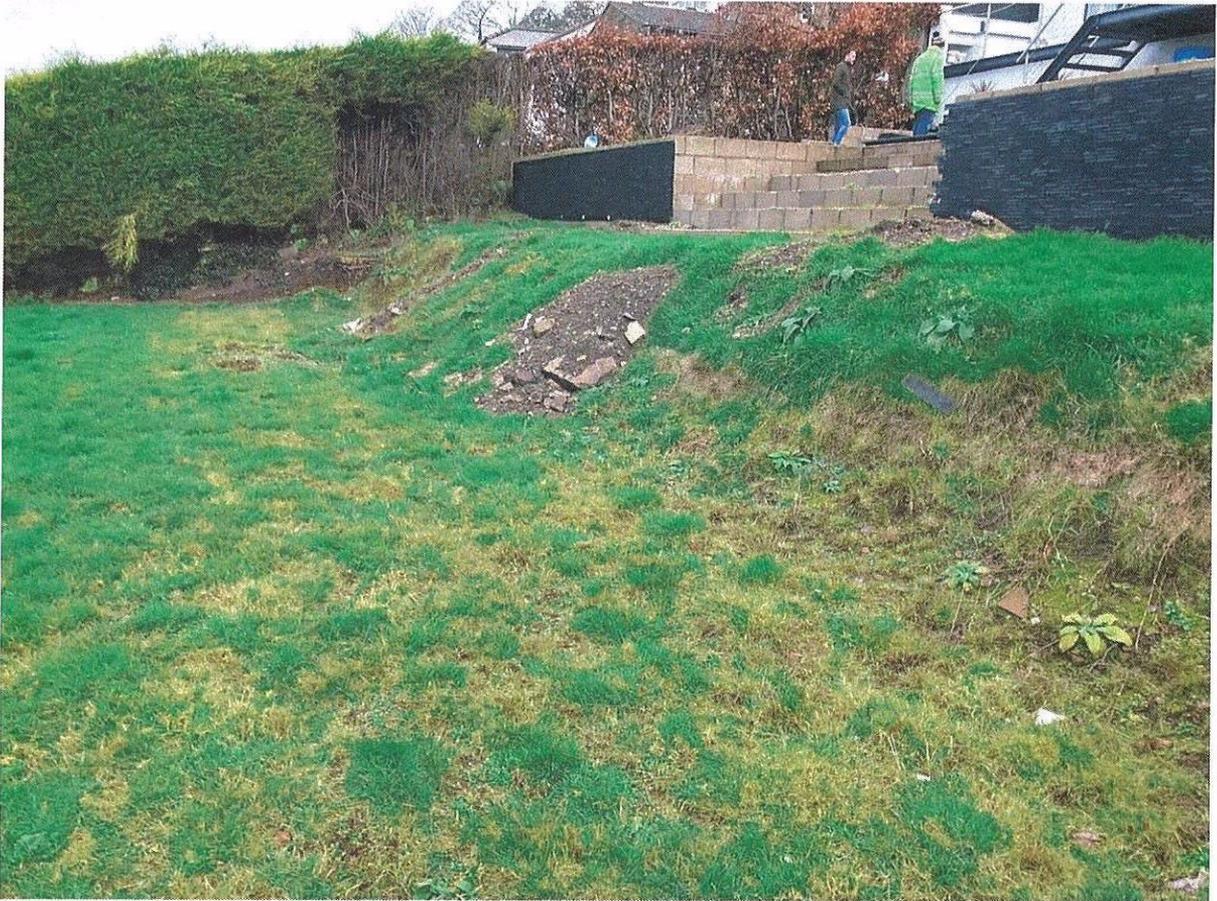
The raised patio surround to the plunge pool area is supported by perimeter retaining walls of appropriate dimensions. The retaining wall has been returned parallel to the boundary of No. 39 so as not to affect the land on the party line.

Photo 1. Top terrace with retaining walls to patio beyond

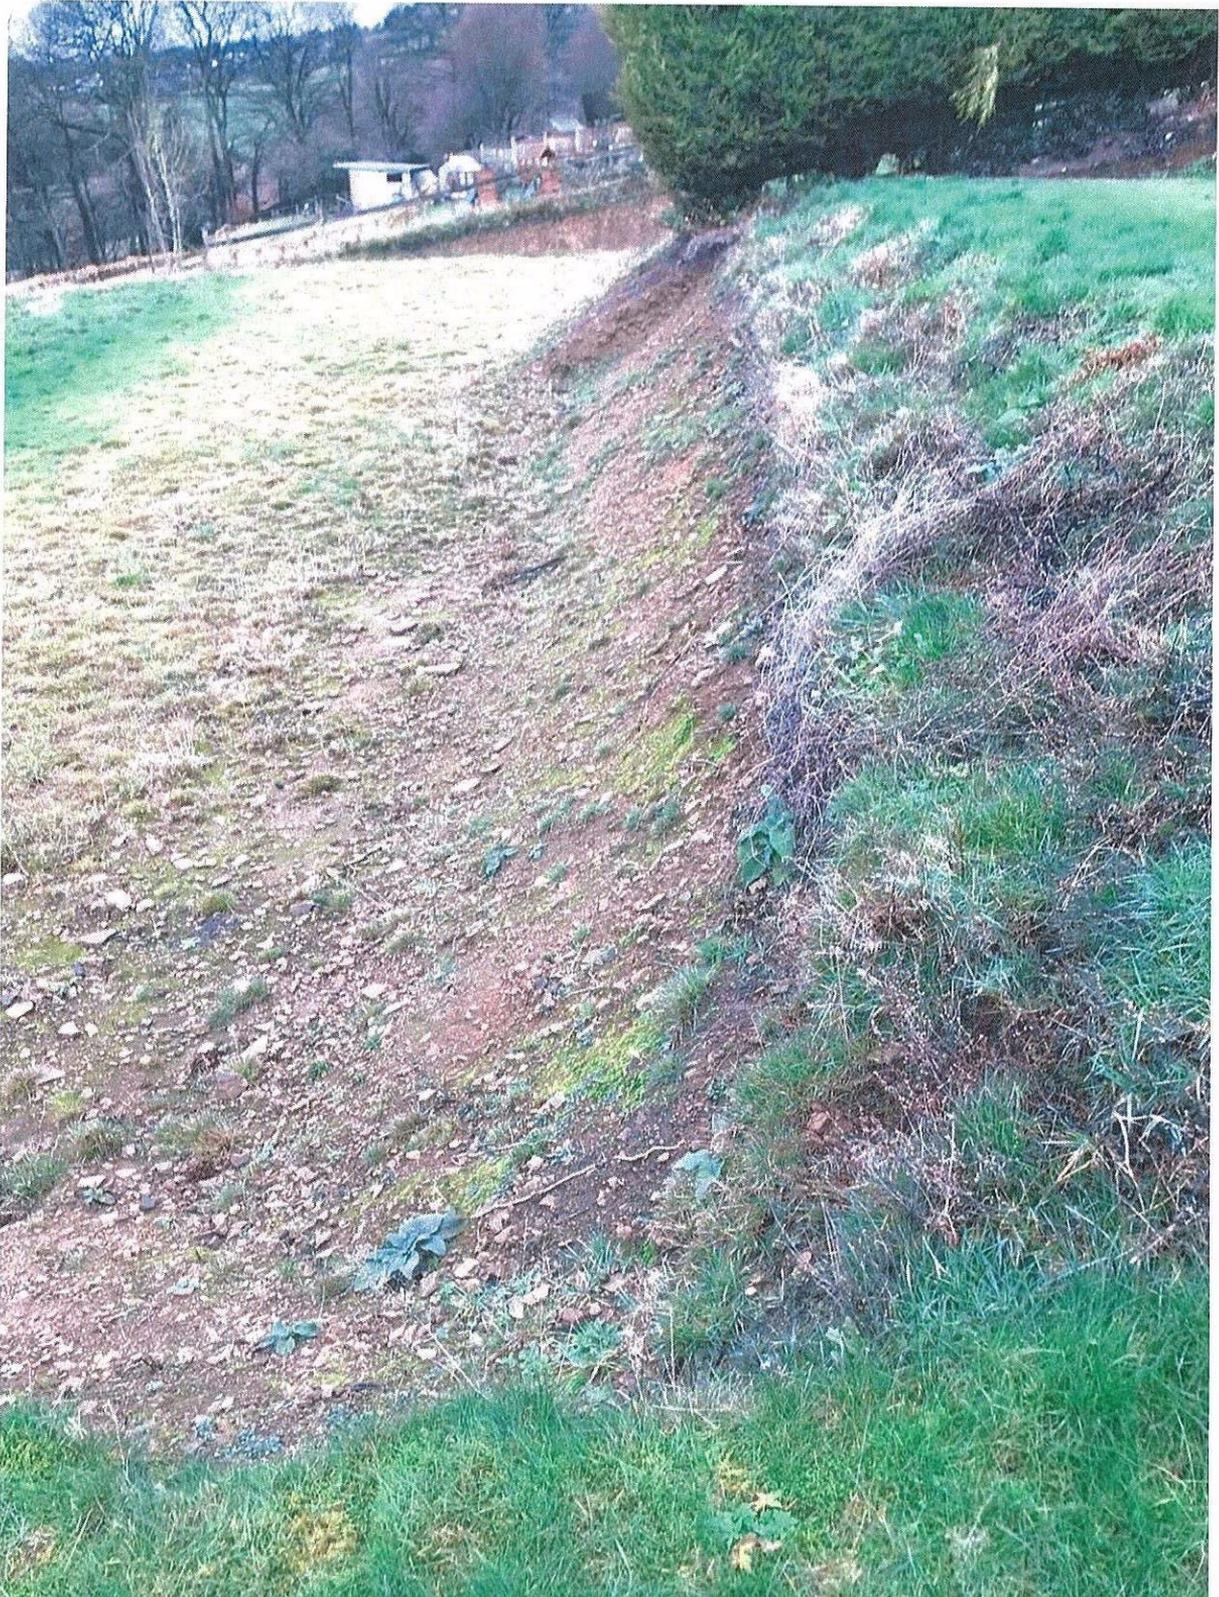
Further down the garden, the earthworks contractor appears to have balanced the cut and the fill such that little or no material has been imported or taken away from site. There are three main terrace slopes as indicated on the ACUMEN drawing. The top two slopes of these are exposed weathered mudrock with the slopes cut to a natural angle of repose. These sloping faces will need seeding / turfing to protect them from weathering and it was confirmed by the client that the intention is to fully grass all surfaces. The two cut face slopes were measured in numerous places with a finished angle of approx 32 degrees.

Photo 2. Middle terrace awaiting turfing

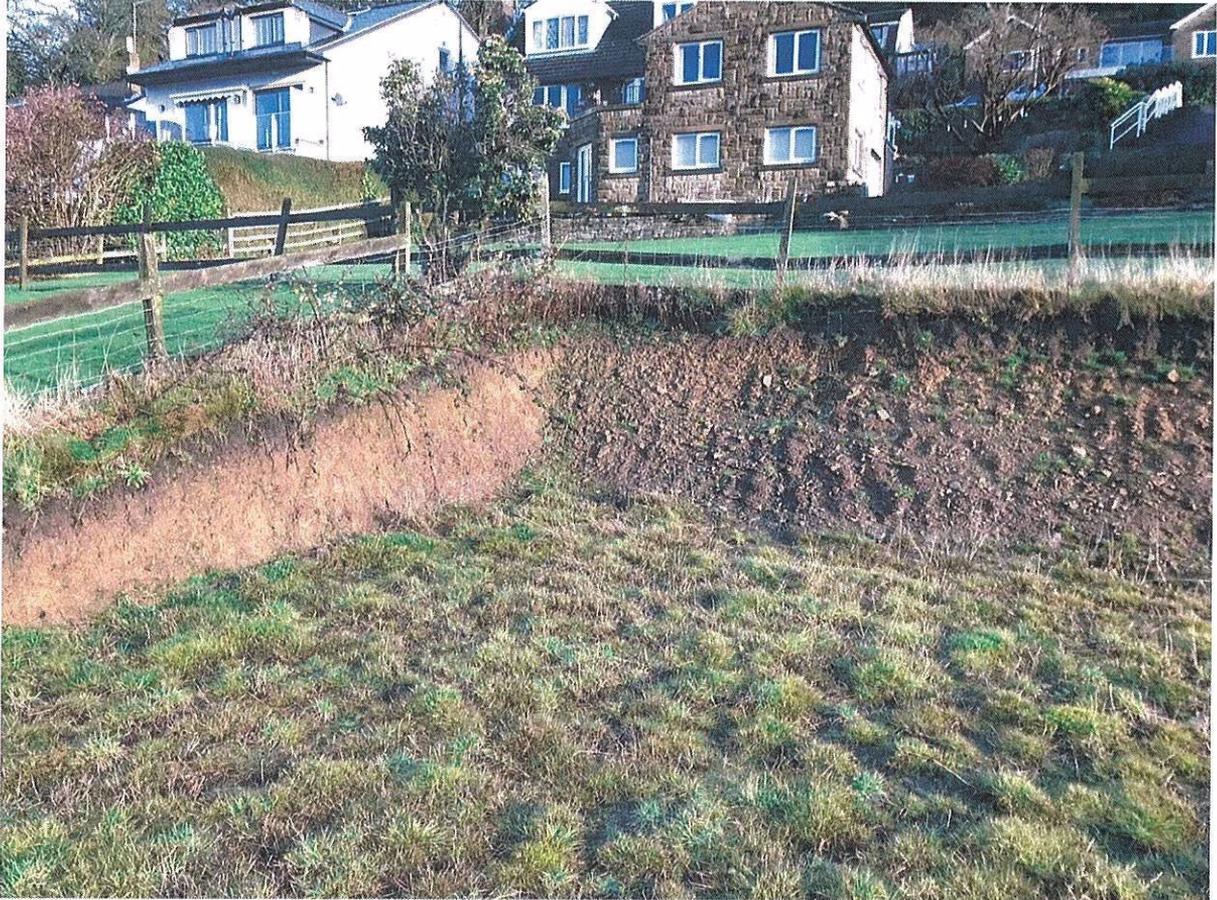
Photo 3. Middle terrace cut faces awaiting turfing

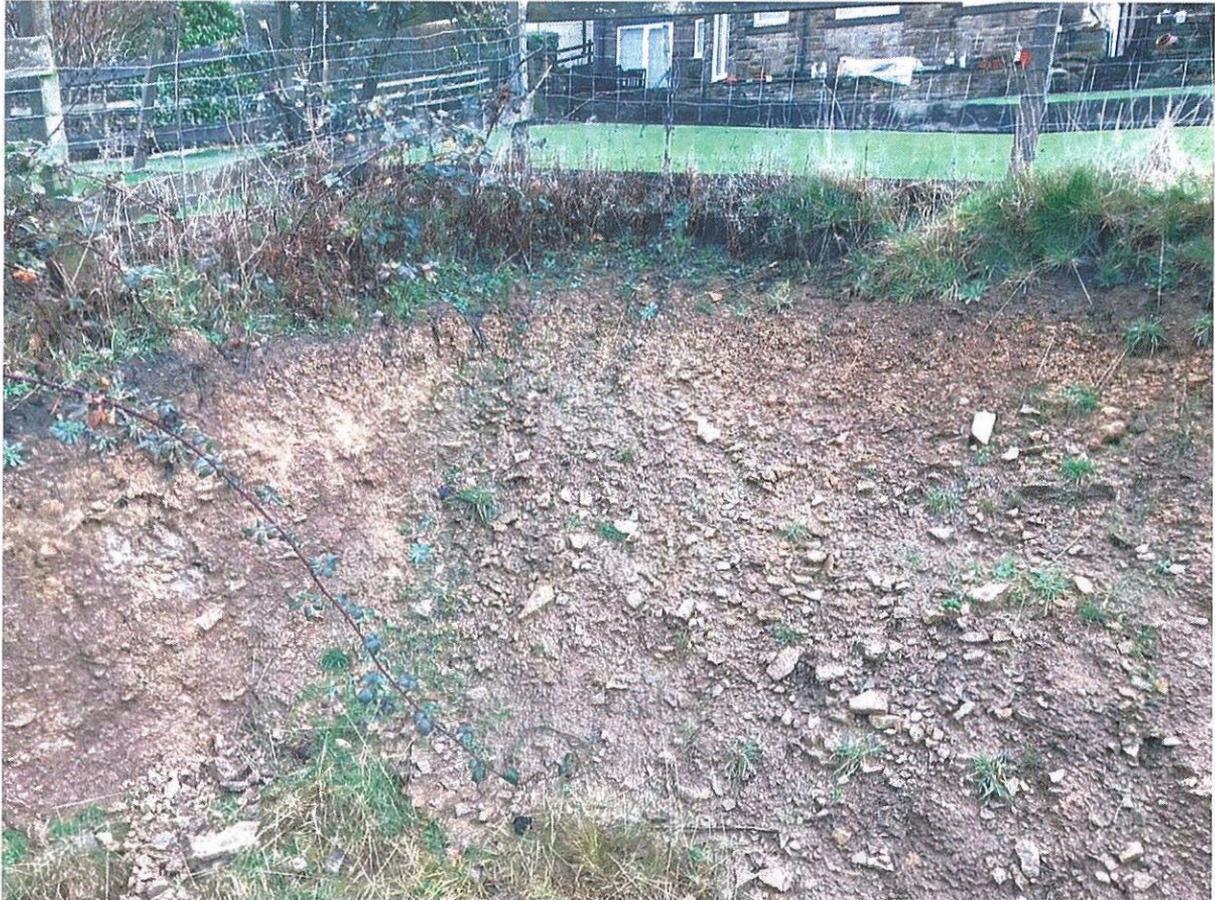
At one location on the boundary (location is highlighted in Appendix B on Figure 1 – marked up site plan) the cut of the slope has encroached, in our view, slightly too close to the boundary with the garden / lawn edge of No 43. A simple limited replacement of material in this location when the slope turfing works are undertaken could mitigate the risk of any possible instability of the neighbour's fence and lawn edge.

The works have no material impact on the boundary with No. 43, save in one location referred to in section 4, indicated on Figure 1 and shown in Photo 4.

Photo 4. Middle terrace cut faces awaiting turfing and nominal additional fill to ensure stability of lawn beyond and the boundary fencepost – See Figure 1 and Recommendation 2.

At one point (as marked on Figure 1) very close to the neighbour's boundary, the excavation has extended right up to the boundary line. We recommend that during the slope finishing / turfing works, a nominal amount of material is reinstated to ensure the neighbour's lawn and fence post remain secure and unaffected.

1. Complete all turfing works to the exposed cut faces of the terracing.
2. Provide nominal additional fill to the location indicated on figure 1 when completing the turfing works to ensure the localised stability of the lawn and the fence posts to the neighbour's garden (See Photo 4).

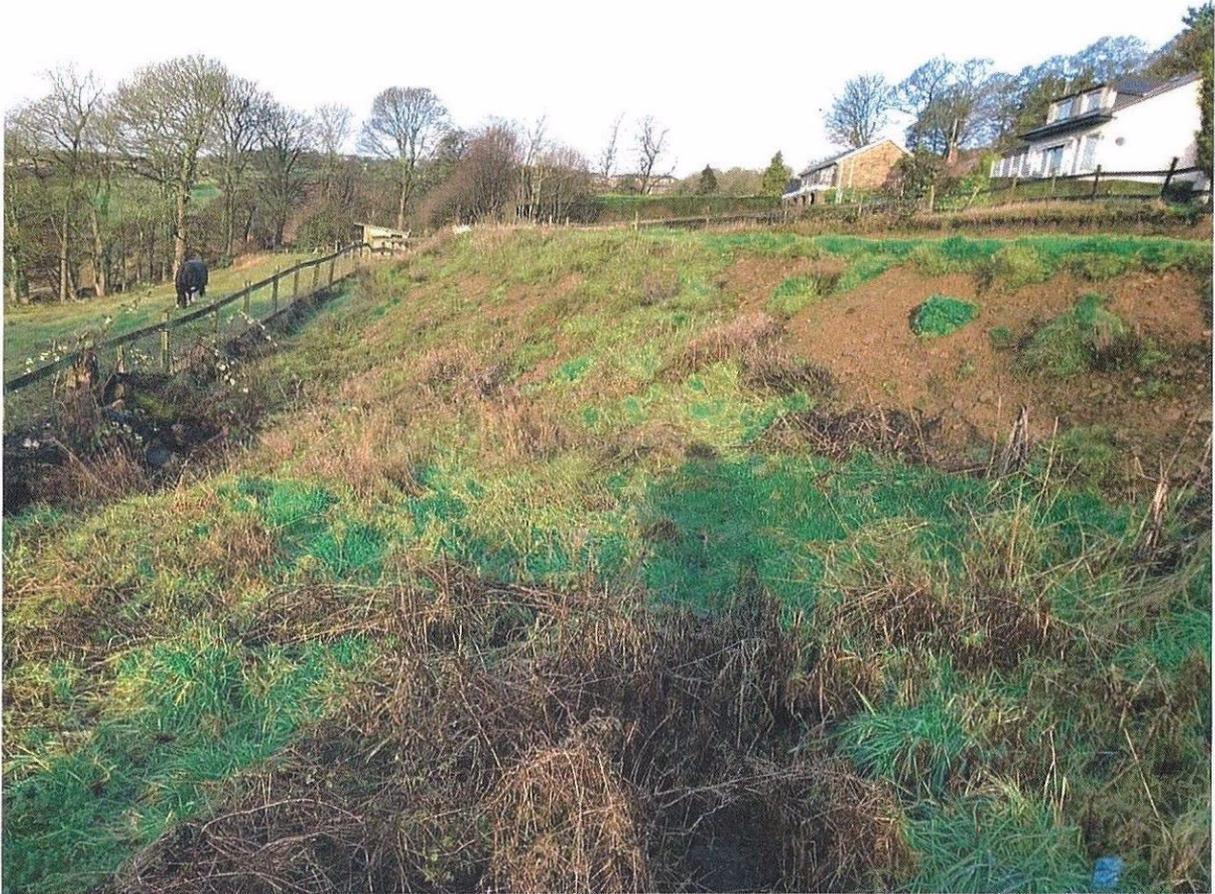
The lowest of the three terrace slopes falls down toward the neighbouring field on the low side of the property. The works have not encroached against the boundary. This slope was also measured at approx 32 degrees, the natural angle of repose and was comprised of the fill, though this slope had partly naturally seeded.

Photo 5. Lower terrace – slope has self seeded in part
