Kirklees Tree Section

Re: UPRN 83120034, 07/76/91 at X 420583 Y 425314,
large Beech in front garden of 81 Upper Lane, Gomersal BD19 4JF

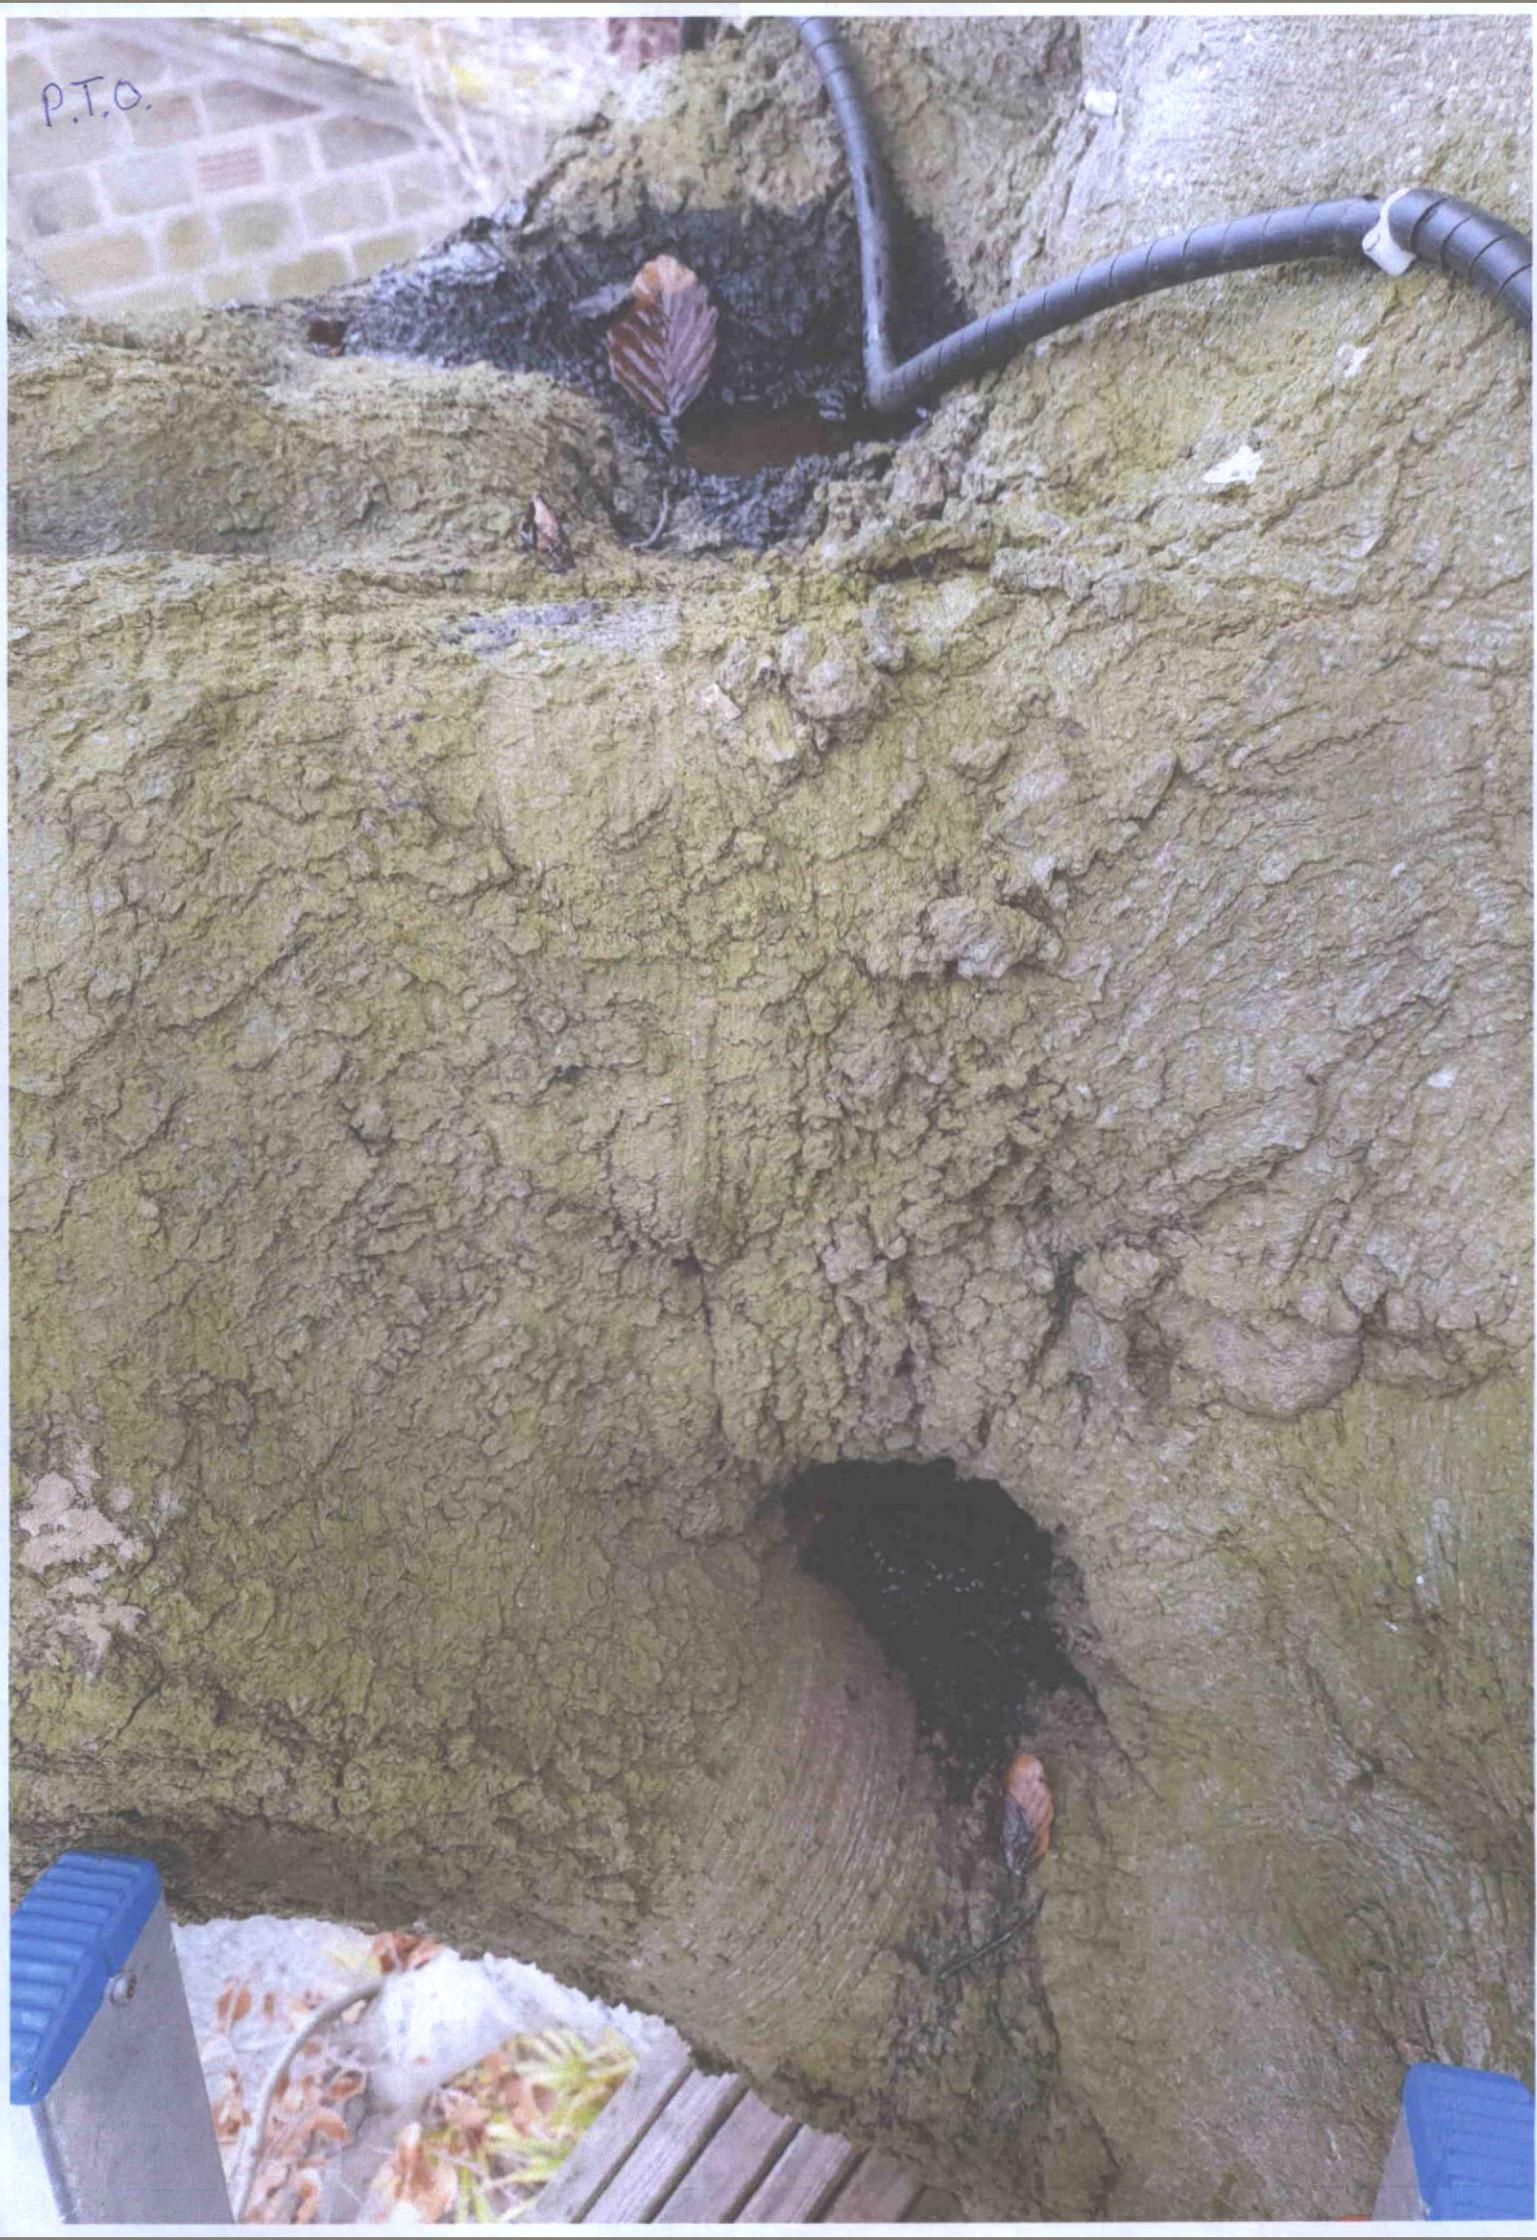
However, that isn't the main subject of this report. There are two pockets of stagnant water at the base of the large limb that leaves the main trunk toward the house then turns toward the boundary wall. Both pools are larger than a tennis ball and I found the bottom of each to be soft with rotting material and the smell was sufficiently bad to confirm the presence of decay. In all other respects the limb looks healthy, but the potential for structural compromise that these two pools present, coupled with the extreme length and weight of the limb, make it a candidate for failure as the rot penetrates and spreads.

I have consequently advised the removal of this limb and an adjacent stub left from previous work which has no apparent signs of life, with an overall aerial inspection and dead wooding.
