## CCTV Survey

Customer	9 BIRKBY ROAD (CORBY)	Resource	Jamie Payne
Contact	David Irving		
Address	Birkby Road Huddersfield HD2 2DR	Job type	Commercial CCTV Survey
		Reference	COM-CCTV26037
		Order number	David Irving
		Date	28/06/2023 03:00 - 11:00
		Job duration	08:00:00
		Driving duration	00:00:02
		Distance travelled	0 mi

Notes CCTV survey of 100m long culvert (Site contact David Irving 07931774788)

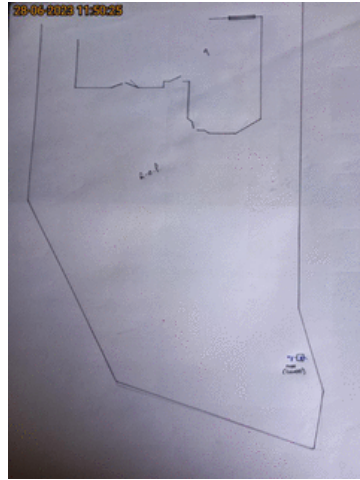
Unable to continue down pipework as is full with silt.

Tanker attended and could not clean through site manager said irving has advised to stop work and is going to dig trenches to expose pipework and potentially continue from there.
