Final Gas Membrane Installation

Validation Report

Myra Homes

(Plots 2,5,6,7&8)

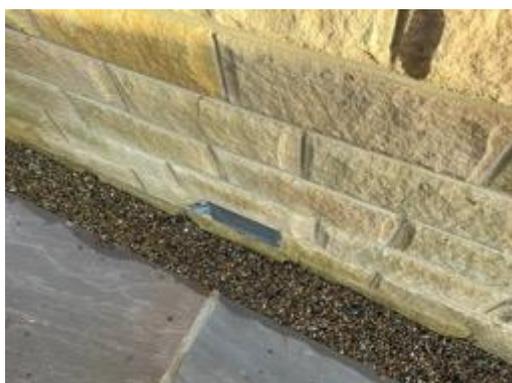
Sealed Airbrick

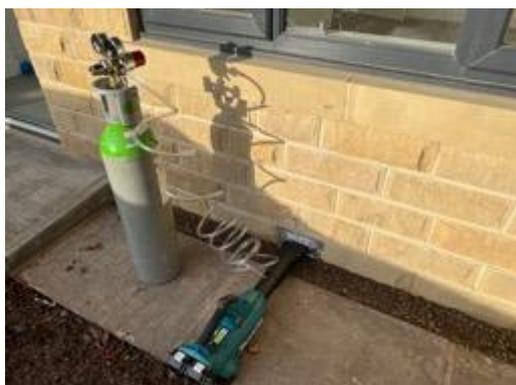
The gas injection point consisted of a Makita air blower with a 10mm nylon gas tube fitted to the face of the air brick then sealed with duct tape, the gas was then introduced into the void at a rate of 20 l/min, the blower fan was turned on and set approx. to a blow speed of 2m/s at the air brick (see below photo).

Gas Injection Point

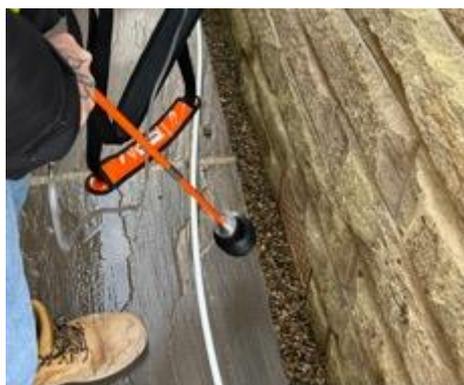
Gas Egress Point

After a period of 2 minutes the test egress point was swept to ensure that the tracer gas was registering and elevated reading at the gas egress point. The start reading at the egress test point was 1340 ppm. (see above photo) On this basis the internal sweep of the property commenced.

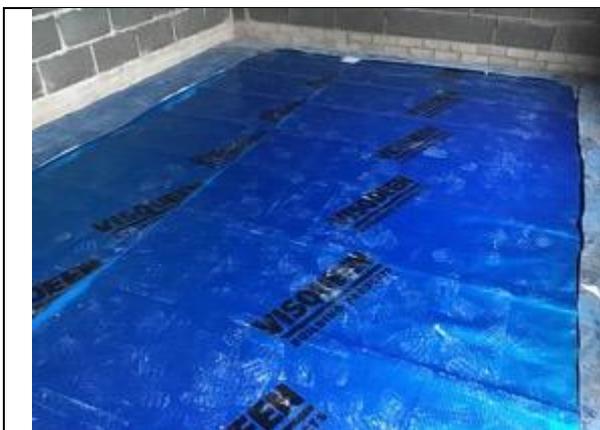
Plot 7 infill installation

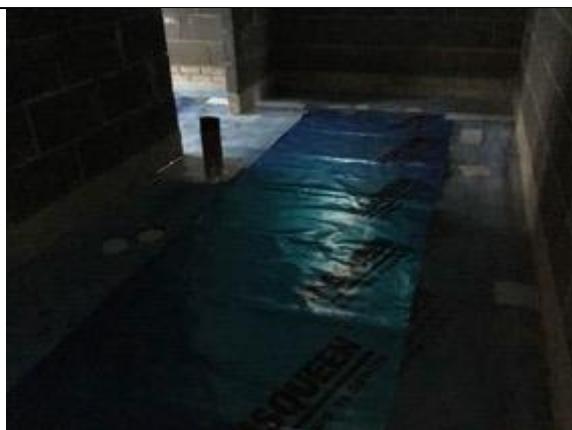
Plot 7 infill installation

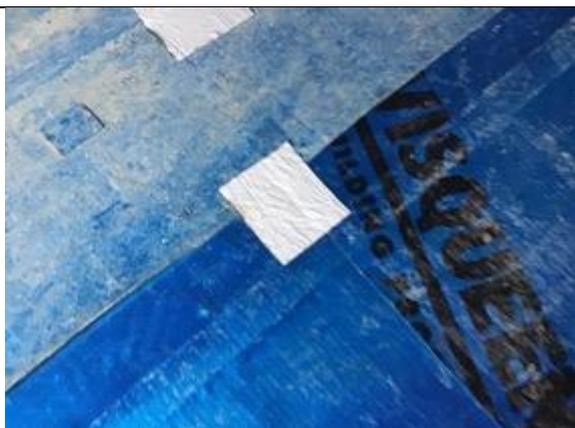
Plot 7 T joint SAGM patch

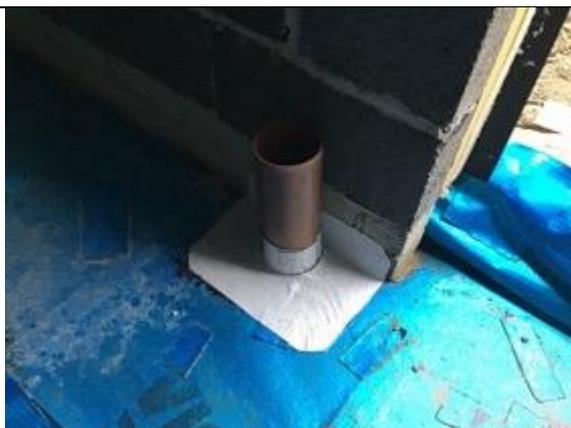
Plot 7 sealed pipe penetration

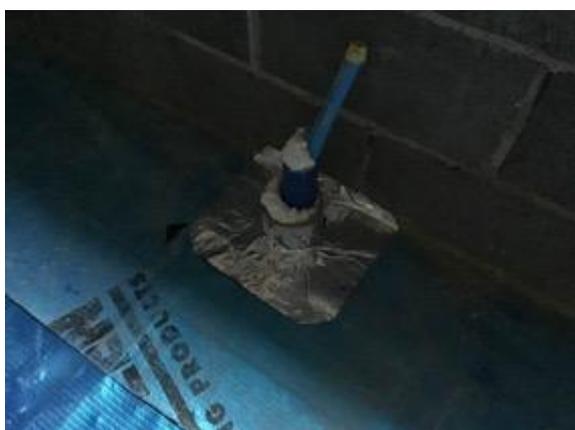
Plot 8 sealed pipe penetration with expanded foam filler between water main and duct

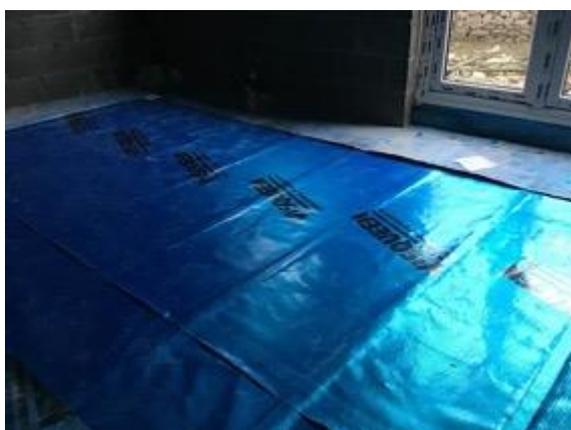
Plot 8 infill installation

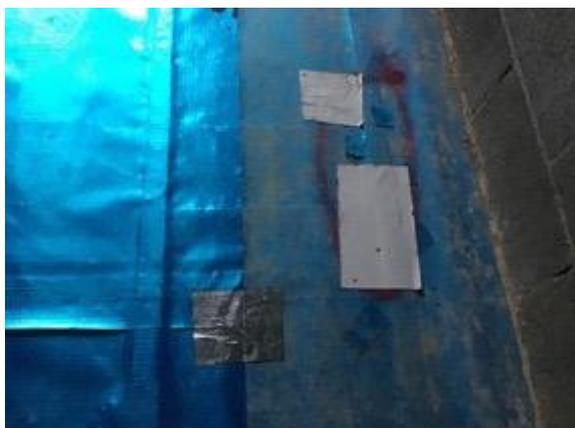
Plot 8 T joint SAGM patch and patch repairs

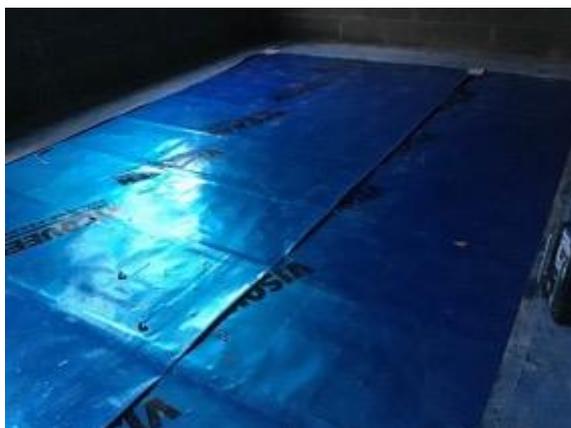
Plot 8 infill installation

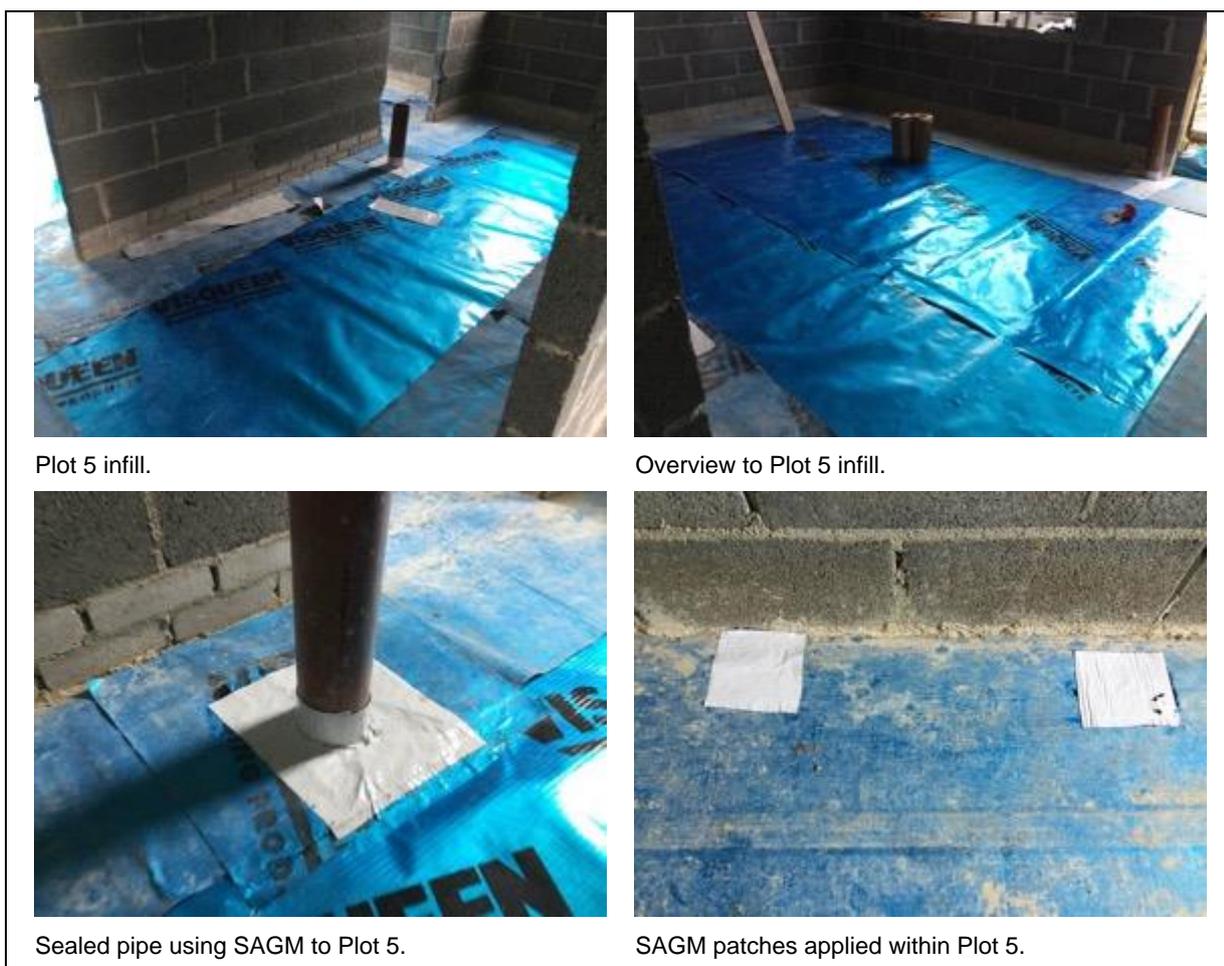
Plot 5 infill.

Overview to Plot 5 infill.

Sealed pipe using SAGM to Plot 5.

SAGM patches applied within Plot 5.

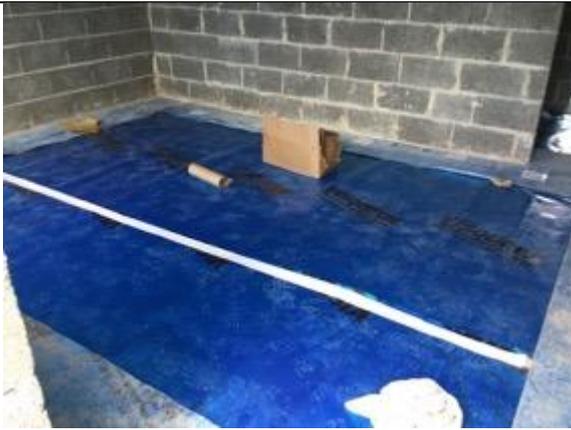
Overview to Plot 6 infill.

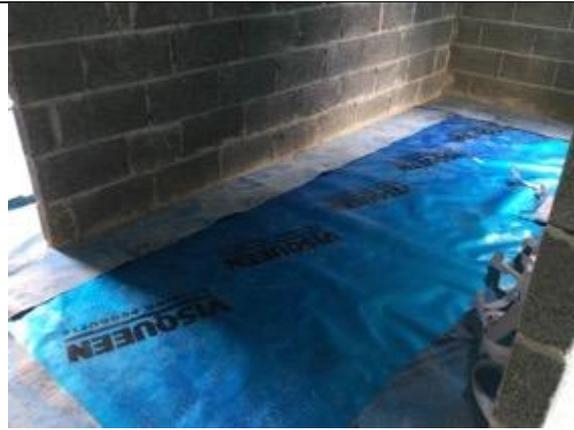
Plot 6 infill.

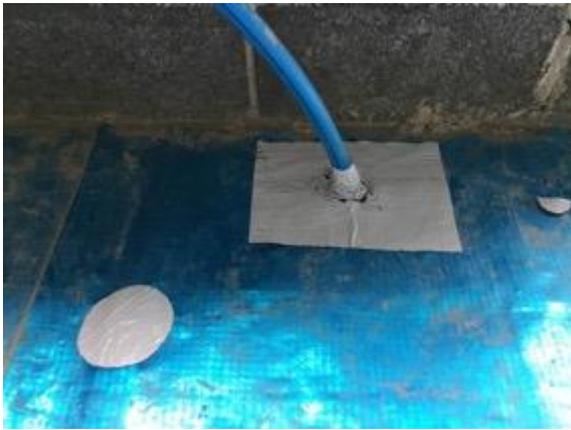
Water pipe sealed with SAGM.

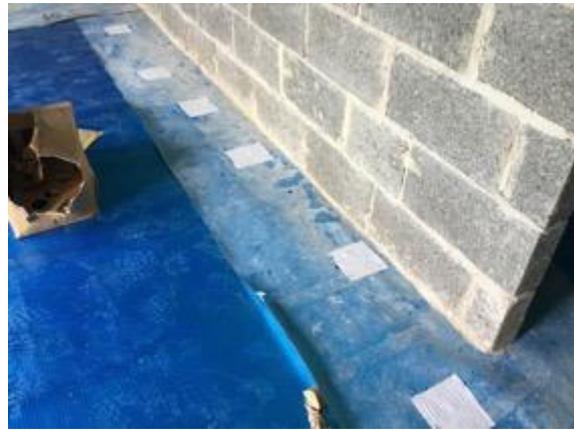
Overview showing the SAGM patches applied within Plot 6
