Blake Lea Lane, Marsden

Photographic Record of Condition

Of Blake Lea Lane Highway Retaining walls

Thursday 19th October 2023

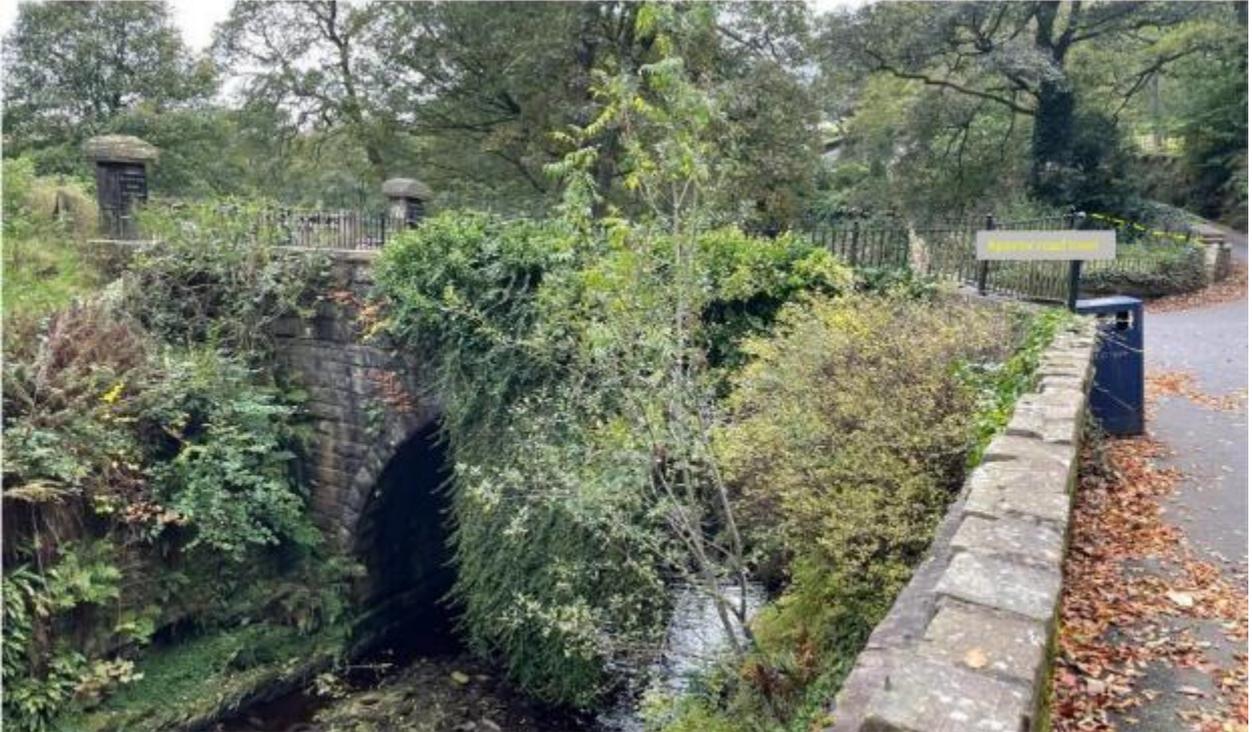
View on Waters Road looking towards start of Blake Lea Lane, section A

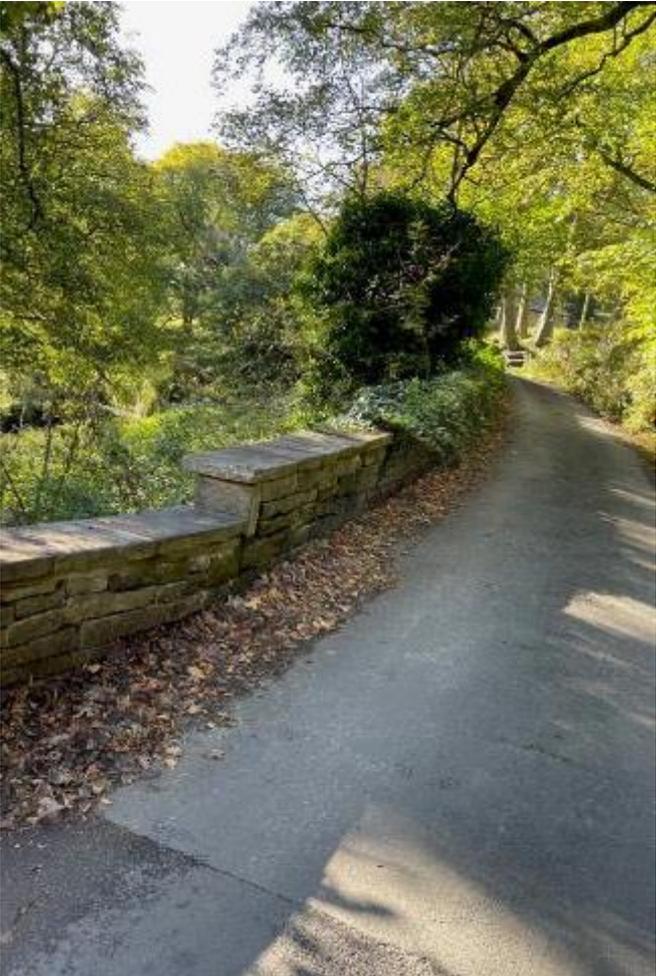
The visible roadside face of the drystone wall looks regular in verticality, although there are one or two instances of larger vertical joints, indicating some previous possible movement or rebuilding of the wall.

Section A - roadside face of wall

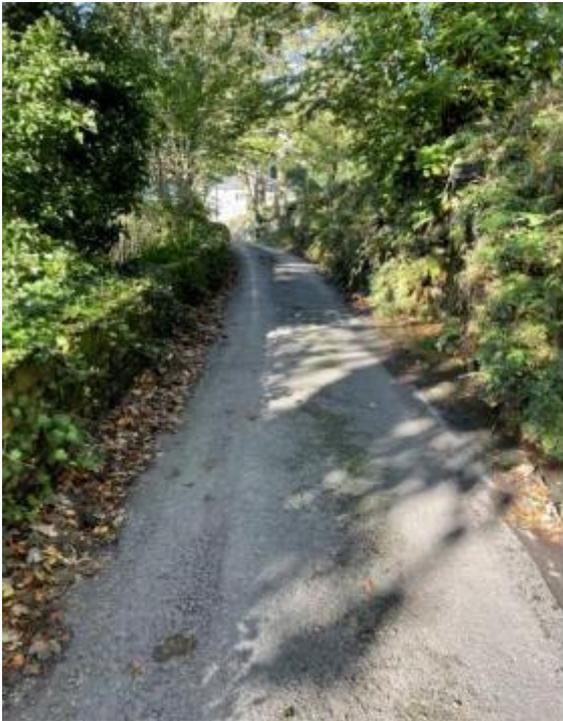
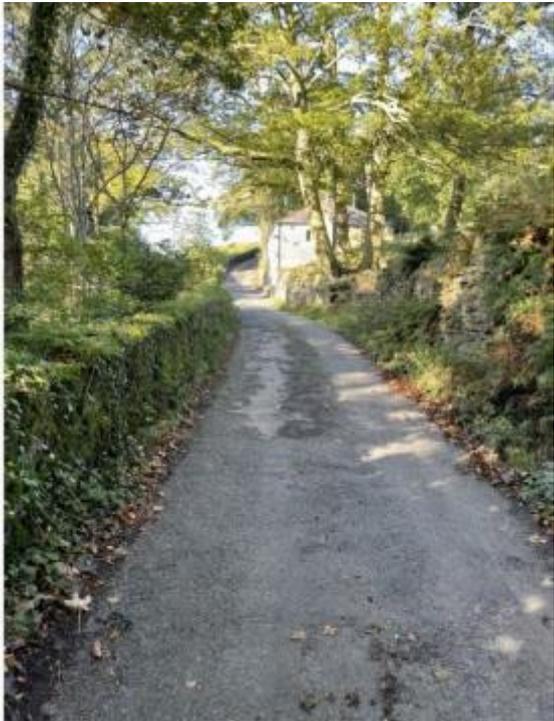
Highway wall A at start of Blake Lea Lane, from roadside

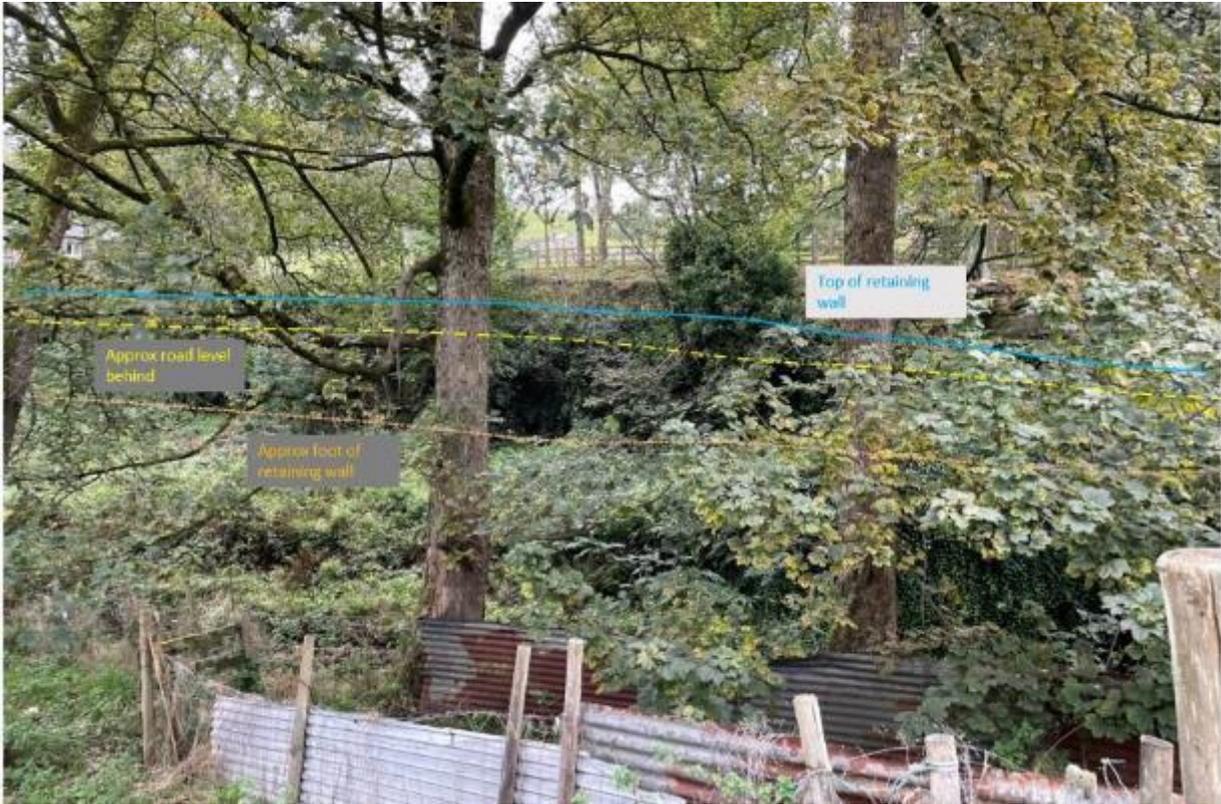
To both faces of upstand of this wall there is vegetative growth of ivy. There are also a number of significant trees and bushes growing out of the vertical channel bank face.

View from across the bridge, looking at rear channel side of highway, section A

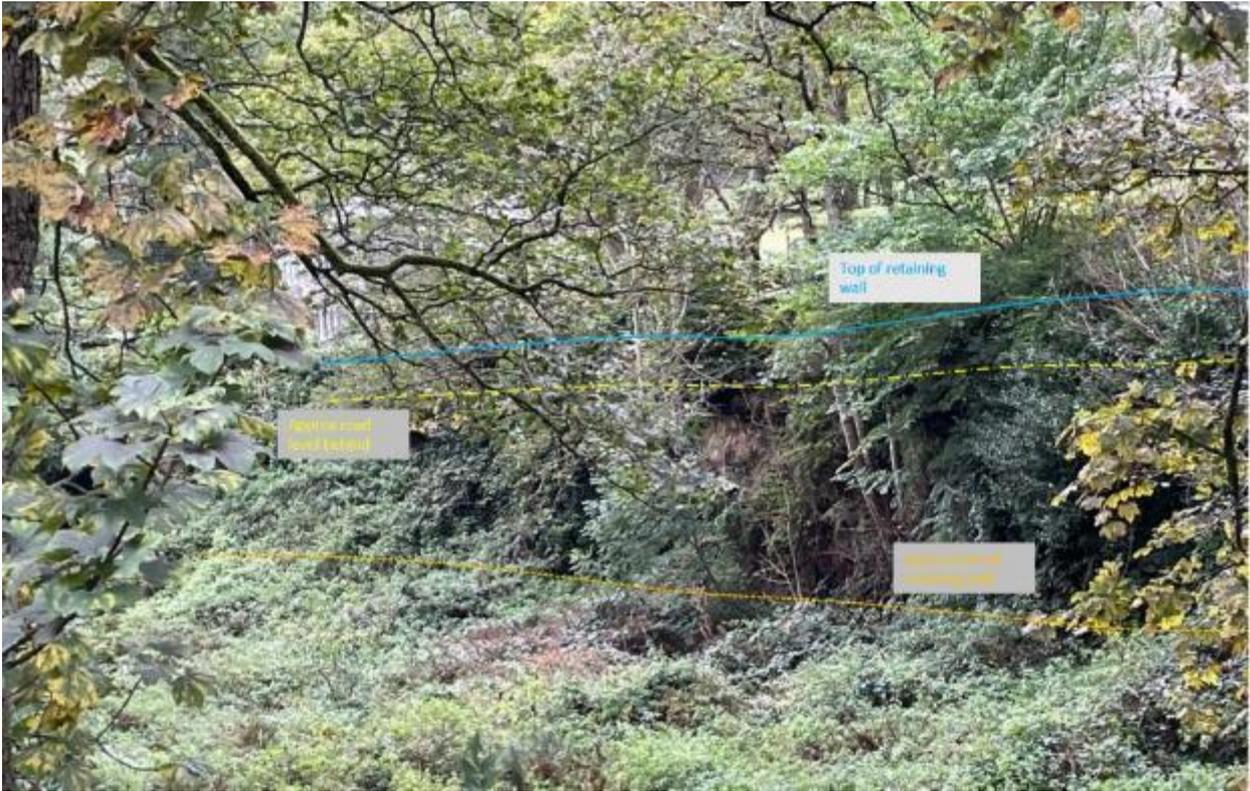
View from across the bridge, looking at rear channel side of highway, section A

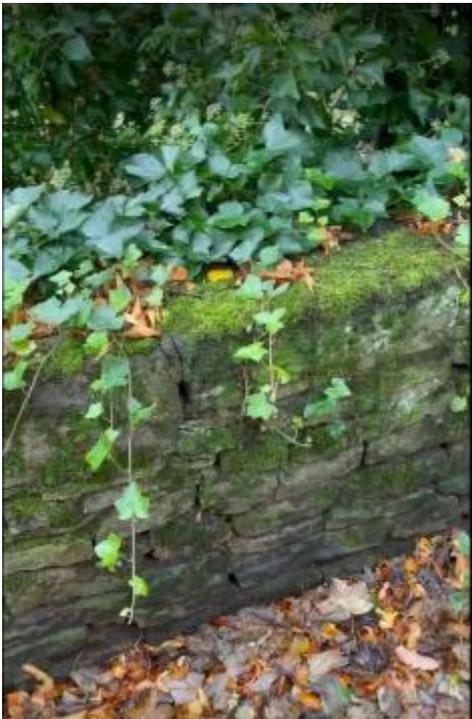
Start of Blake Lea Lane - View of dry-stone wall A, from roadside, with ivy vegetation and enlarged joint

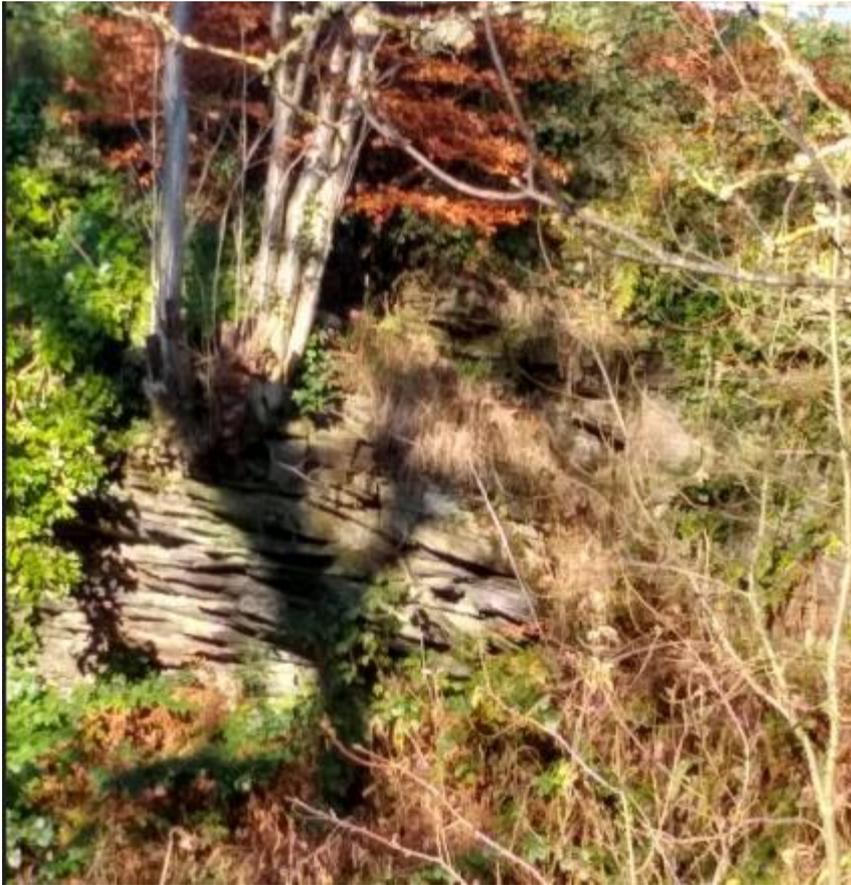
There is extensive vegetative growth out of the stone banking, however there is no indication of any significant distress within the highway wall.

Rear of highway section A, showing natural stone outcrops forming support to highway

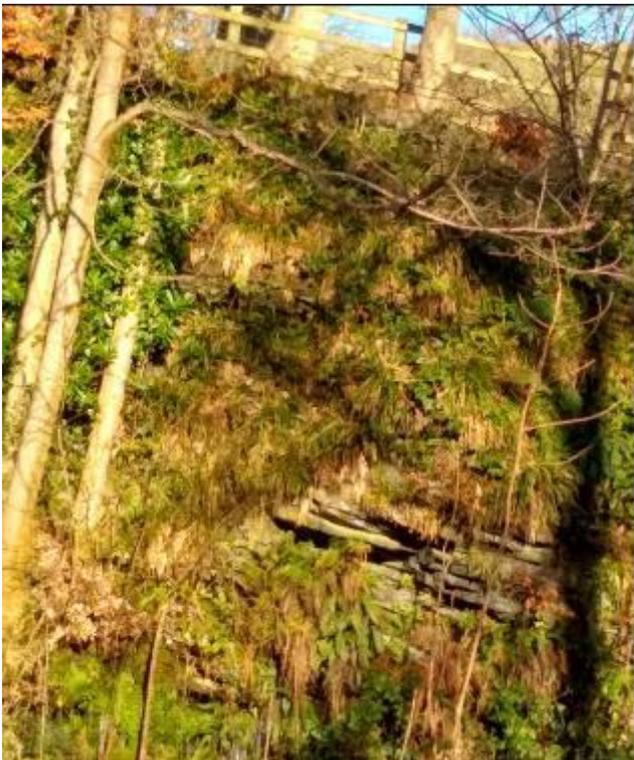
Rear of highway section A, showing natural stone outcrops forming support to highway

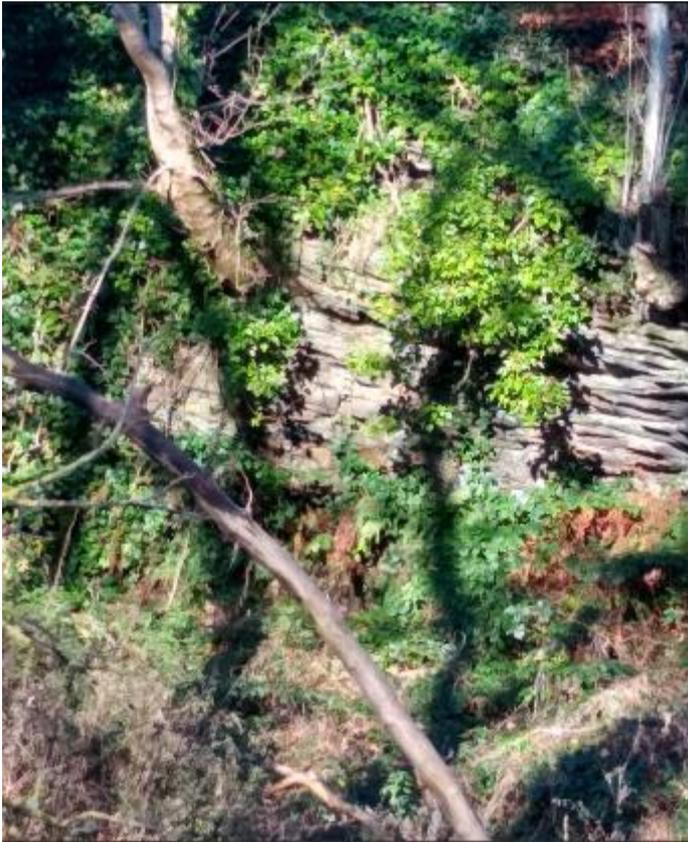
Rear of highway section A, showing natural stone outcrops forming support to highway

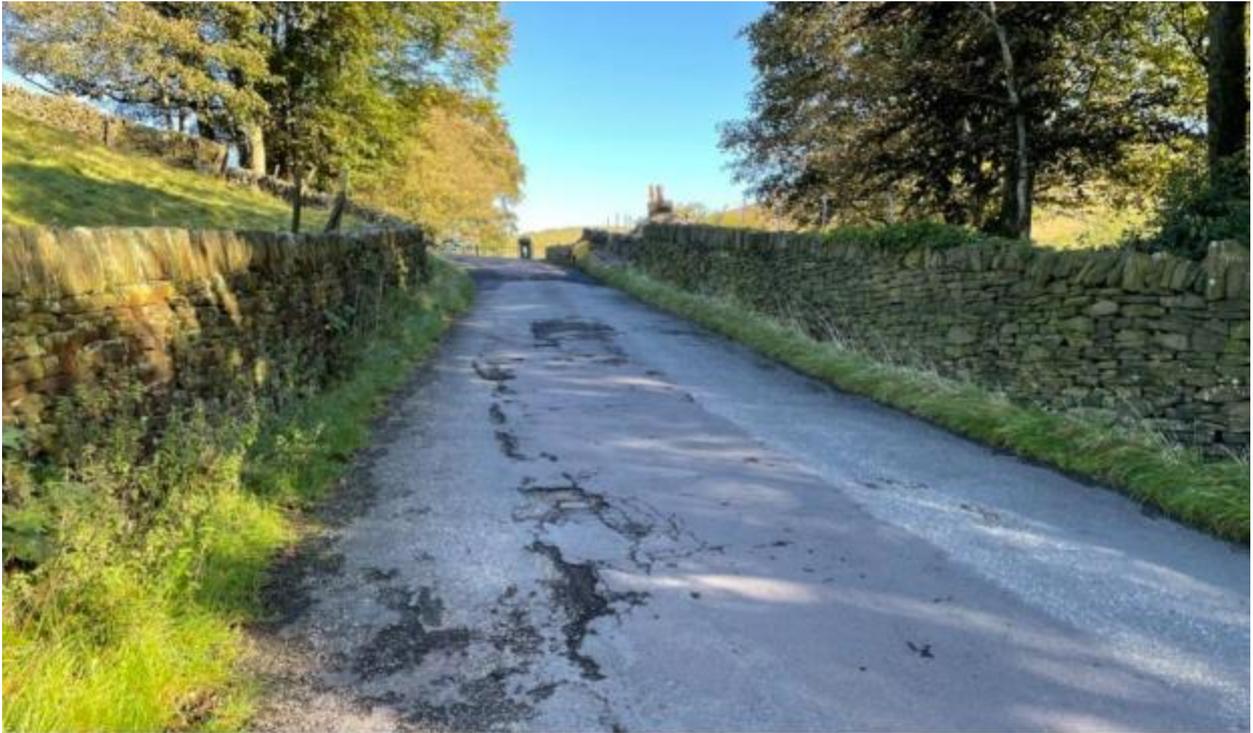
Roadside view of Section B wall (on RHS as heading up to reservoir)

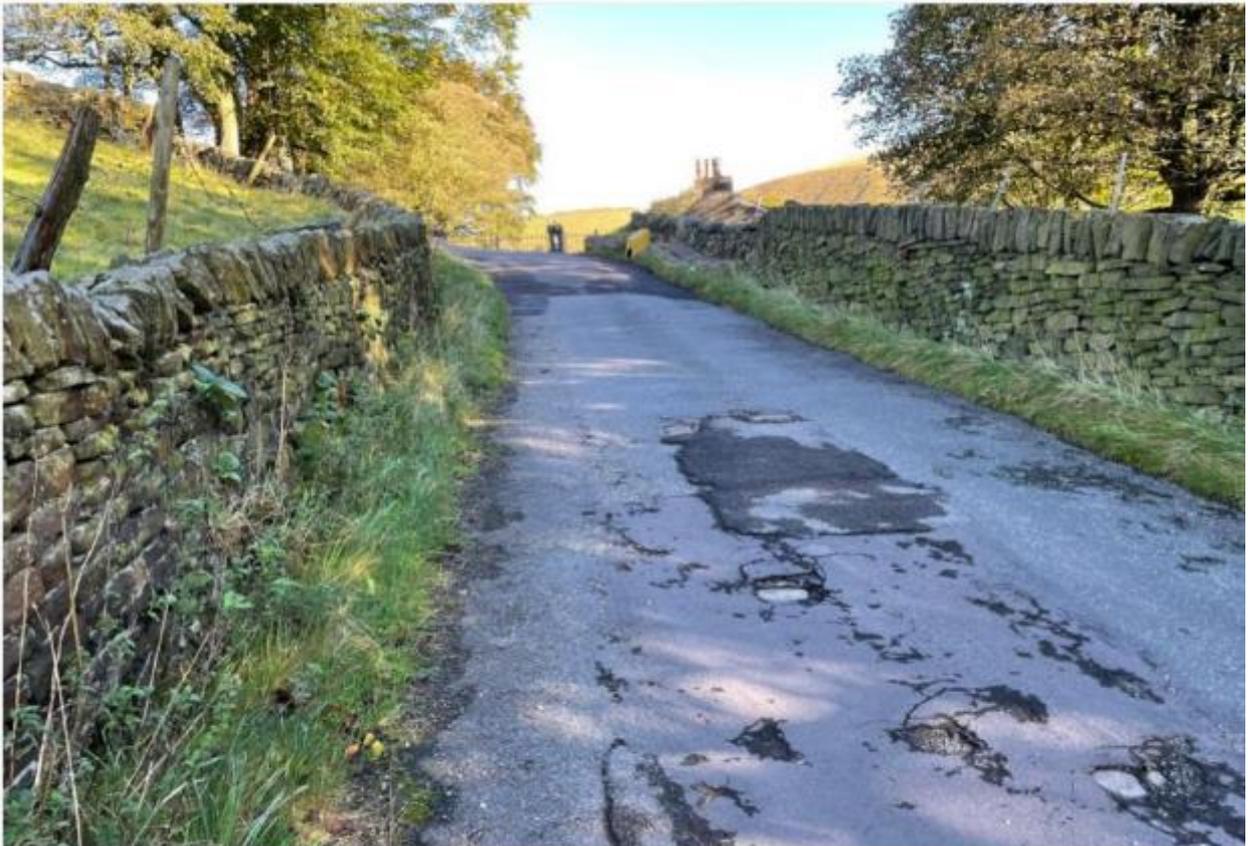
Roadside view of Section B wall (on RHS as heading up to reservoir)

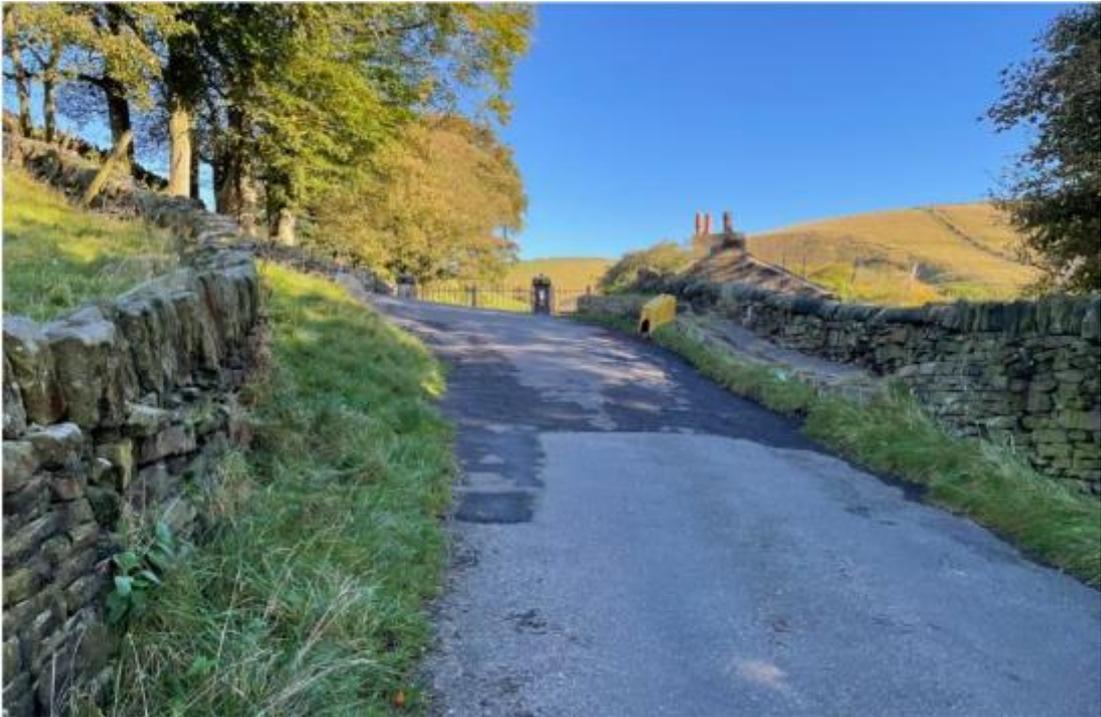
Roadside view of Section B wall (on RHS as heading up to reservoir)

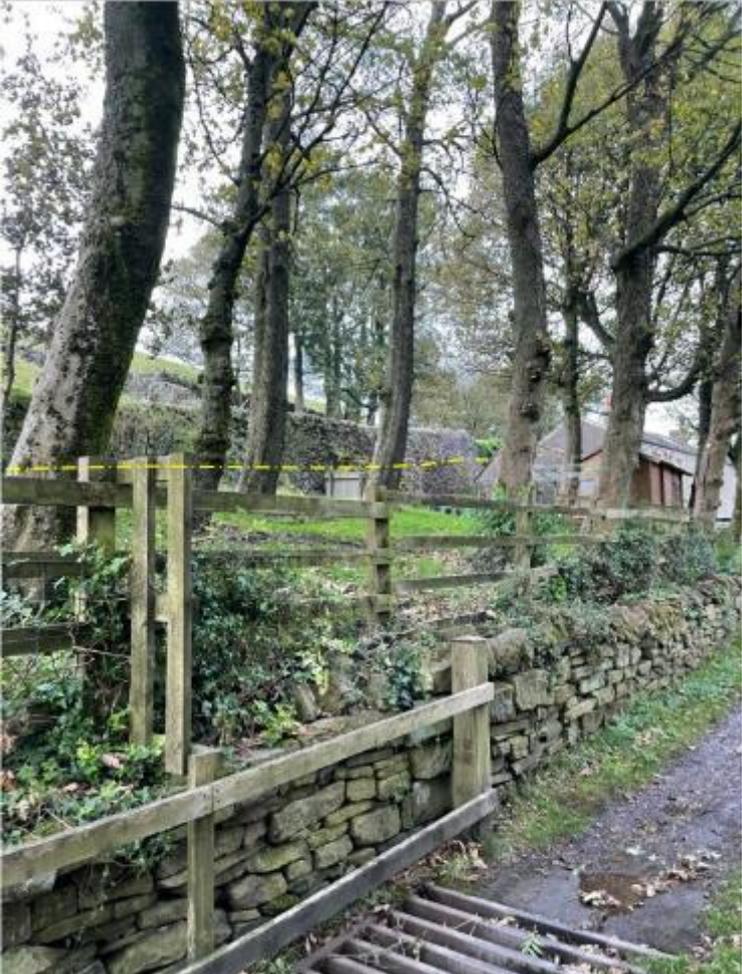
Blake Lea House - view from drive

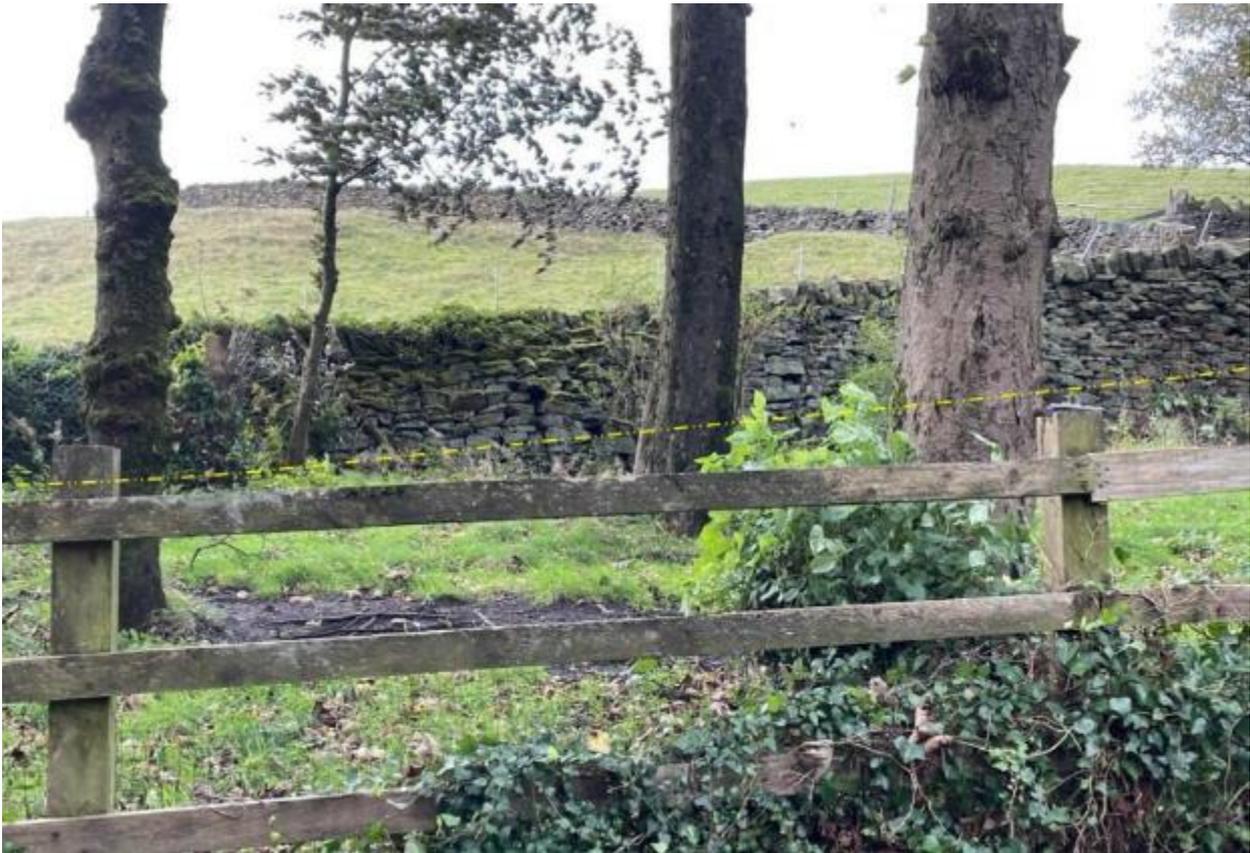
Rear view of Section B - with approximate road level shown as dotted yellow line

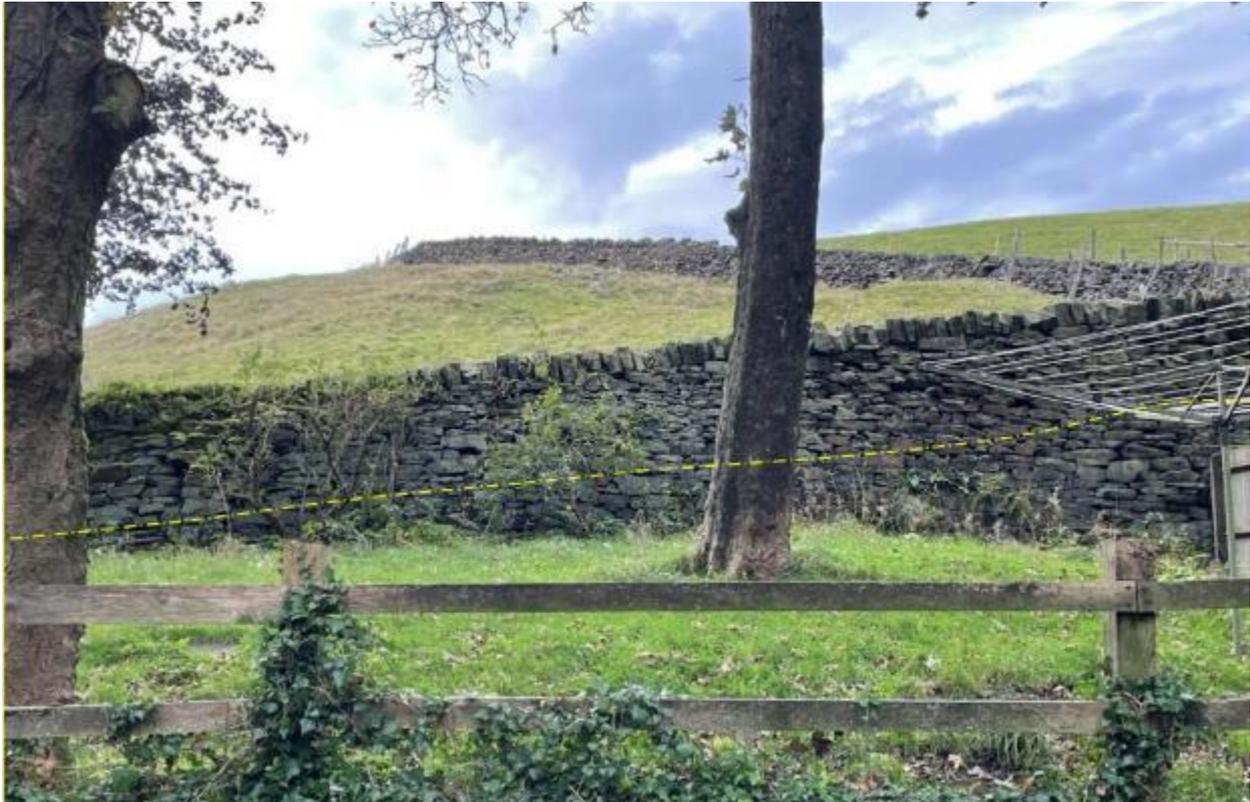
Rear view of Section B - with approximate road level shown as dotted yellow line

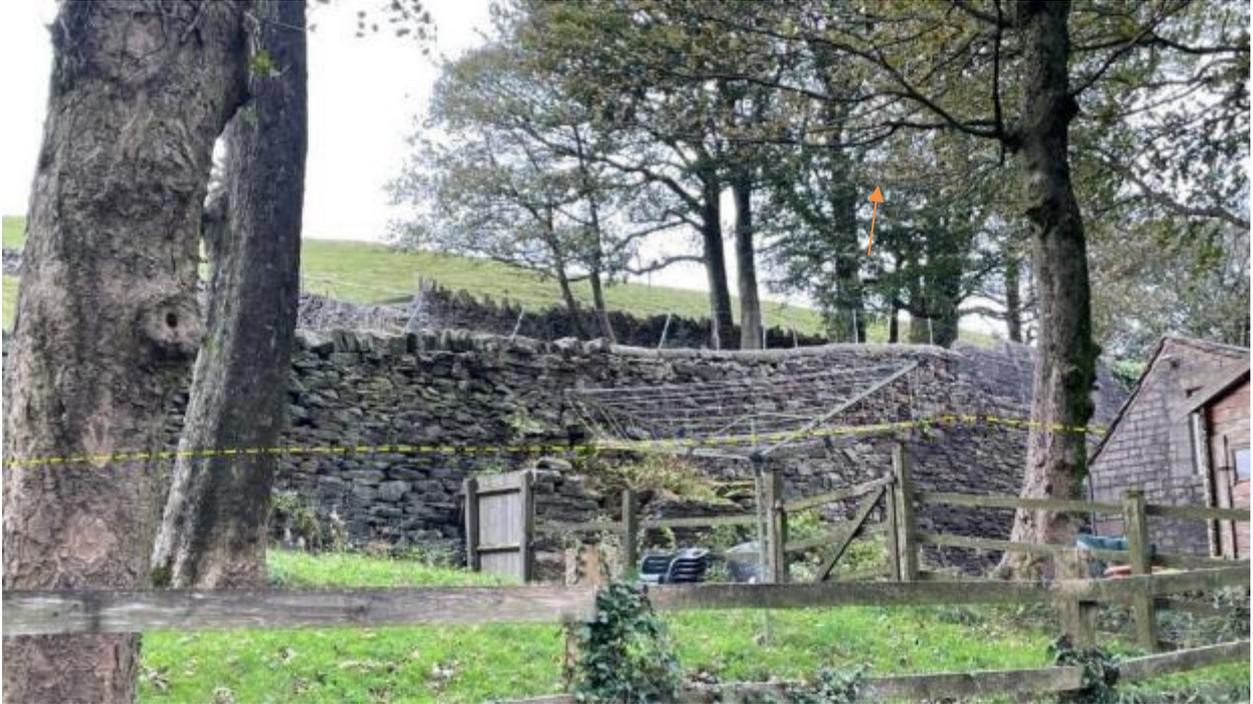
Rear view of Section B - with approximate road level shown as dotted yellow line

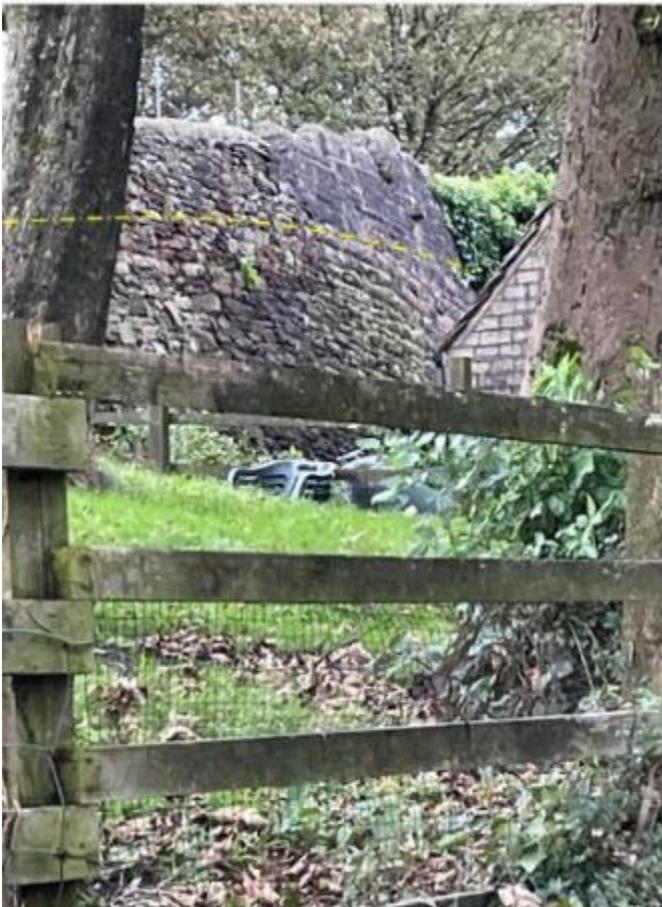
The dry stone wall where it sits above Blake Lea House, has been rebuilt from road level up, using larger stones, and is now mortared on the back face.

Rear view of Section B - where wall is behind Blake Lea House & upper section has been rebuilt & mortared

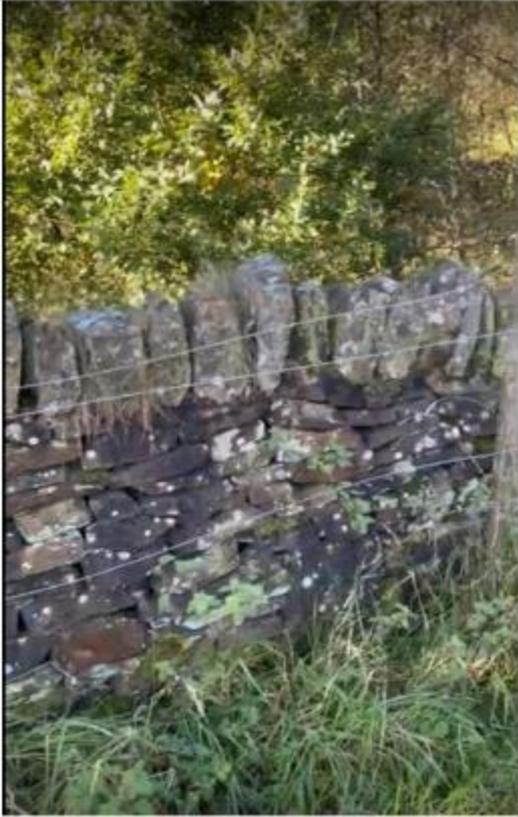
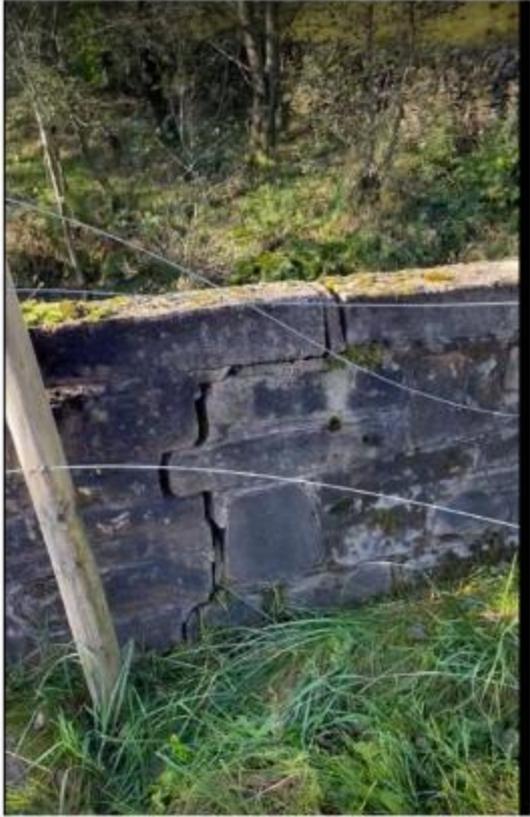
The dry stone wall generally looks in good condition, with some coping stone replacement having occurred.

Typical roadside views of Section C wall
