Ref C578/01/ATS

**Ref: Shallow Mining Investigation on land off Briestfield Road, Briestfield, Dewsbury, West Yorkshire**

# Report on a Coal Mining Risk Assessment

Report No. C2143/21/E/3305

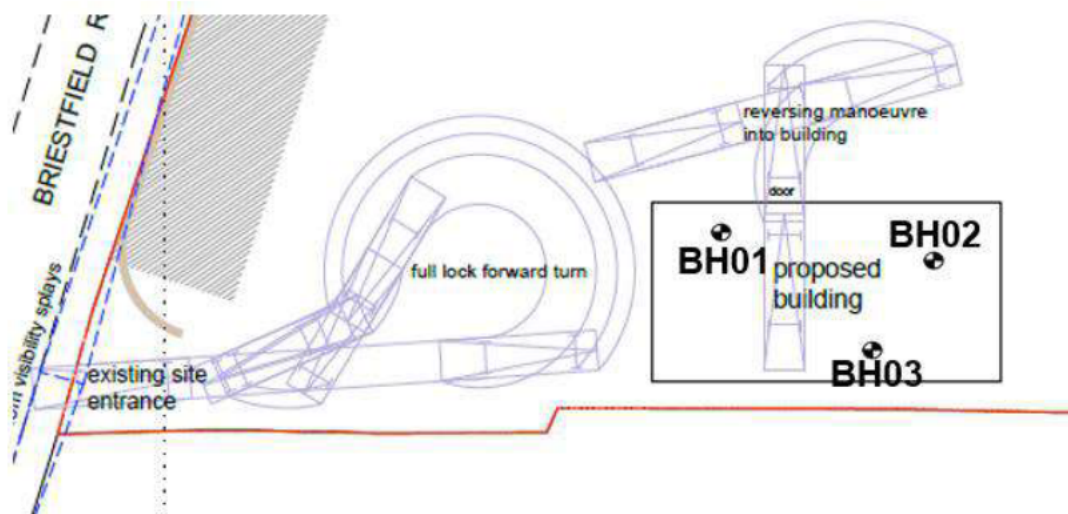
The locations of the exploratory holes are shown below.
