Gas Membrane Installation  
Validation Report  
Holroyd Homes  
Huddersfield  
HD4 7HB  
Version 6 05/06/23

| Housebuilder Name: Holroyd Homes | | Plot Number: 4 & 5 | |
| Site Name: Fold Farm, Huddersfield, | | Detached House | <input checked="" type="checkbox"/> |

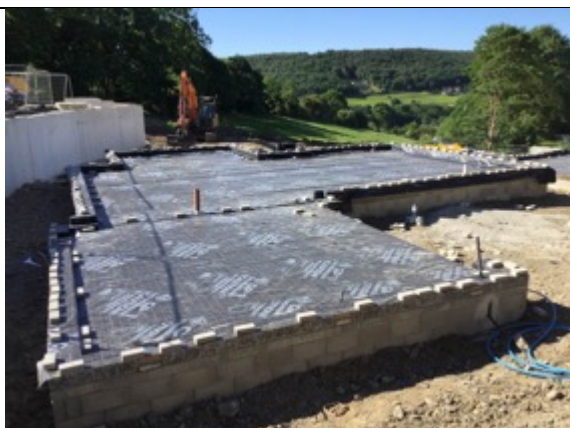
Overview photo looking at Plot 4"

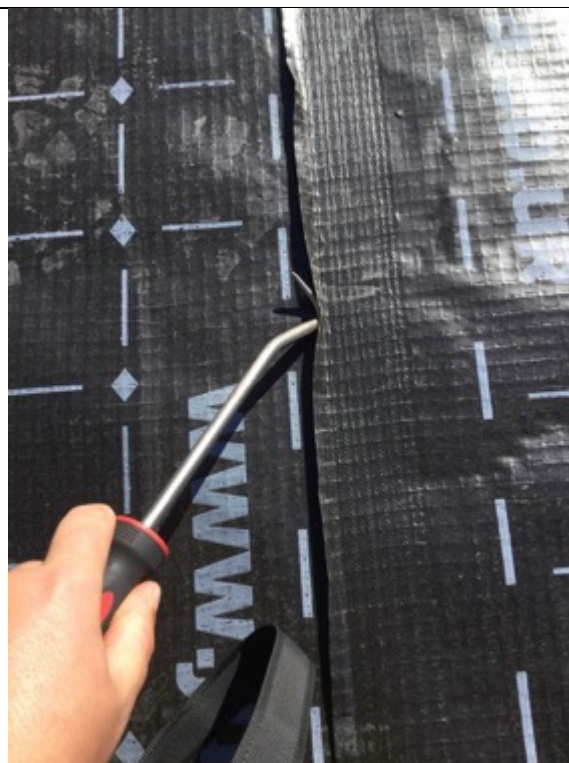
Pick probe testing carried out to the mechanical weld joint.

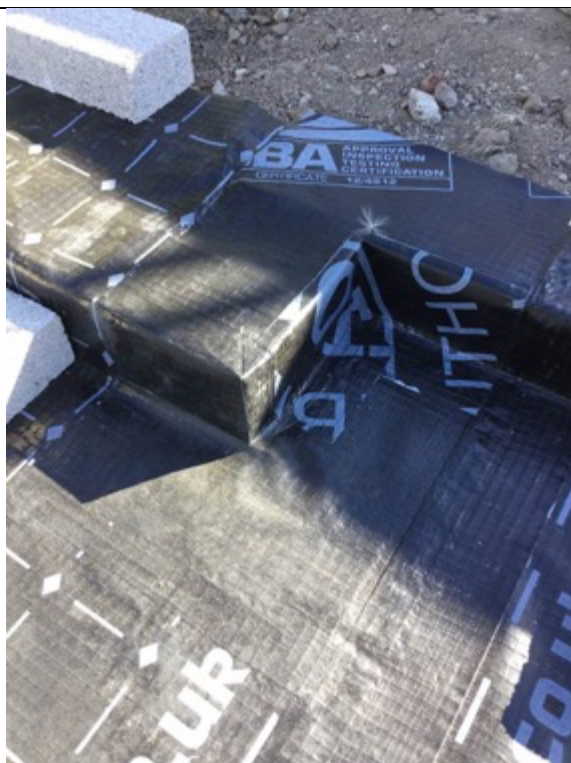
Close up showing the pre formed corner details for this doorway threshold.

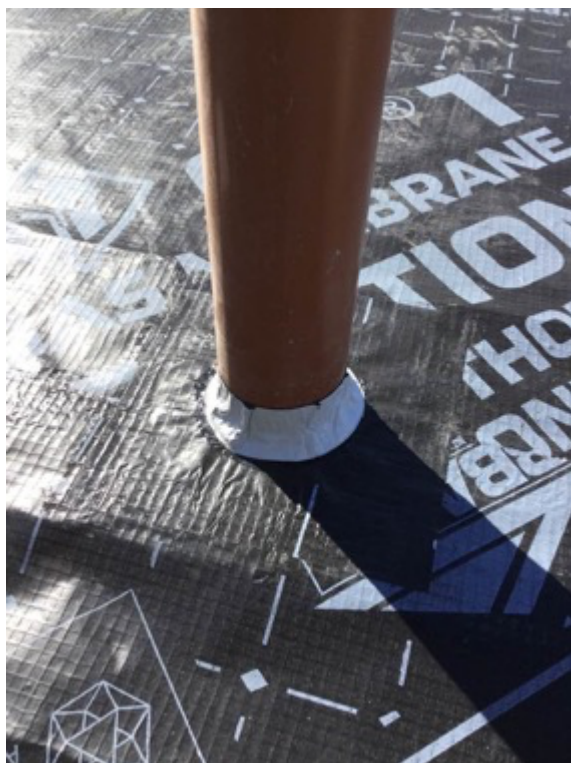
Over view photo showing the SAGM applied to the pipe detail.

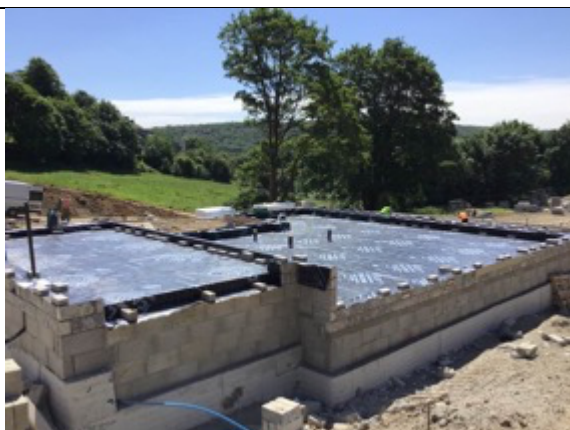
Plot 6 with integral garage full line out installation

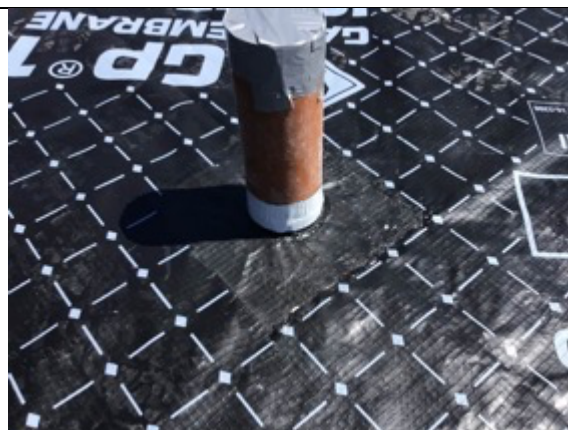
Plot 6 sealed pre formed pipe penetration top hat

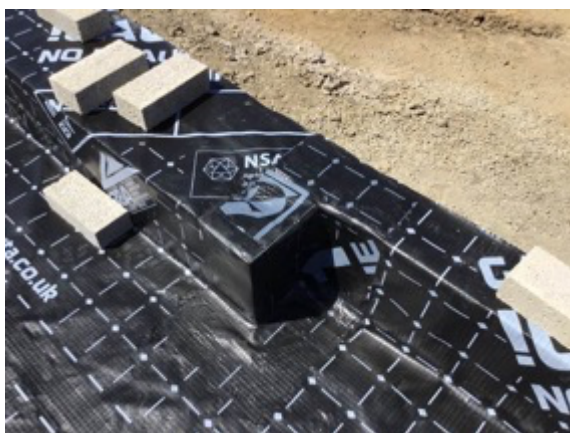
Plot 6 sealed pre formed threshold detail

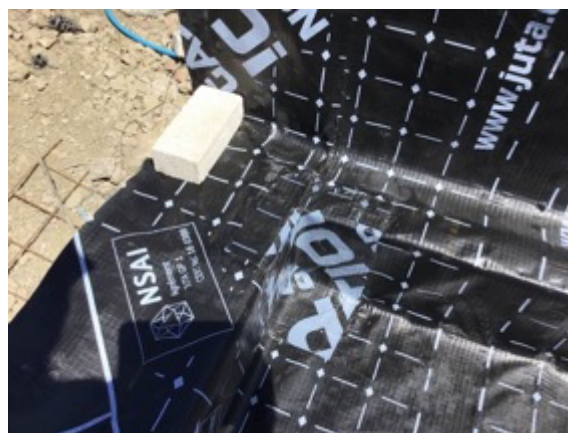
Plot 6 sealed pre formed corner detail

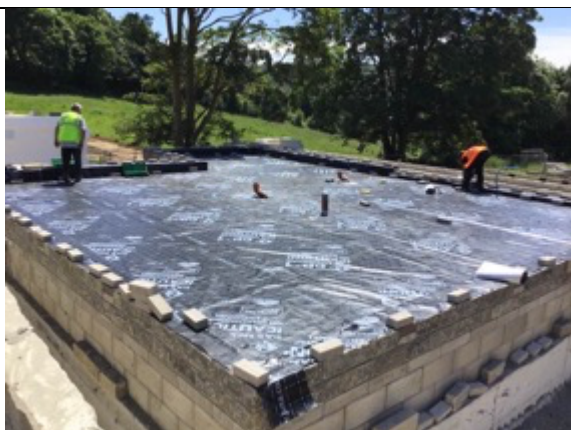
Plot 9 full line out installation

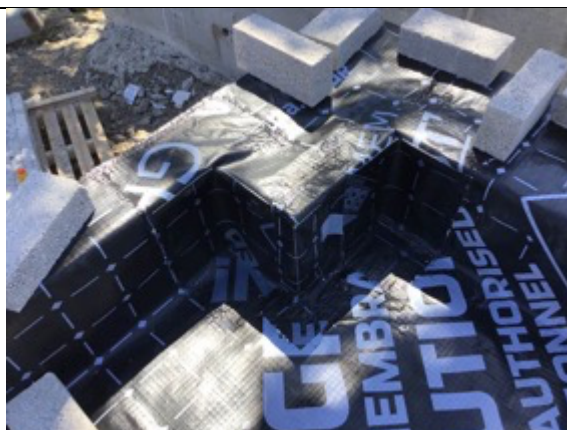
Plot 9 sealed pre formed corner and threshold detailing

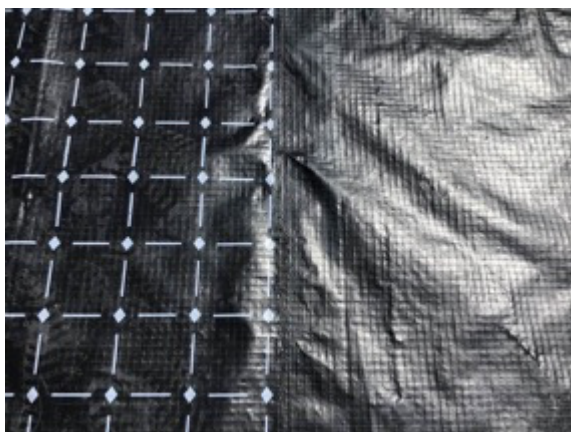
Plot 9 sealed auto weld membrane joint

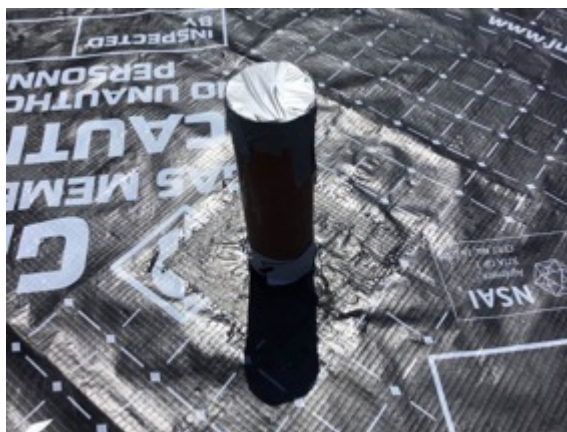
Plot 9 sealed pre formed pipe penetration top hat

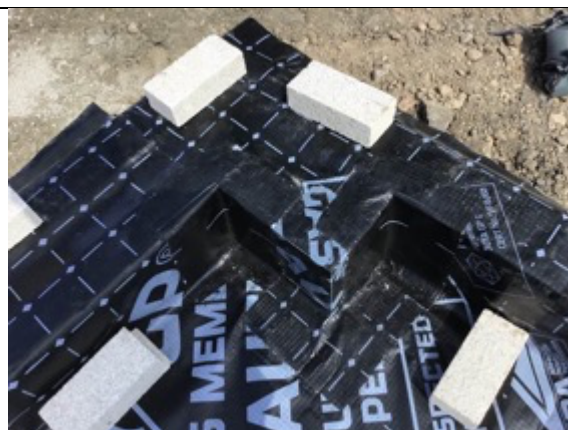
Plot 10 corner detail using preformed corners

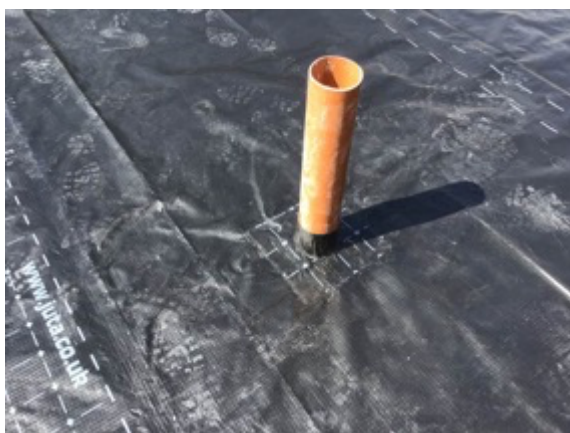
Plot 10 pipe penetration sealed using preformed top hat and SAGM

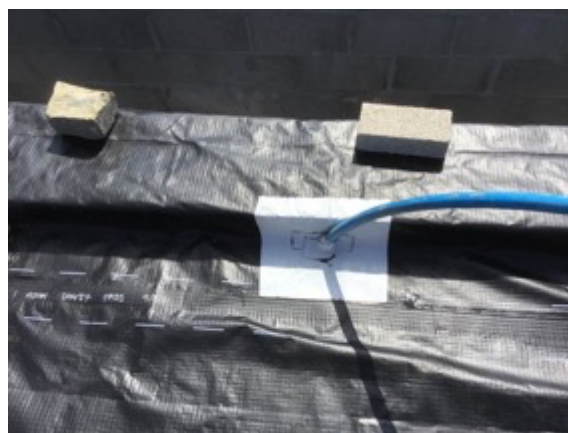
Plot 10 water pipe seal using SAGM

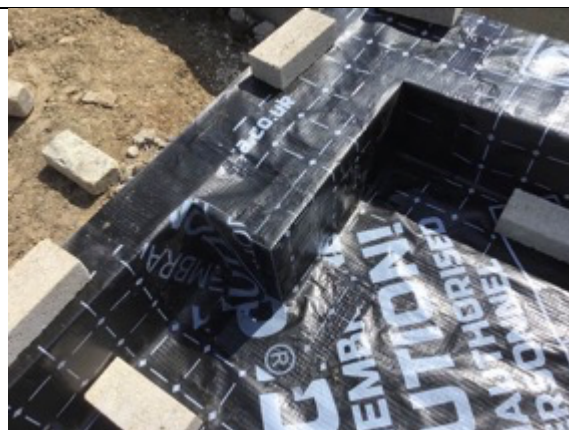
Plot 11 door threshold and corner detail using preformed corners

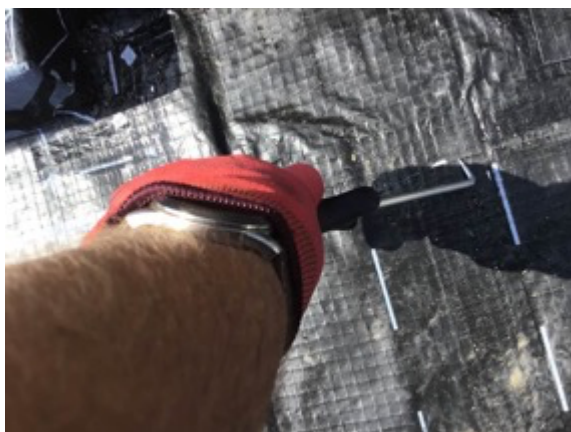
Plot 11 hand welded joint being pick tested

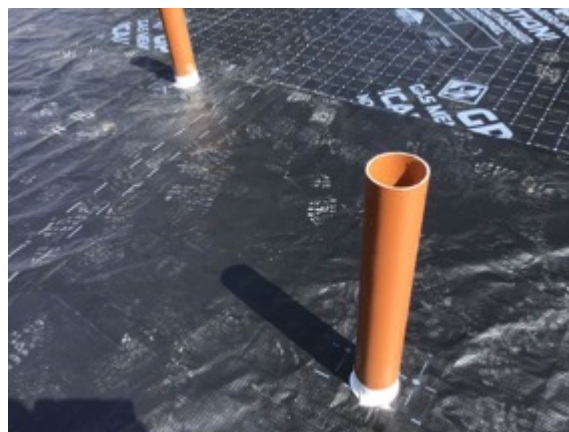
Plot 11 pipe penetrations sealed using preformed top hats and SAGM

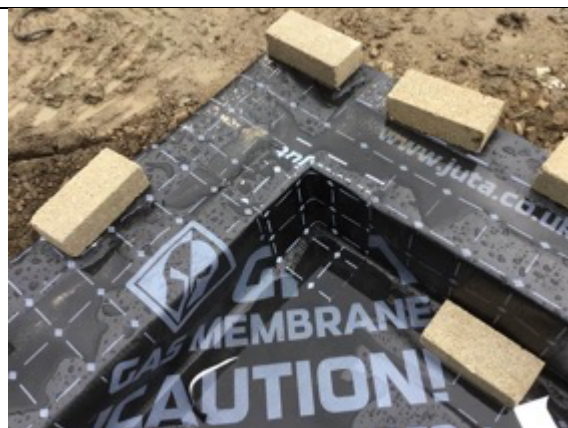
Plot 7 corner detail using preformed corners

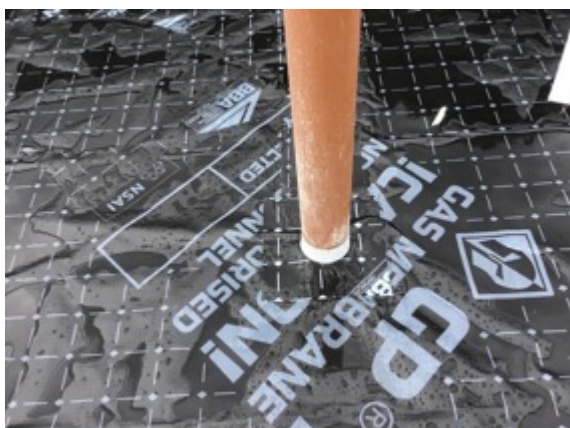
Plot 7 pipe penetration sealed using preformed top hat and SAGM

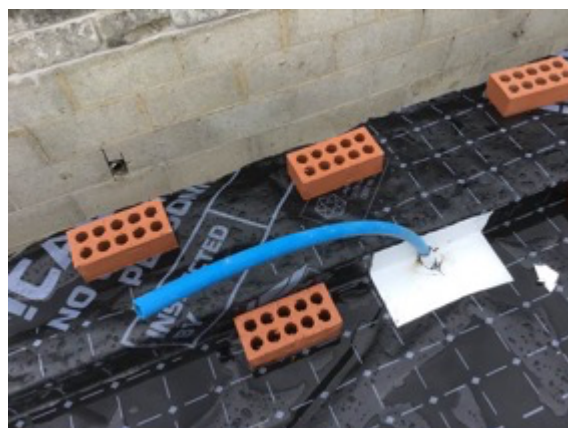
Plot 7 water pipe seal using SAGM

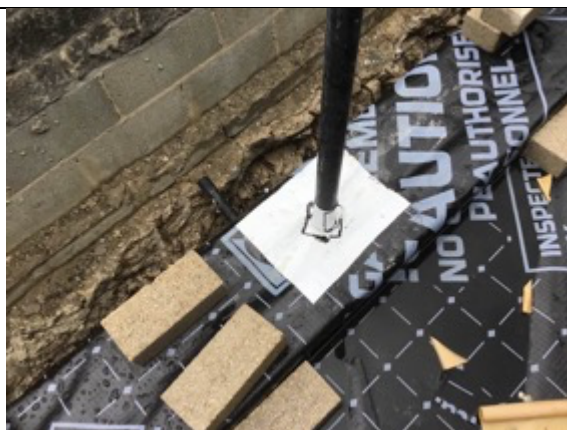
Plot 8 service pipe seal using SAGM

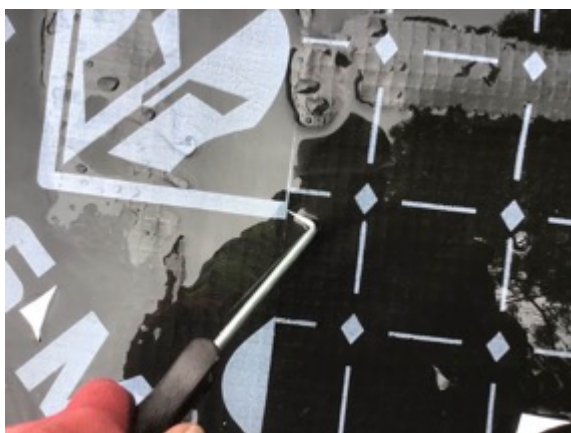
Plot 8 hand welded joint being pick tested

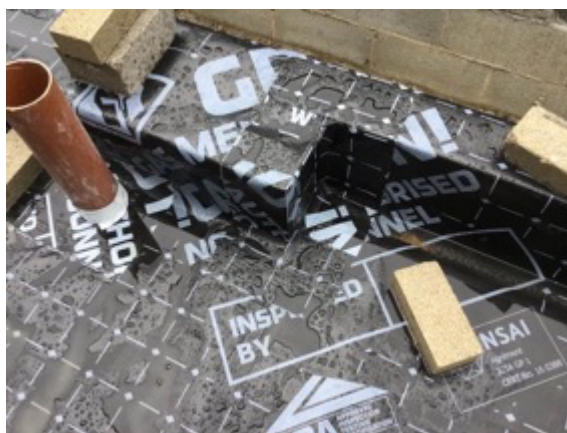
Plot 8p pipe penetration sealed using preformed top hat and SAGM and door threshold using preformed corners

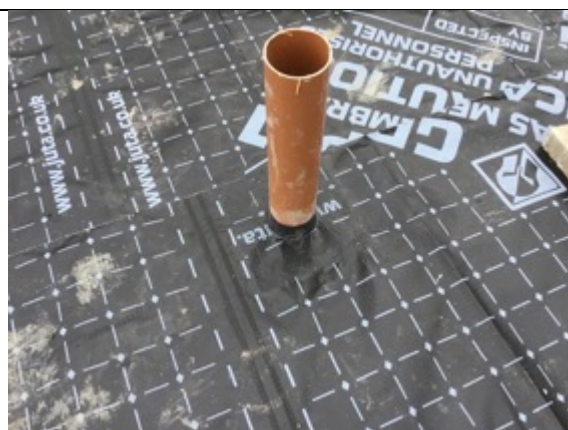
Plot 12 pipe penetration sealed using preformed top hat and SAM

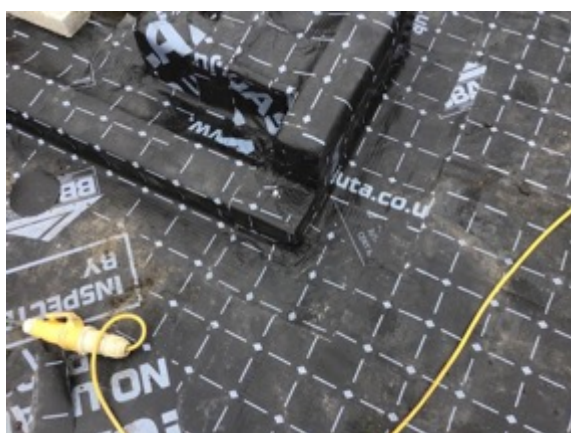
Plot 12 detailing using preformed corners

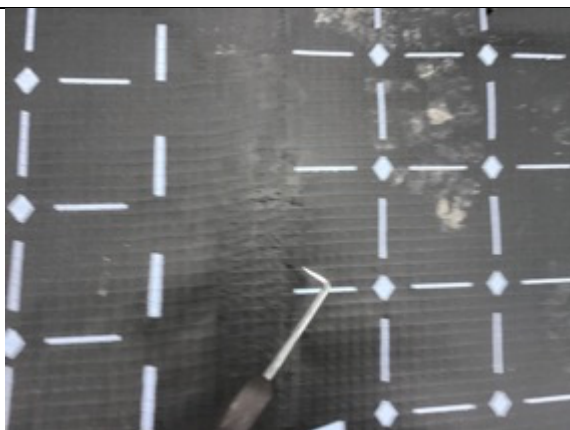
Plot 13 hand welded joint being pick tested

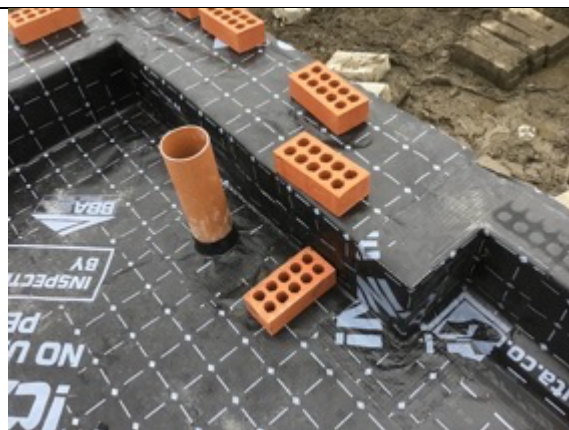
Plot 13 door threshold and corner detail using preformed corners and pipe penetration sealed using preformed top hat and SAM

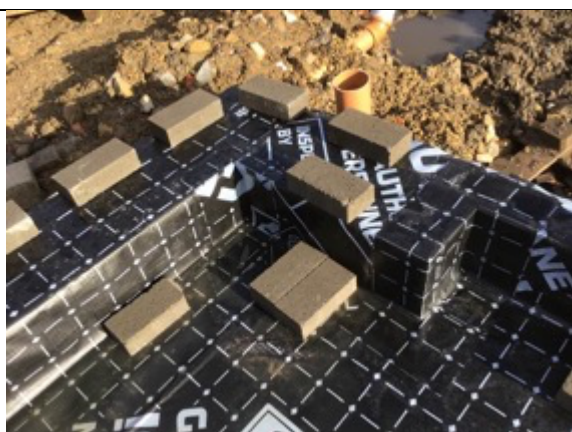
Plot 16 corner detail and door threshold using preformed corners

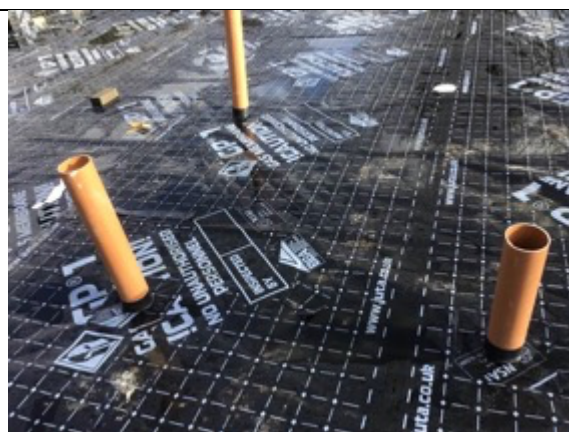
Plot 16 pipe penetrations sealed using preformed top hats and SAM

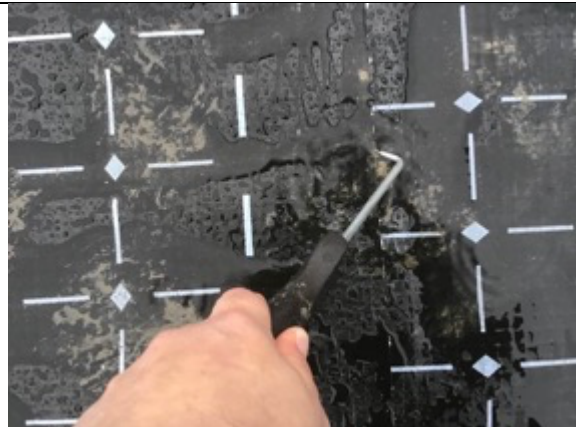
Plot 14 hand welded joint being pick tested

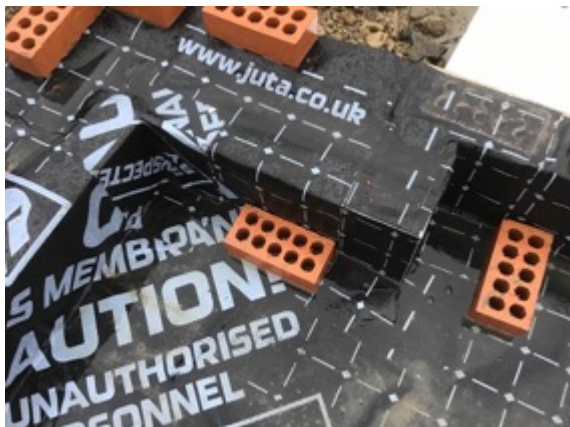
Plot 14 corner detail and door threshold using preformed corners

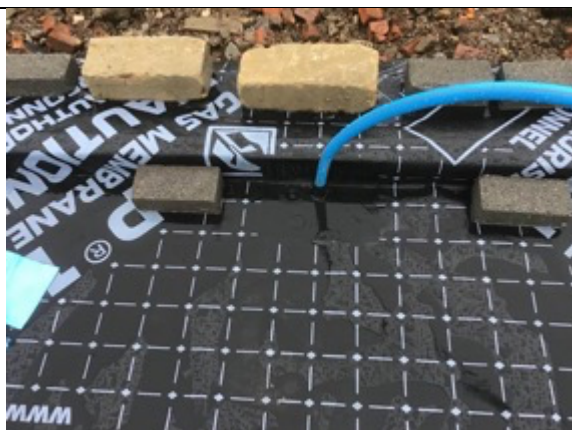
Plot 17 water pipe penetration sealed using SAGM

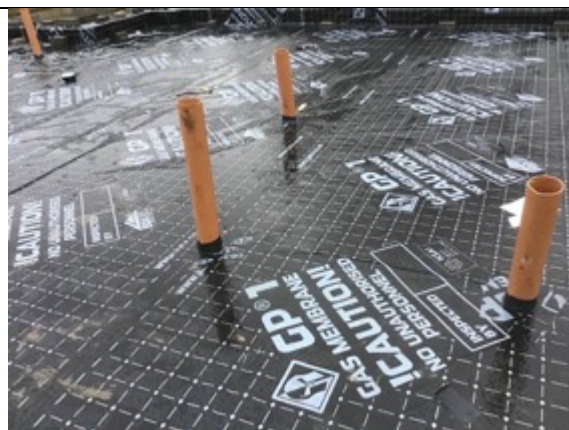
Plot 17 pipe penetrations sealed using preformed top hats and SAM

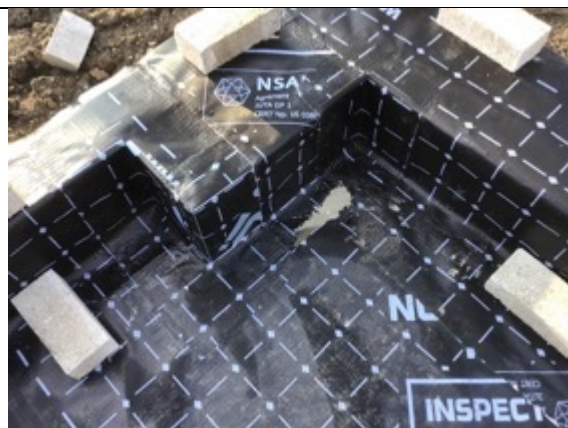
Plot 17 corner detail and door threshold using preformed corners

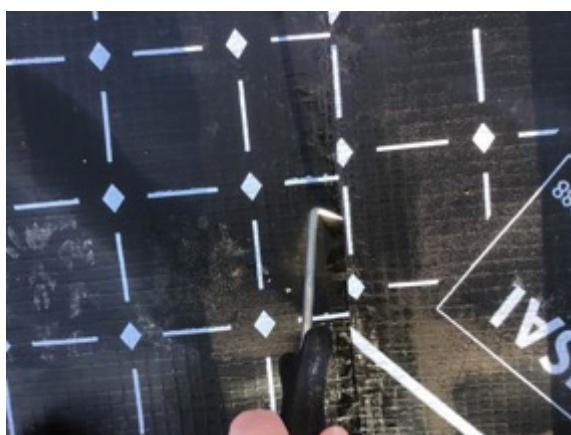
Plot 17 hand welded joint being pick tested

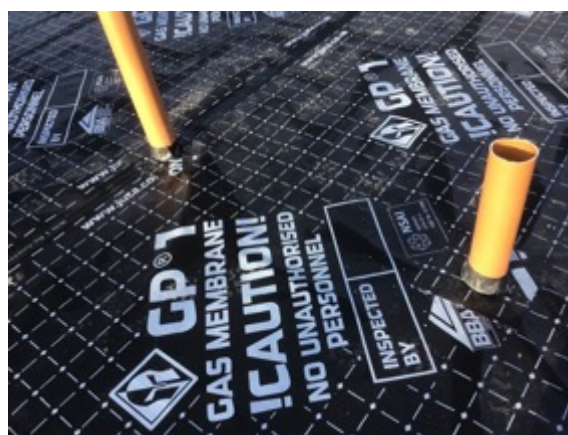
Plot 17 pipe penetrations sealed using preformed top hats and SAM

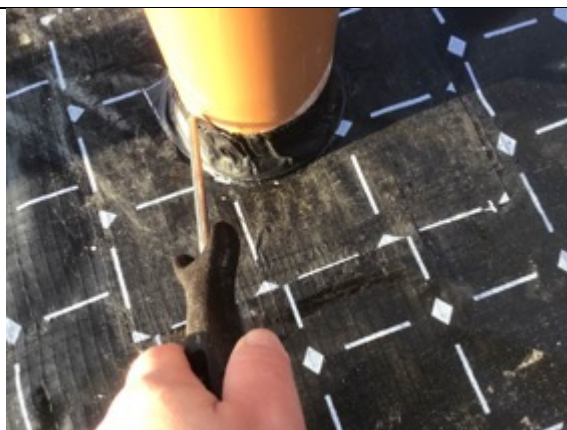
Plot 18 pipe penetration sealed using preformed top hat and SAM being pick tested

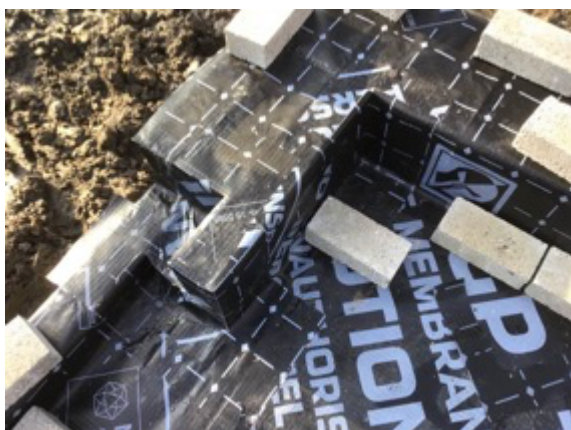
Plot 18 corner detail and door threshold using preformed corners

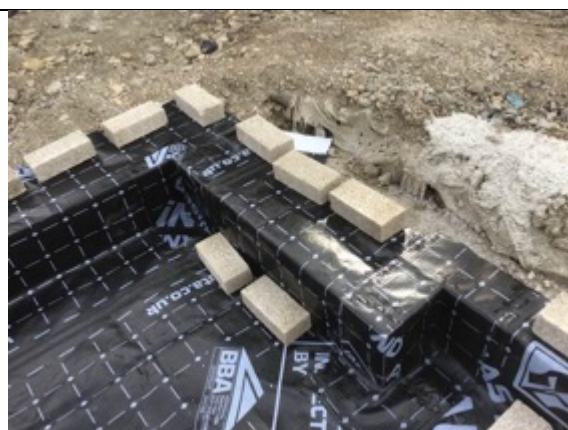
Corner detail and door threshold using preformed corners

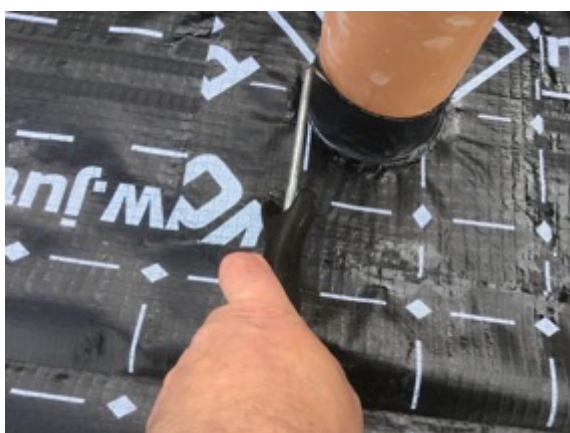
Pipe penetration sealed using preformed top hat and SAM being pick tested

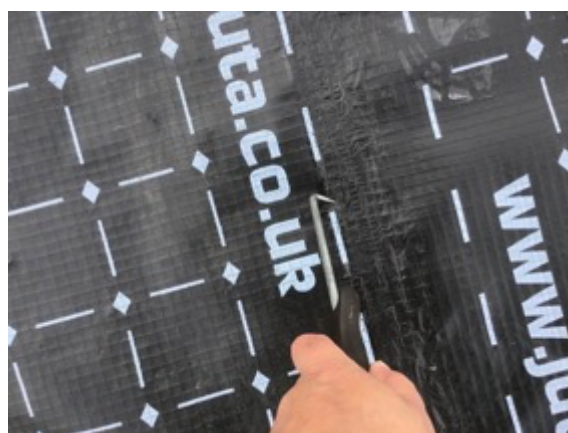
Hand welded joint being pick tested

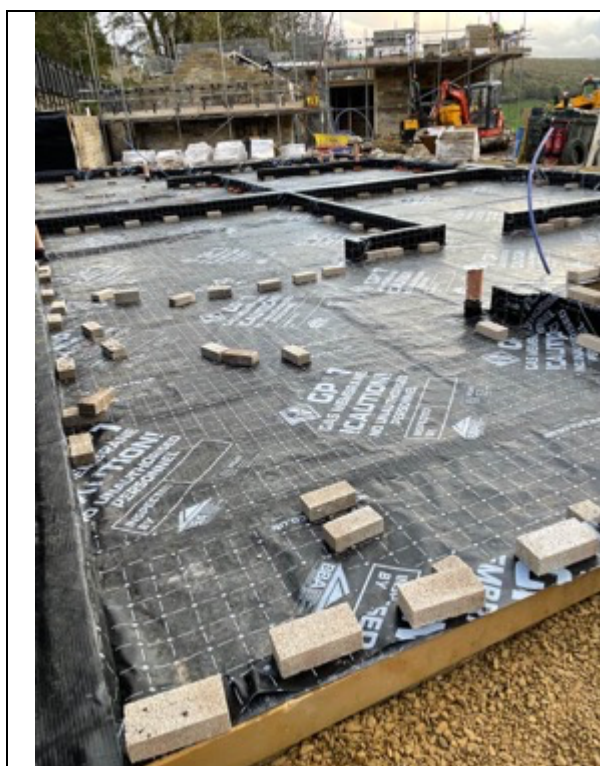
Plots 3 & 2 full line out installation

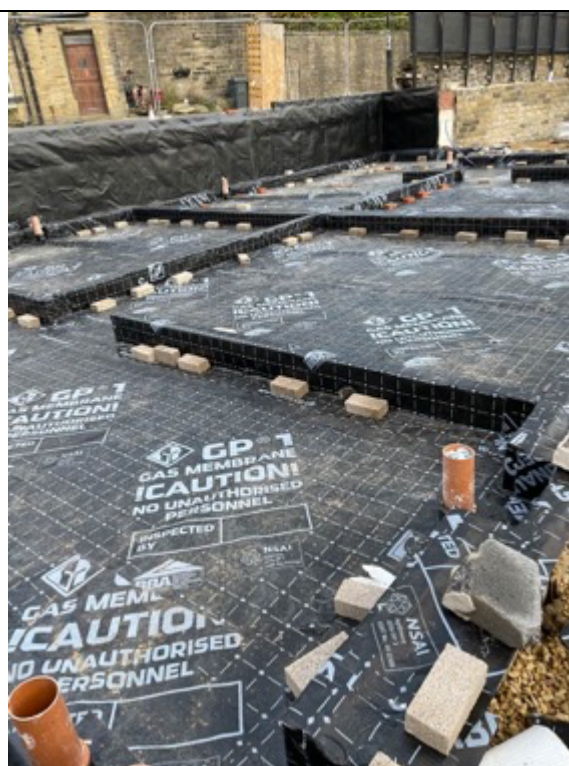
Plots 3 & 2 full line out installation

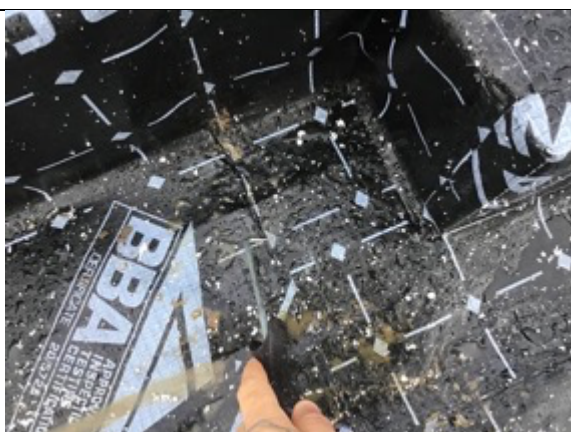
Pick test to hand weld

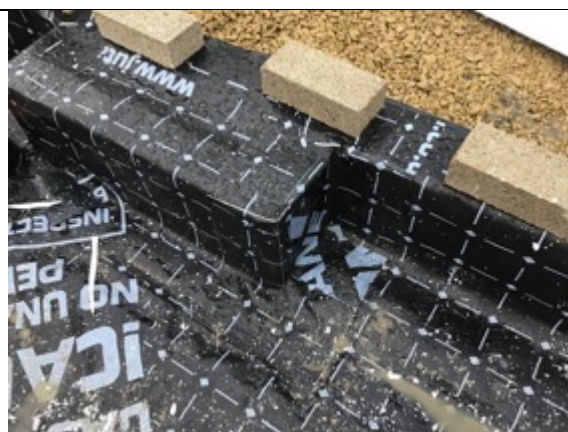
Plot 3 sealed threshold detail

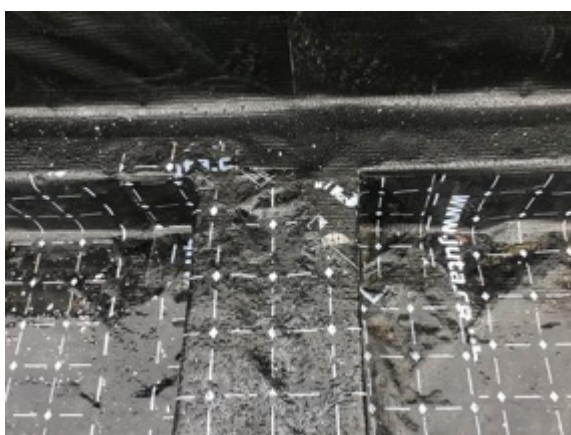
Plot 3 sealed corner detailing

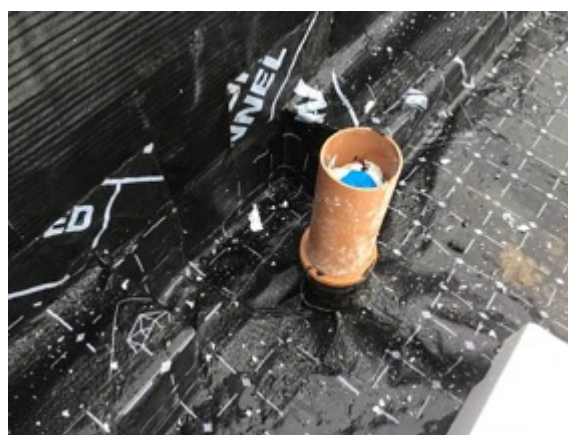
Plot 3 sealed pipe penetration

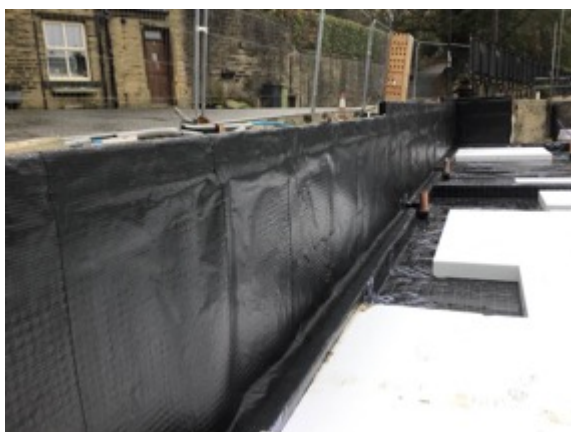
Retaining wall tanking detail

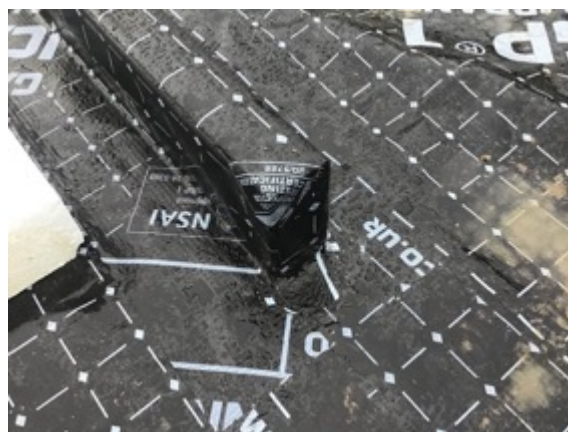
Plot 2 internal wall corner detailing

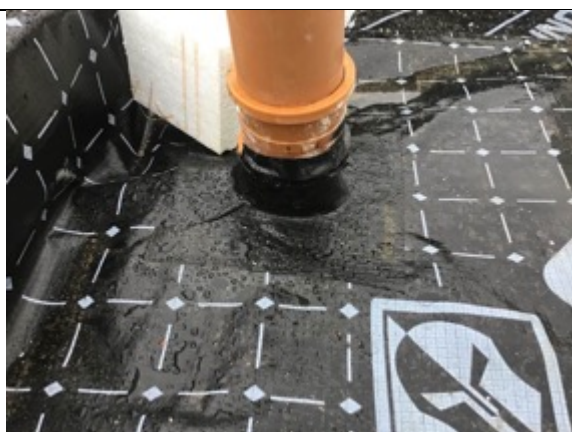
Plot 2 sealed pipe penetration

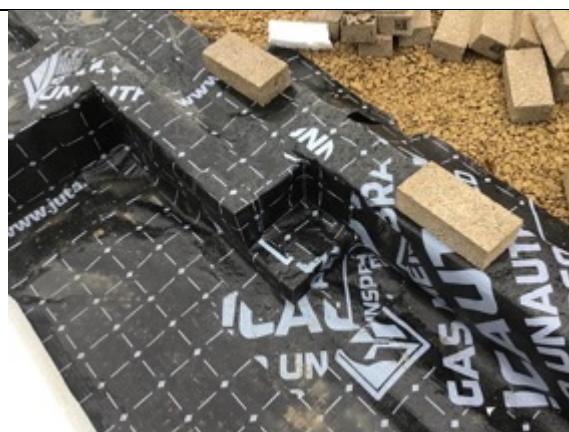
Plot 2 sealed threshold detail
