Gas Membrane Installation  
Validation Report  
Holroyd Homes  
Huddersfield  
HD4 7HB  
Version 3 27/09/21

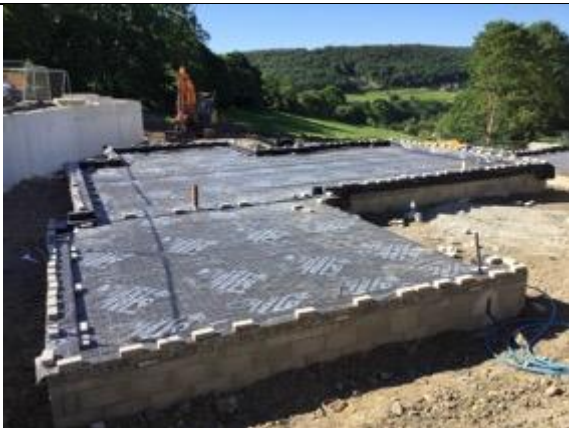
Overview photo looking at Plot 4"

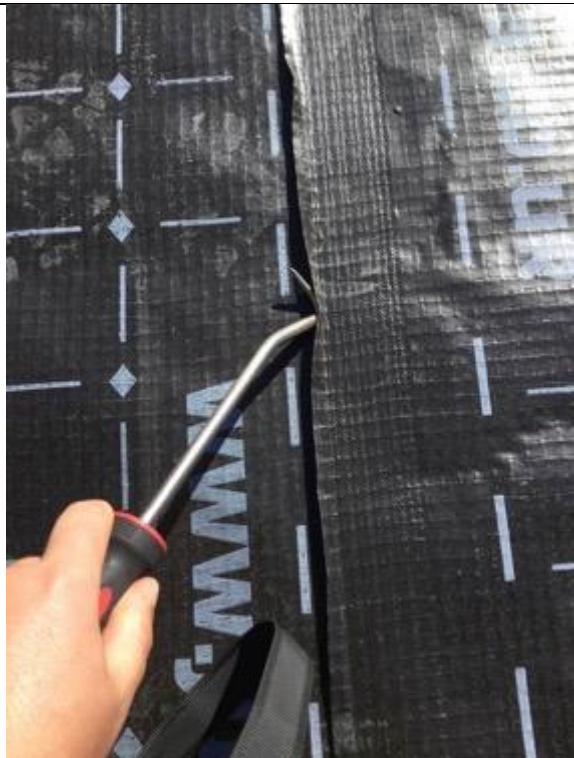
Pick probe testing carried out to the mechanical weld joint.

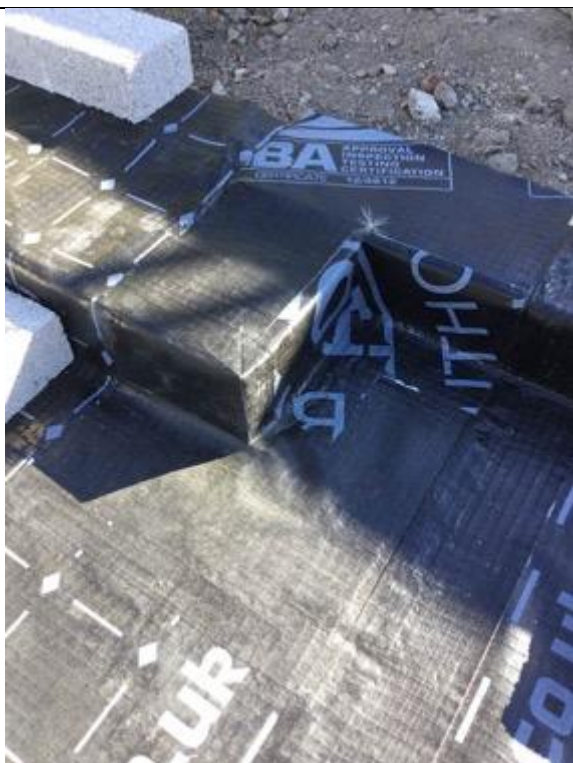
Close up showing the pre formed corner details for this doorway threshold.

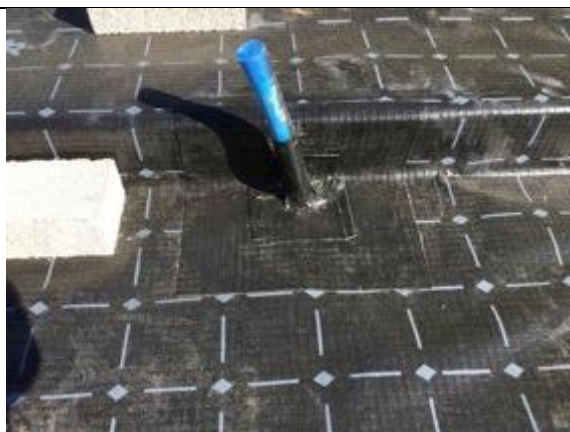
Over view photo showing the SAGM applied to the pipe detail.

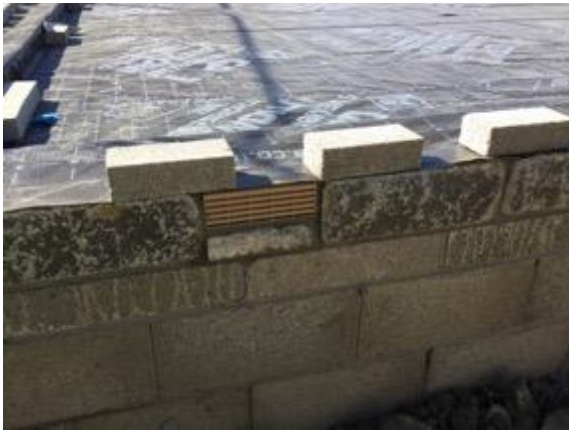
Air bricks in place.

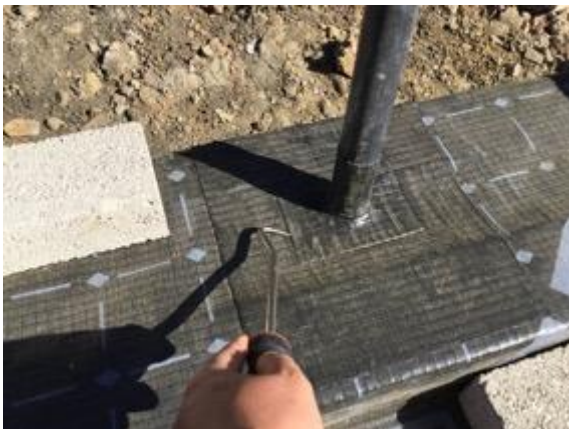
Pick probe testing to the SAGM to the pipe penetration detail.

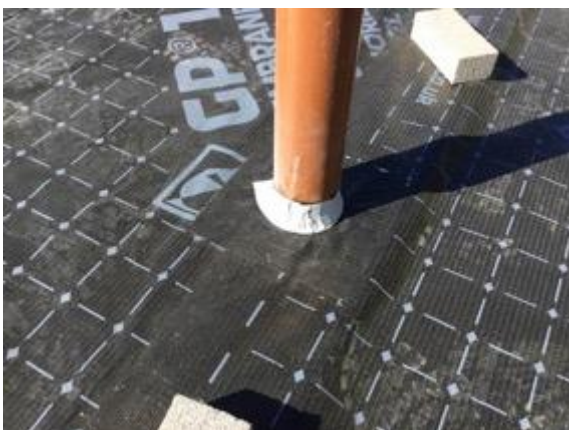
Completed pipe penetration detail to Plot 5.

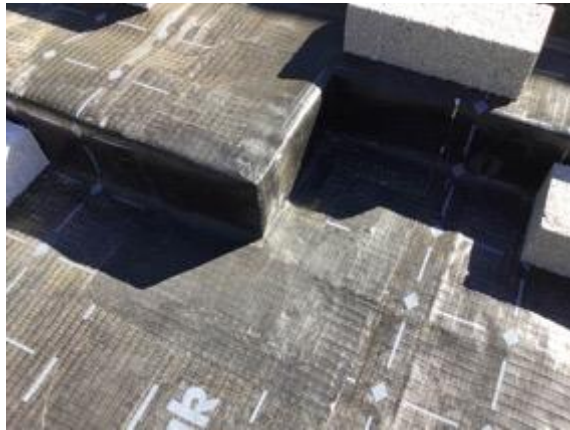
Close up showing the completion of the pre formed corner to the doorway.

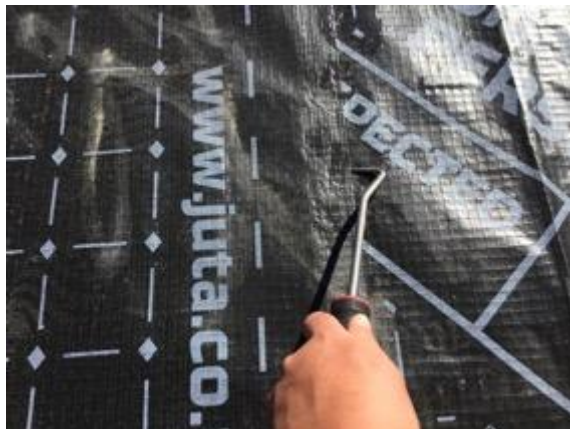
Pick probe testing carried out to the hand welded section to the lap joint.

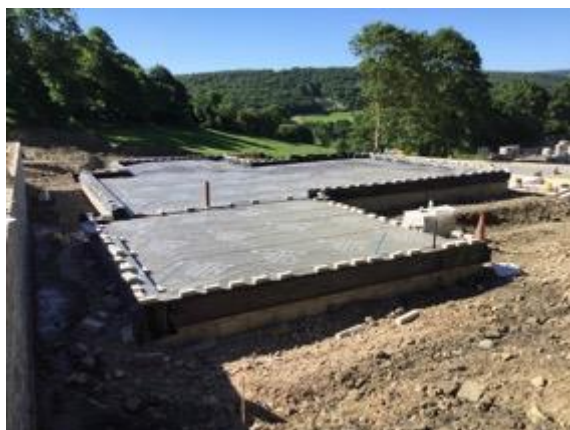
Overview photo showing the completion to Plot 5.

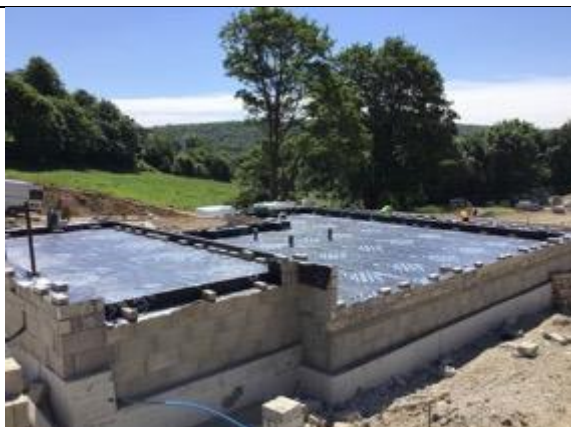
Plot 6 with integral garage full line out installation

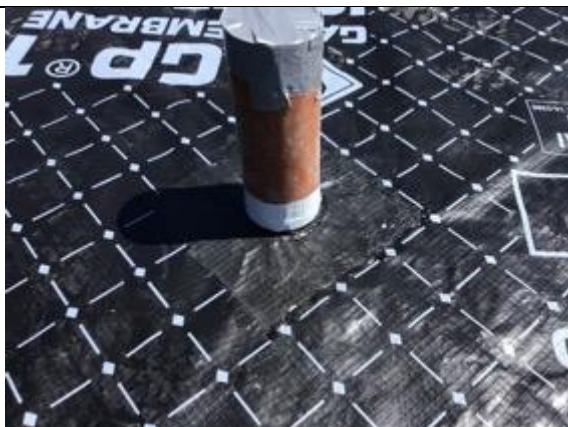
Plot 6 sealed pre formed pipe penetration top hat

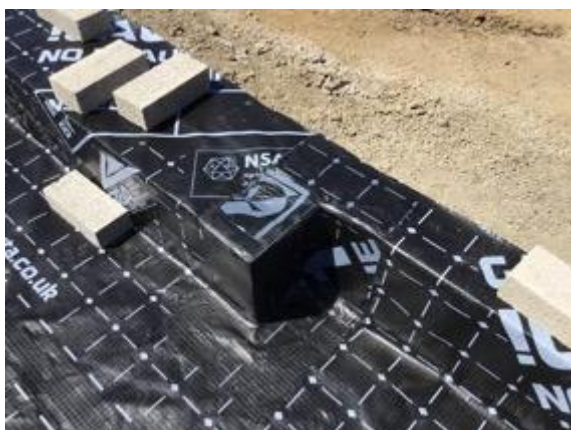
Plot 6 sealed pre formed threshold detail

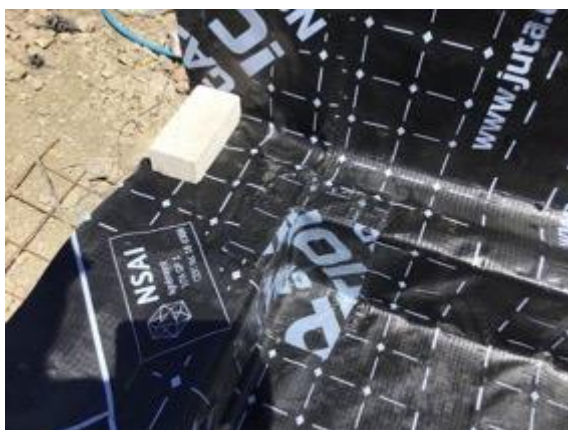
Plot 6 sealed pre formed corner detail

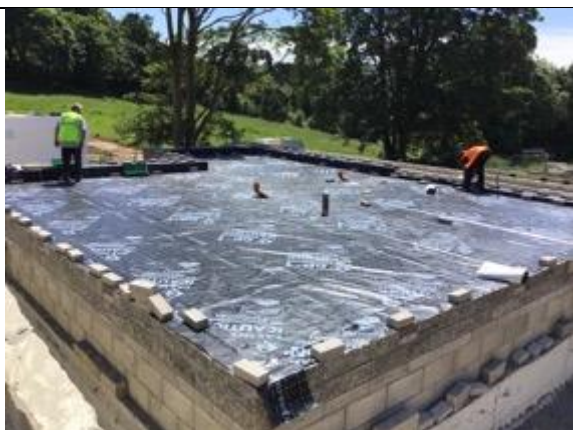
Plot 9 full line out installation

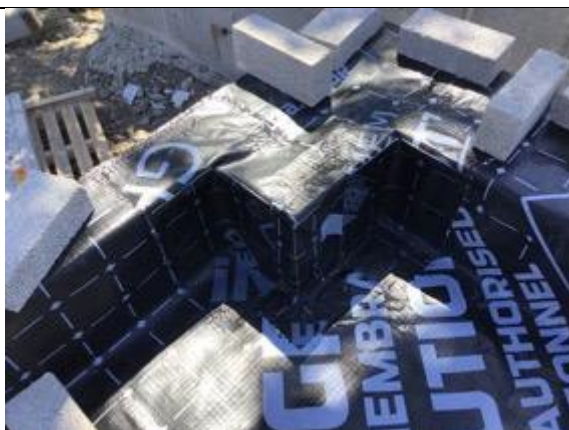
Plot 9 sealed pre formed corner and threshold detailing

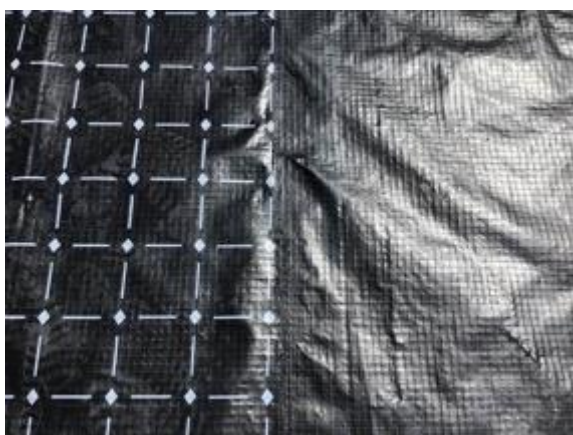
Plot 9 sealed auto weld membrane joint

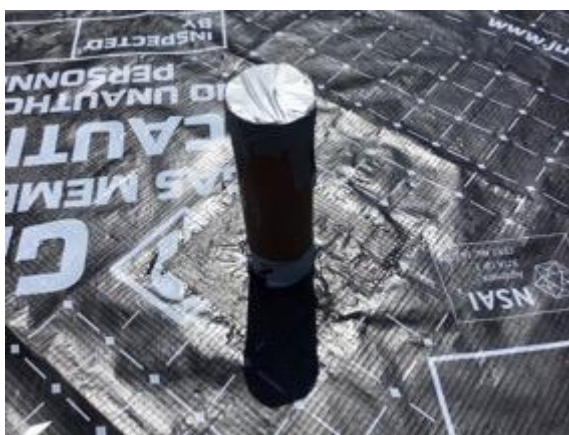
Plot 9 sealed pre formed pipe penetration top hat

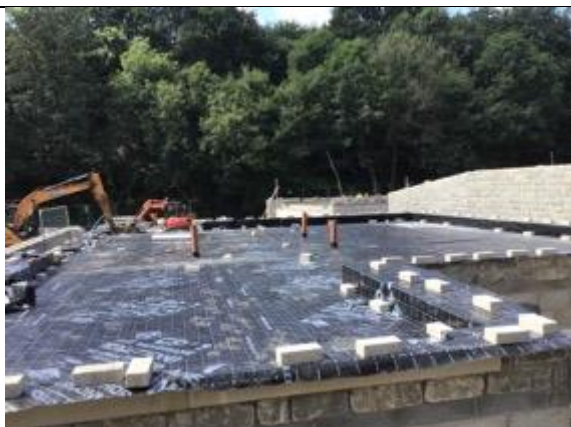
Plot 10 overview

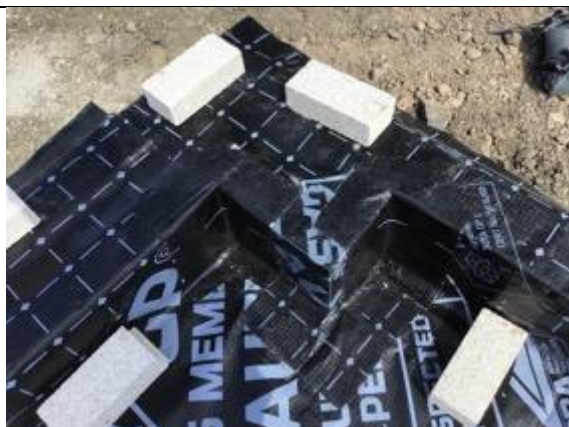
Plot 10 corner detail using preformed corners

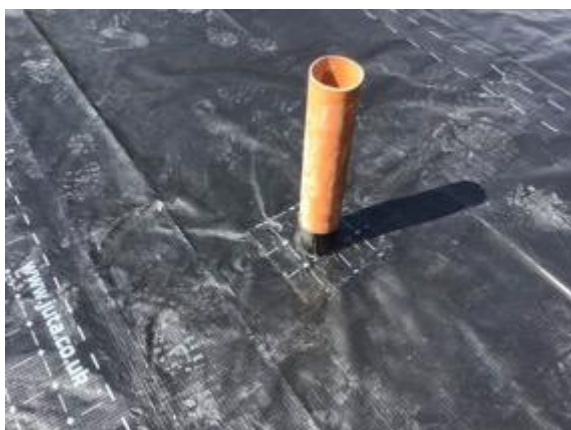
Plot 10 pipe penetration sealed using preformed top hat and SAGM

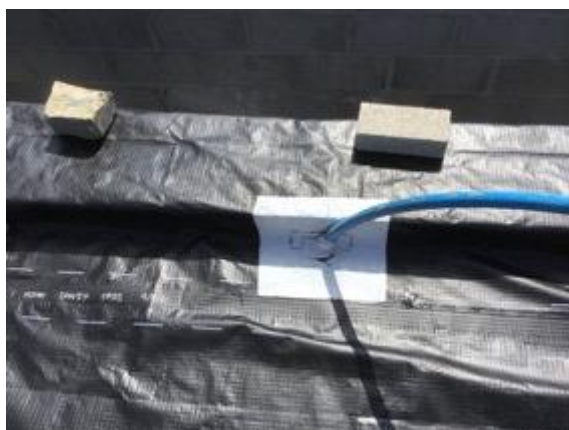
Plot 10 water pipe seal using SAGM

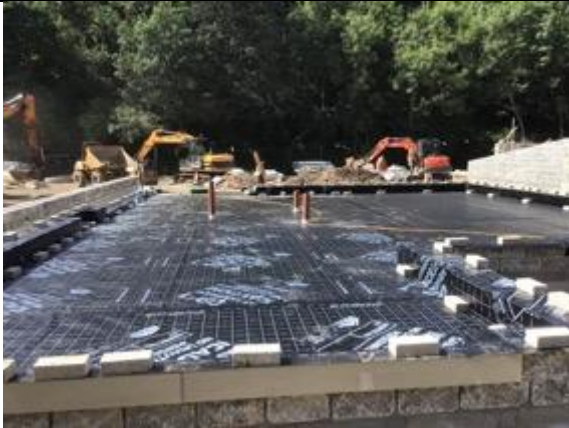
Plot 11 overview

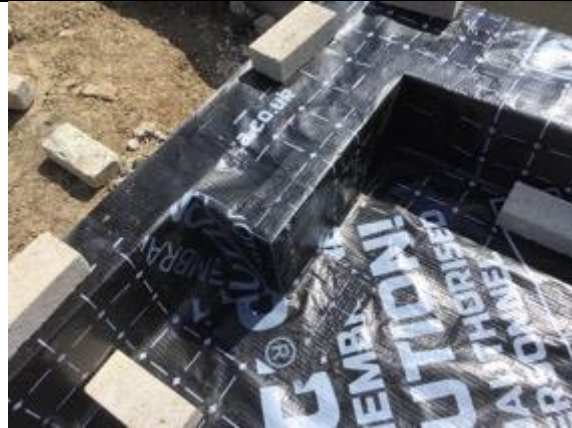
Plot 11 door threshold and corner detail using preformed corners

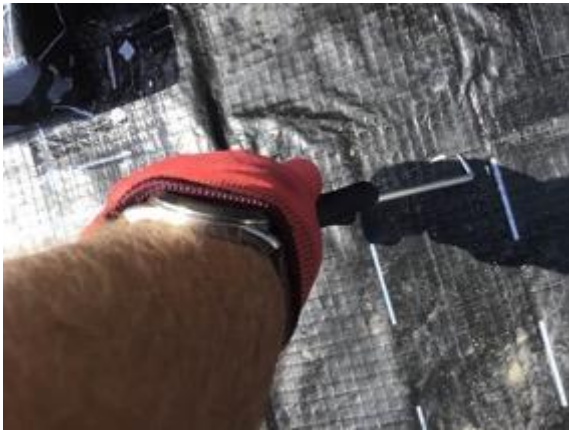
Plot 11 hand welded joint being pick tested

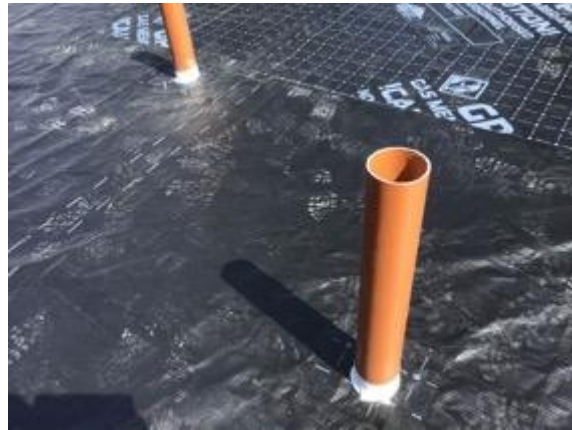
Plot 11 pipe penetrations sealed using preformed top hats and SAGM

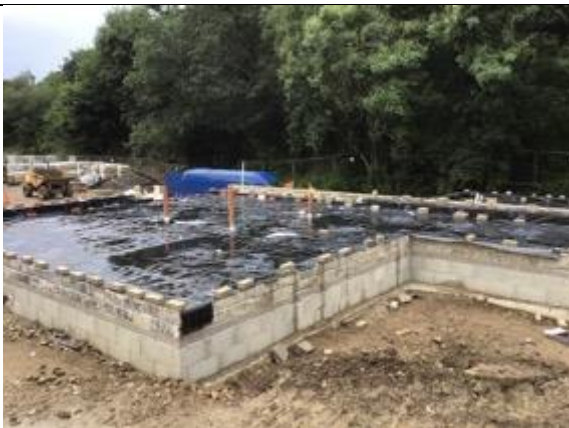
Plot 7 overview

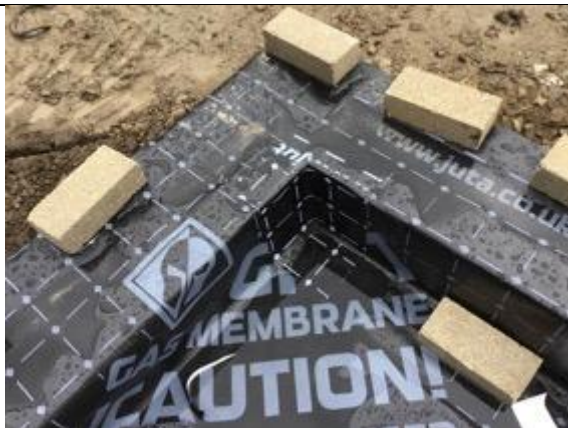
Plot 7 corner detail using preformed corners

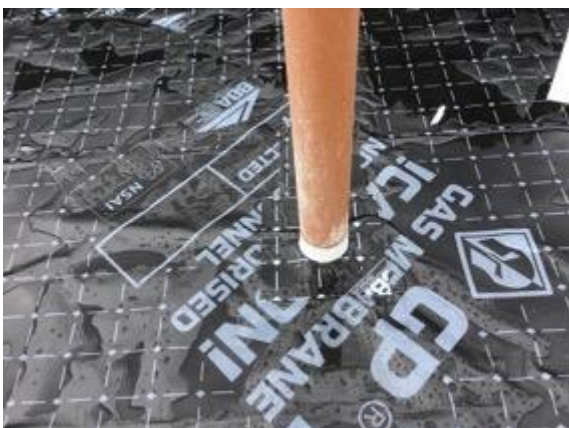
Plot 7 pipe penetration sealed using preformed top hat and SAGM

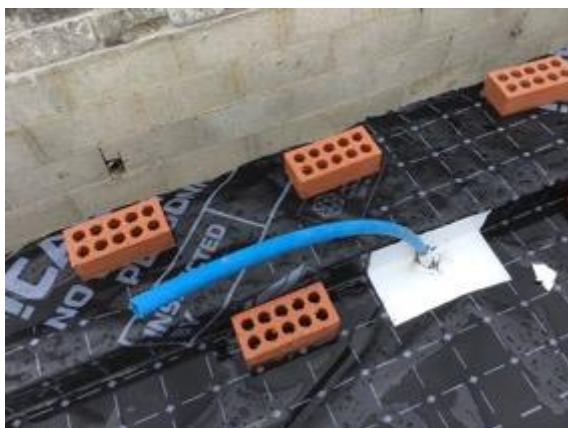
Plot 7 water pipe seal using SAGM

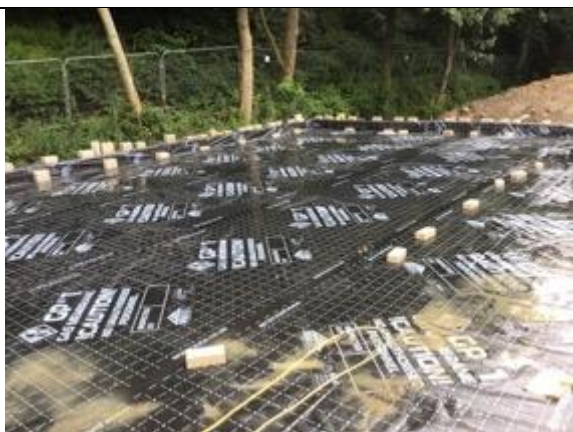
Plot 8 overview

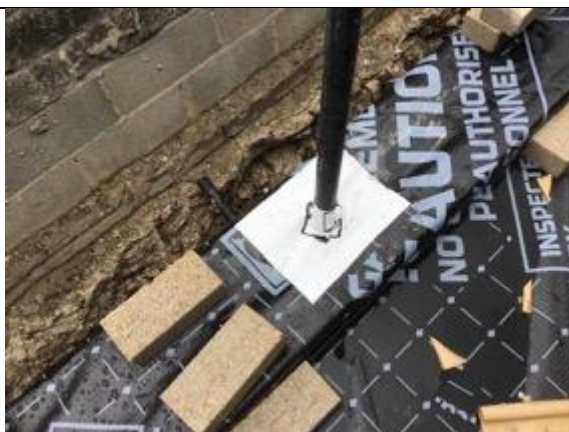
Plot 8 service pipe seal using SAGM

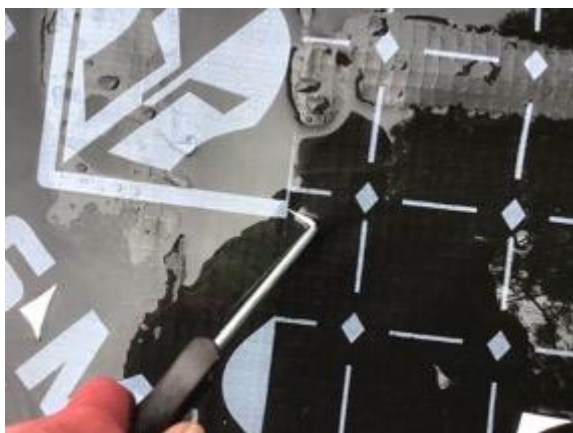
Plot 8 hand welded joint being pick tested

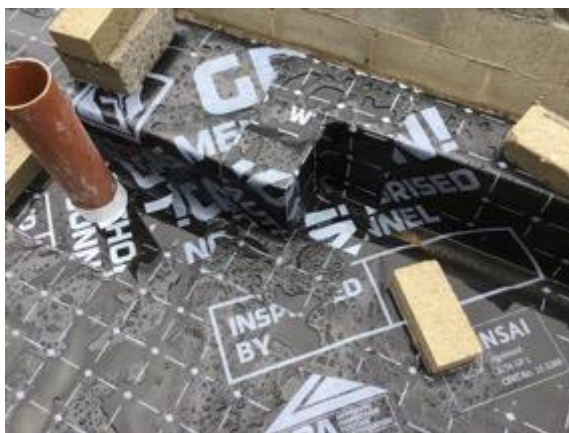
Plot 8p pipe penetration sealed using preformed top hat and SAGM and door threshold using preformed corners
