STRUCTURAL INSPECTION REPORT

Original Mill Offices Building, Newsome
Mills, Ruth Street, Huddersfield
For Connect Housing

Date 23/02/2023
Ref **21197/SIR001**

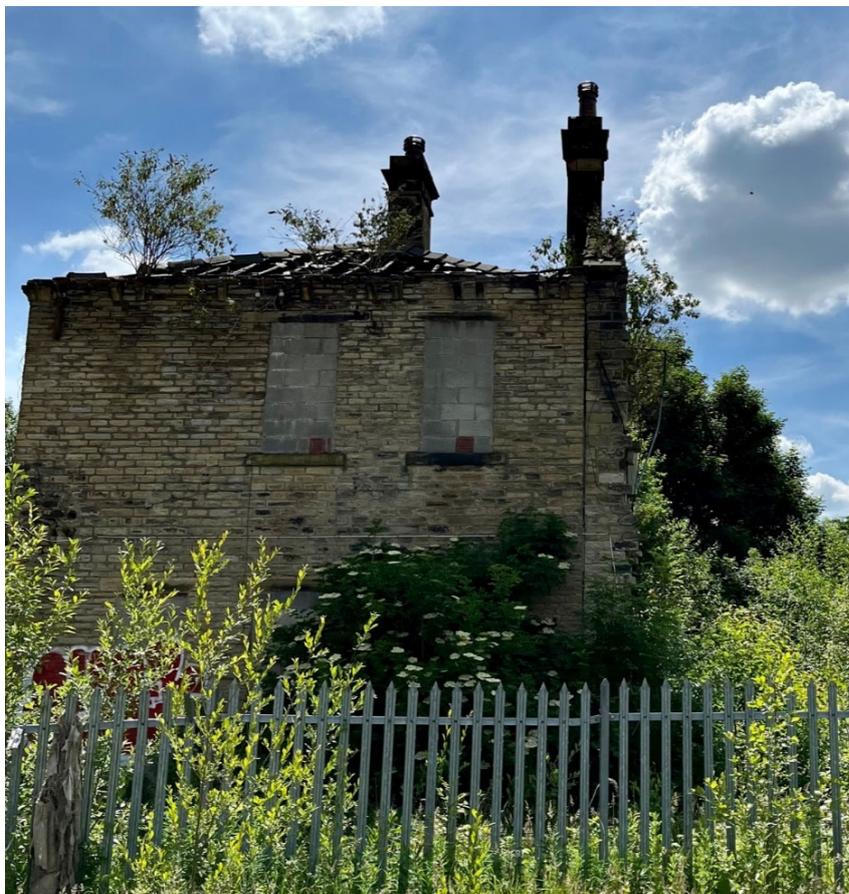
At eaves level vegetation has established itself with consequent deterioration of the external wall constructions at high level. Associated water ingress into the exposed building fabric has deteriorated the structural integrity of the walls at eaves with much of the high-level stonework having become dislodged and potentially at risk of falling.

Whilst a comprehensive internal inspection of the building has not been possible due to safety concerns, the building’s structural integrity is clearly severely compromised and that the process of deterioration is accelerating due to water ingress.

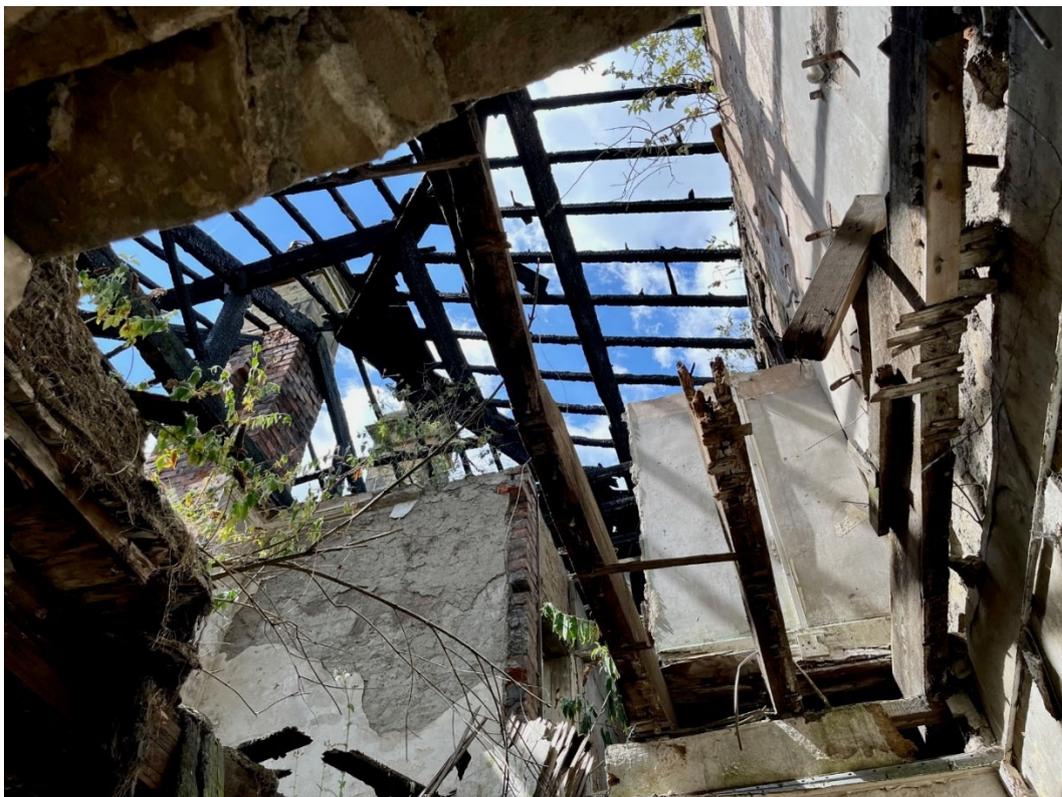
All remaining timber elements of the remaining roof structure, including the central queen-post truss and associated timber purlins and rafters show significant signs of fire damage. The charred timbers can be clearly observed from ground level.

Whilst most of the roofing materials have been lost, a small proportion remain including some of the ridge tiles. These are not suitably secured and from ground level slipped tiles can be observed at the building eaves and along the ridge lines. In its current condition, the remnant roofing materials are at risk of falling, particularly in strong winds.

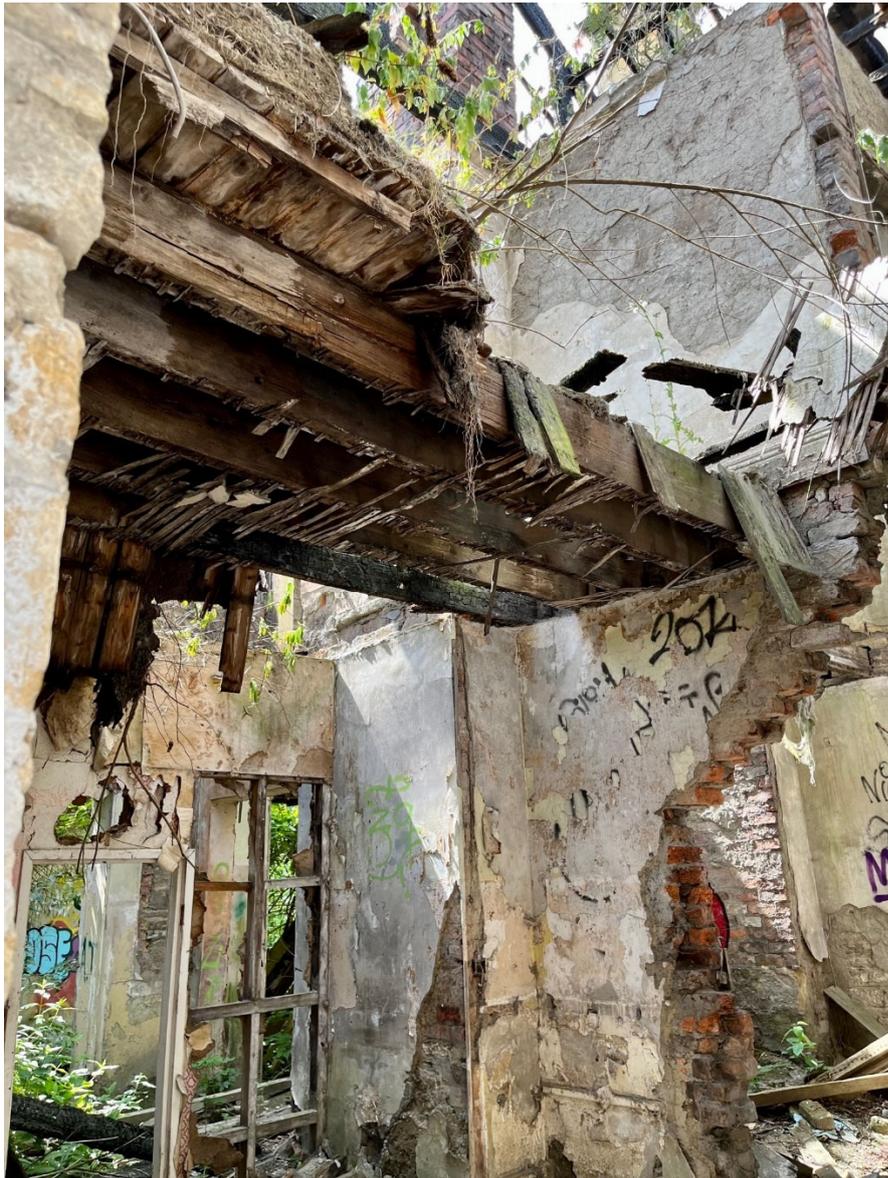
The original chimney stack remains and from ground level appears to be reasonably vertical. However, the essential lateral restraint to the chimney previously afforded by the original roof construction is now significantly diminished and its continued stability in high winds cannot be guaranteed. The same holds true for the remaining gable wall and chimney stack that adjoins the rear elevation of the mill office building.

Safe internal inspection of the building is not possible. However, a partial inspection revealed a section of completely collapsed first floor construction and evidence of widespread structural deterioration due to water penetration and fire damage.

The collapse of the first floor has removed essential lateral restraint to external wall constructions and has significantly impacted on the overall integrity of the building structure.

The loss of the roofing materials and the fire damage to the roof structure along with the substantial collapse of the first floor and the associated loss of lateral restraint to the external walls render the building unsafe and consequently it should be secured against entry immediately.

The controlled demolition of the building is therefore recommended under a contract which should include all necessary CDM measures.

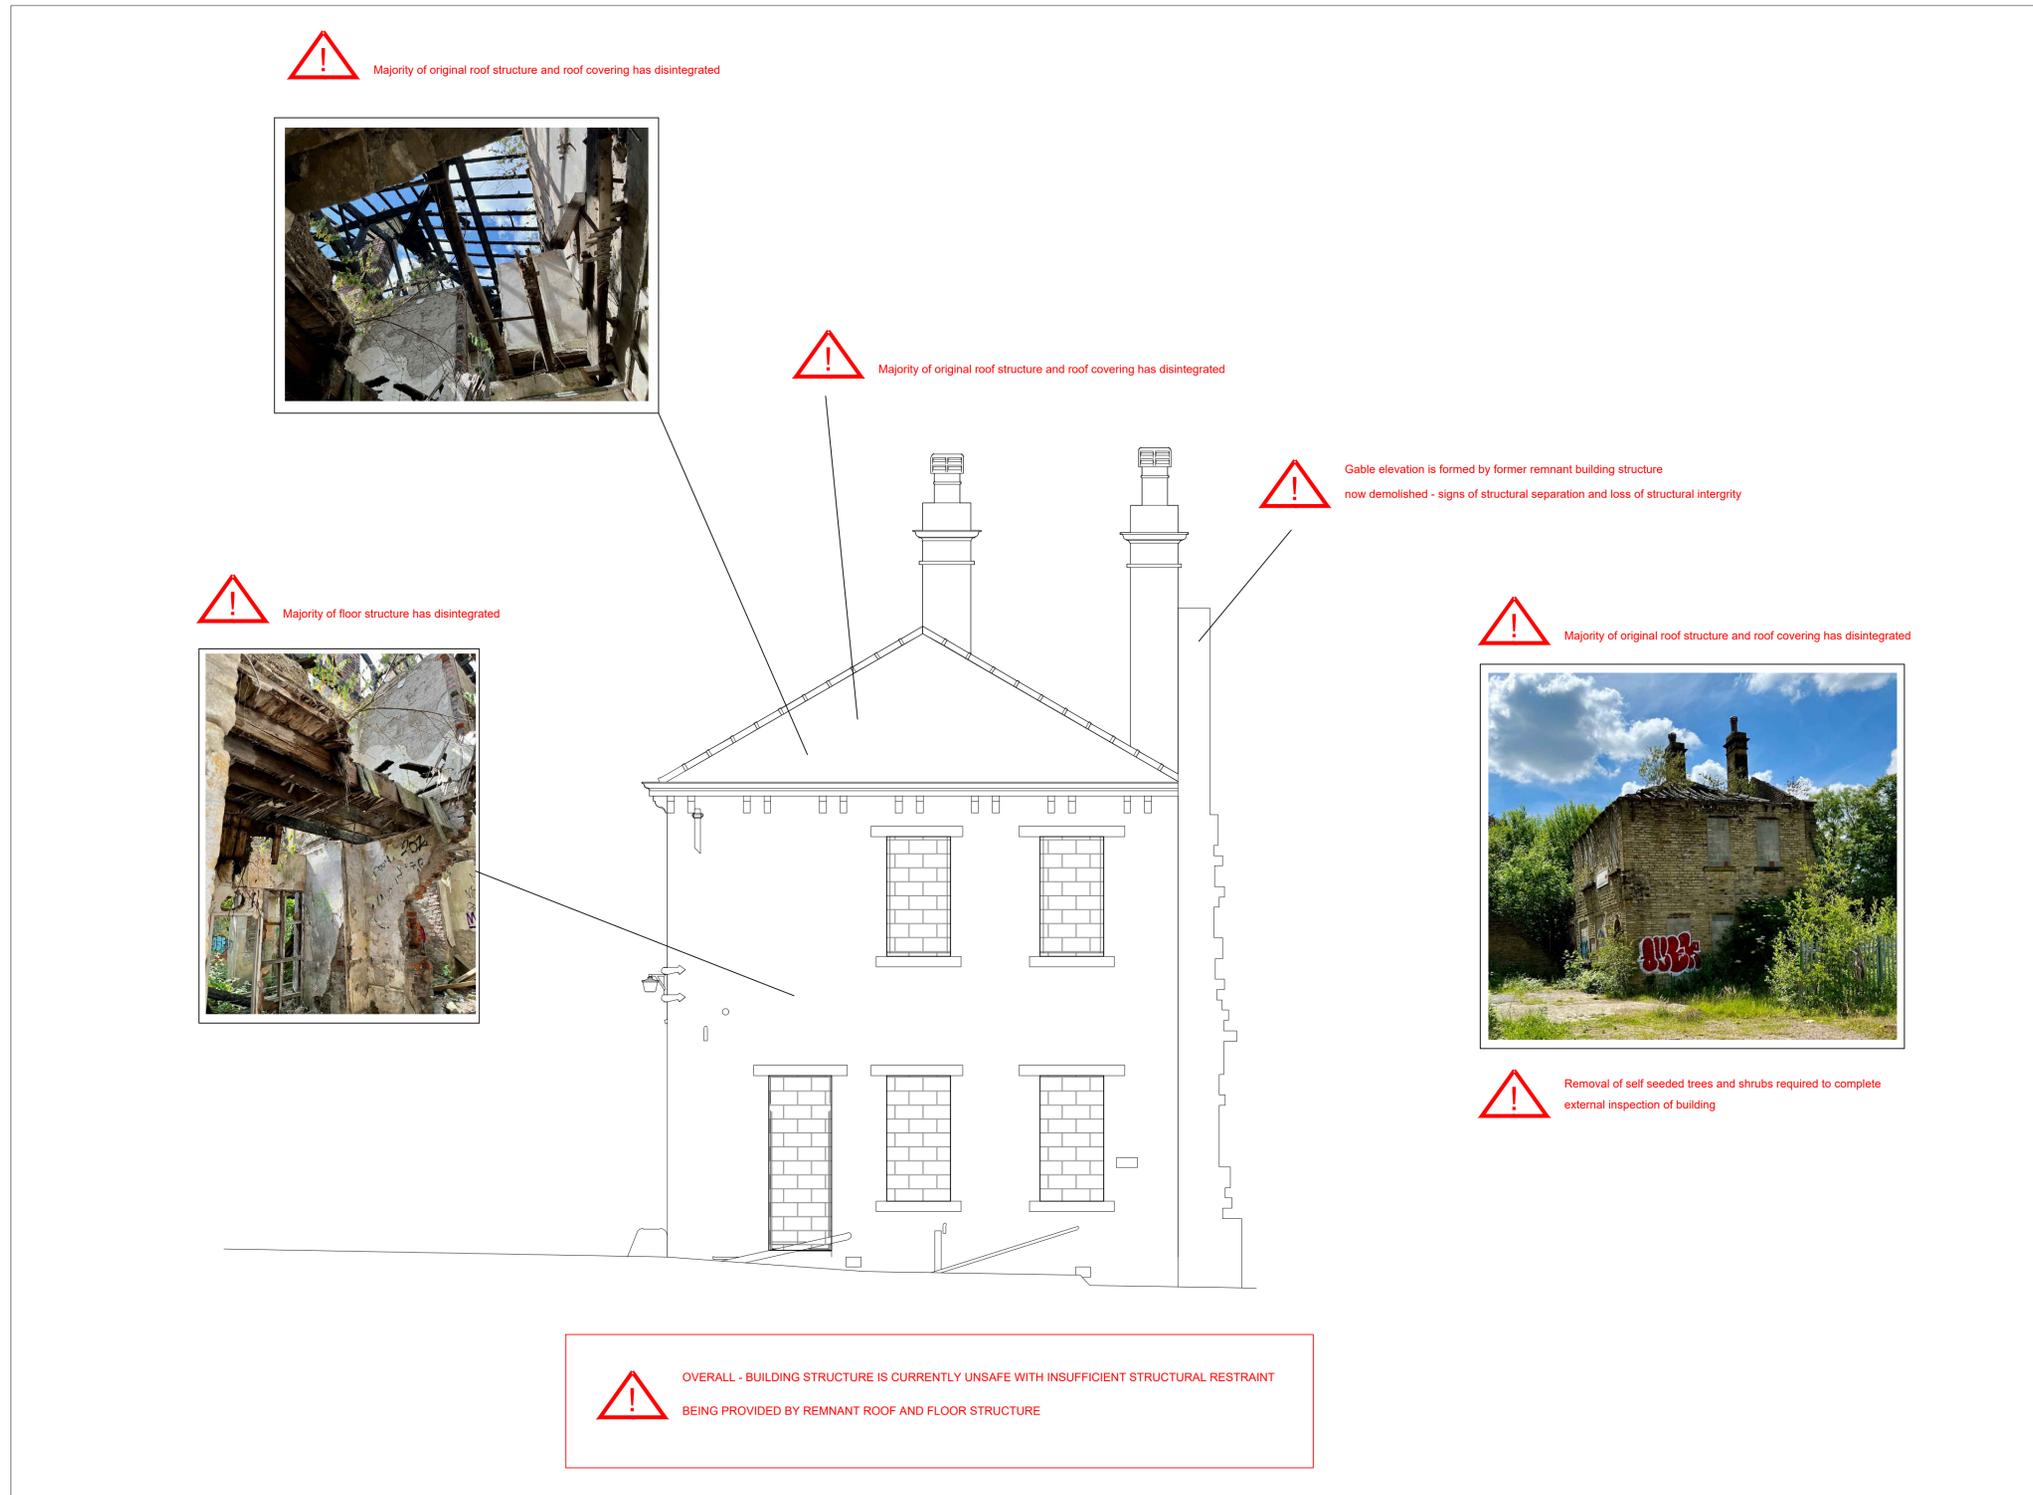
ELEVATION 1

PRELIMINARY STRUCTURAL HAZARD ASSESSMENT						
Hazard	Description	Risk to	Design stage risk mitigation proposals	Date of action or work stage	Risk closed/open/residual	Risk Action owner
				Immediate	Open	Land owner

NOTE - DETAILED IMPLEMENTATION OF ESSENTIAL STRUCTURAL REPAIR WORKS TO LISTED BUILDING FABRIC TO BE AGREED FOLLOWING PLANNING AND LISTED BUILDING CONSULTATIONS
