DRAINAGE INVESTIGATION REPORT

CLIENT CONNECT HOUSING
ASSOCIATION LTD

SITE NEWSOME MILL
HUDDERSFIELD

DATE 05/09/2022 JOB No. 8203

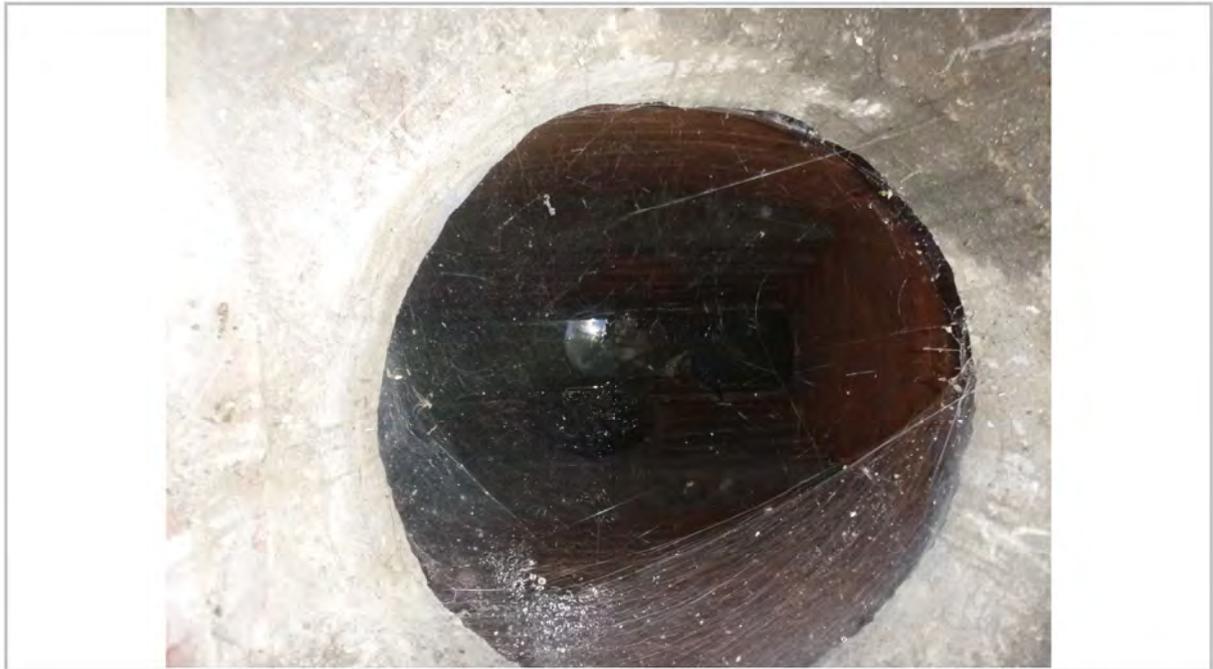
NODE REF	EDS2	
SURVEY DATE	05/09/22	
NODE TYPE	MH/IC/GULLY/OTHER	
STATUS	PU/PR	
FUNCTION	F/SW/C	
INVERT DEPTH(M)	2.55M	
CONSTRUCTION	BR/PCC/OTHER	
REMARKS (Photos etc)	BRICK RUBBLE IN CHANNEL

GP3 EDS2
BRICK RUBBLE IN CHANNEL

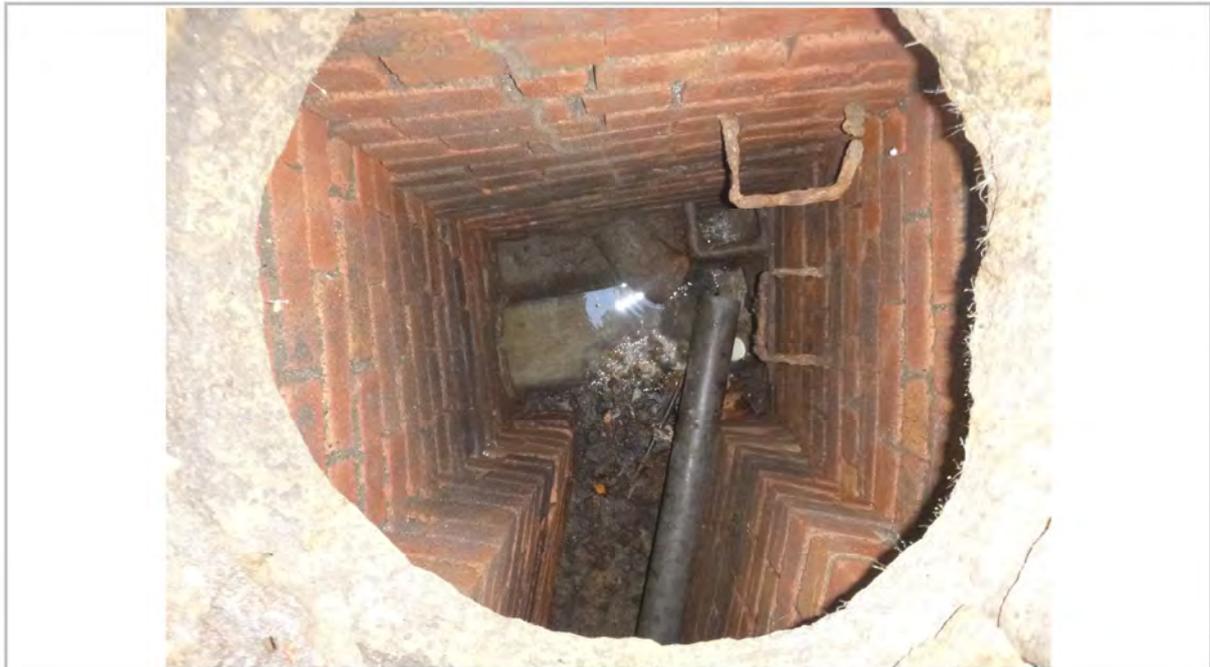
NODE REF	EDS3	
SURVEY DATE	05/09/22	
NODE TYPE	MH/IC/GULLY/OTHER	
STATUS	PU/PR	
FUNCTION	F/SW/C	
INVERT DEPTH(M)	2.2M	
CONSTRUCTION	BR/PCC/OTHER	
REMARKS (Photos etc)	BRANCH D RUNS ALONG 400MM DUCT OBSTRUCTING FLOW IN CHAMBER

GP5 EDS3
CABLE DUCT INTO CHAMBER. BR D OBSTRUCTING FLOW, NO ACCESS TO CCTV SURVEY. NO VEHICULAR ACCESS.

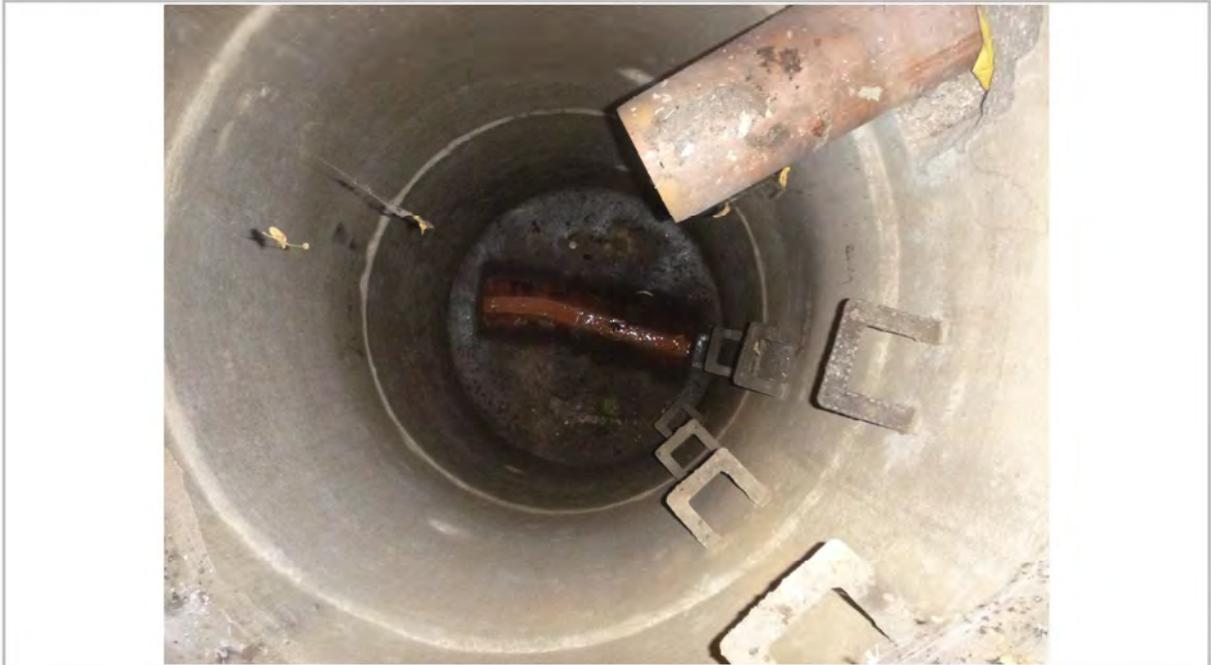
EDS7
GP13

NODE REF	EDS7	
SURVEY DATE	05/09/22	
NODE TYPE	MH/IC/GULLY/OTHER	
STATUS	PU/PR	
FUNCTION	F/SW/C	
INVERT DEPTH(M)	3.09M	
CONSTRUCTION	BR/PCC/OTHER	
REMARKS (Photos etc)	BR B FROM ROAD GULLY

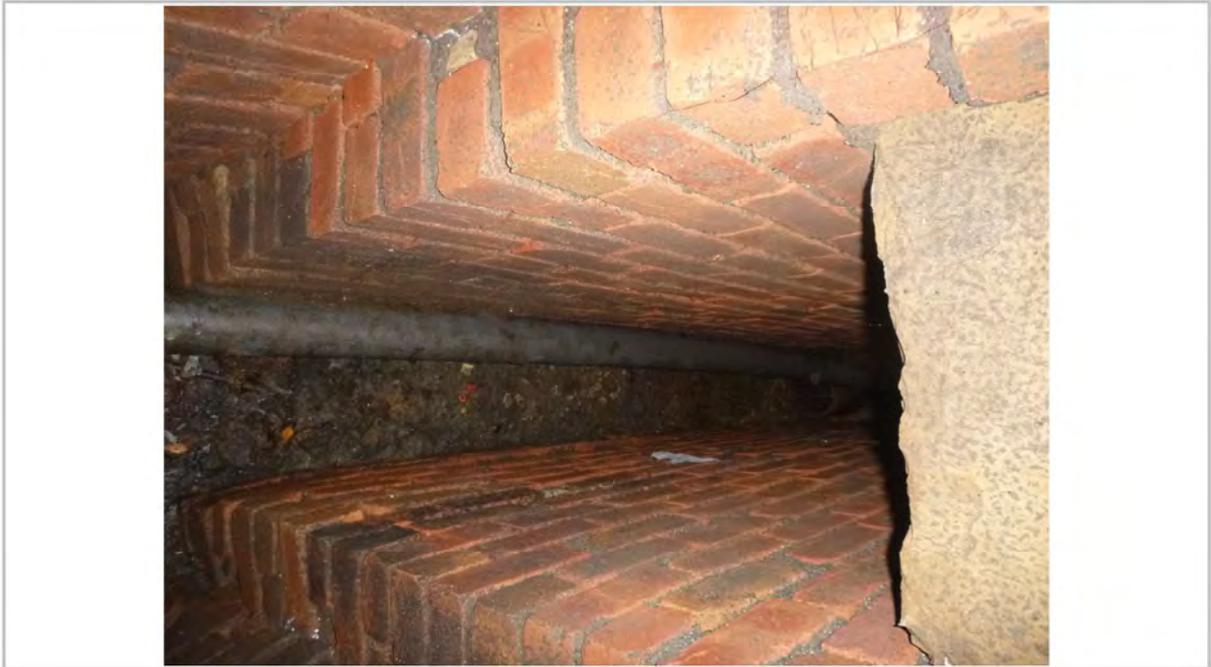
GP23 EDS3 - VIEW UP DUCT FROM CHAMBER

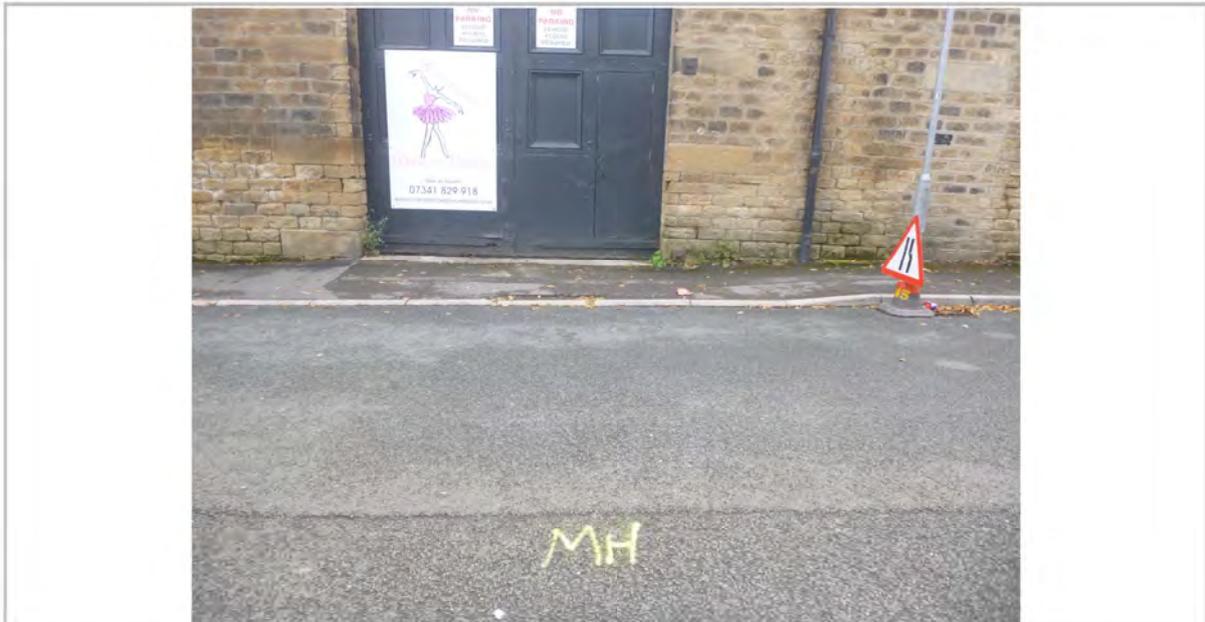
GP24 EDS2A - BURIED

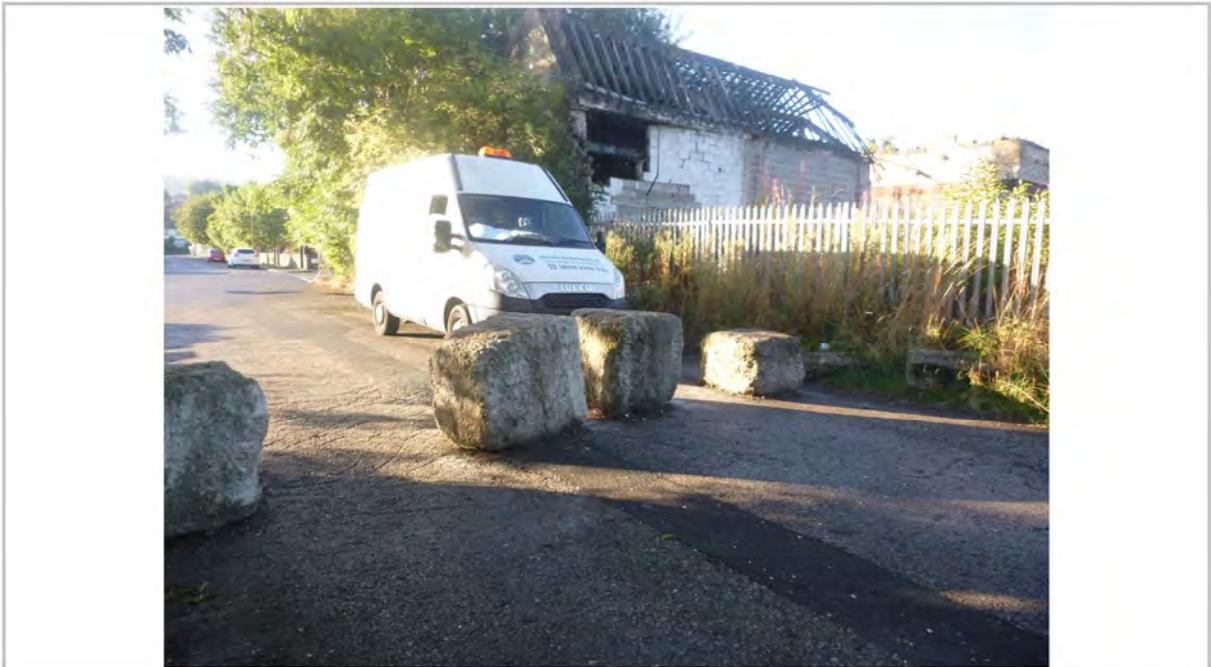
GP27 NO VEHICULAR ACCESS ALONG LINE OF PUBLIC SEWER

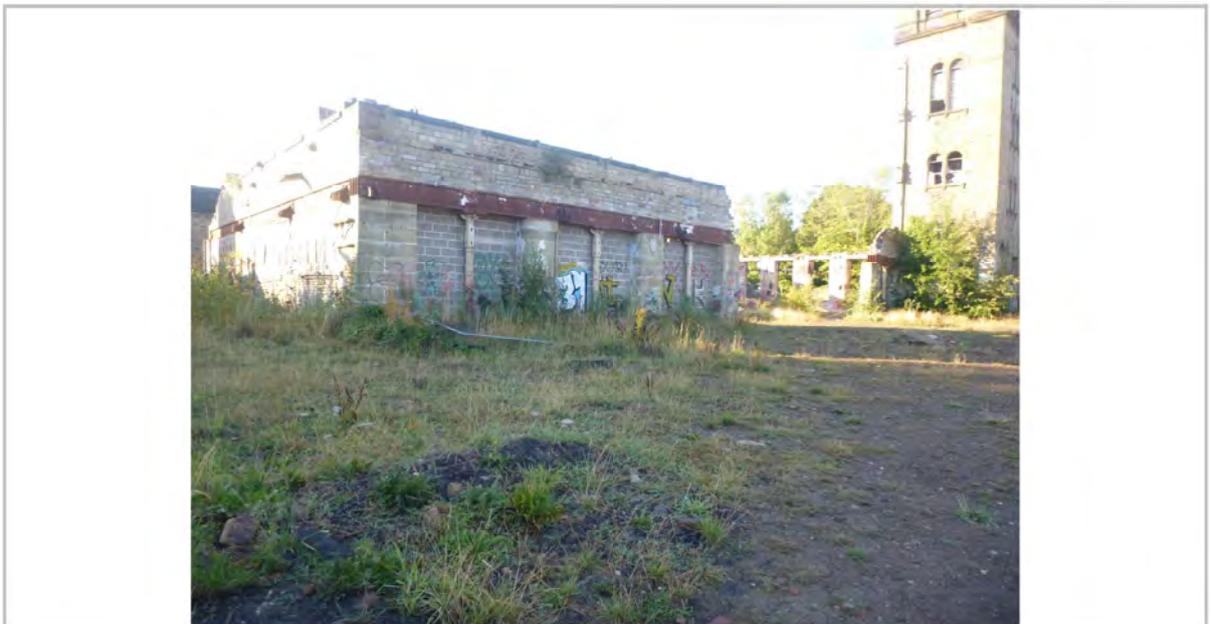
GP28 UNABLE TO LOCATE ANY FURTHER CHAMBERS ON SITE

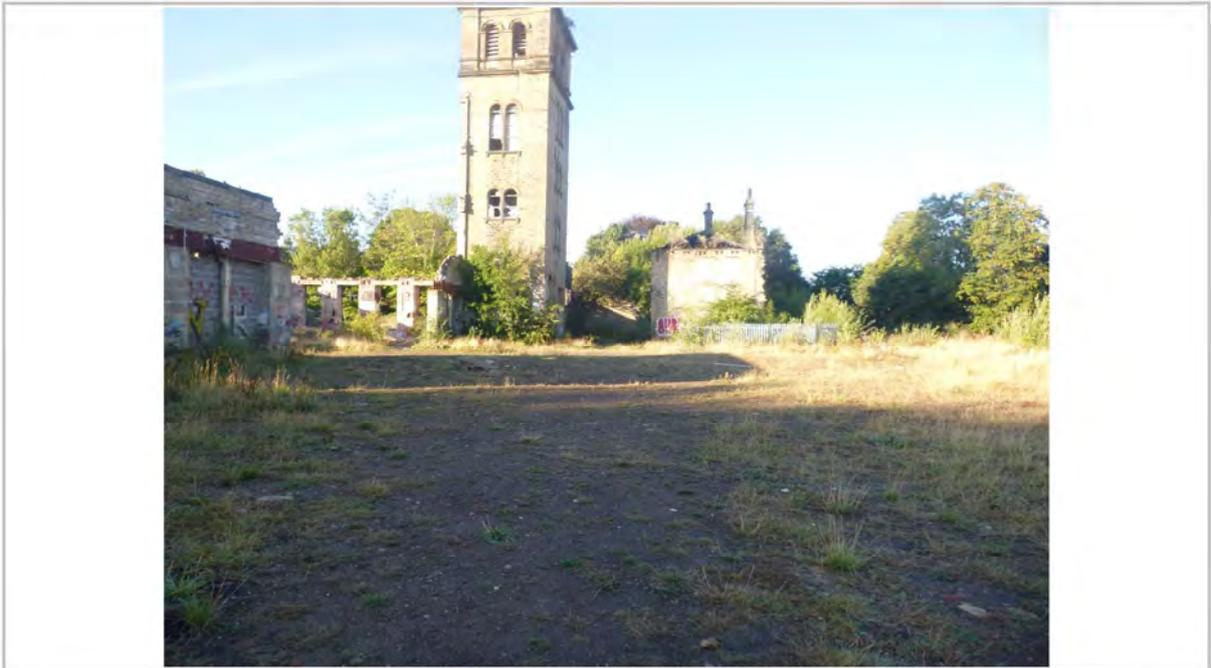
GP29 UNABLE TO LOCATE ANY FURTHER CHAMBERS ON SITE

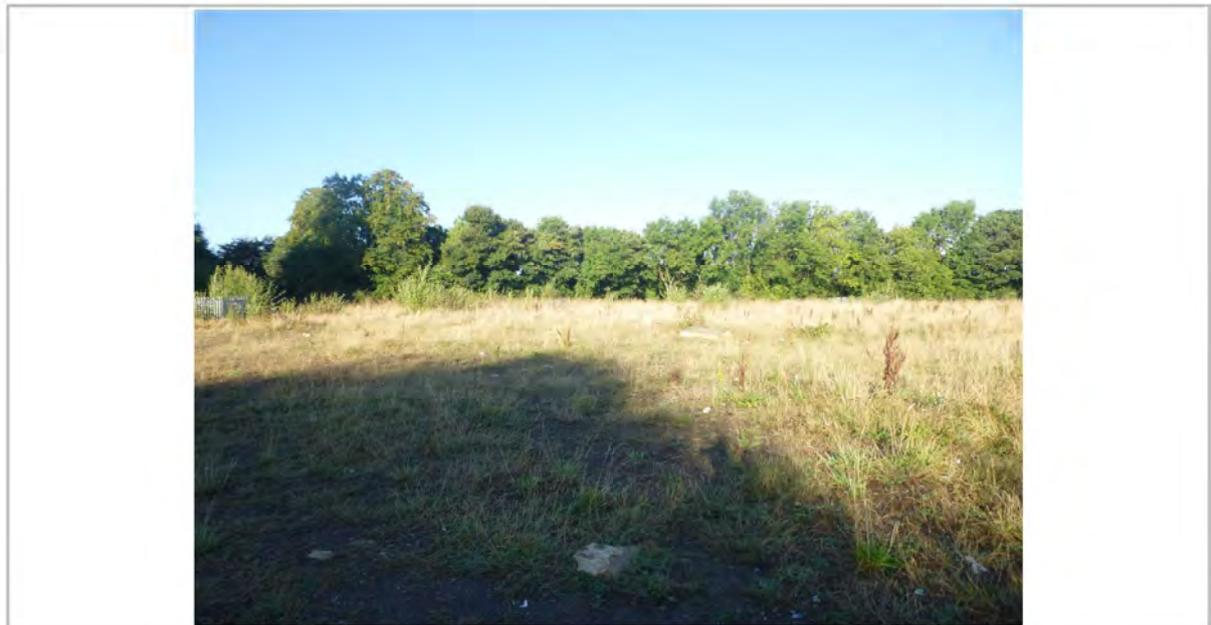
GP30 UNABLE TO LOCATE ANY FURTHER CHAMBERS ON SITE

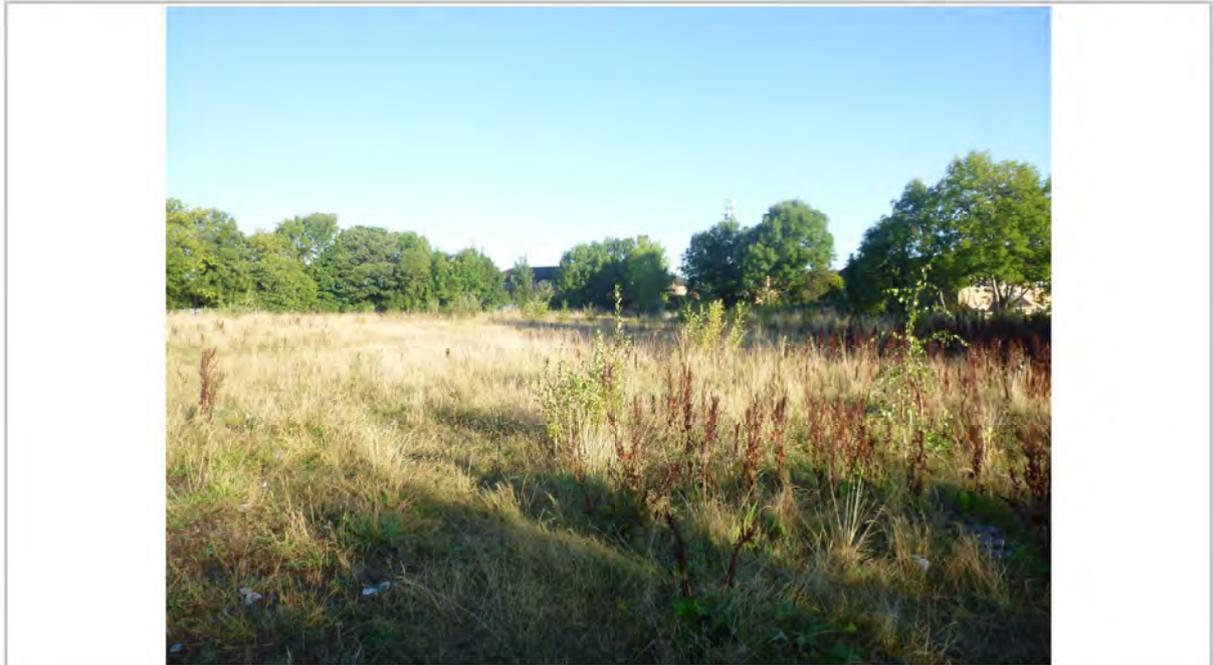
GP31 UNABLE TO LOCATE ANY FURTHER CHAMBERS ON SITE

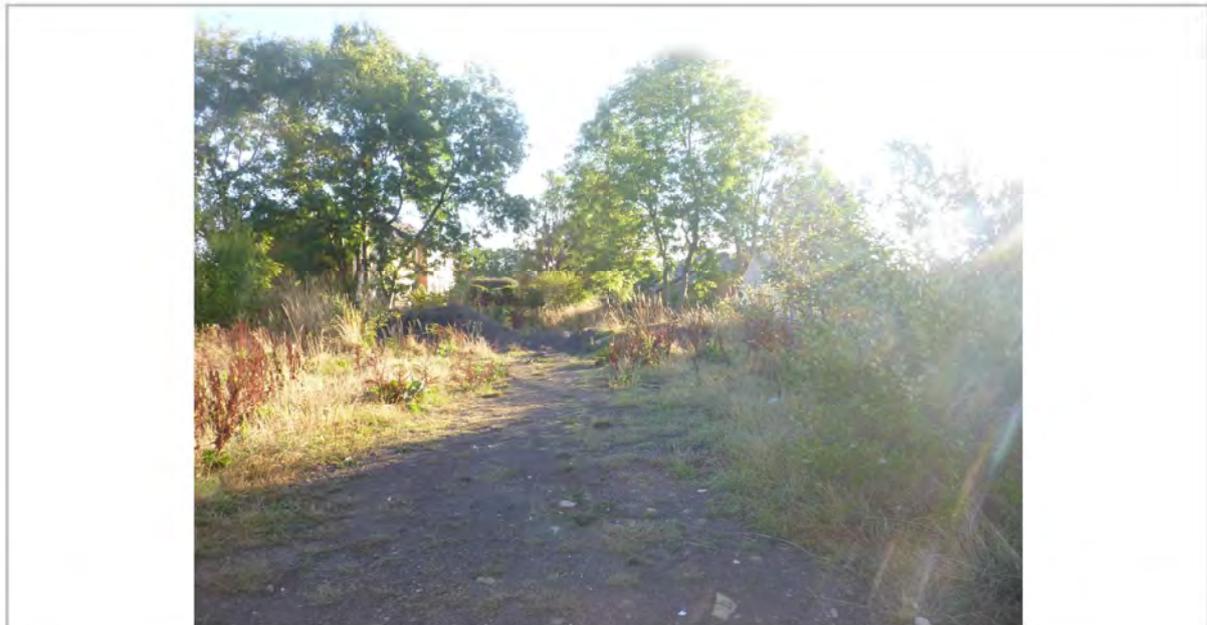
GP32 UNABLE TO LOCATE ANY FURTHER CHAMBERS ON SITE
