Date 6<sup>th</sup> September 2023  
Our Ref: 23345

**Re: Main River Culvert Condition Technical Note for proposed Conversion at 31 Chapel Hill, Linthwaite**

**Project:**  
 Refurbishment of  
 Former Methodist  
 Chapel to create  
 9 Apartments.

**Address:**  
 31 Chapel Hill,  
 Linthwaite,  
 Huddersfield,  
 HD7 5NJ

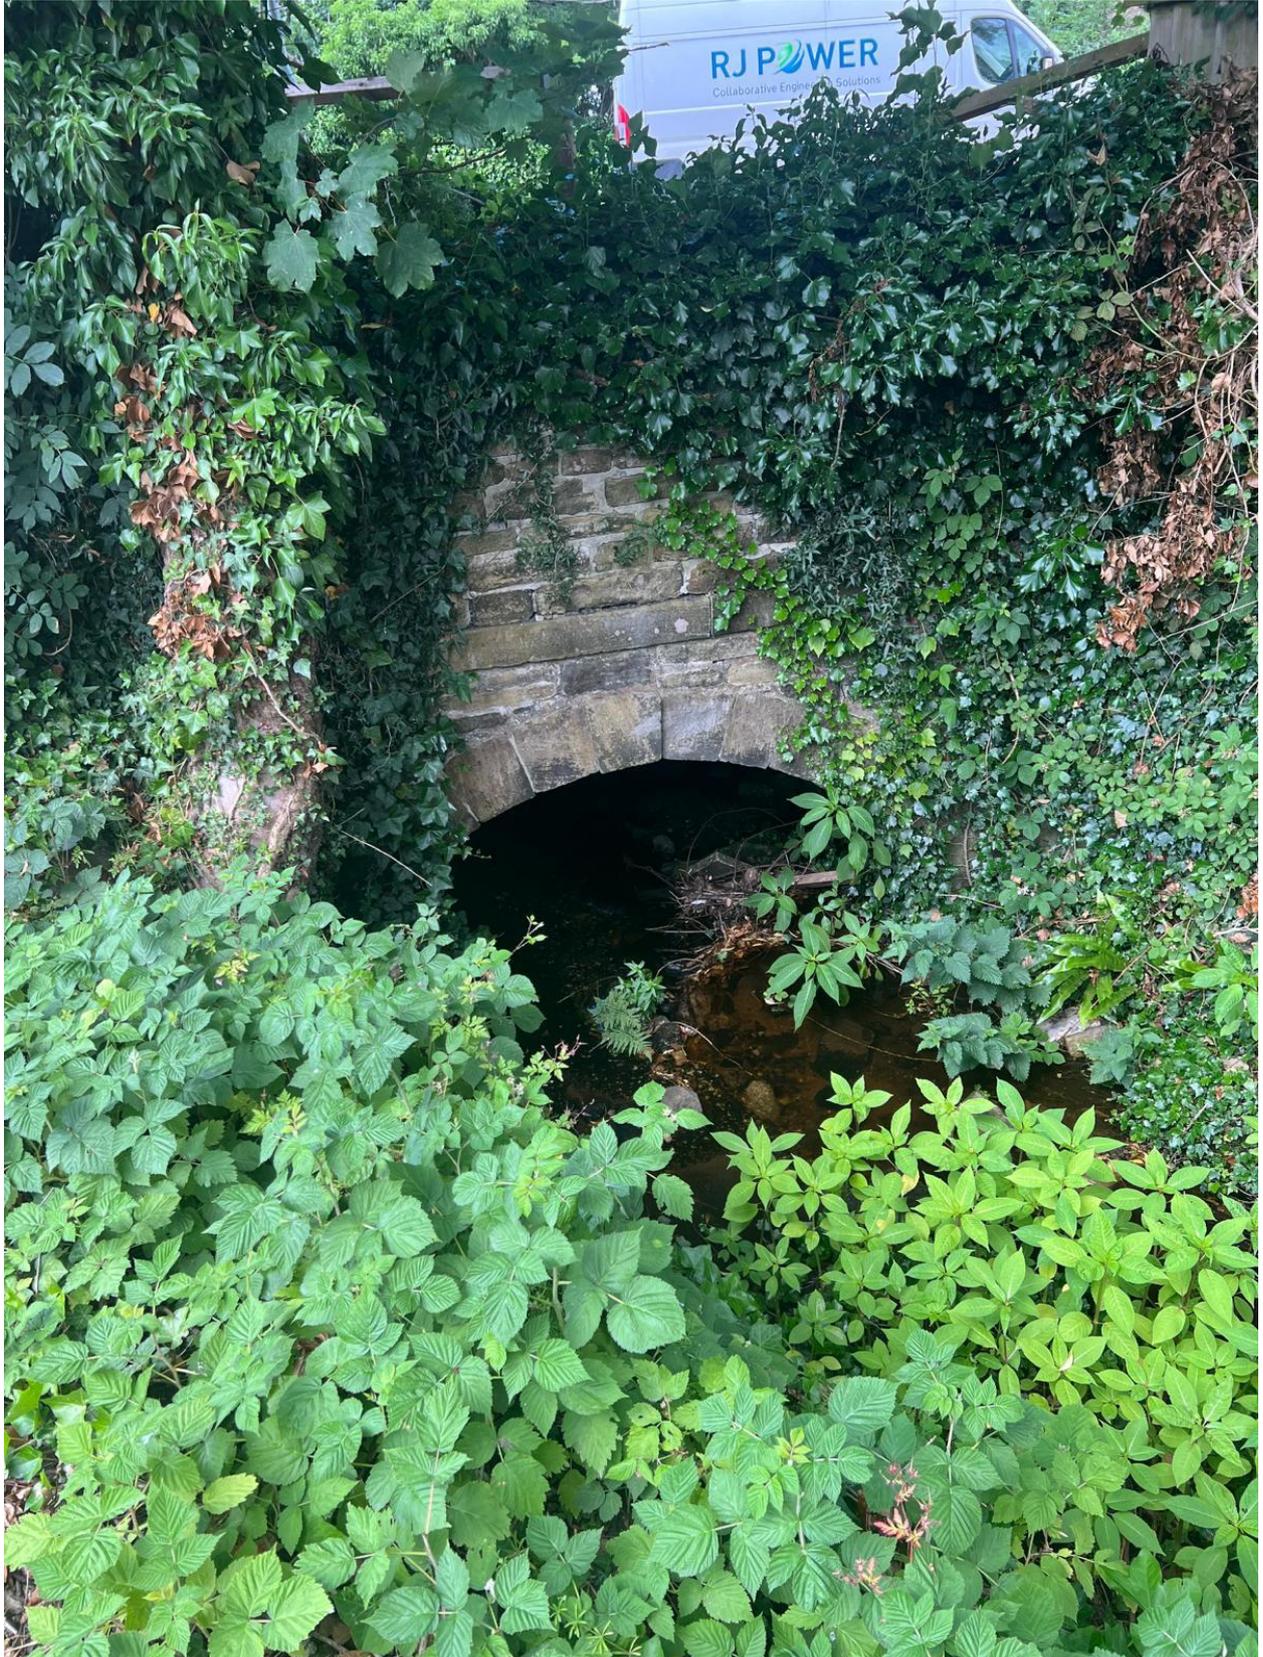
- From visual inspection, the culvert appears in reasonable condition, with no indication of defects or deterioration (stone arch construction).
- The loading applied to the culvert from an adopted highway is far in excess of the loading from a private car parking area for residential dwellings. In addition to this the access space will prohibit any larger vehicles from accessing this area.

Entrance to culvert to south of development site (van is driving over on Waingate)

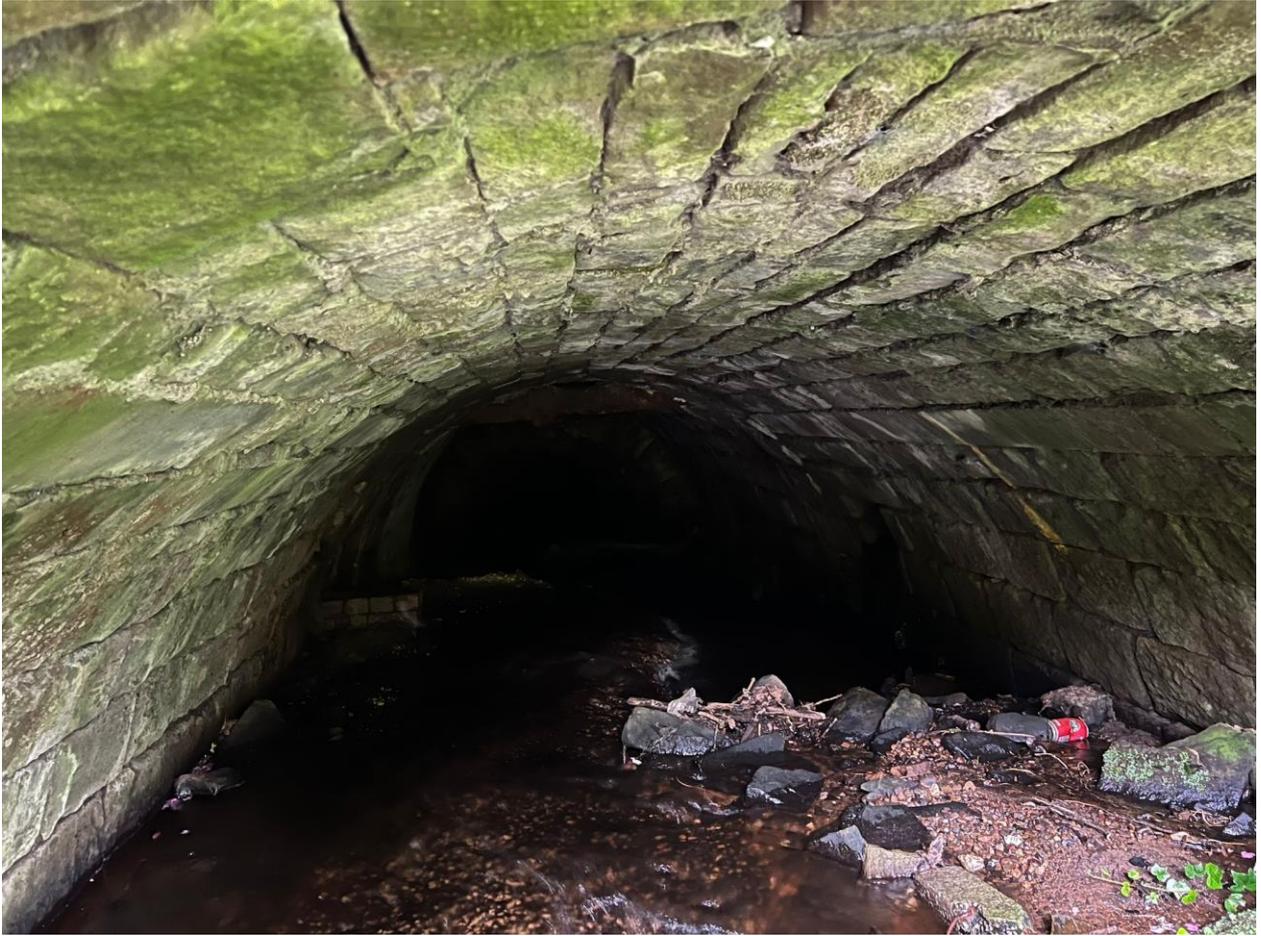
Photograph of culvert construction
