STRUCTURAL DESIGN CONSULTANTS & SURVEY REPORTS

**STRUCTURAL INSPECTION REPORT
DATE: 03/03/23
REF: MDL - 6813**

Linthwaite Methodist Chapel
31a Chapel Hill
Linthwaite
Huddersfield
HD7 5NJ

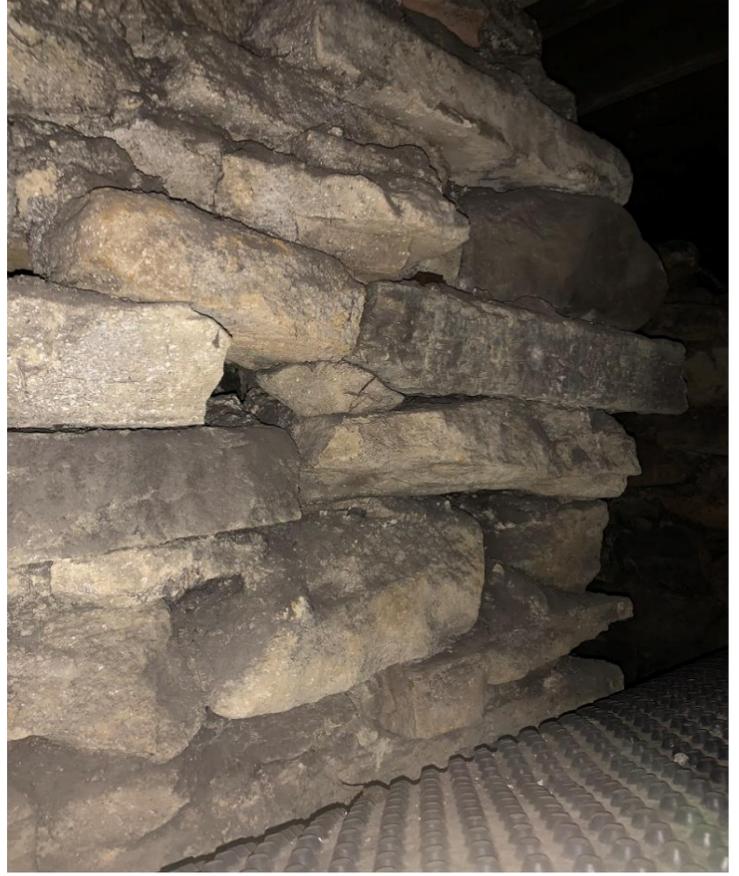
10

The accessible cellar areas to the main building shows no signs of any recent or ongoing movement. The area itself showed no real signs of severe penetrative damp. Minimal cracking noted to all walls deemed historical and not ongoing. All within tolerances. Though further investigation required to ascertain general structural integrity of exposed footing areas during proposed renovations. **Pic Ref: 10-11 Internal Areas**

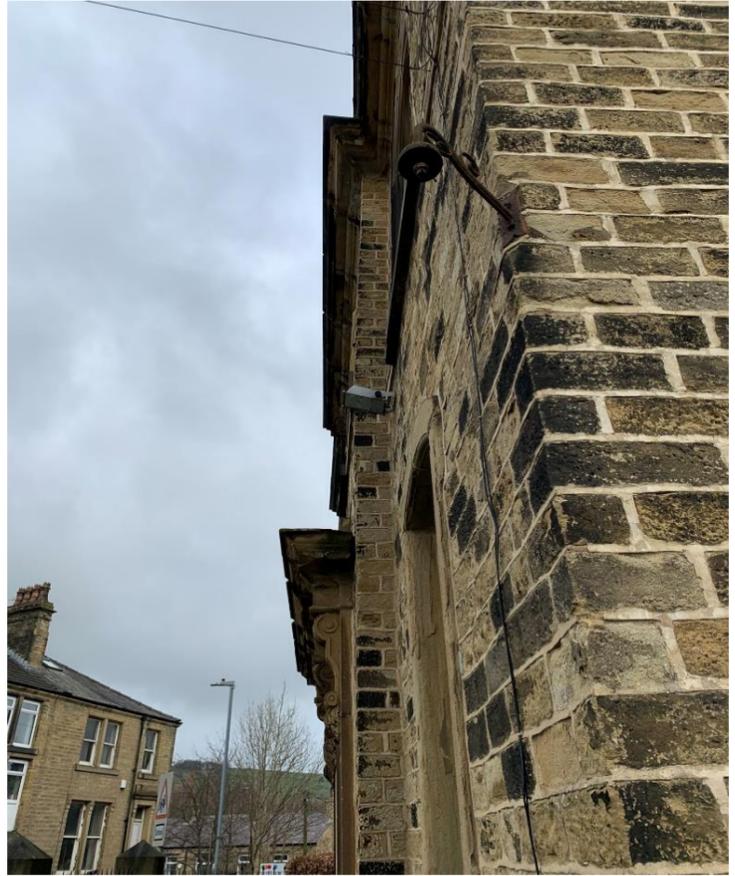
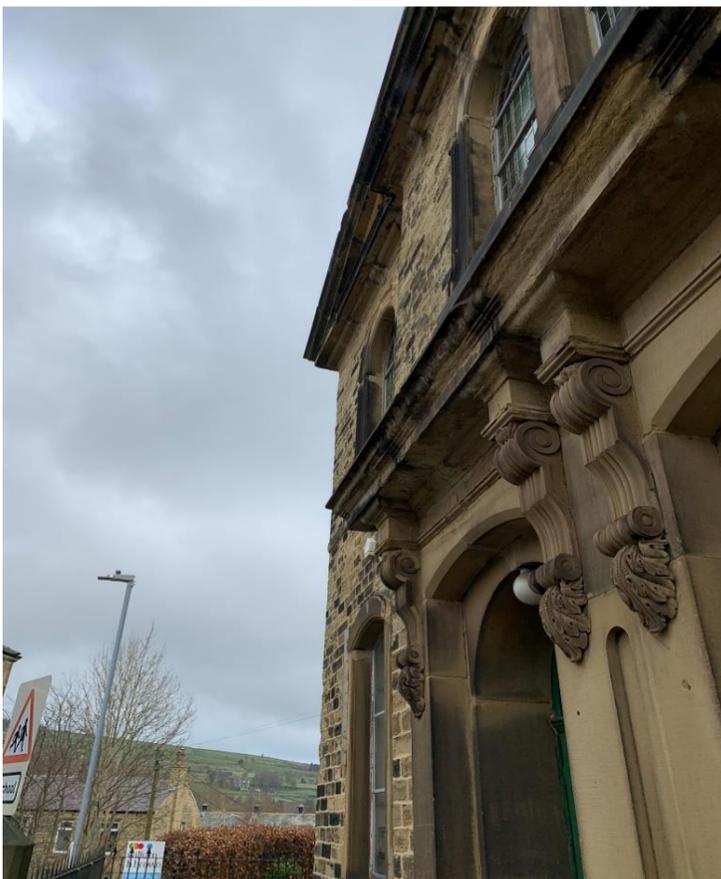
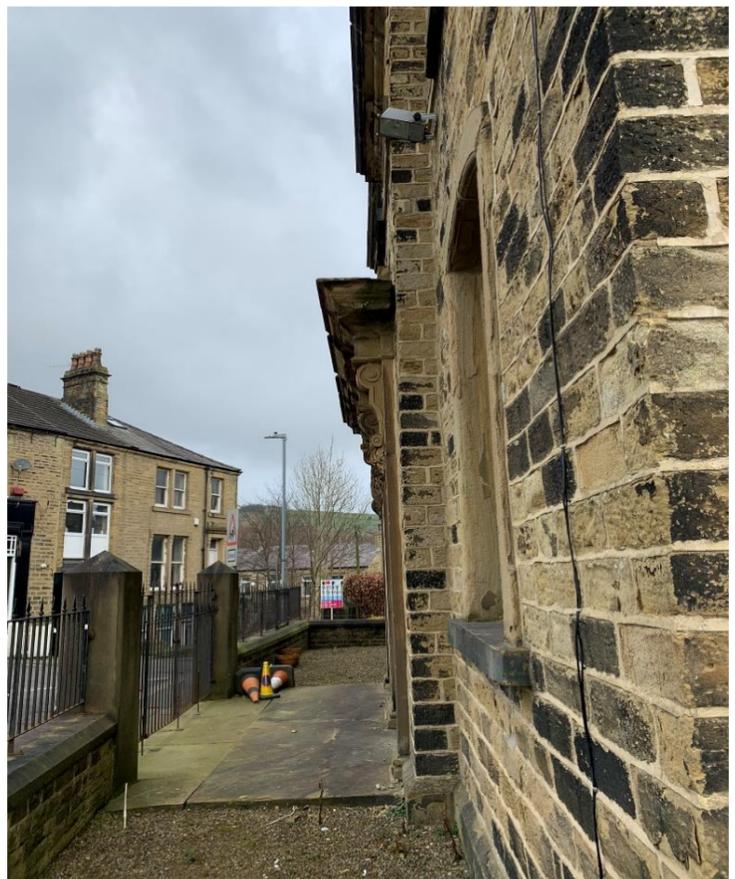
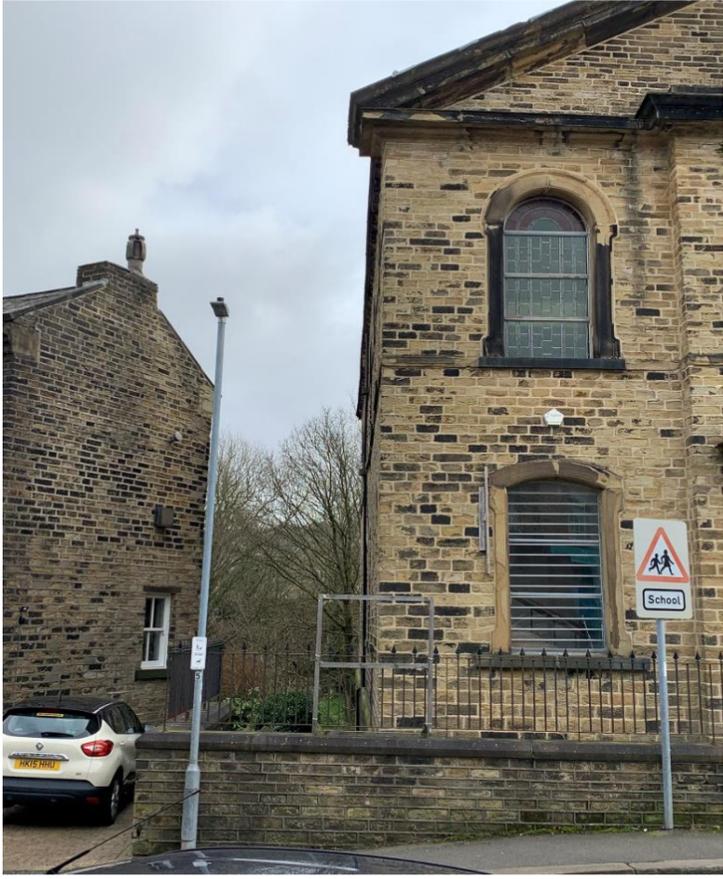
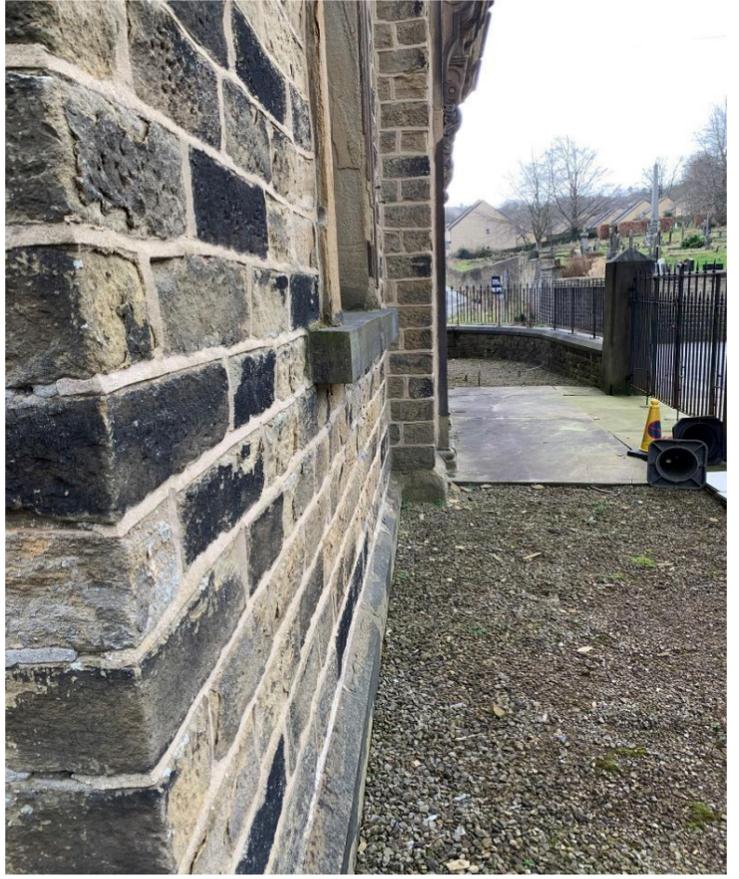
There is further delamination to the architectural stone on the front elevation. Failure has occurred over time through the wetting and drying cycle, and possibly exacerbated by frost attack. Remedial works in the form of sandblasting/ cleaning and epoxy resin/ mortar repairs. **Pic Ref: 1-6 External Areas**

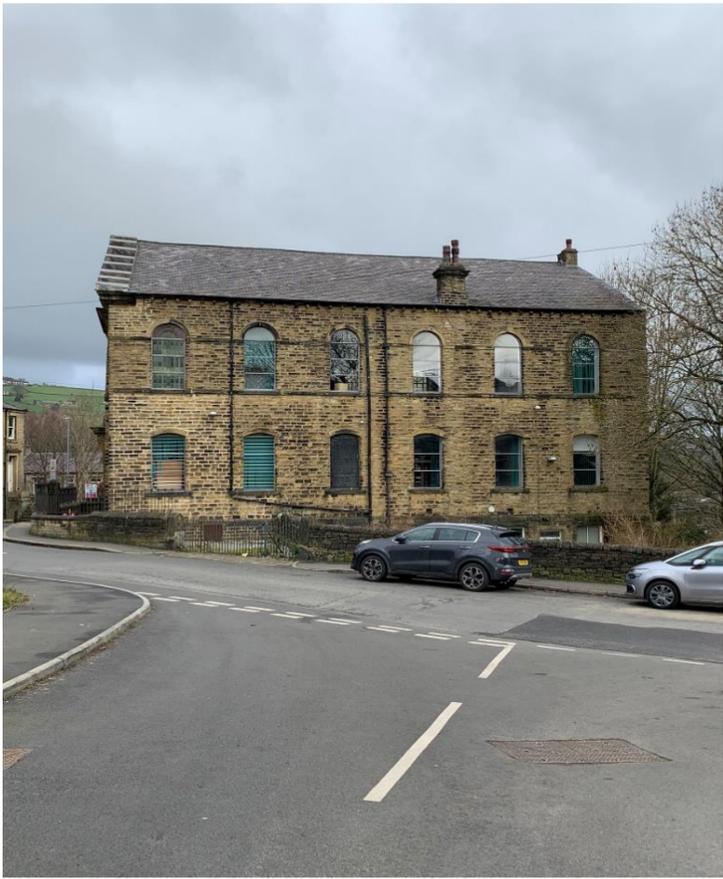
The external roof show minimal signs of deflection and moderate signs of spread. Though there is moderate deflection to the central ridge line. **Pic Ref: 9 External Areas**

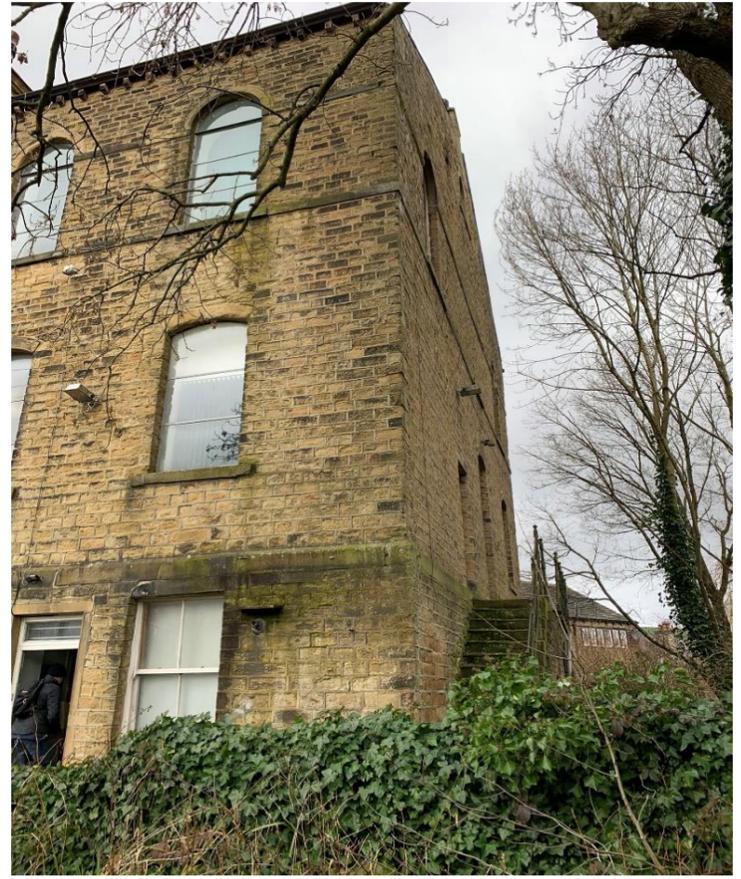
The independent stone stair structure to the rear of the building has moved away from the rear property suggesting subsidence due to inadequate foundations. This will need to be removed completely during the proposed works. **Pic Ref: 16 External Areas**
