Hazel Dransfield & Jane Atkinson  
**Helm Farm**  
Structural Inspection Report

Rev01 | 12 April 2023

Project number: 22-142

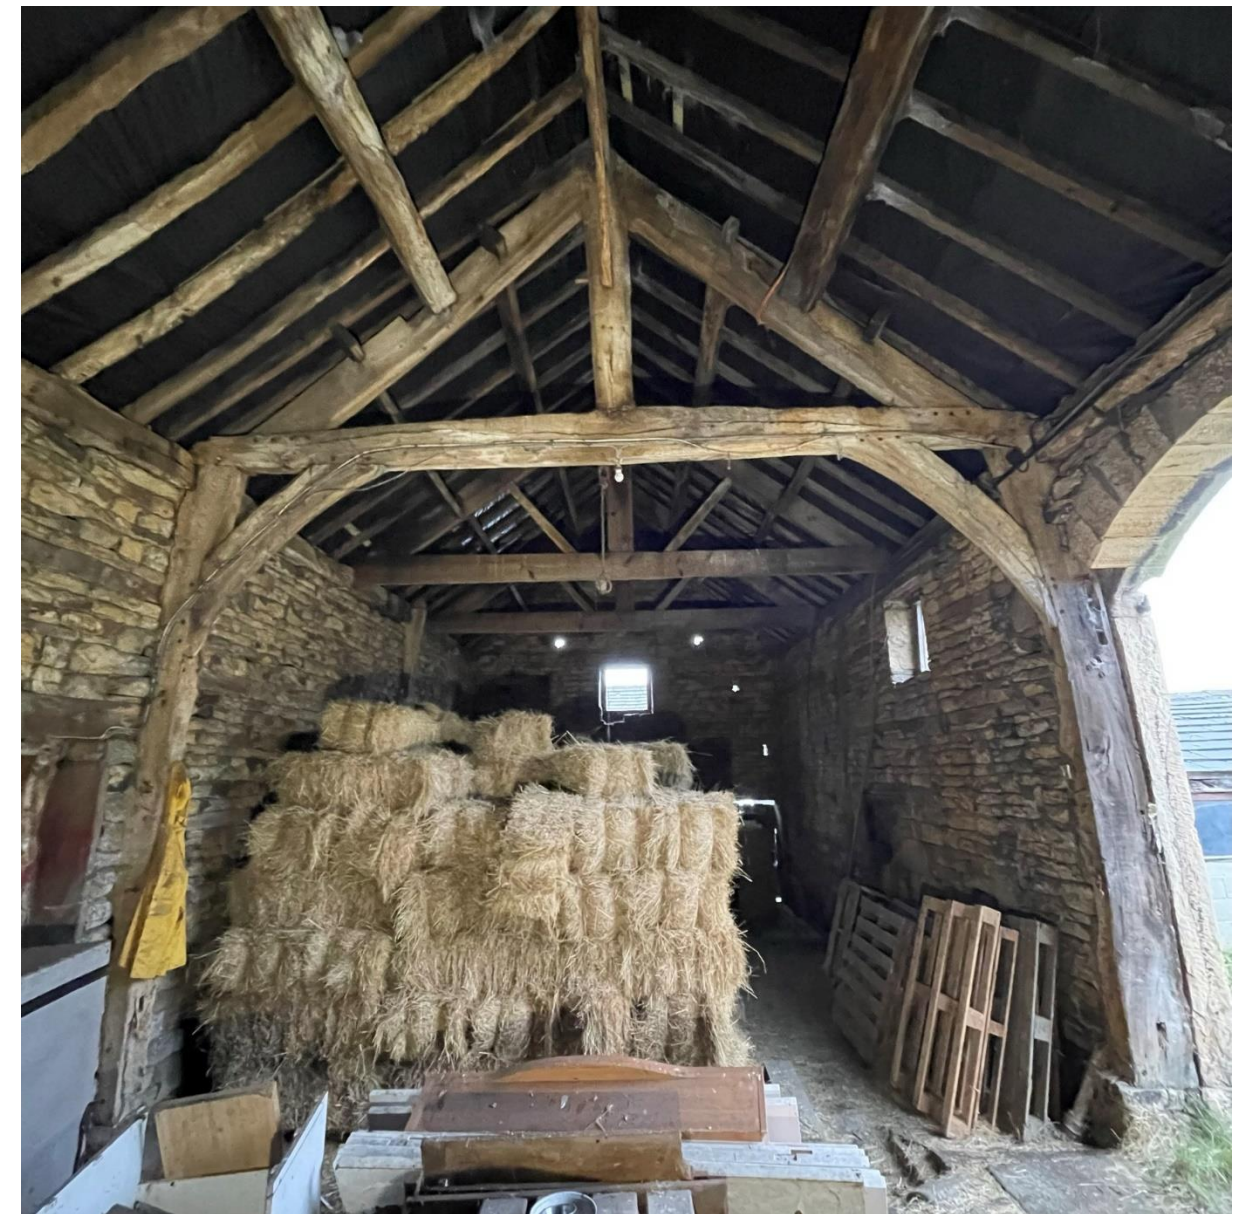
Figure 5 King post truss to foreground on timber posts with bracing and two queen post trusses to background having replaced a single original king post truss (note: timber columns to original king post truss are still present in wall).

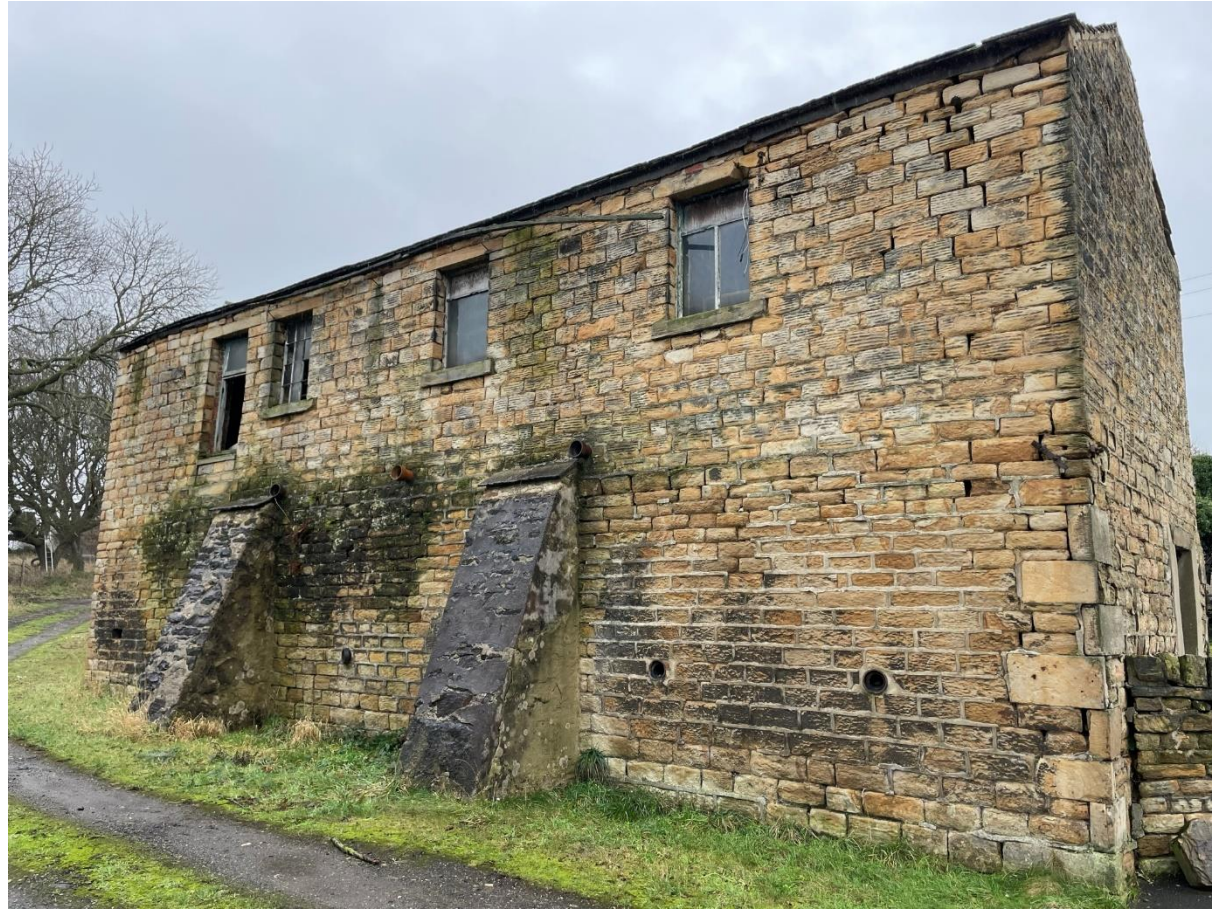
To the north elevation, two coursed stonework buttresses have been installed. The buttresses measure approx. 1200mm wide at the base and 2800mm high.

Figure 8 North elevation with stonework buttresses

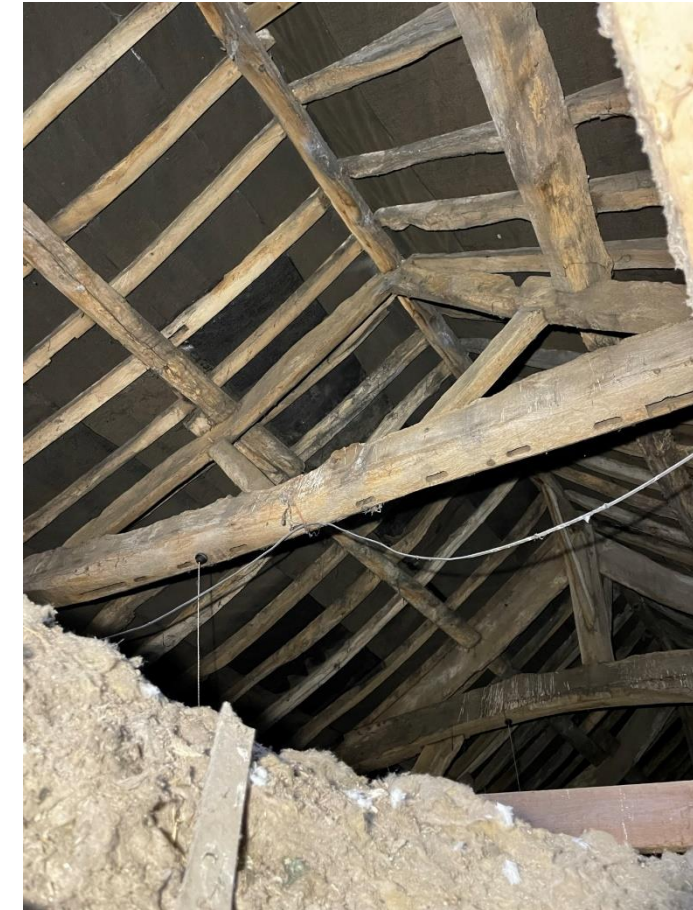
Figure 10 Replacement truss to foreground with typical king post truss with cambered bottom chord to background in main barn.

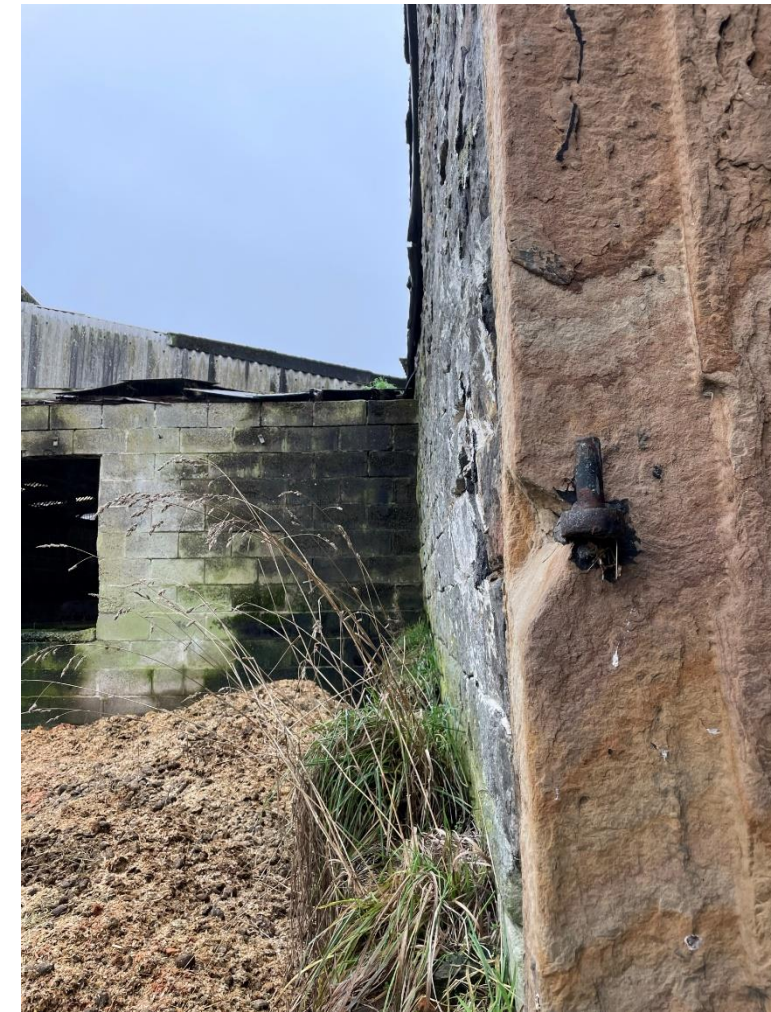
The east elevation wall to the south of the large opening appears distorted with some movement having occurred to the stonework. The risk of further movement/distortion can be reduced by introducing strapping and a buttressing partition as described previously.

Figure 14 Distortion of east elevation, south of large opening.

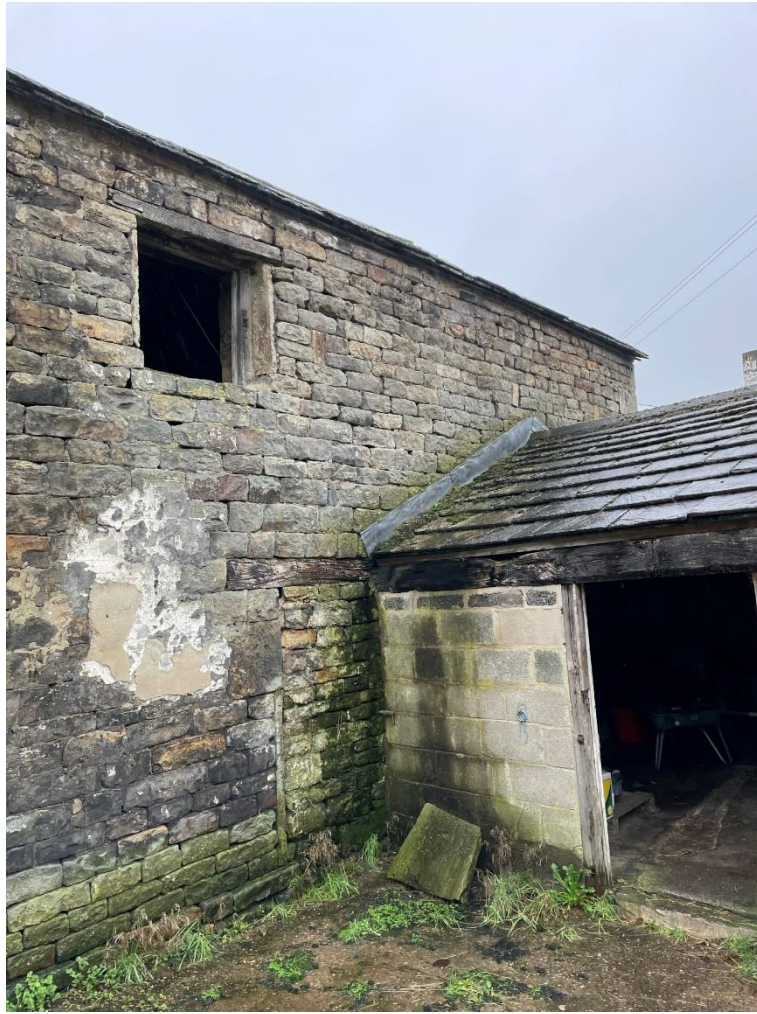
Figure 15 Timber lintels to east elevation.

As part of good repair and maintenance, it is recommended that where there are existing timber lintels, these are replaced with stone lintels with steel 'L-Strip' lintels beneath to provide additional support. Where openings with timber lintels have been infilled, it is recommended that the timber lintel is removed and replaced with stonework coursed into the existing stonework.

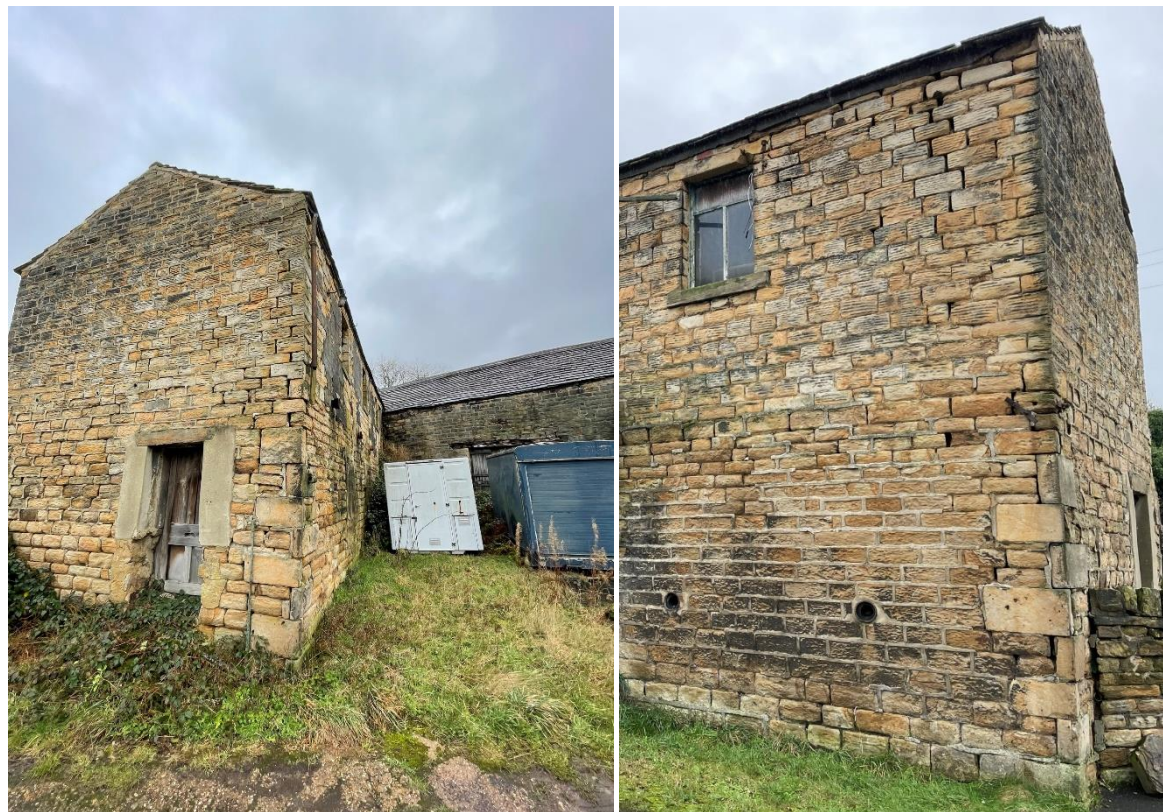
To the corners of the west gable there appears to be some movement and debonding of the stonework including loss of mortar from the joints. It is recommended that these corners are reinforced with helical steel bars to tie the masonry together and prevent further movement.

Figure 16 (a) South corner of west gable elevation; (b) North corner of west gable elevation.

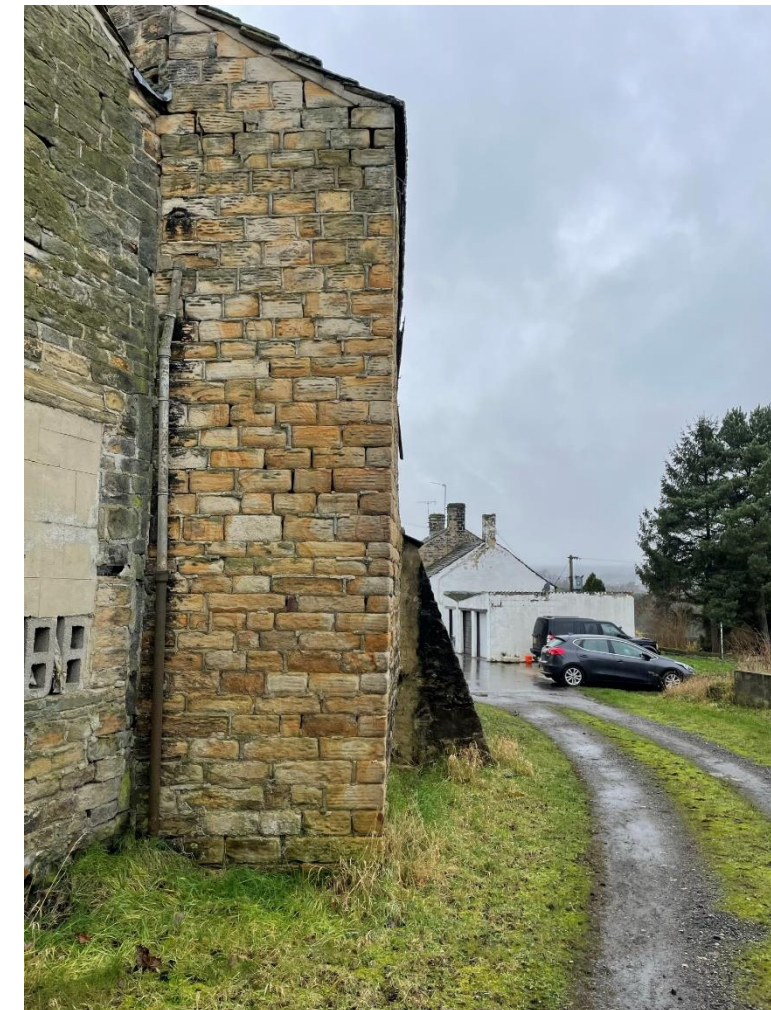
The north elevation is distorted between ground level and a height of approx. 2800mm. This movement is likely to be long standing as two buttresses have been installed to this elevation to limit further movement (it is not known when the buttresses were installed). It is noted that the buttresses do not show any signs of distress suggesting limited local movement following the installation. As a minimum it would be prudent to allow for rebuilding of the section of wall between the two buttresses and ground and first floor levels which is most severely distorted.

Figure 17 Distortion of north elevation viewed from east.

To prevent further movement, it is recommended that any partition walls introduced as part of the conversion are designed as structural partitions to provide lateral support/buttressing of the external walls. This can be achieved using blockwork partitions or timber studwork sheathed with OSB/3 or plywood, nailed at close centres, with steel restraint straps at close vertical centres to tie the partition to the external stonework.

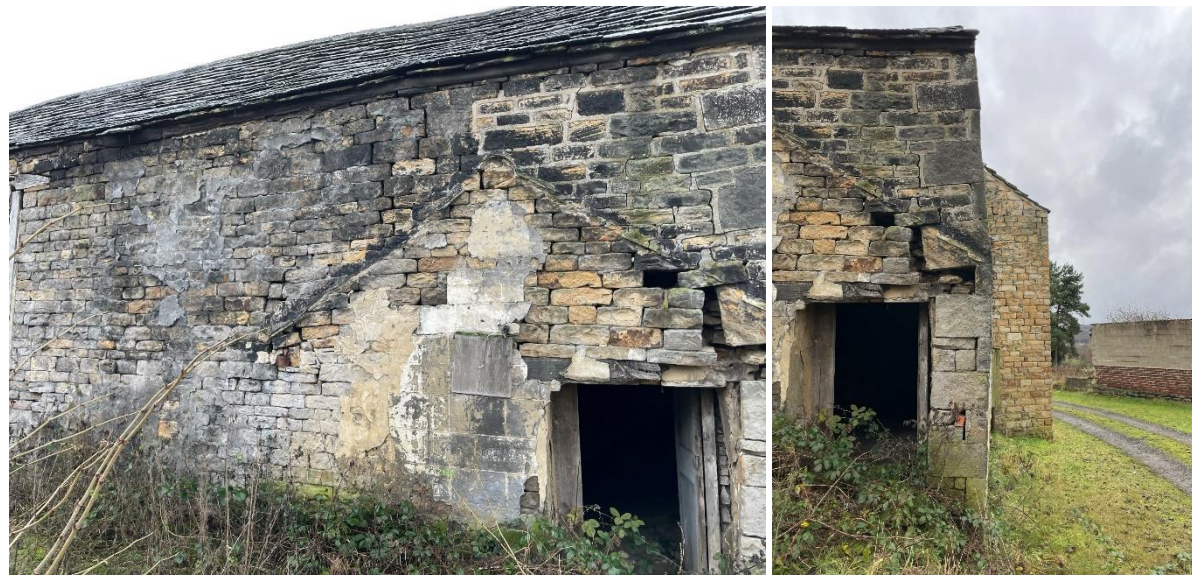
The north gable elevation is distorted. There is limited tying between the north gable elevation and the east elevation (see Figure 18b). It appears that the movement is progressive as repointing local to the north-east corner has been undertaken in the past and further movement and cracking to the mortar joints has since occurred. Cracking was also observed in the north gable elevation (see Figure 19). It is recommended that part of the north gable elevation and the northern section of the east elevation is taken down and rebuilt, with the extent indicated in Figure 20. Temporary propping may be required until the permanent works for the conversion are complete.

Figure 18 (a) North end of east elevation; (b) Distortion of north gable elevation.

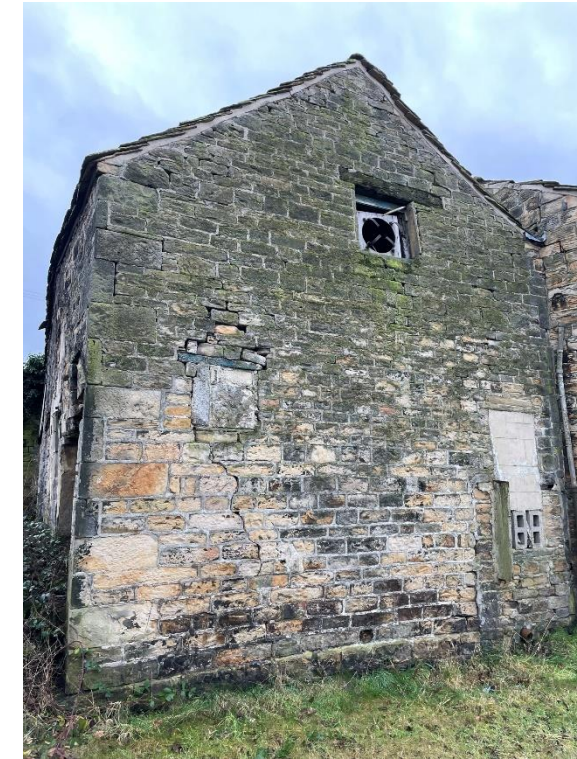
Figure 19 North gable elevation with cracking.

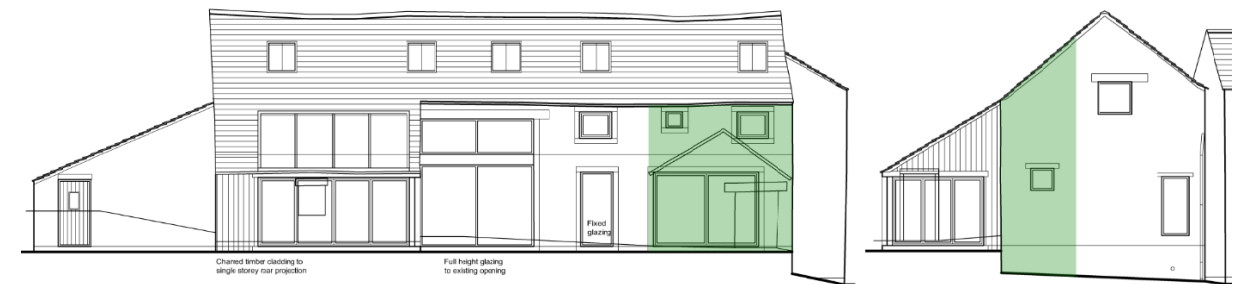
Figure 20 East (left) & north (right) elevations of Stone Barn C with areas of wall to be rebuilt indicated green.

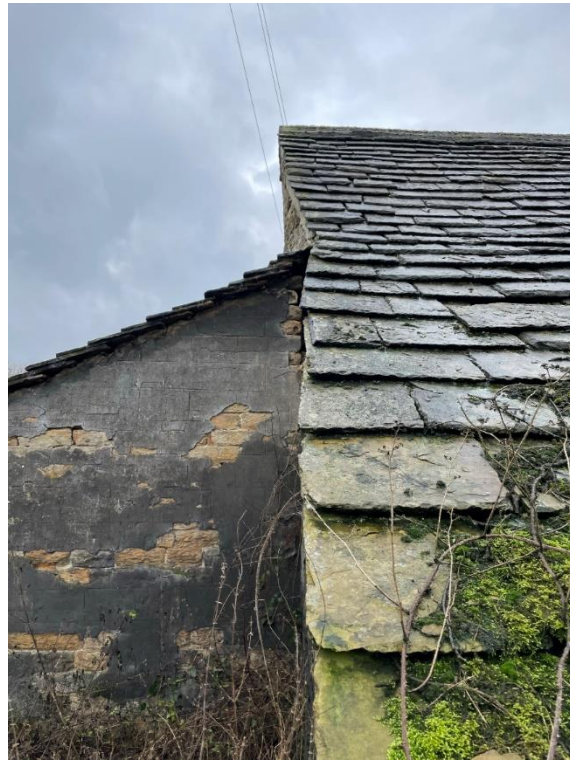
The top of the south gable appears to be distorted (see Figure 21). It is likely that the movement is caused by listing of the roof structure (see Section 3.3.2). The top portion of the gable, above the adjoining single pitched roof, should be taken down and rebuilt.

Figure 21 Distortion of south gable view from east.

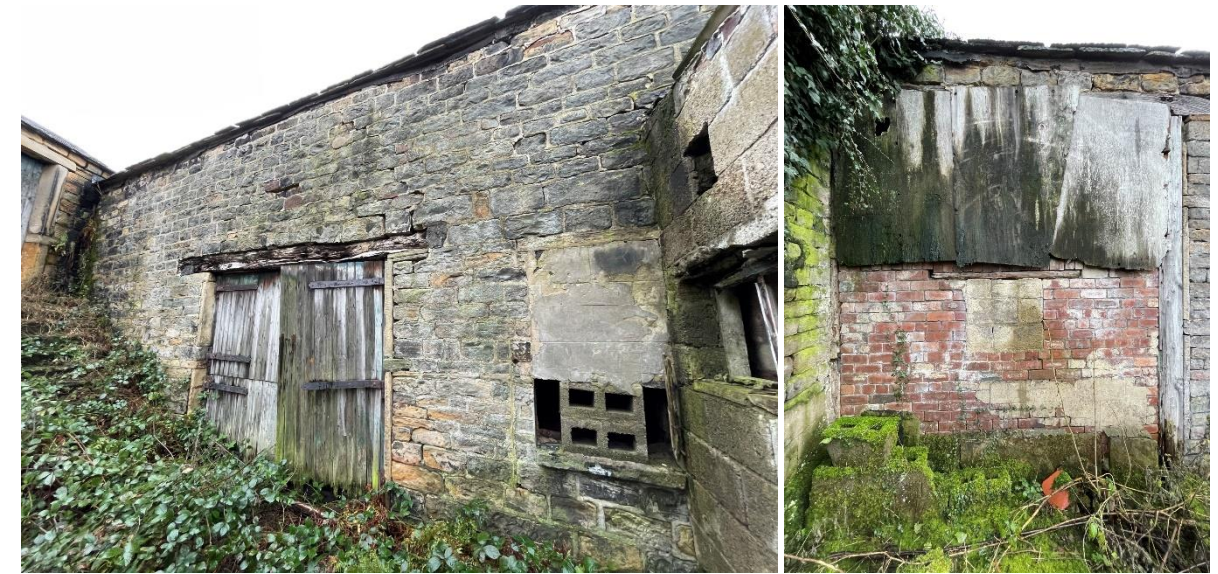
Figure 22 (a) Door opening to west elevation with timber lintel; (b) Large infilled opening to east elevation with timber lintel.

As part of good repair and maintenance, it is recommended that where there are existing timber lintels, these are replaced with stone lintels with steel 'L-Strip' lintels beneath to provide additional support or steel beams with facing stonework. Stepped cracking was observed in the stonework above the timber lintel above the door opening to the east elevation. This will need reinforcing with helical steel bars and repointing following the replacement of the timber lintel.

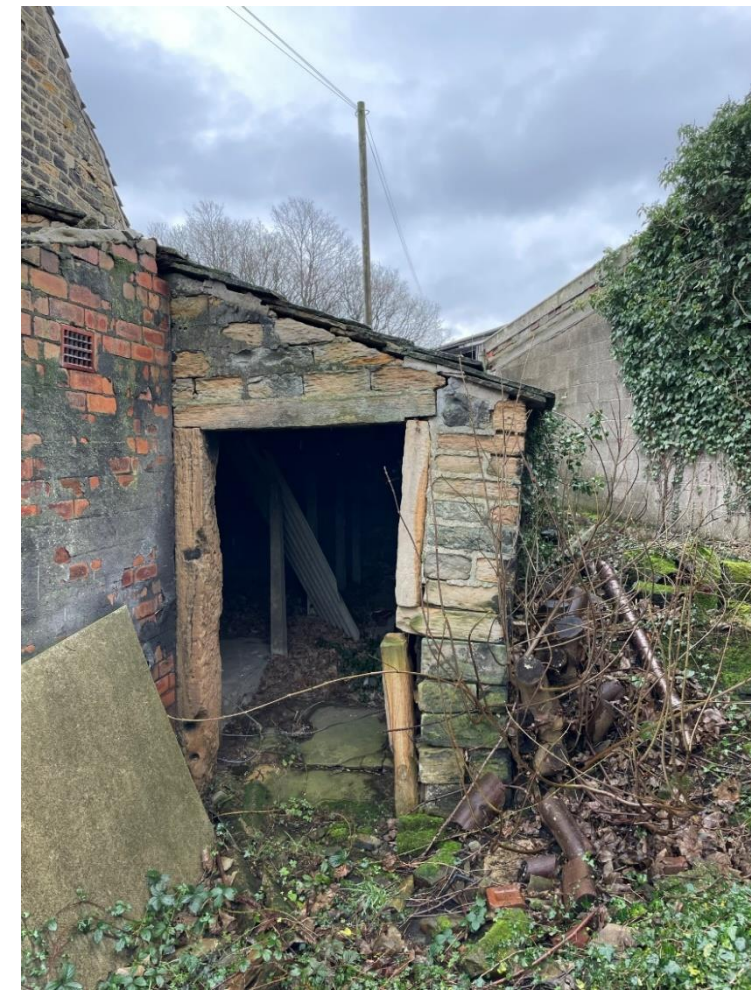
The south-west corner of the southern extension is distorted. This appears to have been caused by a tree growing adjacent to the wall (now cut back). It is recommended that the wall local to the tree where distortion has occurred is taken down, the existing tree stub removed, and the wall rebuilt.

Figure 23 Distortion of south-west corner of southern extension, viewed from west with tree stub adjacent.

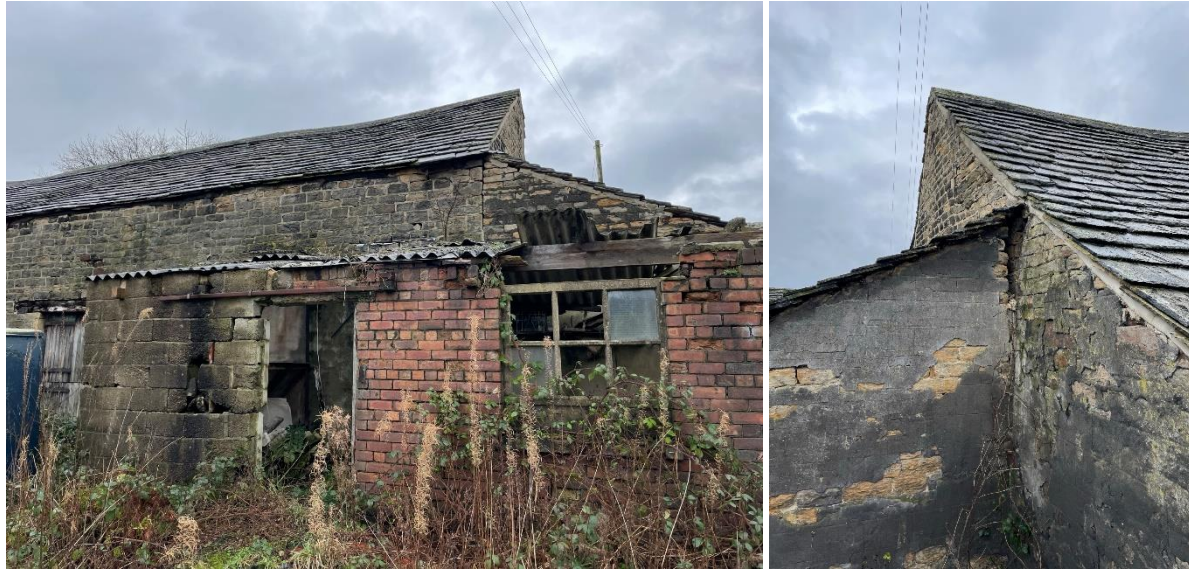
Where the south extension interfaces with the main barn, the stonework is not coursed or tied in to the main barn. The south extension should be tied to the main barn with helical steel bars.

Figure 24 Interface of south extension with main barn (a) West elevation; (b) East Elevation.

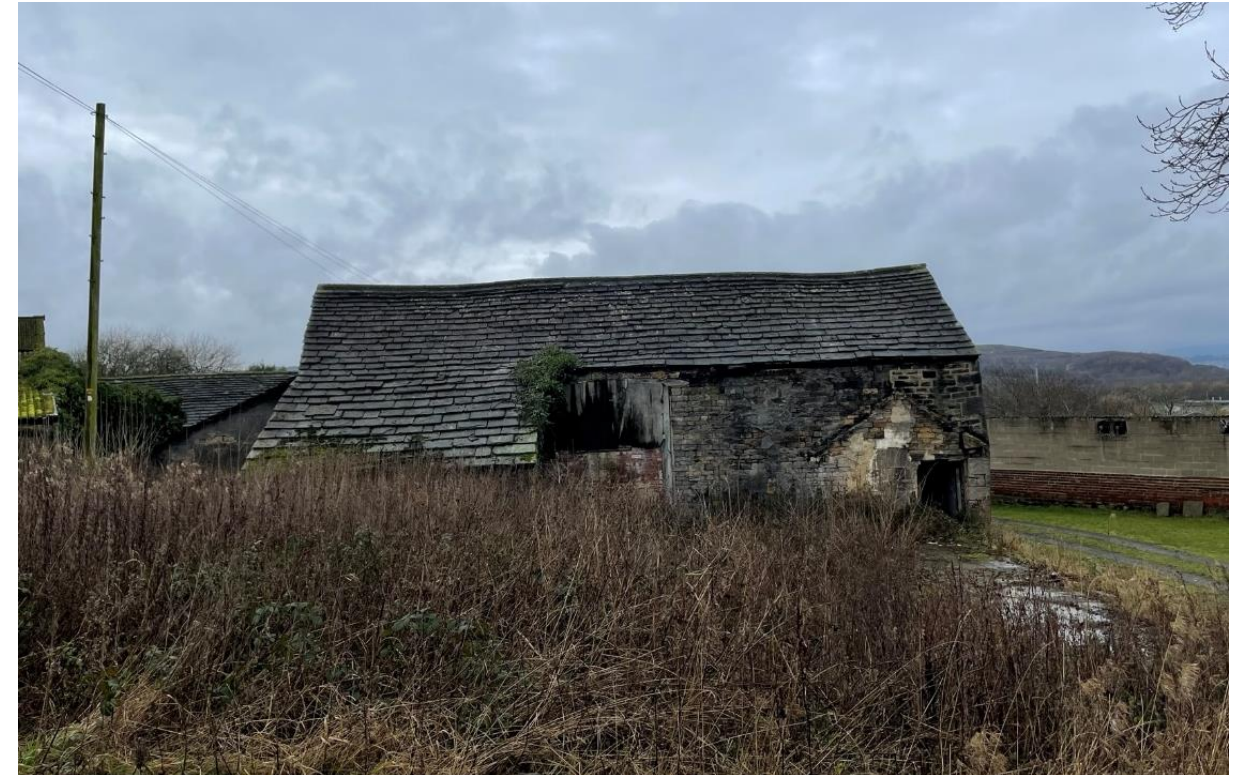
From ground level the existing roof structure appears to be listing to the south. It is noted that a close inspection has not been undertaken at this stage. It is assumed this movement has caused the distortion to the south gable elevation and impacted on the movement to the north gable elevation.

Figure 25 View of Stone Barn C from east showing listing of roof to south.

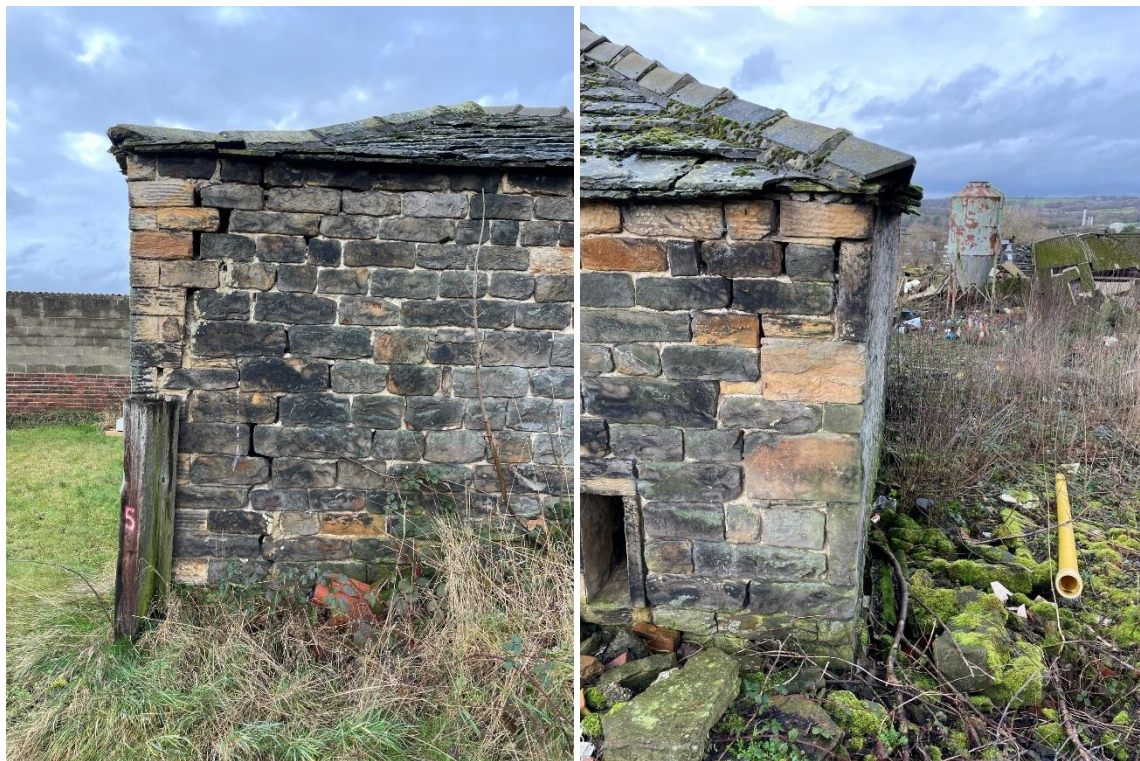
To the corners of the south gable there appears to have been some movement and debonding of the stonework including loss of mortar from the joints. It is recommended that these corners are reinforced with helical steel bars to tie the masonry together and prevent further movement, however, the top few courses of the south-west corner may need to be rebuilt locally given the extent of the movement.

Figure 26 Movement to south elevation (a) West corner (b) East corner.

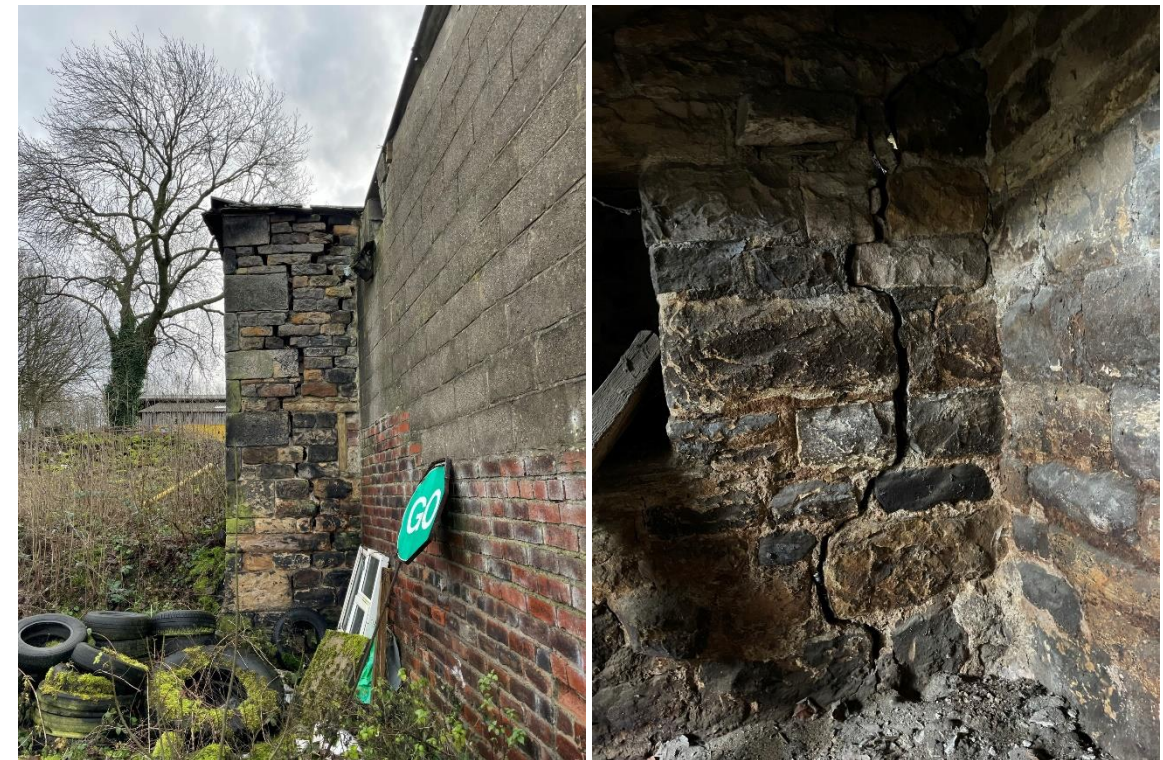
Movement and debonding of the stonework was observed to the north-east corner of the Garages including loss of mortar from the joints (see Figure 27). The cracks continued through the internal leaf of stonework. It is understood that this elevation is to be removed as part of the proposed conversion works and therefore local repairs are not required.

Figure 27 (a) Movement to south-west corner of Garages; (b) Internal cracks matching external movement in south-west corner.

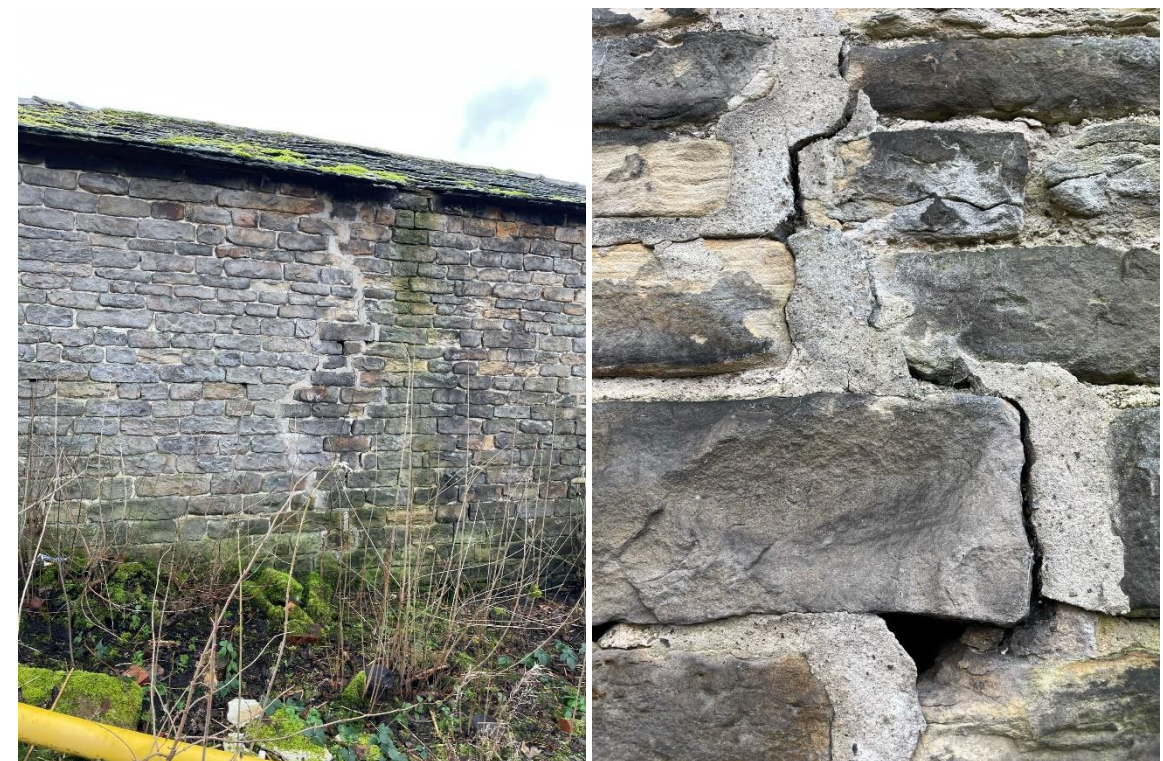
A crack in the mortar joints at the centre of the east elevation was observed. This has previously been repointed but further cracking has appeared suggesting the movement may be progressive. As a minimum the wall should be reinforced with helical steel bars to tie the masonry together across the existing crack.

Figure 28 (a) Repointed crack to east elevation; (b) Cracking to repointed mortar joints.

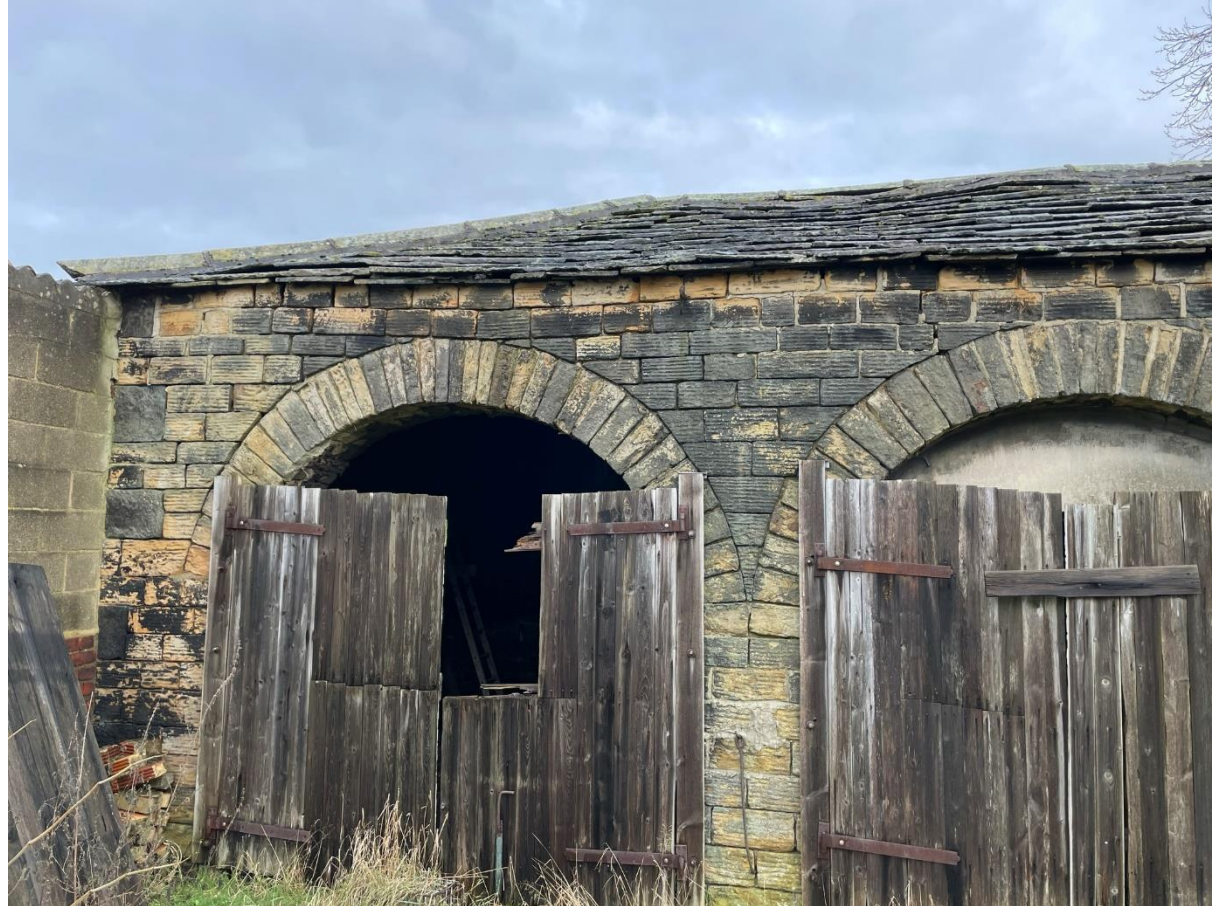
There is slight movement of the stonework arches to the west elevation, with some of the bed joints having dipped over the arches, although the level of movement is not considered to be severe. As part of good repair and maintenance, it is recommended that steel arch lintels are introduced beneath the stone arches to provide additional support and steel helical bars installed to the mortar joints over the arches to limit further movement.

Figure 29 Stone arches to west elevation.
