**Mill 5
Parkwood Mills
Stoney Lane
Huddersfield
HD3 4ZQ**

**Structural Inspection
of
End Gable Wall**

**August 2022
Y89**

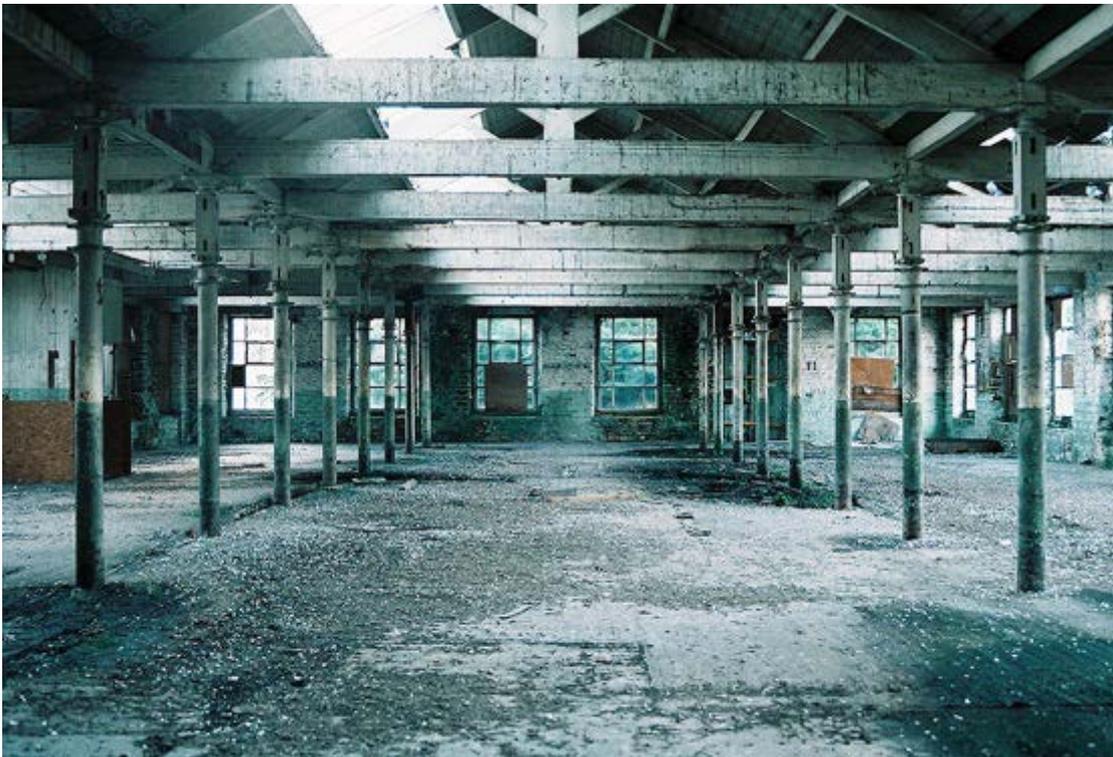
Figure 4 - Historical image, date unknown. Condition of roof and upper floor now considerably more deteriorated and partially collapsed.
