QTRA: Individual Tree Schedule

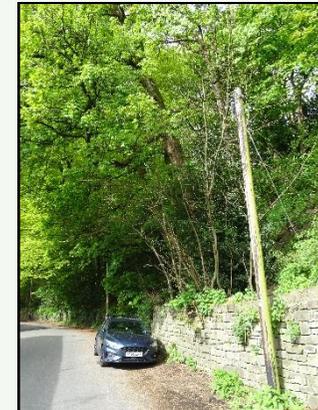
Group 1.1 **Mixed Species Group**

Group located within compartment one, immediately adjacent Howgate Road. Comprises sycamore, ash & holly. Crowns of several trees low over road, contacting telecoms lines and obscuring light splay. QTRA: Failure of ash stems onto parked cars.

Prune	6hrs	Medium	Remove young diseased ash stems Crown lift to clear 5m over road Prune to clear telecoms line and light splay Prune back to boundary of adjacent property (wooden fence)
-------	------	--------	---

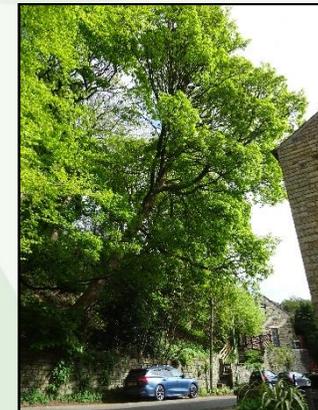
Tree 1.2 **Sycamore (*Acer pseudoplatanus*)**

Tree located within compartment one, immediately adjacent Howgate Road. Moderate lean to main stem & asymmetric crown to the southwest, overhanging road. Apparent recent removal of adjacent mature sycamore (approx. 3m to the north), resulting in a gap in the woodland canopy and increased & unaccustomed wind loading. Pronounced ribs of reaction wood on the upper side of the base of the main stem. Current tree architecture is such that there are adequate growth points for crown pruning (leaf bearing material in late mature sycamore tends to be at distal ends of branches).

Option 1: Prune	18hrs	Medium	Reduce entire crown by approximately 2.5m to 3m
Option 2: Remove	25hrs	Medium	Remove and replace

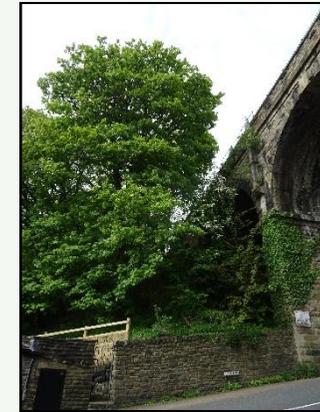
Tree 1.3 **Sycamore (*Acer pseudoplatanus*)**

Tree located within compartment one, immediately adjacent railway bridge MVL3/61. Fine mature tree. Pronounced ribs of reaction wood on the upper side of the base of the main stem. Woodland edge tree. Crown currently in line with boundary fence. Potentially causing minor nuisance to residents of adjacent property (i.e. honey dew, shading, leaf fall etc.).

Management Recommendations	Estimated Time	Priority	Comments
No work required

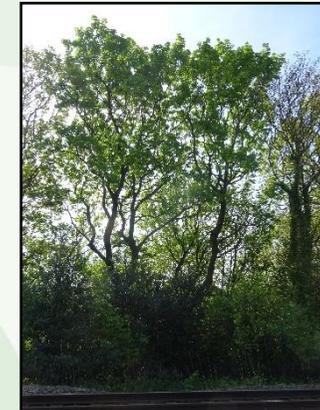
Tree 1.4 **Sycamore (*Acer pseudoplatanus*)**

Tree located within compartment one, towards top of embankment. Anchored on steep bank with highly adapted rooting system. Voids beneath rooting system. Twin stemmed tree with tight union and included bark to south between codominant stems. Northern side of union obscured by bankside, preventing full inspection. Unlikely to reach road or adjacent properties in the event of failure. May however, impact on the rail network. QTRA: N/A

Management Recommendations	Estimated Time	Priority	Comments
Further investigation			Hand tool excavation around northern side of union Rail specific risk assessment

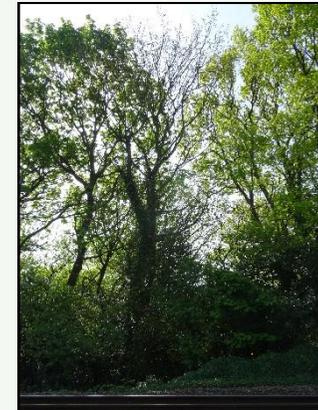
Tree 1.5 **Sycamore (*Acer pseudoplatanus*)**

Tree located within compartment one, towards top of embankment. Anchored on steep bank with highly adapted rooting system. Void beneath main stem probed to depth 400mm. Tight fork with extensive included bark between codominant stems. Leaves just emerging at time of inspection, later than those of adjacent trees of the same species. Unlikely to reach road or adjacent properties in the event of failure. May however, impact on the rail network. QTRA: N/A

Management Recommendations	Estimated Time	Priority	Comments
Further investigation			Remove epicormic growth & ivy & reinspect Rail specific risk assessment

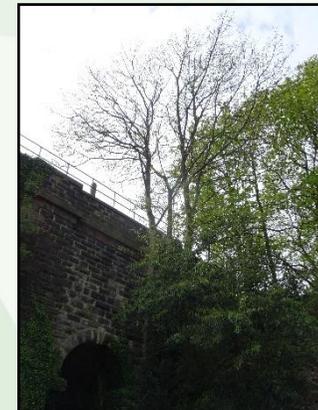
Tree 2.1 **Sycamore (*Acer pseudoplatanus*)**

Tree located within compartment two, immediately adjacent railway bridge MVL3/61. Multi-stemmed tree with tight unions and early onset included bark between codominant stems. Anchored on steep bank. Likely constricted rooting area due to proximity to bridge structure. Asymmetric crown. QTRA: Failure of codominant stem onto Holme Road.

Management Recommendations	Estimated Time	Priority	Comments
No work required
