## VISUAL STRUCTURAL INSPECTION REPORT

11 WOOD STREET,  
SKELMANTHORPE

MR S BOND

Report Ref:132/010/STR\_v1.0

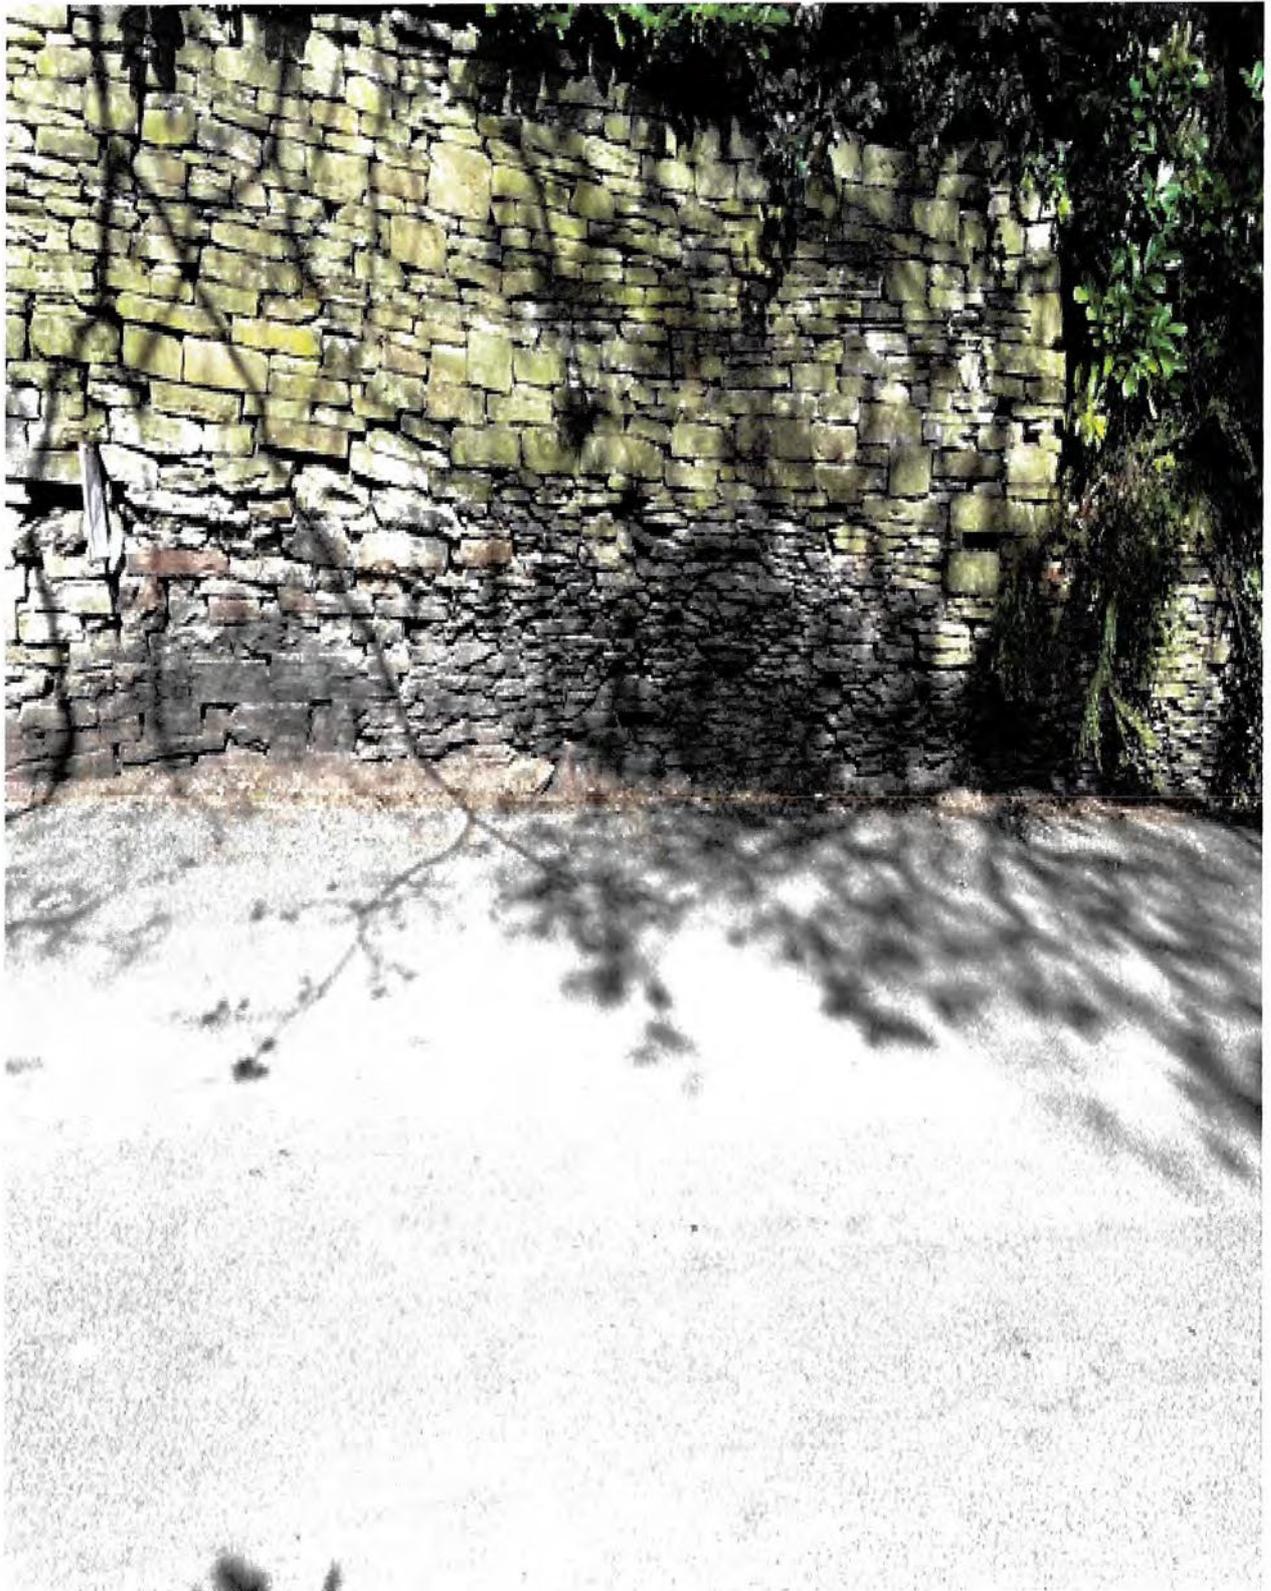
Title: **Area A Photos – photo A1**

- 3.2 A significant bulge was viewed to the wall (see photographs A1-A4). Also refer to Appendix B elevation drawing for Area A for the approximate location of this defect. Also refer to the section sketches in Appendix B. In addition to the bulge viewed to the wall, the masonry in this area appears to have been loosely stacked on the original dry stone wall.

- 4.1 The wall is clearly in a poor state of repair as evidenced by the photographs provided in this report. The wall has been repaired several times in the past clearly demonstrating that the condition of the wall is deteriorating over time. The bulge in the wall in Area A in particular is a clear indication of the poor condition of the wall.

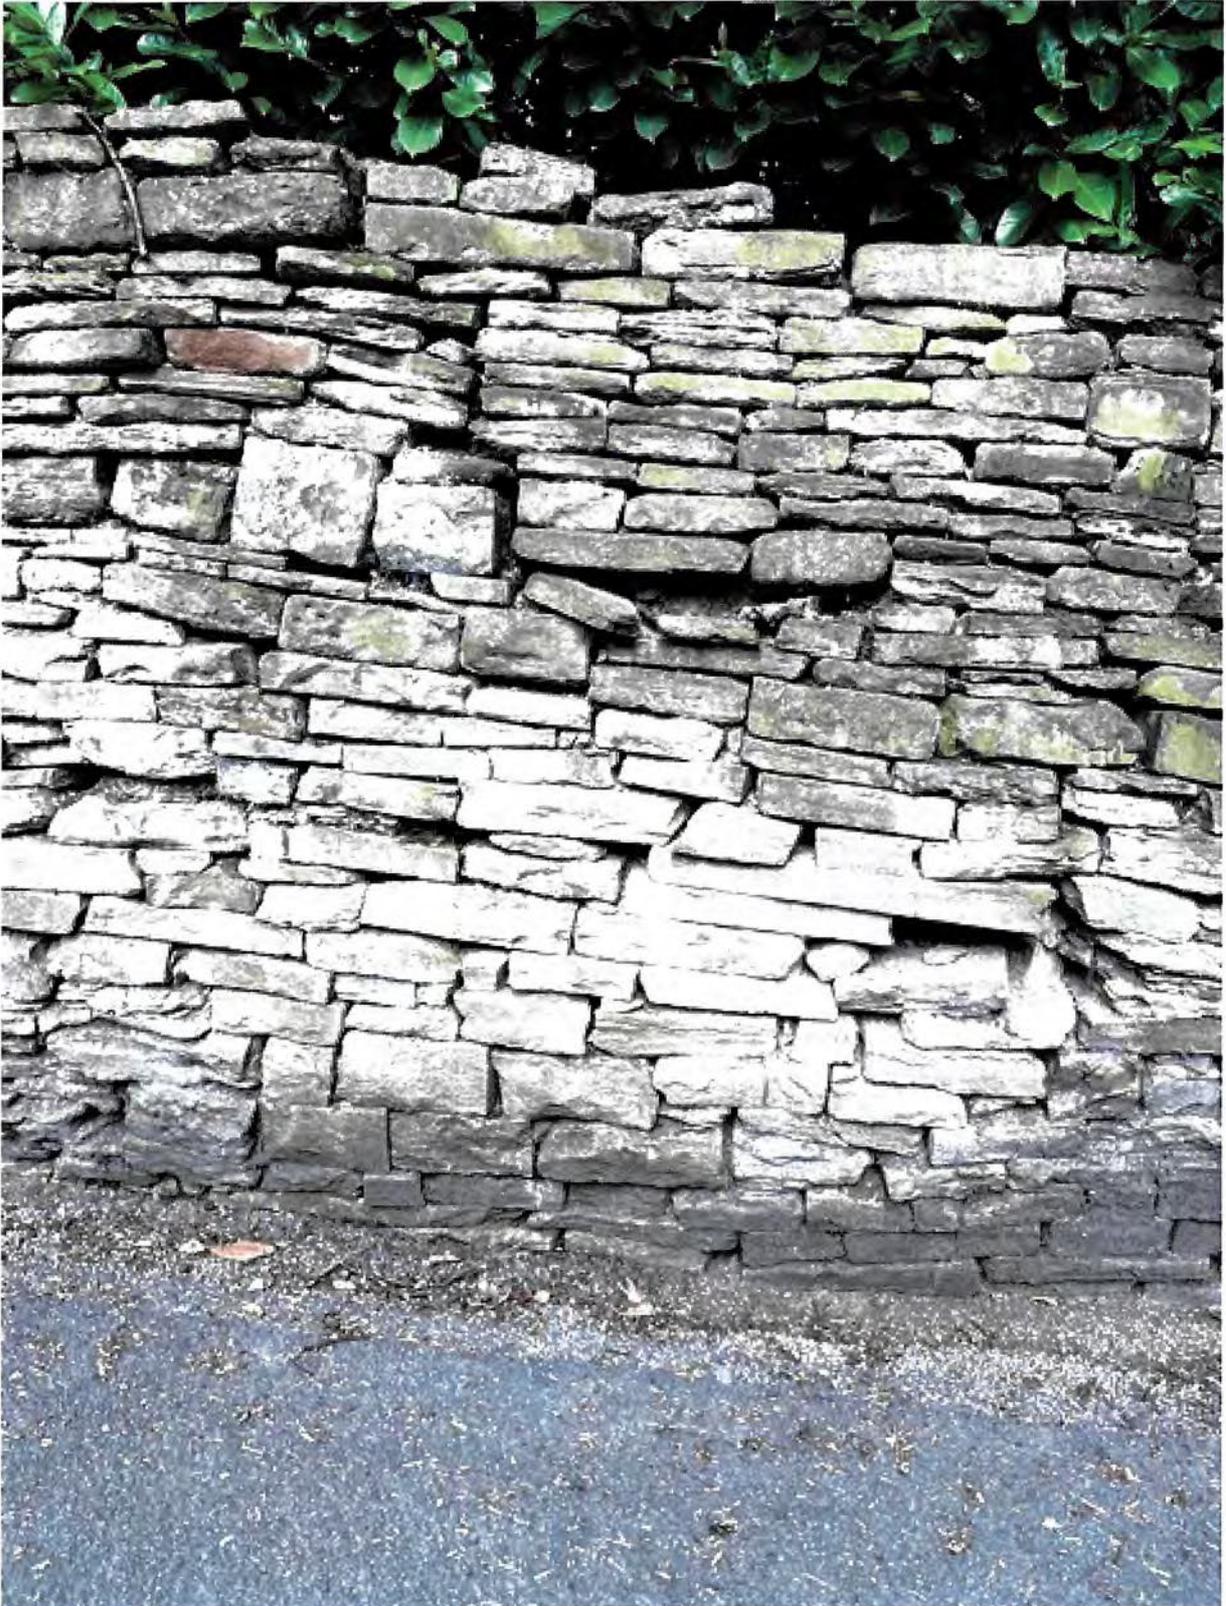
Title: **Area B Photos – photo B1**

- 3.3 A previous localised repair is evident to Area B, see photographs B1 - B3 and elevation drawing Area B in Appendix B.
- 3.4 We have been advised that repairs have been undertaken on several occasions including in 2004, 2010/2011 and 2016. The 2016 repair was undertaken by Kirklees Council and is indicated as Area C in the elevations included in Appendix B and photograph C1 in Appendix A.

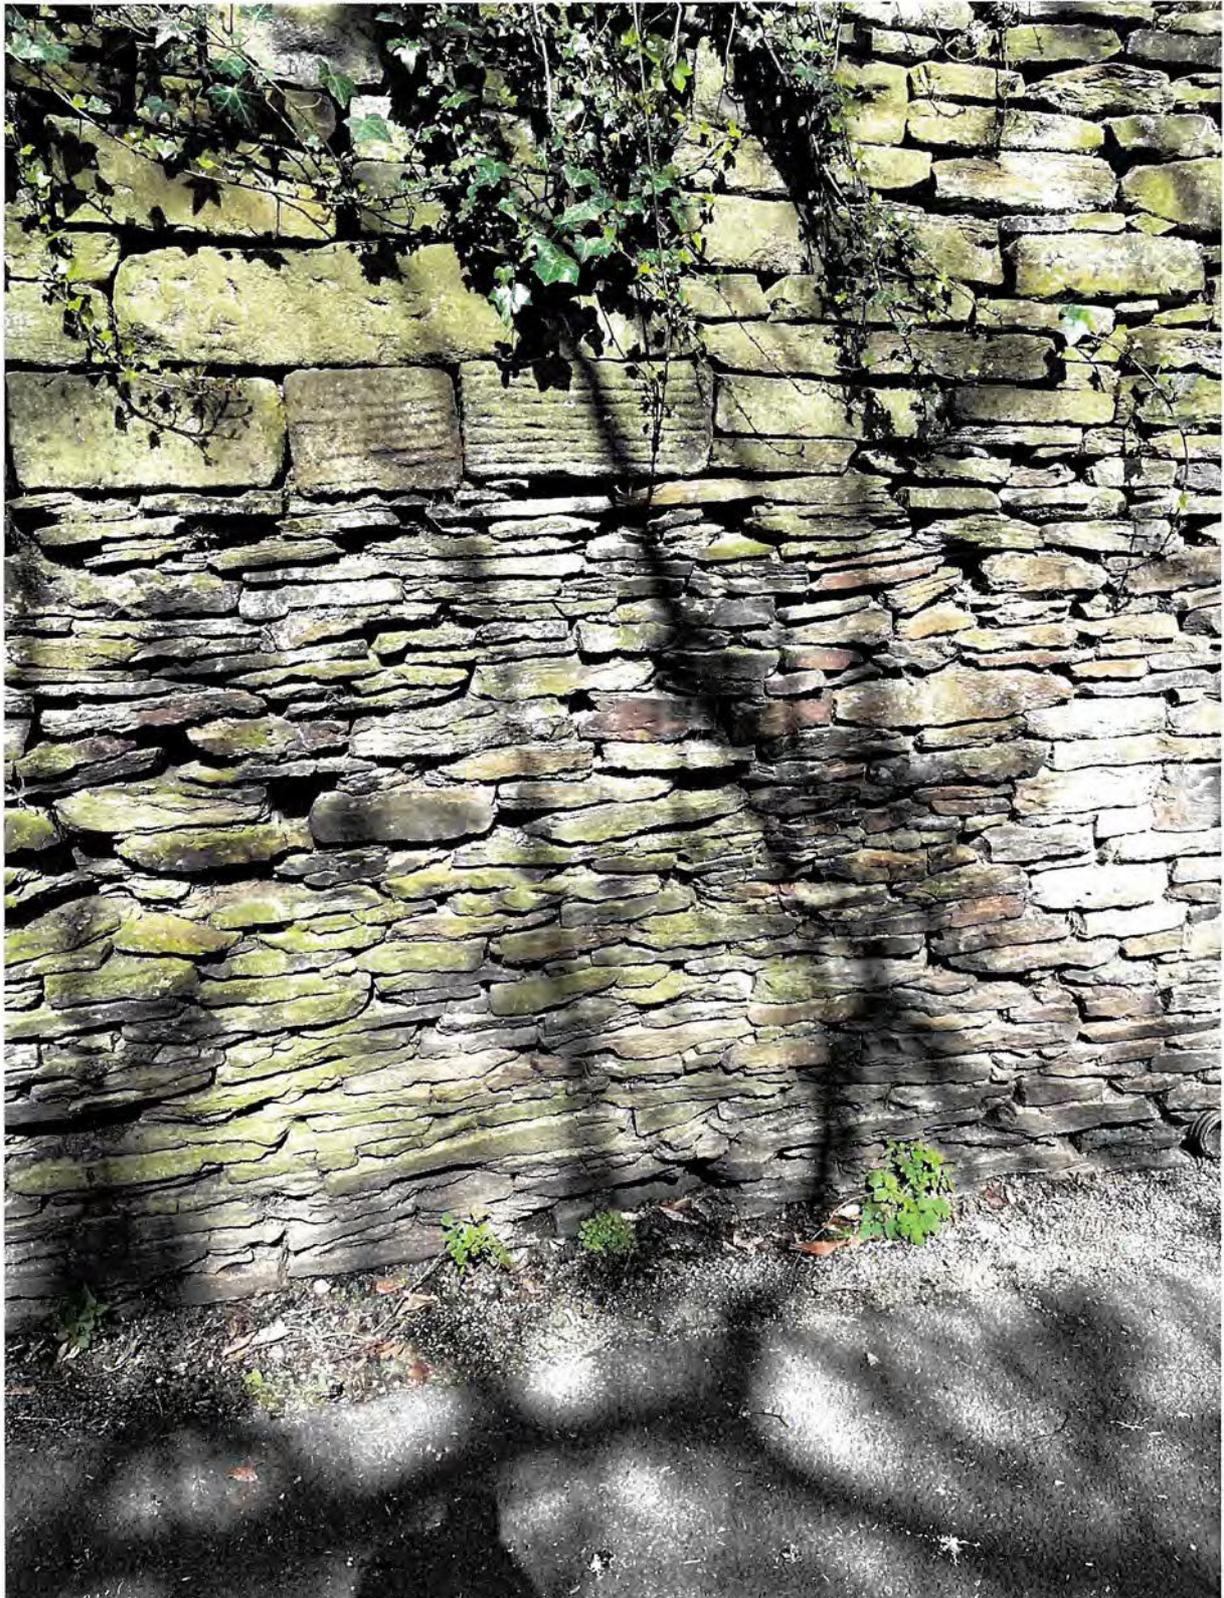
Title: **Area D Photos – photo D1**

- 3.5 In Area D (refer to elevations in Appendix B), a stone wall appears to have been constructed directly on top of an original dry stone wall at some point in the past. Numerous voids are present within the walling in this area, refer to photographs D1 - D5 in Appendix A.

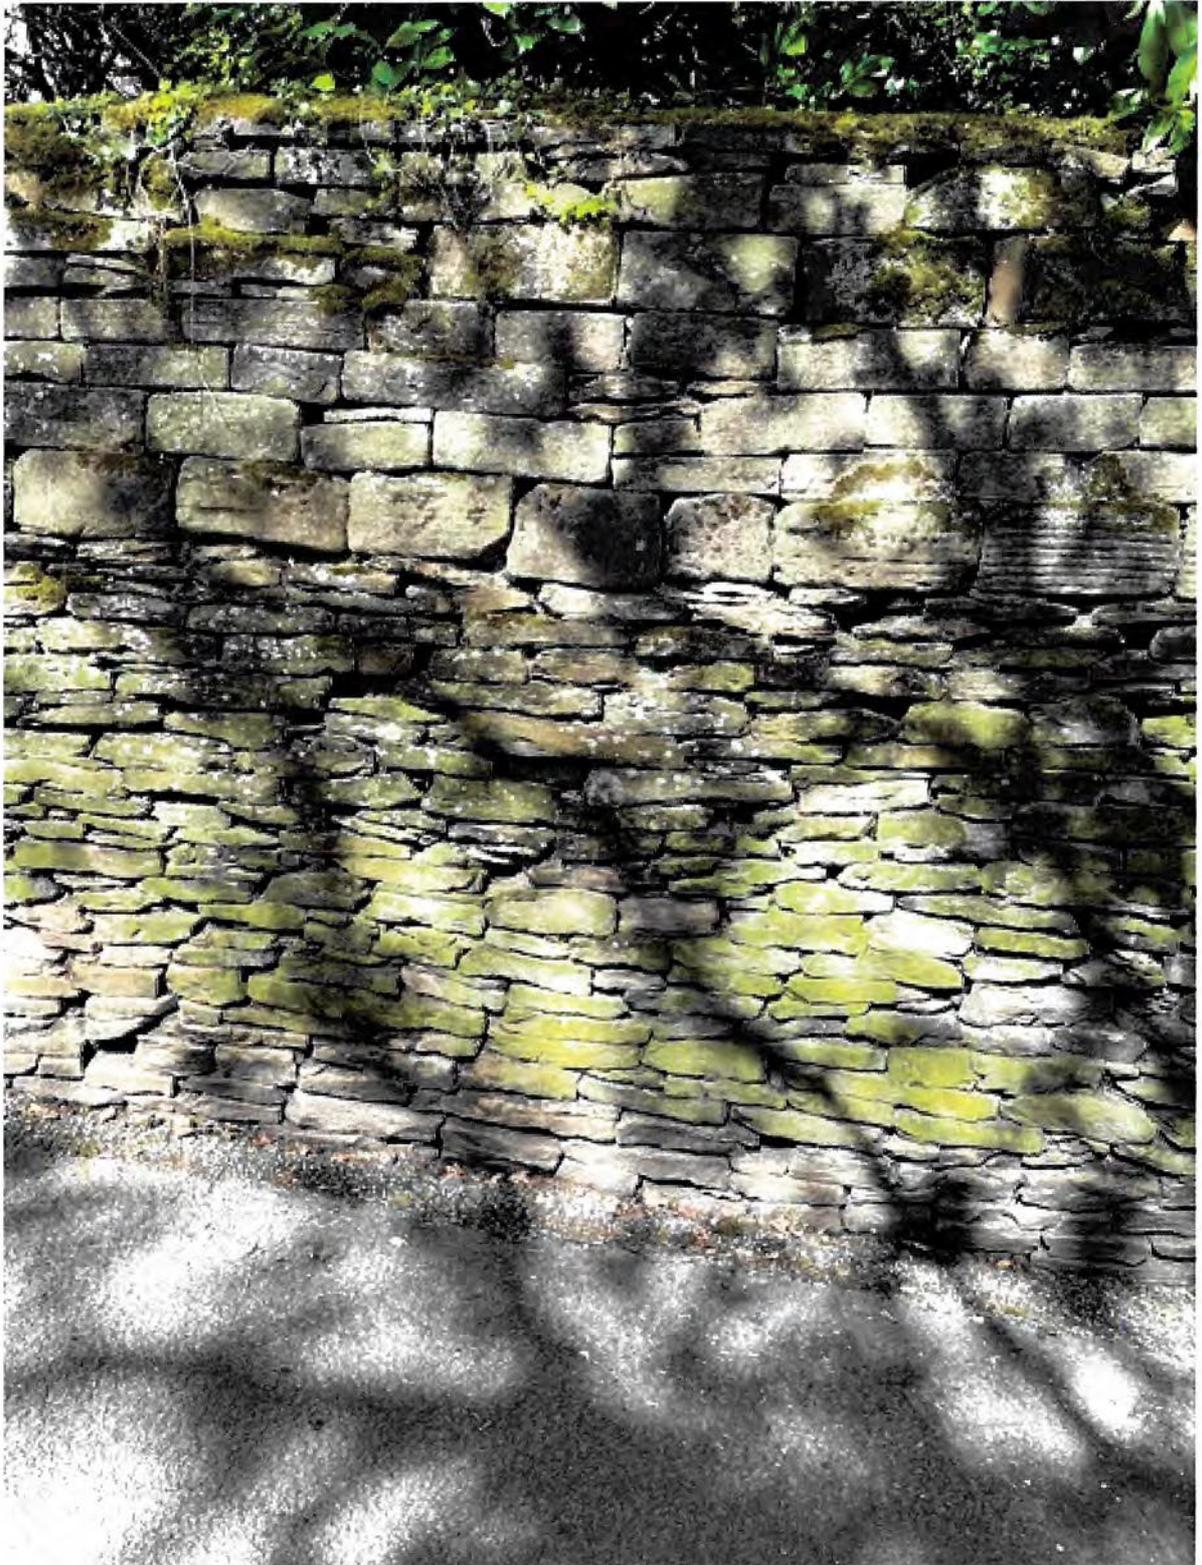
Title: **Area E Photos – photo E1**

- 3.6 In Area E (refer to elevations in Appendix B), as with Area D, a stone wall appears to have been constructed directly on top of an original dry stone wall at some point in the past. Numerous voids are present within the walling in this area, refer to photographs E1 - E3 in appendix A.
