Drainage Report

Site
Warren McNab
60 Lister Street
Moldgreen
Huddersfield
HD5 8BB

4549 McNab - CCTV Survey Report : 24/05/23

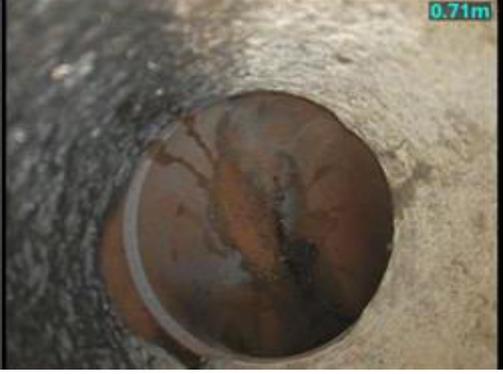
00.70m	0:00:14	BJ	Broken pipe from 06 o'clock to 09 o'clock at joint - Severity 4	Image Provided - Ref: 0_2

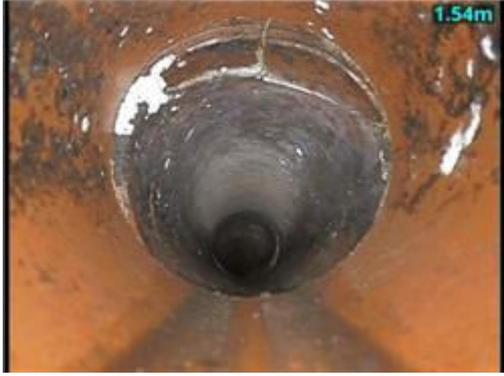
01.50m	0:00:37	BJ	Broken pipe from 10 o'clock to 02 o'clock at joint - Severity 4	Image Provided - Ref: 0_6

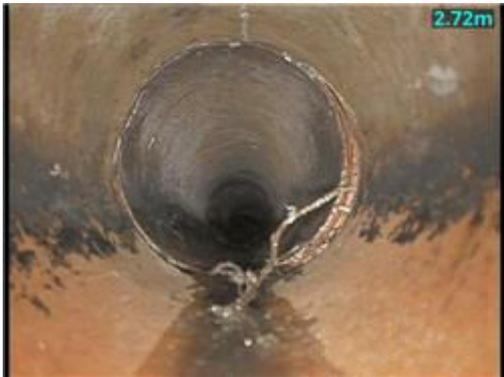
Pos	Video Ref	Code	Description	Image
02.70m	0:01:18	RJ	Roots at joint - Severity 3	Image Provided - Ref: 0_7

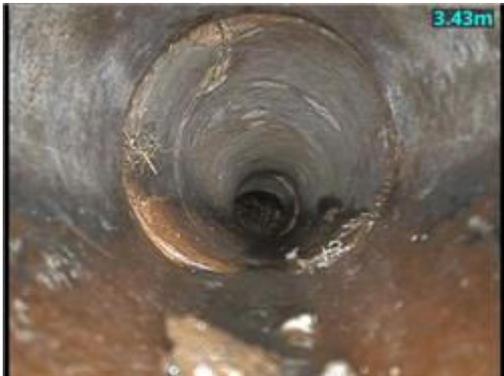
03.40m	0:01:31	RJ	Roots at joint - Severity 3 Band: F	Image Provided - Ref: 0_8

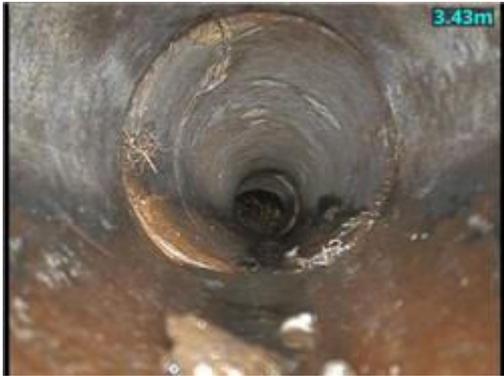
03.40m	0:01:35	FCJ	Fracture circumferential from 07 o'clock to 12 o'clock at joint - Severity 3	Image Provided - Ref: 0_9

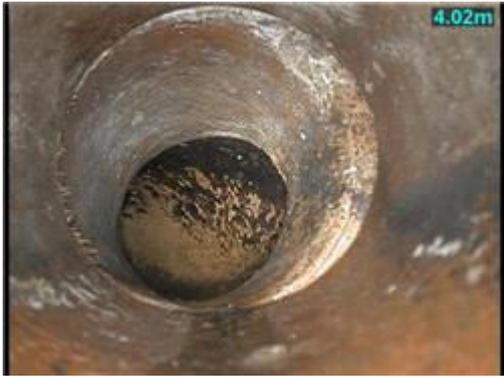
04.00m	0:01:48	RJ	Roots at joint - Severity 3 Band: F	Image Provided - Ref: 0_10

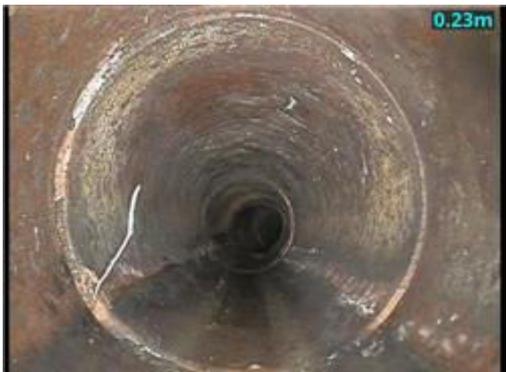
00.20m	0:00:10	RJ	Roots at joint - Severity 3 Band: F	Image Provided - Ref: 1_2

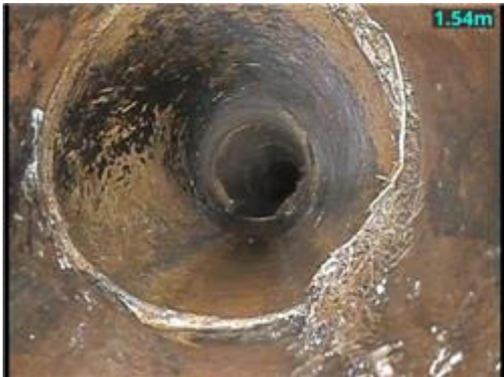
Pos	Video Ref	Code	Description	Image
01.50m	0:00:24	RJ	Roots at joint - Severity 3	Image Provided - Ref: 1_3

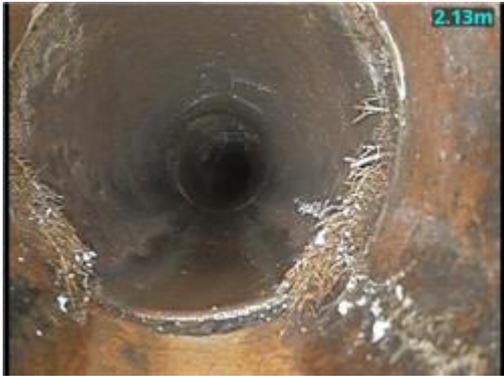
02.10m	0:00:40	RJ	Roots at joint - Severity 3	Image Provided - Ref: 1_5

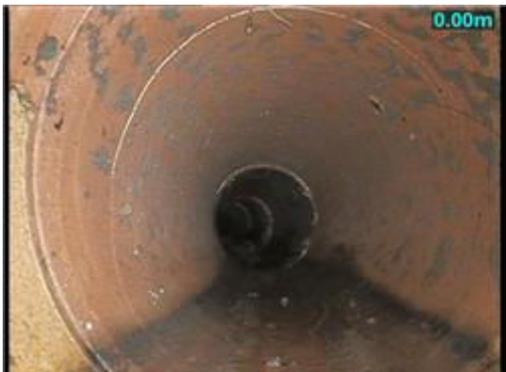
00.00m	0:00:00	CCJ	Crack, circumferential from 07 o'clock to 02 o'clock at joint - Severity 1	Image Provided - Ref: 2_2

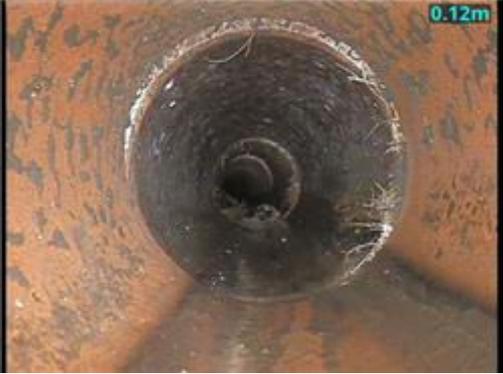
Pos	Video Ref	Code	Description	Image
00.10m	0:00:11	RJ	Roots at joint - Severity 3 Band: F	Image Provided - Ref: 2_3

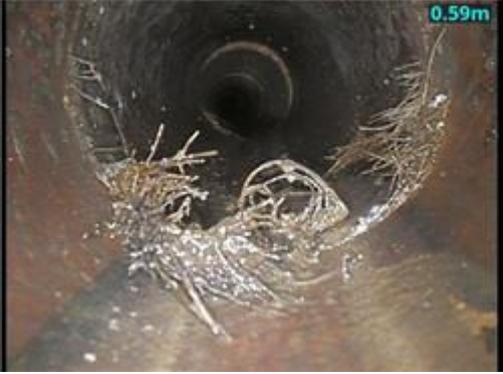
00.60m	0:00:21	RJ	Roots at joint - Severity 3	Image Provided - Ref: 2_4

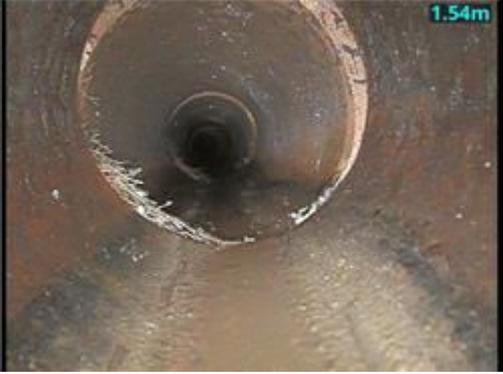
01.50m	0:00:33	R	Roots - Severity 3	Image Provided - Ref: 2_5

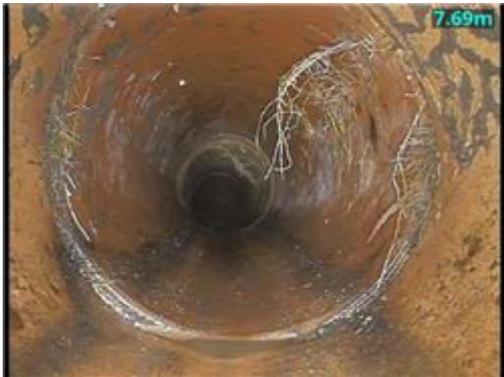
Pos	Video Ref	Code	Description	Image
07.70m	0:02:01	RJ	Roots at joint - Severity 3	Image Provided - Ref: 2_11

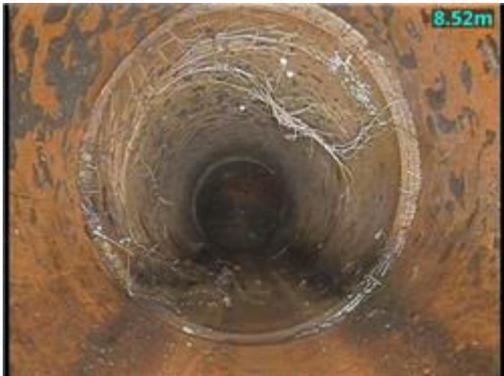
08.50m	0:02:10	RJ	Roots at joint - Severity 3	Image Provided - Ref: 2_12

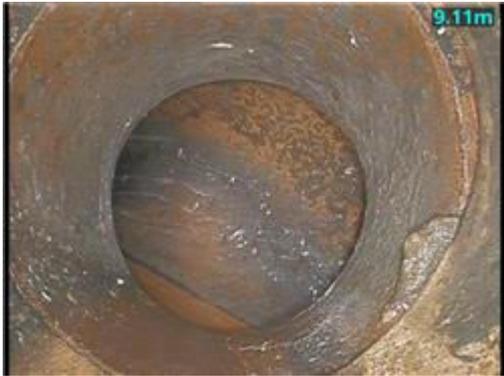
09.10m	0:02:23	DEEJ	Attached deposits, encrustation from 03 o'clock to 04 o'clock: 5% Cross sectional area loss at joint - Severity 3	Image Provided - Ref: 2_13

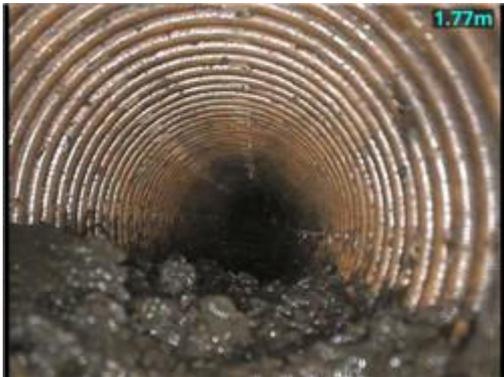
Pos	Video Ref	Code	Description	Image
01.80m	0:00:27	DES	Settled deposits fine: 25% Cross sectional area loss - Severity 3	Image Provided - Ref: 3_3

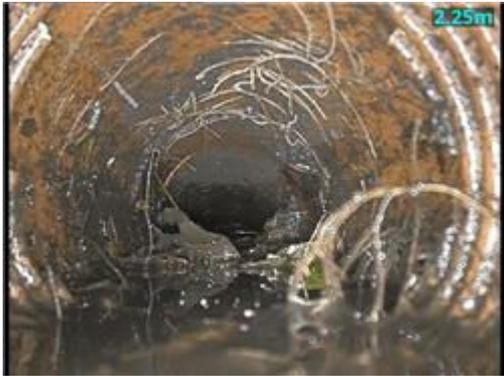
02.30m	0:00:39	RJ	Roots at joint - Severity 3 Band: F	Image Provided - Ref: 3_5

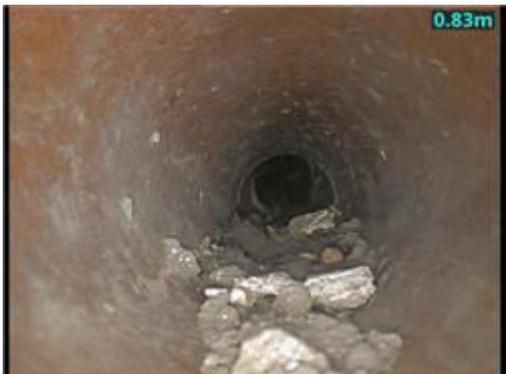
00.80m	0:00:14	DER	Settled deposits coarse: 20% Cross sectional area loss - Severity 3	Image Provided - Ref: 4_2

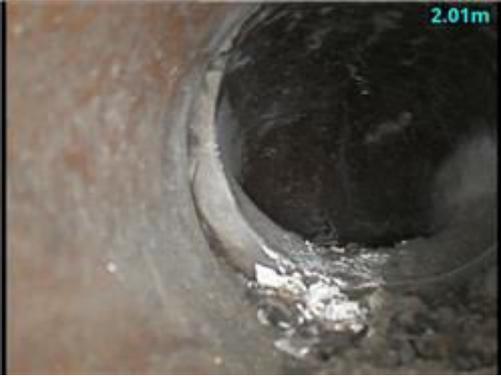
Pos	Video Ref	Code	Description	Image
02.00m	0:00:41	JDMJ	Joint displaced medium at joint - Severity 3	Image Provided - Ref: 4_3

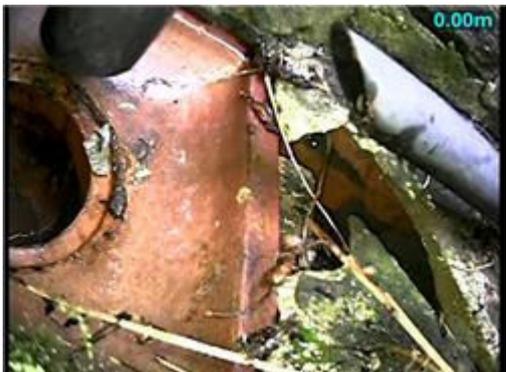
00.00m	0:00:12	REM	General remark LARGE VOID NEXT TO GULLY	Image Provided - Ref: 5_2

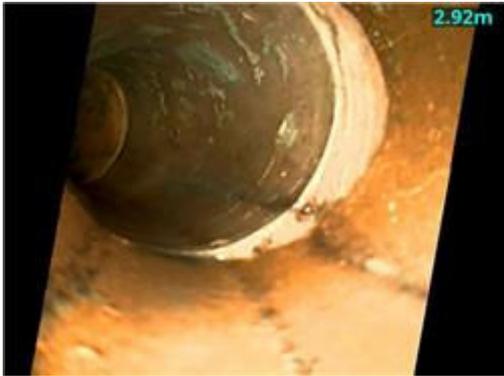
02.90m	0:03:12	JDMJ	Joint displaced medium at joint - Severity 3	Image Provided - Ref: 5_5

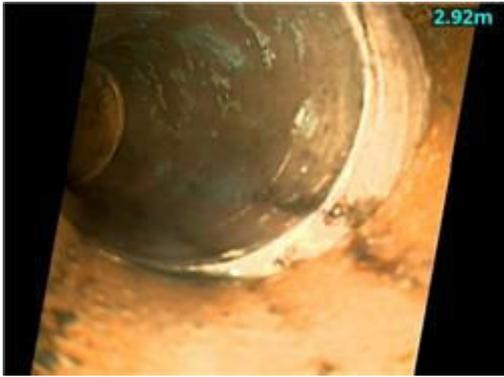
02.90m	0:03:15	LLHJ	Line of drain/sewer deviates left [half] at joint	Image Provided - Ref: 5_6
