Our Ref: E19/7612/JF/002A

**Re: Development at Cumberworth Road, Skelmanthorpe**

Further to your request we have attended the above site to undertake an inspection of the gas membrane to confirm that the quality of the installation is satisfactory in plots 8-14 at the above site.

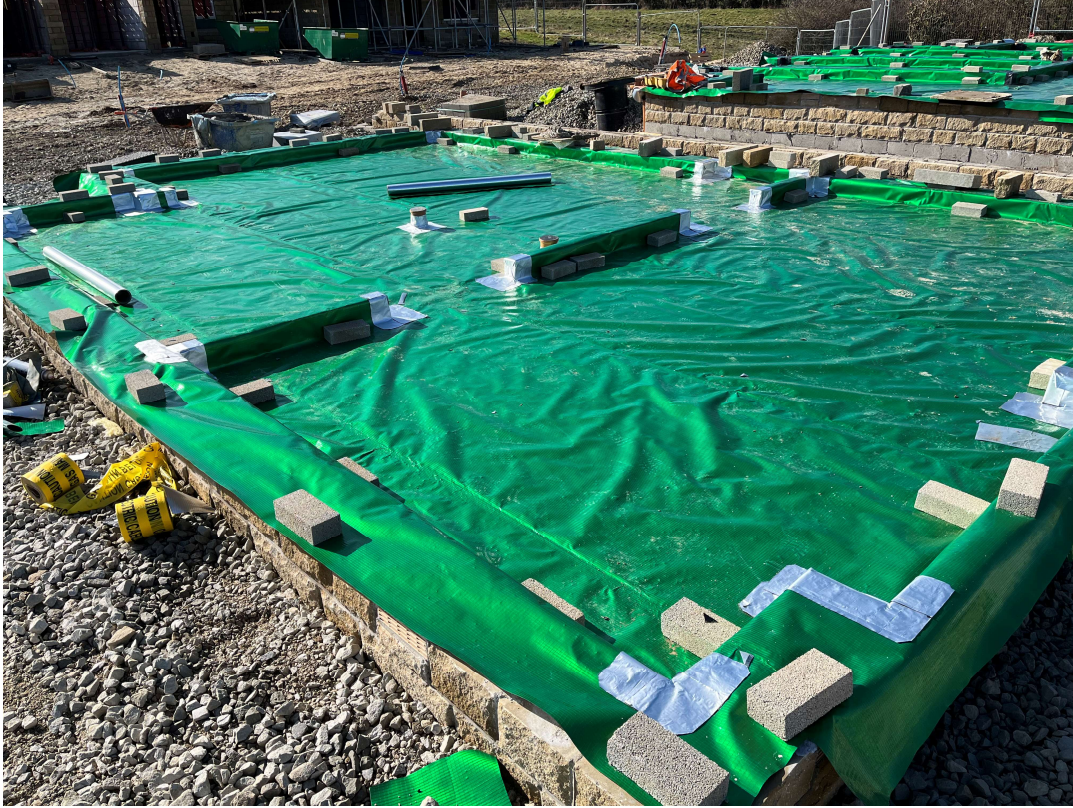
Plot 8 – Overall membrane layout

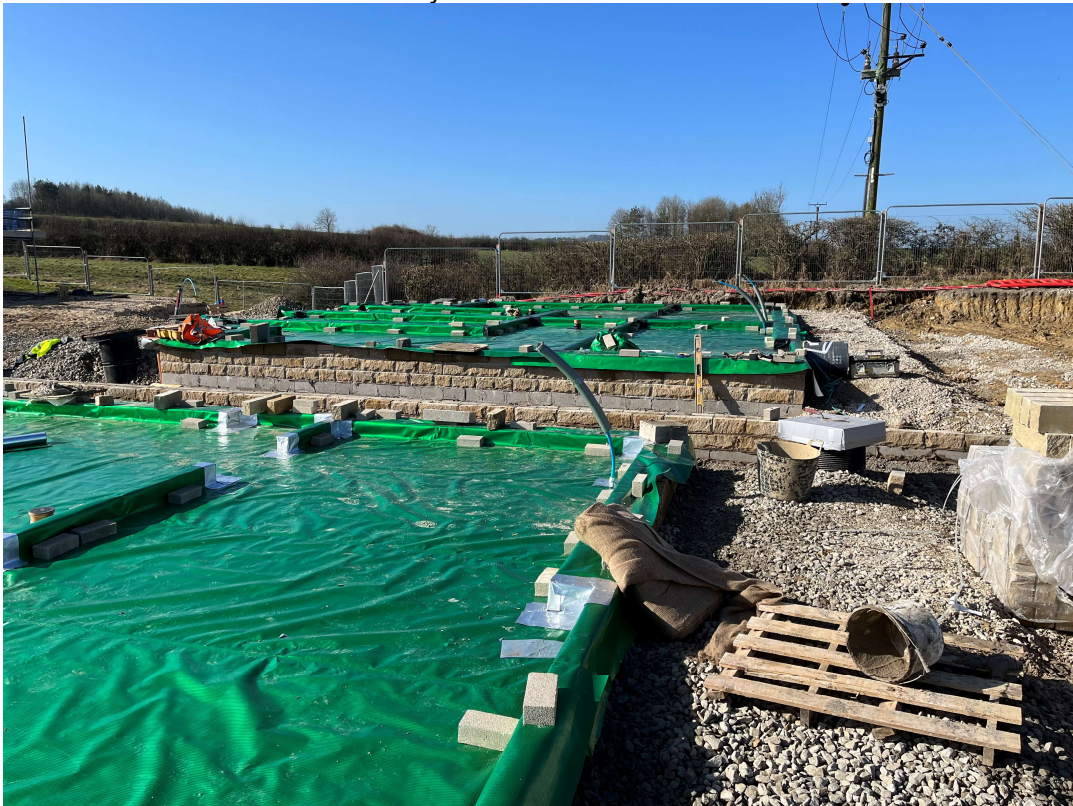
A lack of surface preparation was noted beneath the membranes on plots 8 – 10. However, following a thorough visual & hands-on inspection, we can confirm that there were no rips or tears in the membrane as a result of any debris beneath. Insulation was also installed immediately after the inspection and followed by screed pour to ensure no damage occurred.

Plots 8 - 10 – Overall membrane layout

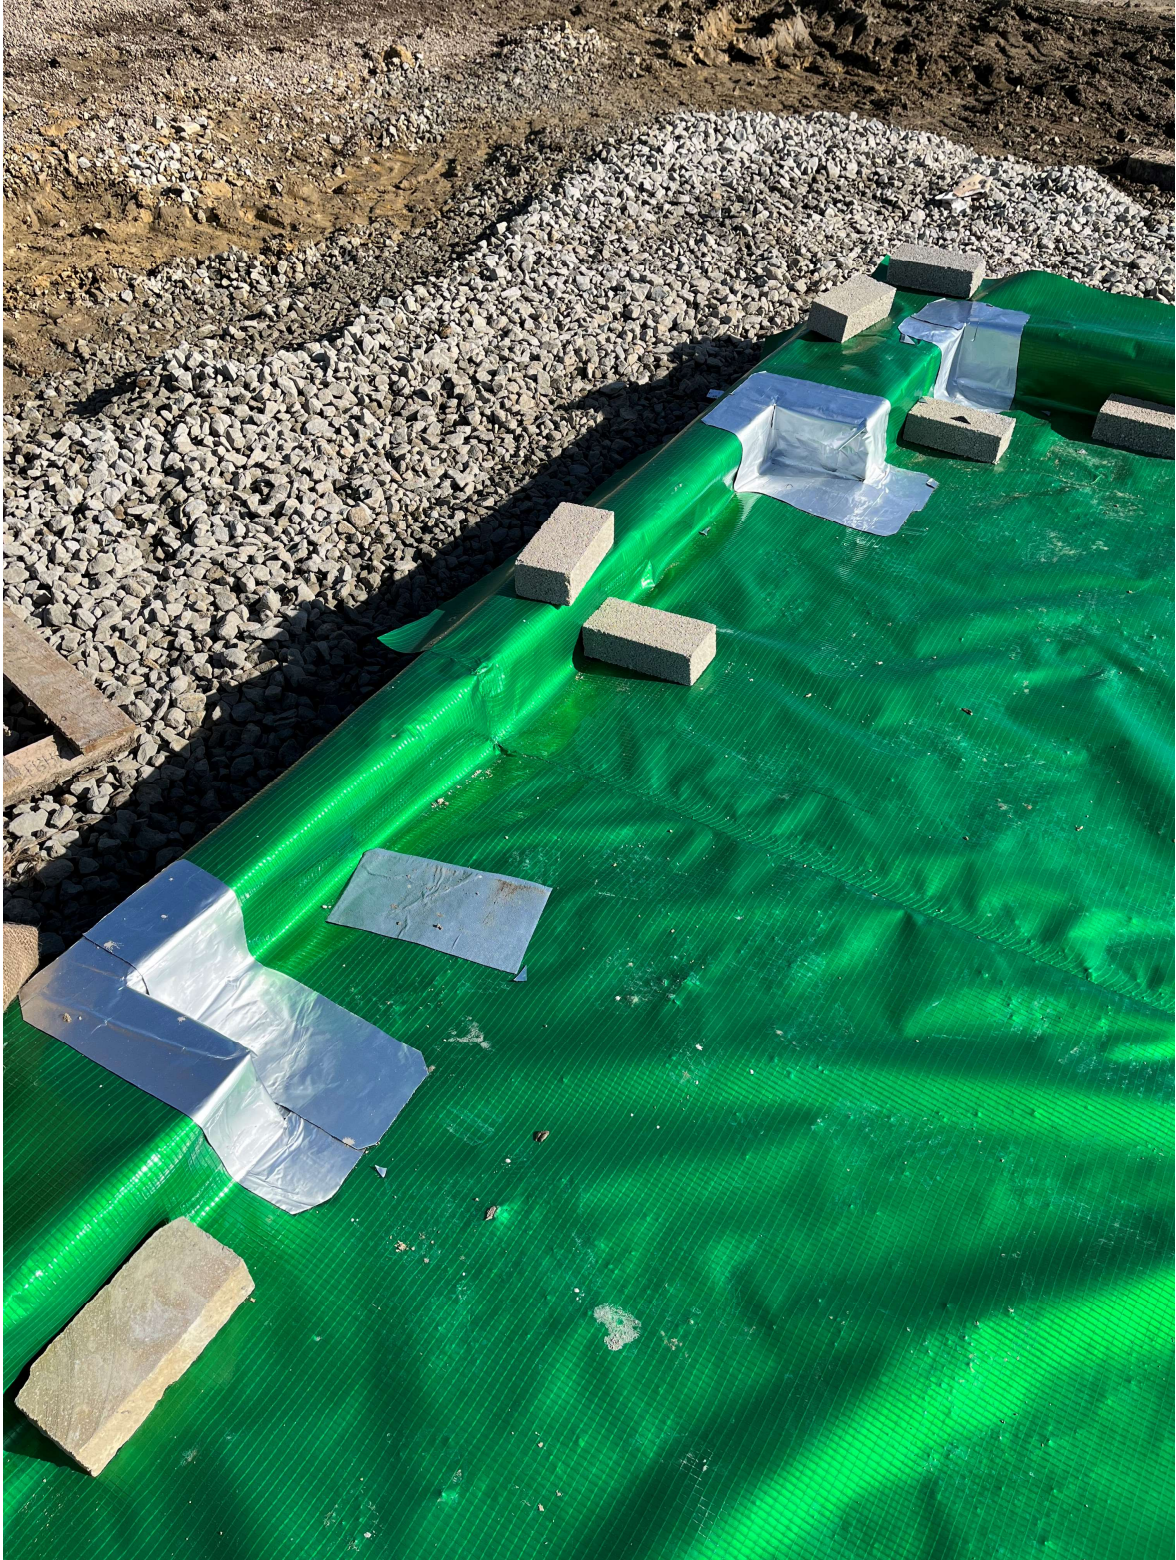
Plot 8 – Membrane layout with jointing

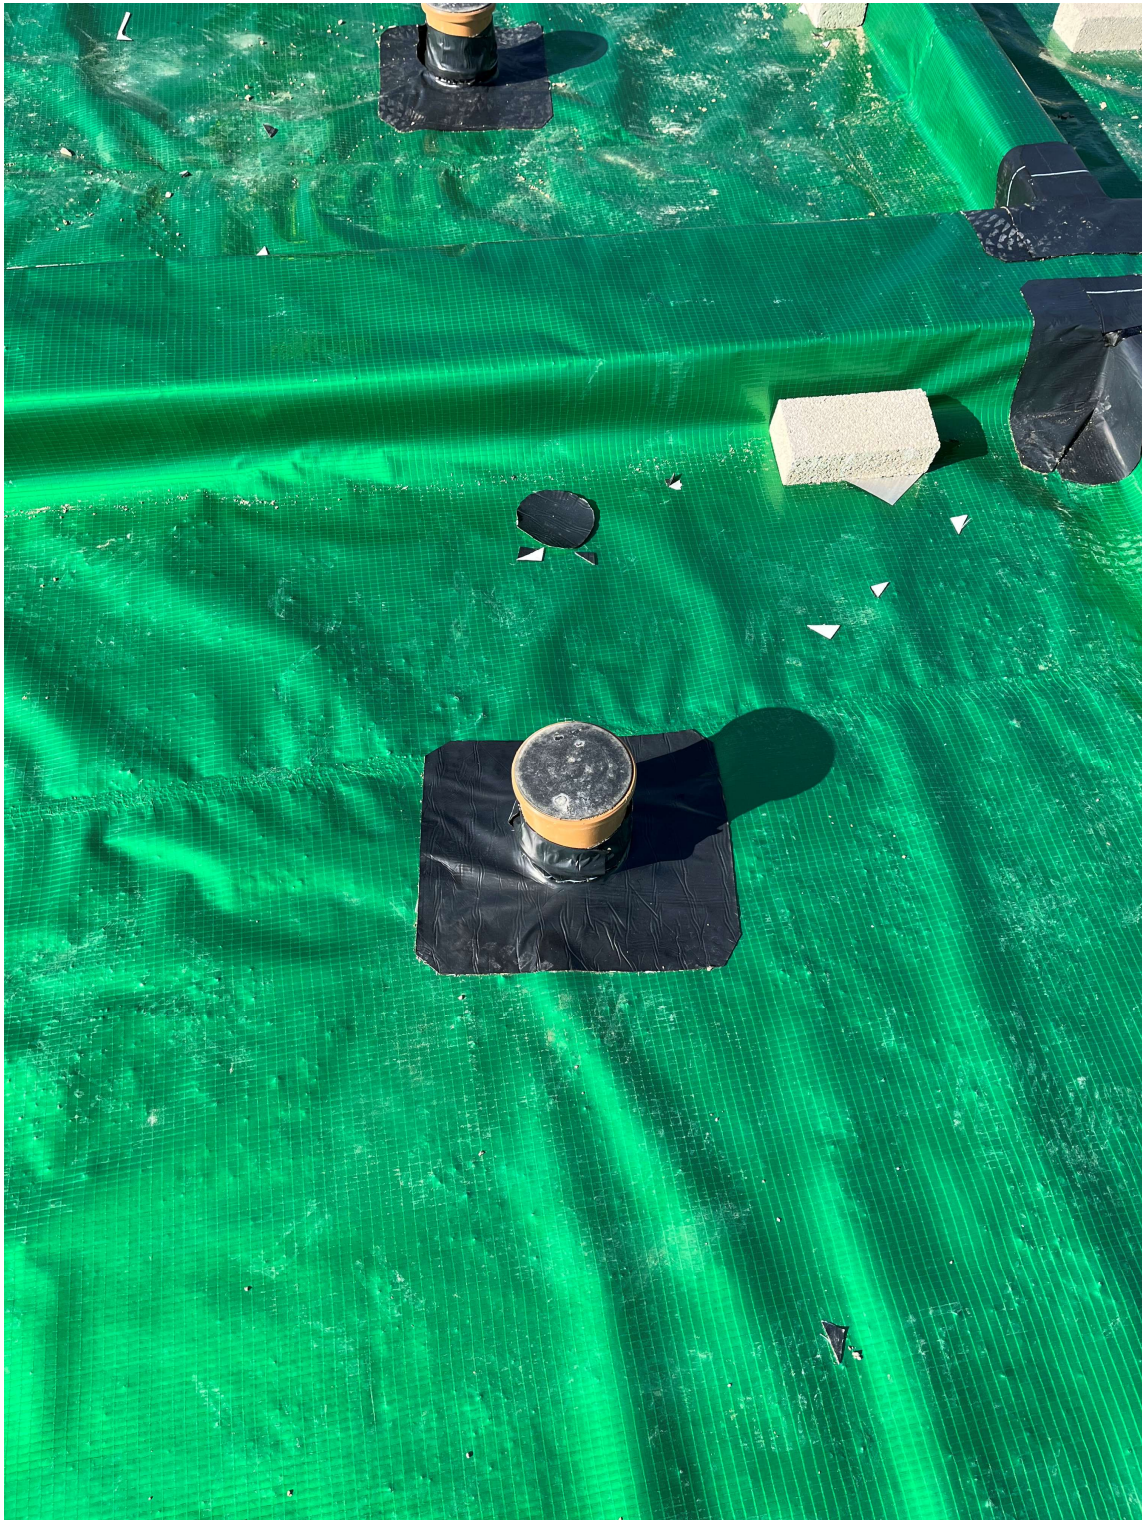
Plot 9 & 10 – Tophat & membrane layout with jointing

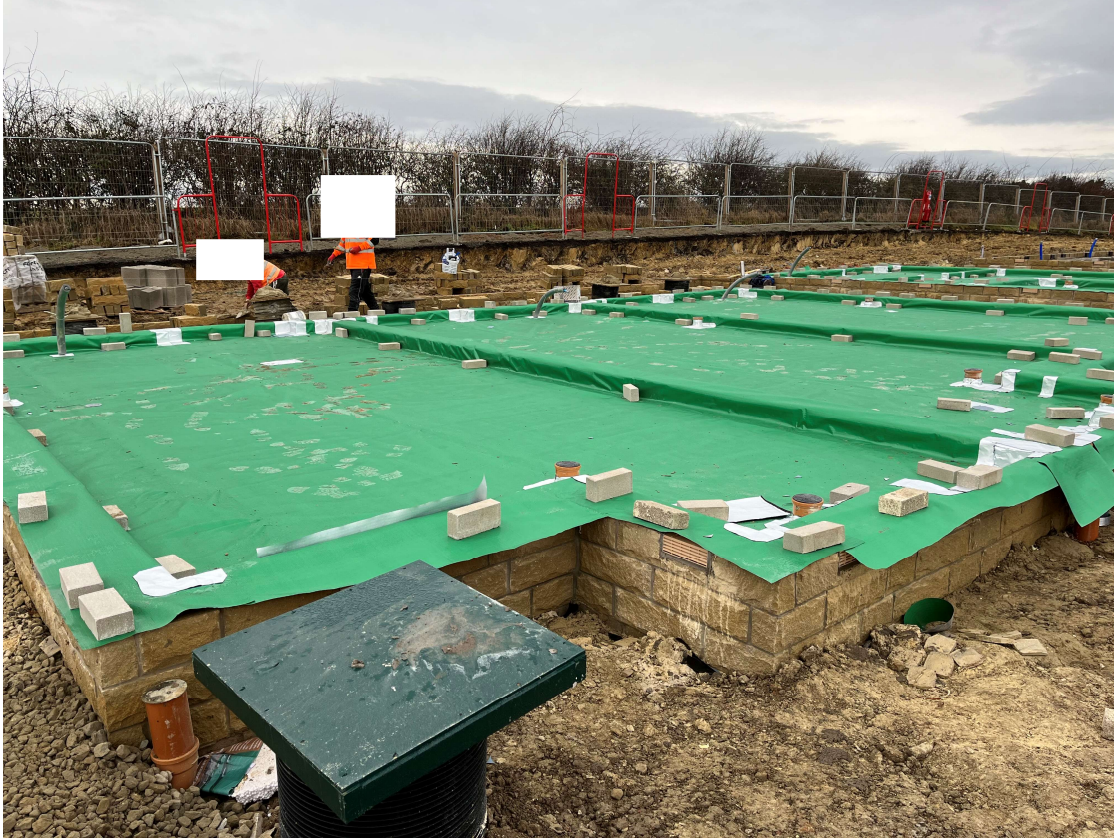
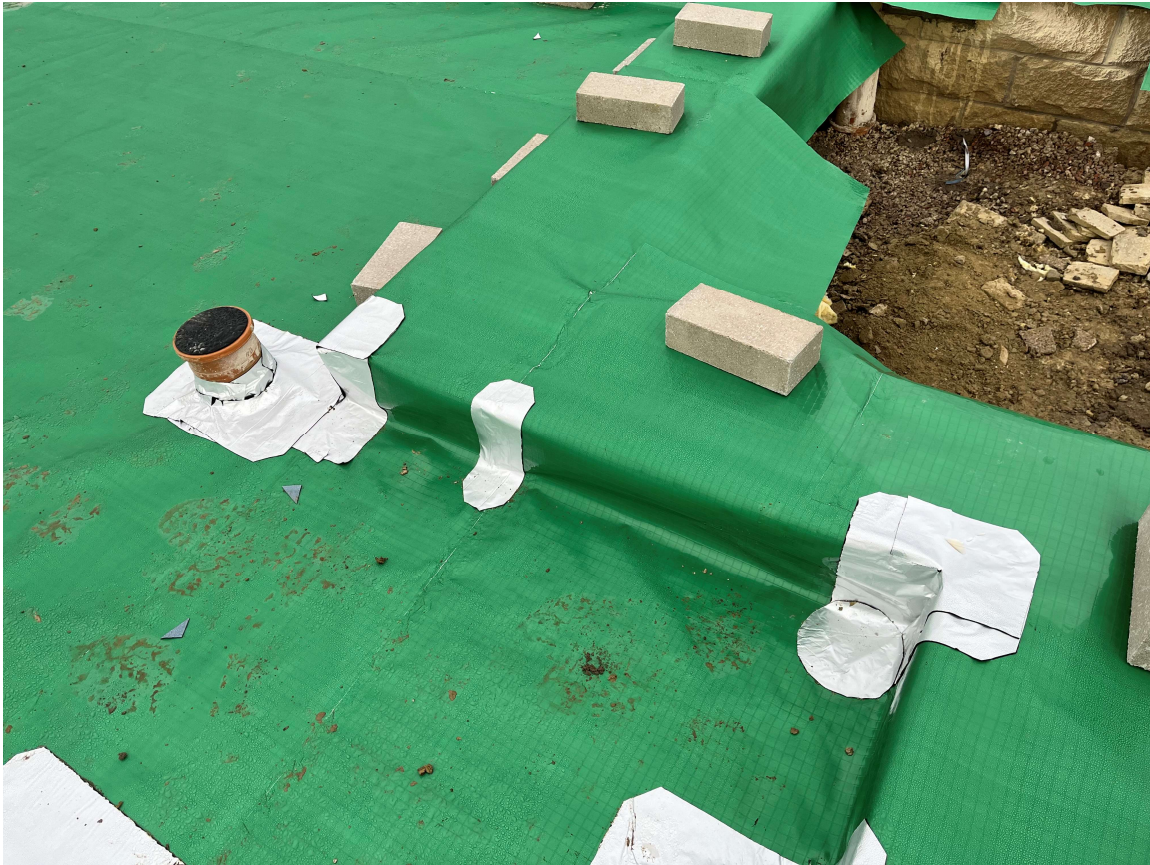
Plots 11 – 13 – Overall membrane layout

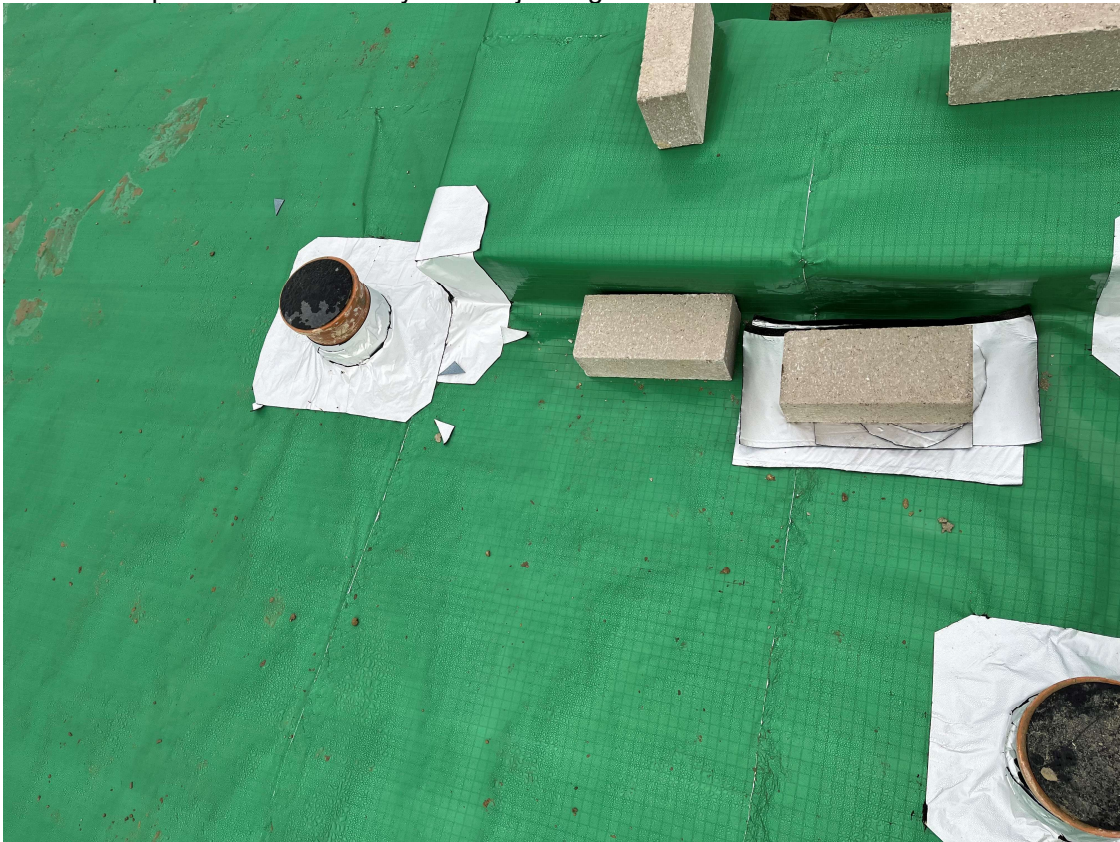
Plot 11 – Tophat & membrane layout with jointing

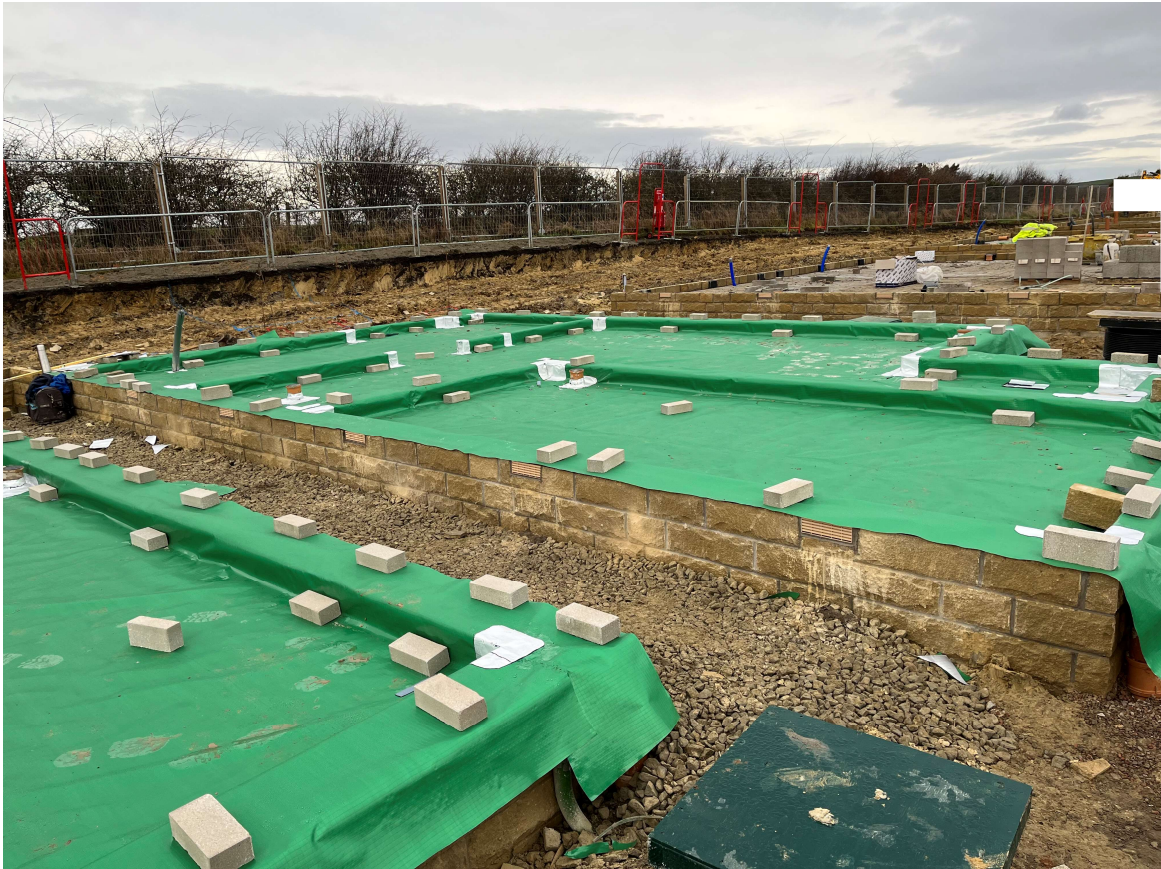
Plot 14 – Overall membrane layout
