Annual Tree Health & Woodland Inspection.

Woodland Place.

2689.

14th June 2023.

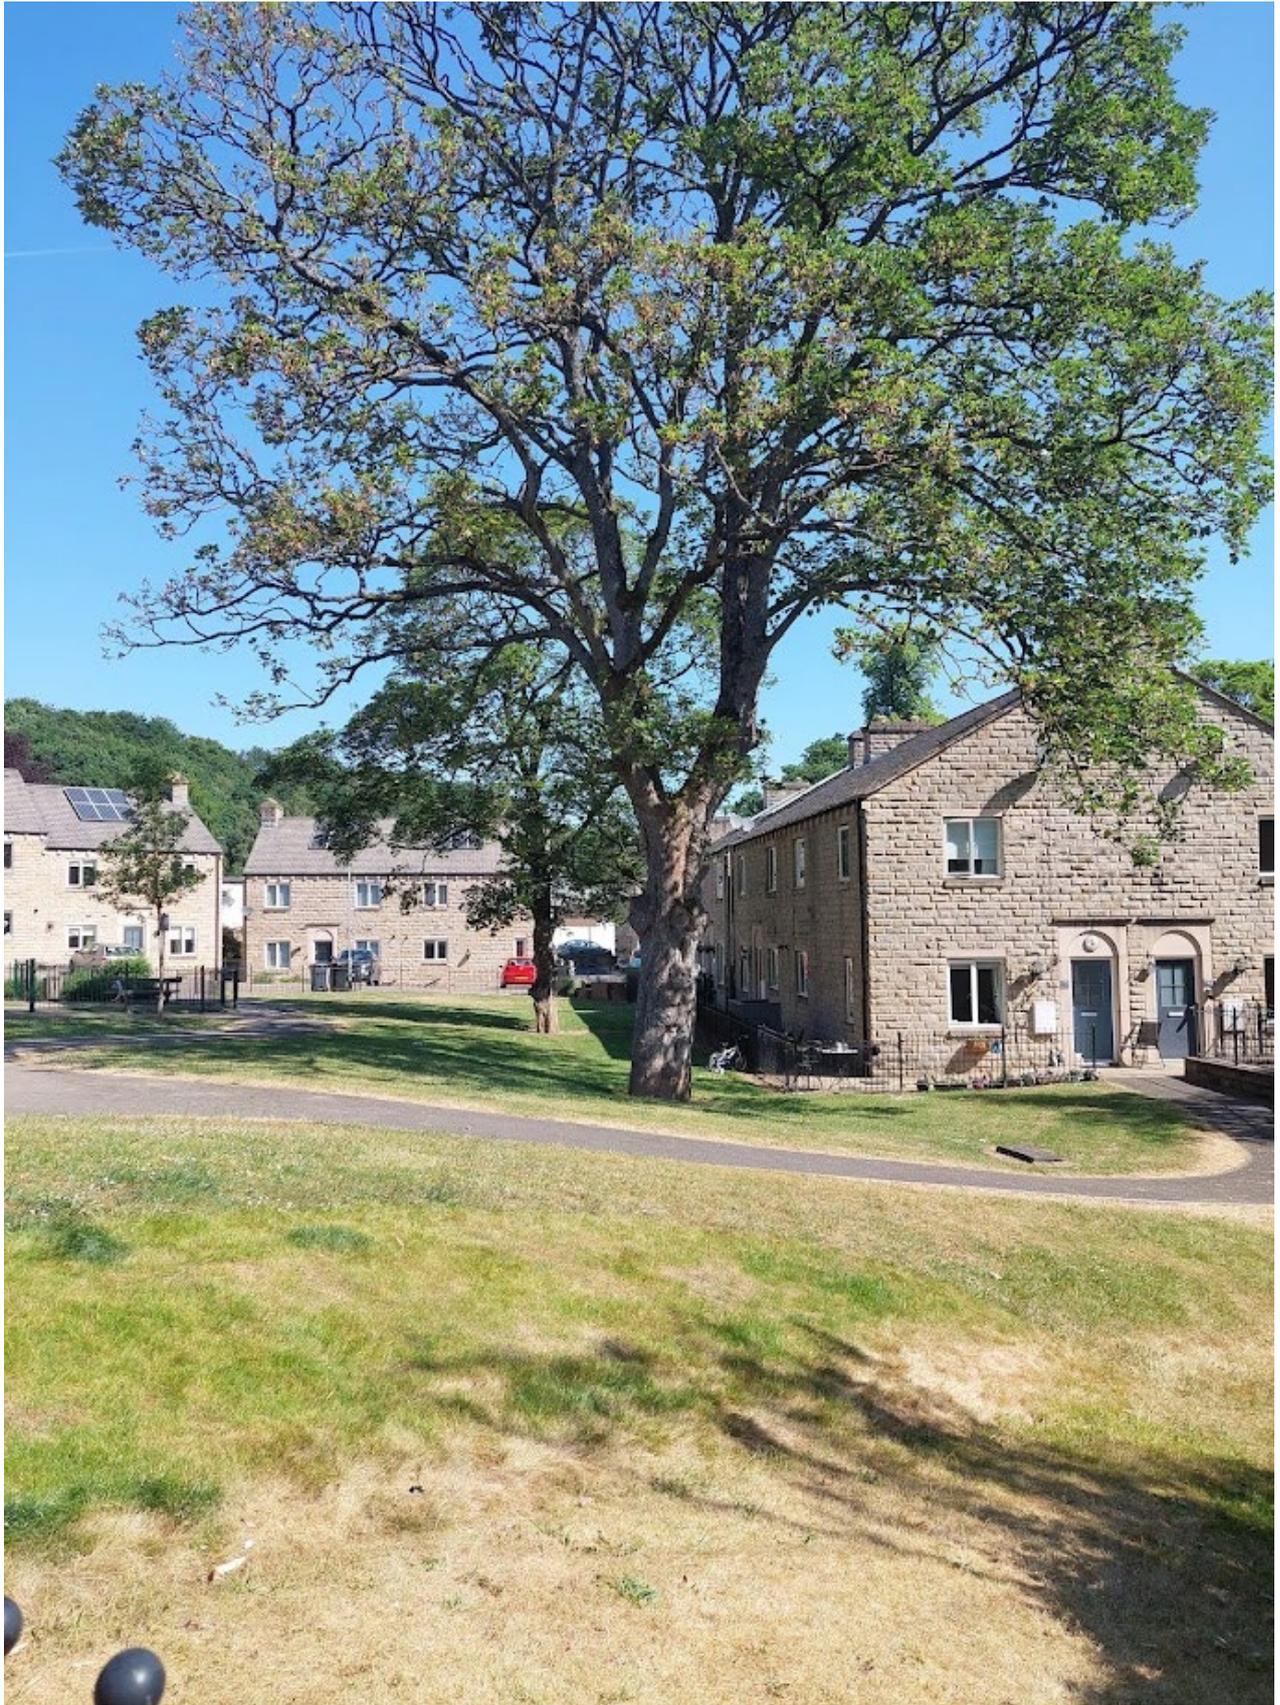
T1 and T2 are both suffering from stress most likely caused by the development, drainage pit at bottom of tree, their health is in decline exhibiting stress. Sparse canopies, small foliage, discoloured foliage.

T1 & T2, small foliage, discoloured foliage, sparse canopies.
